# Housing and Property Chamber First-tier Tribunal for Scotland

## Decision with Statement of Reasons of the First-tier Tribunal for Scotland (Housing and Property Chamber) under Section 24(1) of the Housing (Scotland) Act 2006

Chamber Ref: FTS/HPC/RT/19/0942

Property Address: 14 Dundonald Street, Dundee DD3 7PW (“the house”)

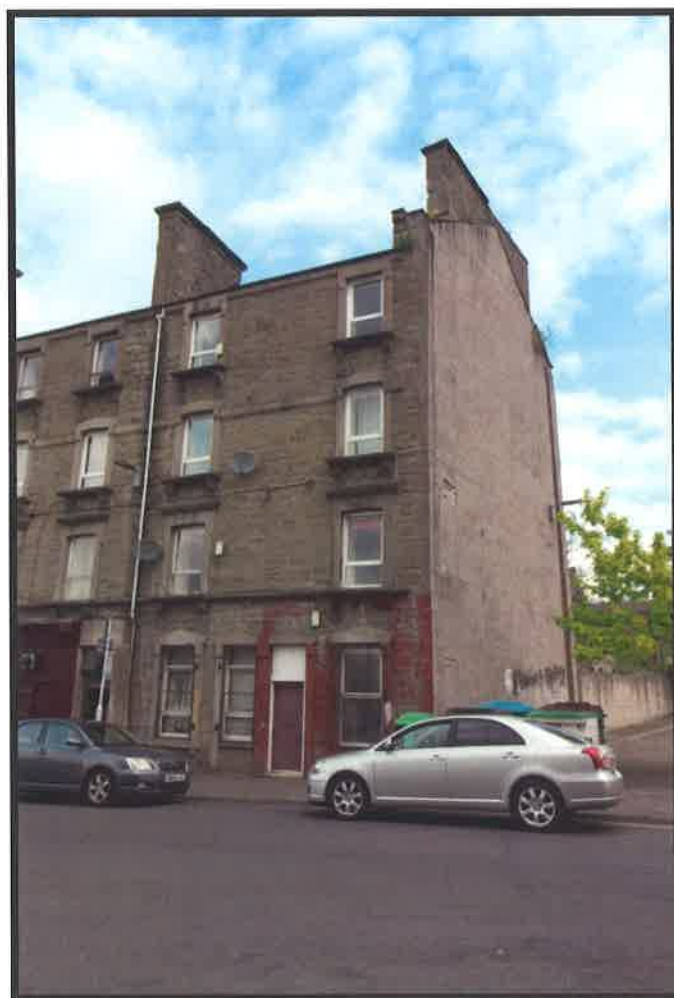
Figure 1 Front Elevation

- (xiii) The pointing to the stonework around the front elevation of the flat was seen to be weathered with some areas missing and there were cracks to the concrete areas. A vertical crack was seen close to the junction of the gable and front elevation running from ground level to around the second floor level. There are some areas of missing render which expose brickwork and timber lintels. Vegetation growth was seen to the masonry at the gable and front elevation.

- (12) To ensure that the extractor fan within the bathroom operates.
- (13) To point the stonework around the front elevation of the flat and to deal with the cracks close to the junction of the gable and front elevation.

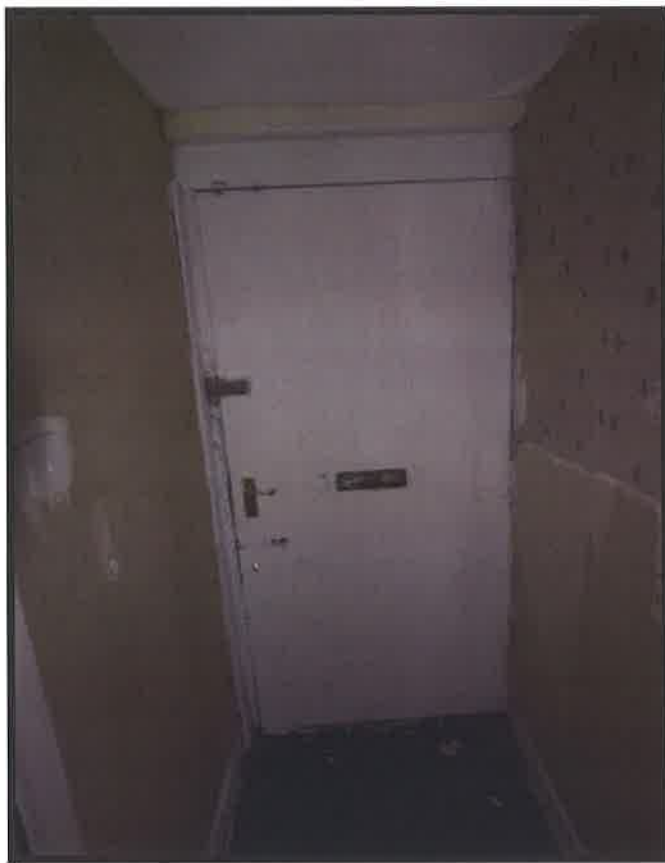
Figure 2 Inside face of front door.

- (ii) There was no heat or smoke detection within the lounge/kitchen.
  - (iii) The floor coverings throughout were seen to be soiled.
  - (iv) The front door is not wind and waterproof. The main deadlock to the door could only be moved with a key on the outside of the door so the door could not be properly secured from inside the flat other than by way of cylinder lock. There was damage to the wall linings from impact from the door handle. There was no draught excluder fitted.

- (3) To replace the floor coverings throughout the property to render it reasonably fit for human habitation.
- (4) To ensure that the entry door to the property is secure and draught proof and fits into a doorframe and that the main deadlock can be secured from within the property.

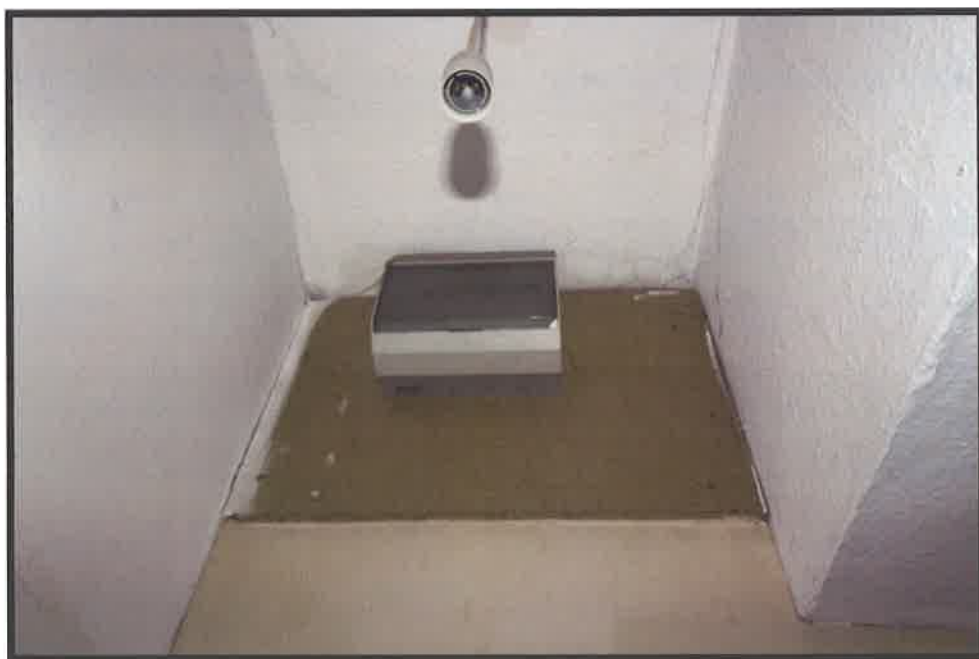
Figure 3 Consumer unit.

(xiv) Throughout the inspection there was aspects of the electrical installation which gave cause for concern, such as the bare electrical conductors at the airing cupboard, various loose fittings, the defective hob and extractor fan and lack of evidence of recent electric testing.

- (16) To arrange for a check of the electrical apparatus within the property and to provide a copy of the Electrical Installation Condition Report confirming that the installation is "satisfactory" with no C1 or C2 defects.

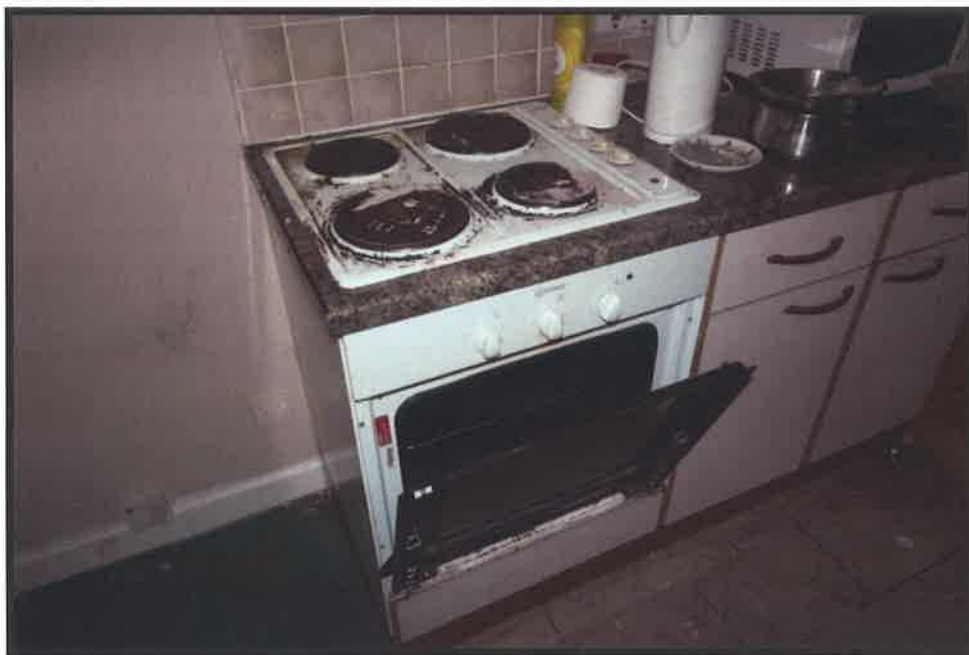
Figure 4 Oven and hob.

3. There is a significant amount of work to be undertaken to the property in relation to the following:-
  - (i) The oven and hob needs to be either replaced or repaired. The cooker rings do not work. The oven door is broken.

- (1) To repair or replace the hob to ensure that it is working order and to ensure that there is an outer door on the build-under oven.
- (2) To ensure the provision of heat and smoke detection within the lounge/kitchen interlinked with the inner hall smoke alarm.

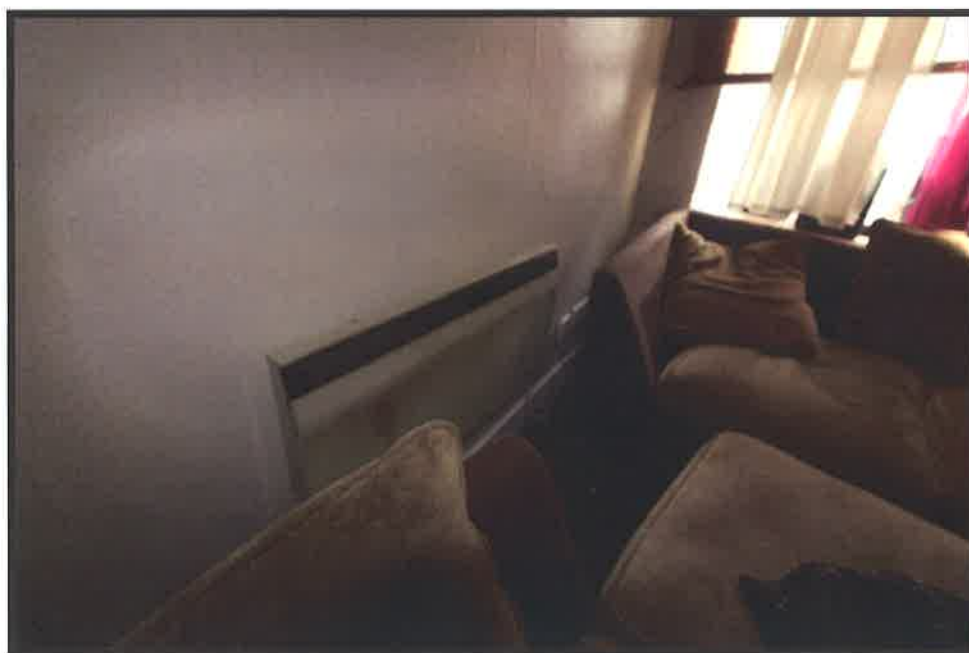
Figure 5 Lounge/kitchen heater.

3. The property was occupied and furnished, with floor coverings in place in most apartments.
4. The lounge/kitchen was inspected first. The built-in hob was found to be marked and soiled. The tenant stated that it did not work and that he used the microwave for cooking. There is a built under oven and it could be seen that the outer door of the double skinned door was missing. There was no heat or smoke detection within the lounge/kitchen. The electrical outlet for the panel heater was loose and the panel heater discoloured and scorched. The floor coverings were seen to be soiled.

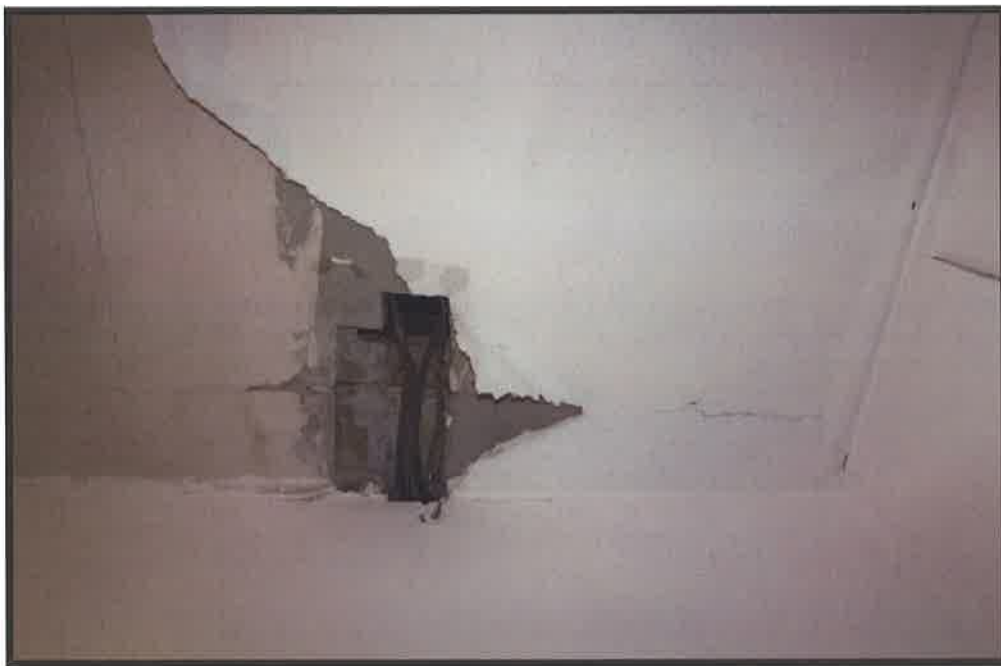
Figure 6 Inner hall ceiling

- (v) There was a small hole in the ceiling in the inner hallway which appeared to be the result of water ingress. The wallpaper had peeled down and was missing to part of the ceiling.

- (5) To repair the hole in the ceiling which appears in the inner hallway and redecorate.
- (6) To replace and properly attach the smoke alarm within the hallway and to ensure that it is in working order.

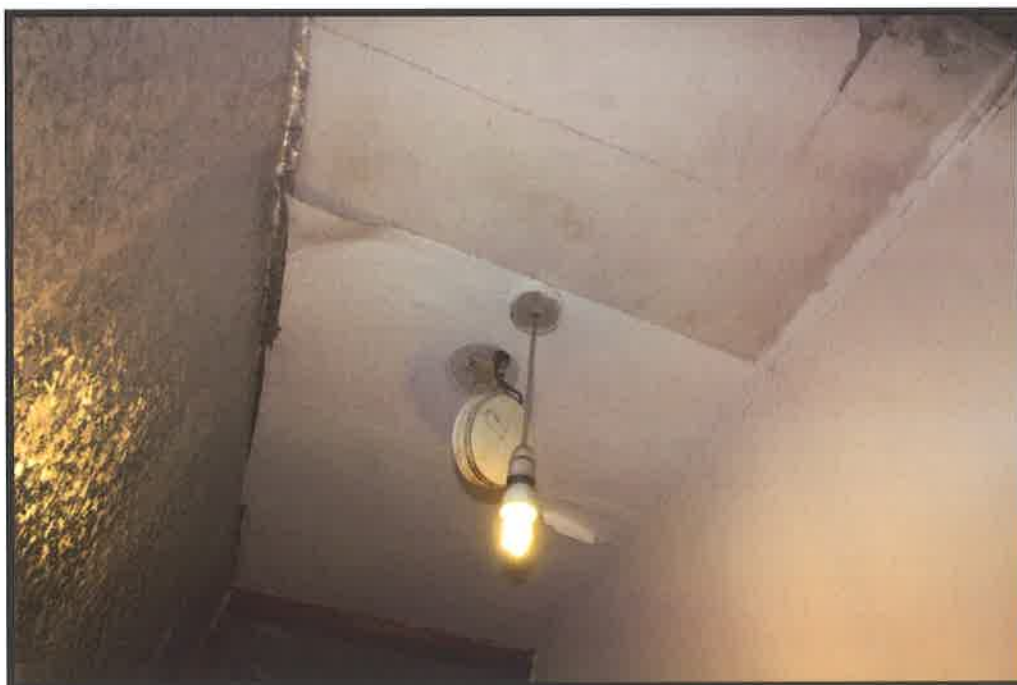
- (vi) The smoke alarm in the inner hall was hanging down suspended by the power cable.
  - (vii) The hatch or cover to the upper section of the airing cupboard in the inner hallway was missing.

Figure 7- Inner hall ceiling - smoke alarm.

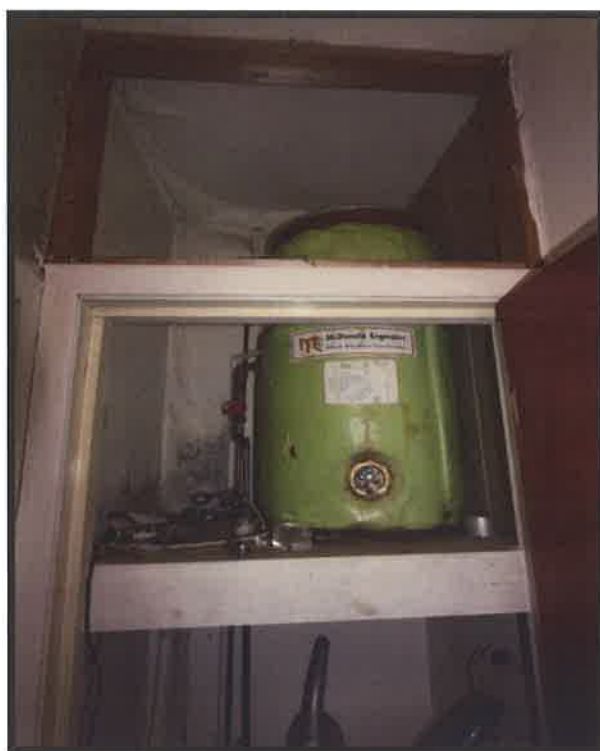
Figure 8- Airing cupboard/immersion heater.

- (viii) Inside the airing cupboard the main supply flex to the immersion heater was disconnected with bare wires showing and the cover to the immersion heater had been removed. There is no hot water as a result of this.

- (7) To fit a hatch or cover the upper section of the airing cupboard.
- (8) To ensure that the hot water cylinder is in working order.
- (9) To repair or replace the bedroom window to ensure that it is capable of being open and closed properly and in all respects in proper working order. Further to ensure that the external security screen is capable of being opened from within the property to allow the window to be opened fully in the event of an emergency.

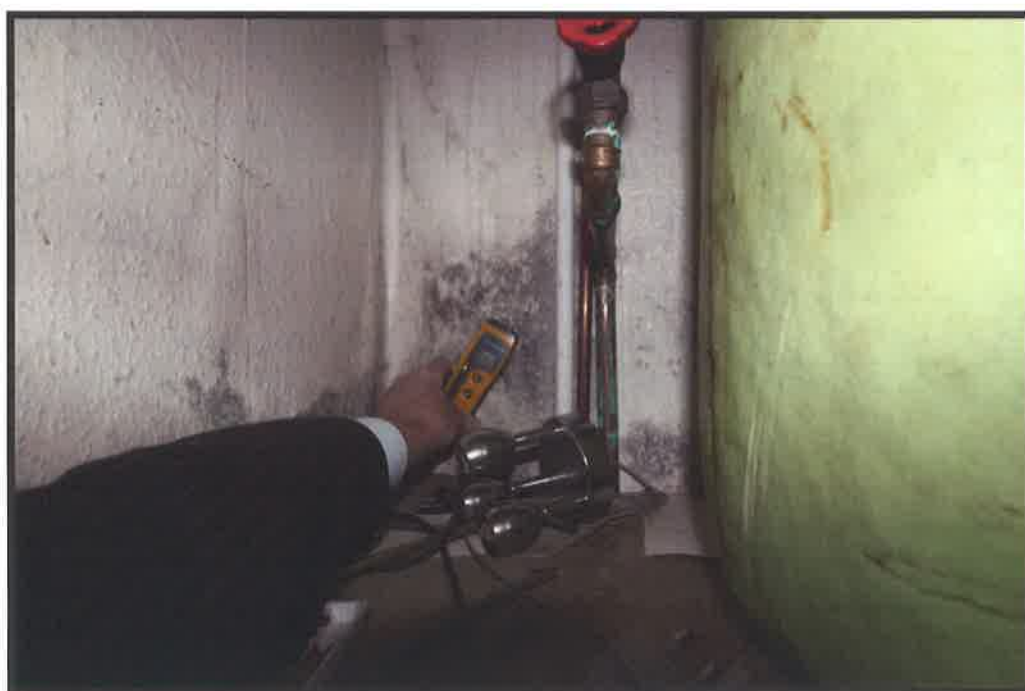
Figure 9 Mould to walls, airing cupboard.

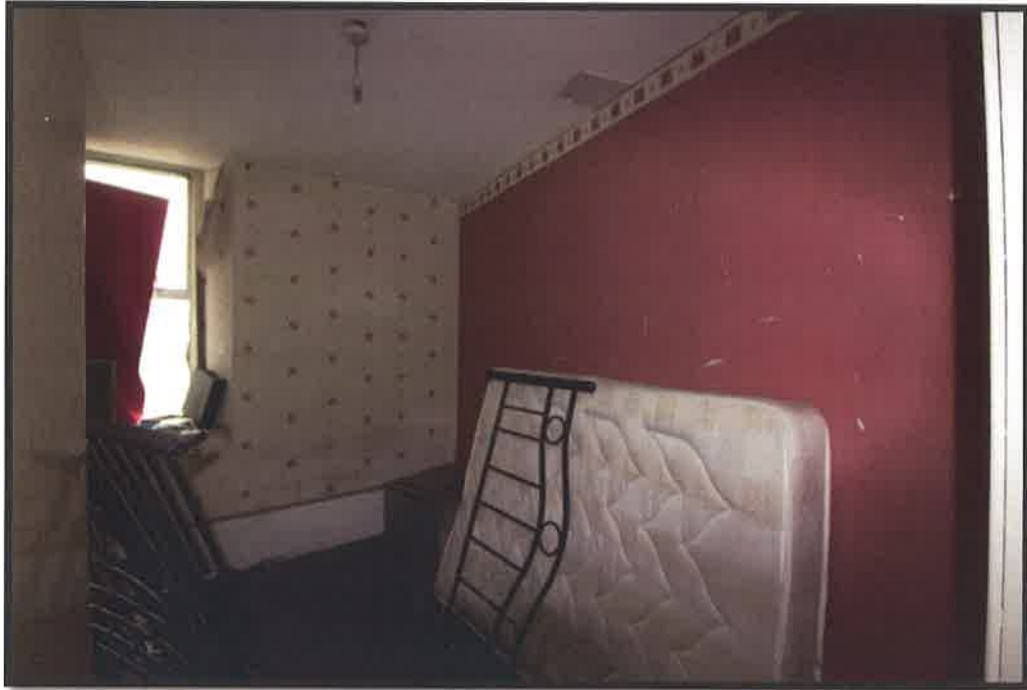
- (x) In the bedroom the ceiling rose was seen to be loose with a gap between it and the ceiling. There were two roughly fixed sections of plasterboard affixed to the ceiling apparently as patched repairs.

Figure 10 Bedroom overview - loose ceiling rose, patched ceiling.

- (10) To re-attach the ceiling rose to the ceiling of the property.
- (11) To properly replace the sections of plasterboard affixed to the ceiling from being patch repairs.

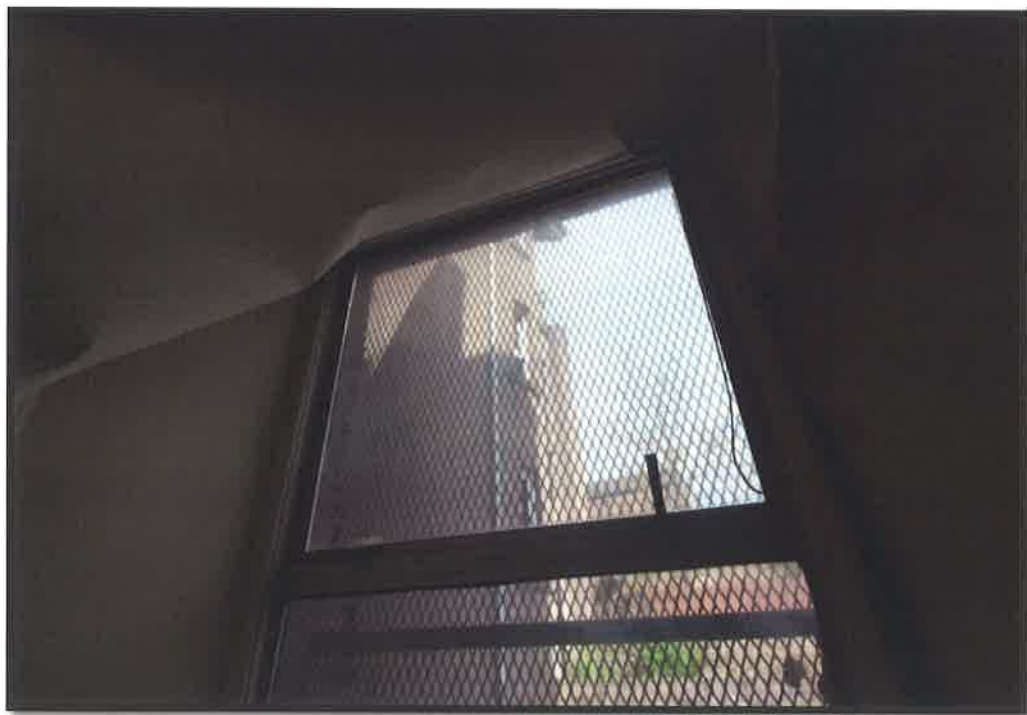
Figure 11 Bedroom window.

- (ix) In the bedroom the external security screen prevents the window opening fully. The blocks to the window catches were missing or damaged and one handle was missing.

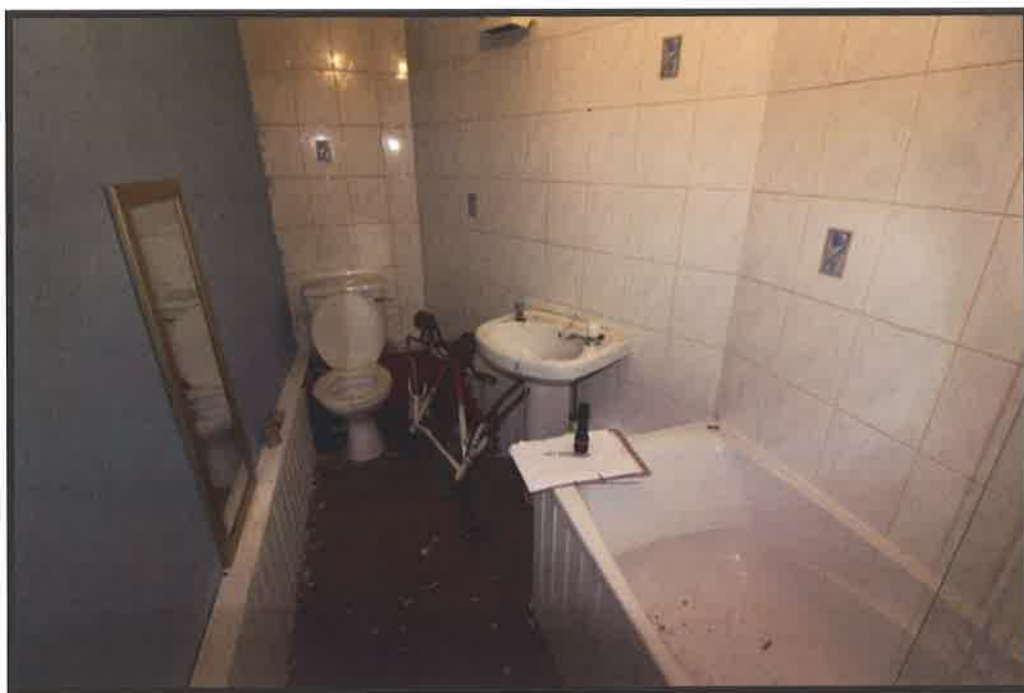
Figure 12 Bathroom overview.

- (xi) In the bathroom there was no floor covering. The extractor fan did not operate.
  - (xii) In the exterior of the building at the rear the terminal to the bathroom extractor duct was missing.

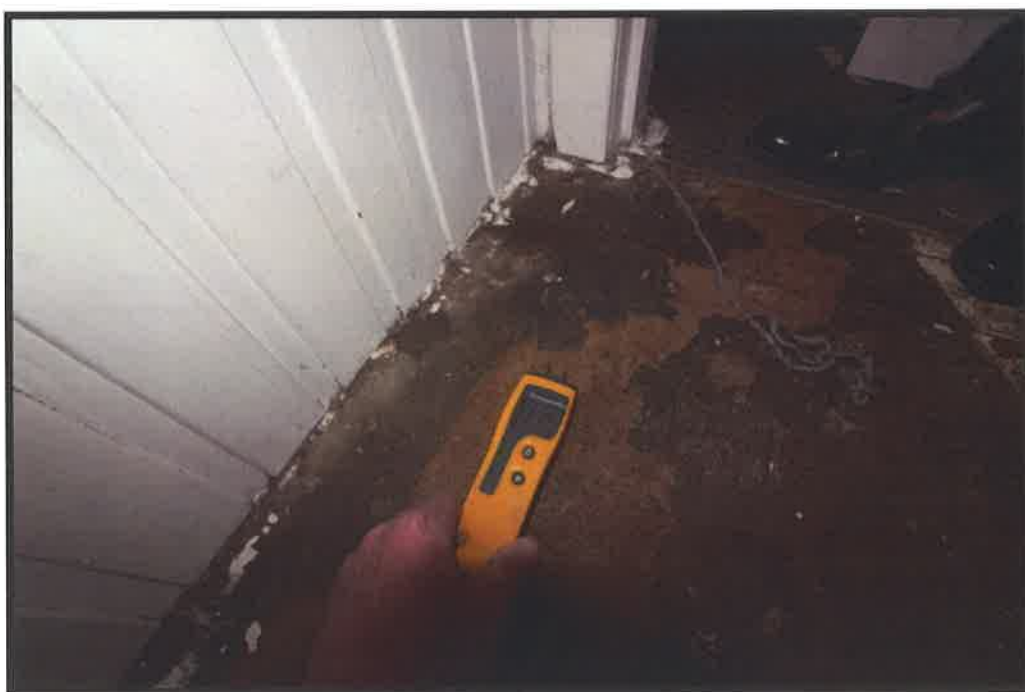
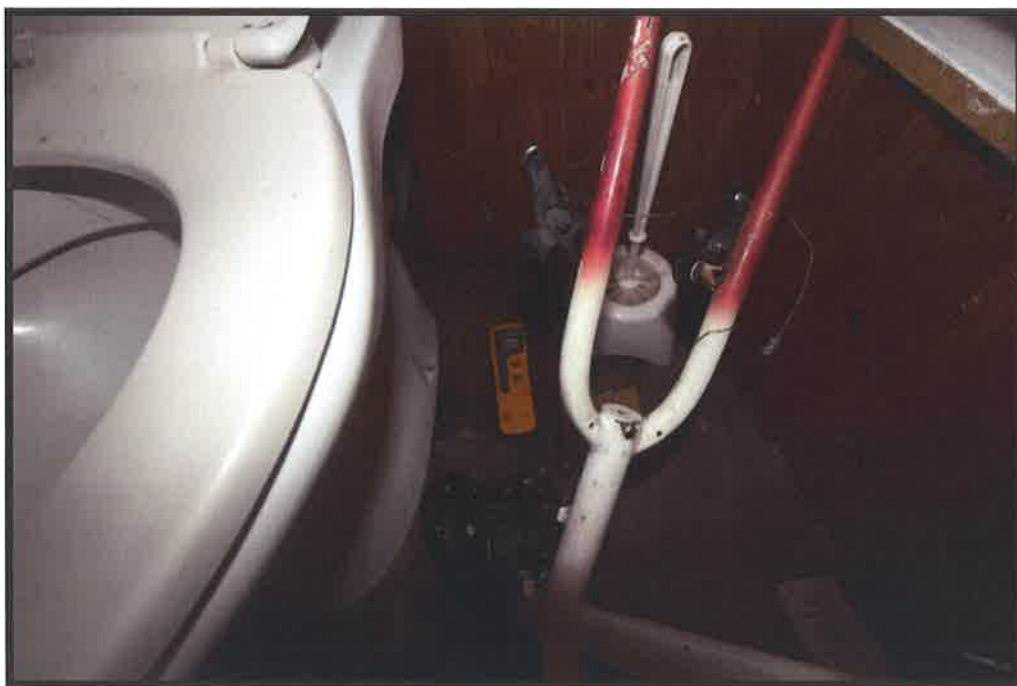
8. The bathroom was then inspected. The chipboard floor was fully exposed, there being no floorcoverings in place. The joints to the flooring had opened up and the surface of the chipboard was rough, indicating that the floor had been wet or damp for a period. However, when tested with the moisture meter, the flooring was found to have normal levels of moisture. The flooring was found to be reasonably firm underfoot. It was found that the extractor fan did not operate when the light was switched on and there was no other visible switch.

Figure 13 Bathroom floor and meter reading.

Figure 14 Bathroom floor and meter reading.

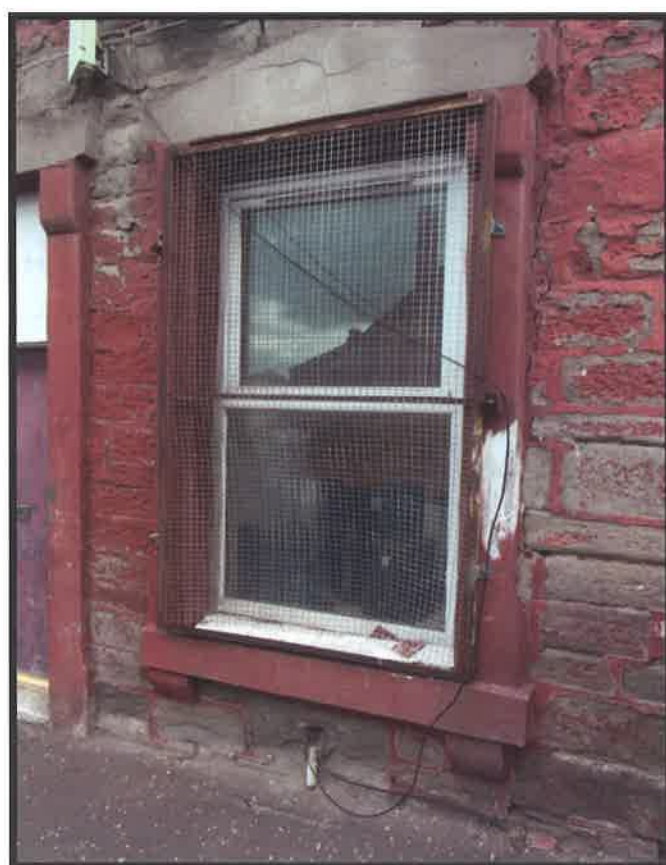
Figure 15 Front window.

9. The exterior of the building was then inspected. It could be seen that the security screens fitted to the lounge/kitchen and bedroom windows could not be removed or opened easily from the outside, or from within the flat with the windows opened. The terminal to the bathroom extractor duct was missing. The pointing to the stonework around the front elevation of the flat was seen to be weathered with some areas missing and there were cracks to the concrete areas. A vertical crack was seen close to the junction of the gable and front elevation, running from ground level to around the second floor level. There are some areas of missing render, with exposed brickwork and timber lintels visible. Vegetation growth was seen to the masonry at the gable and front elevation.

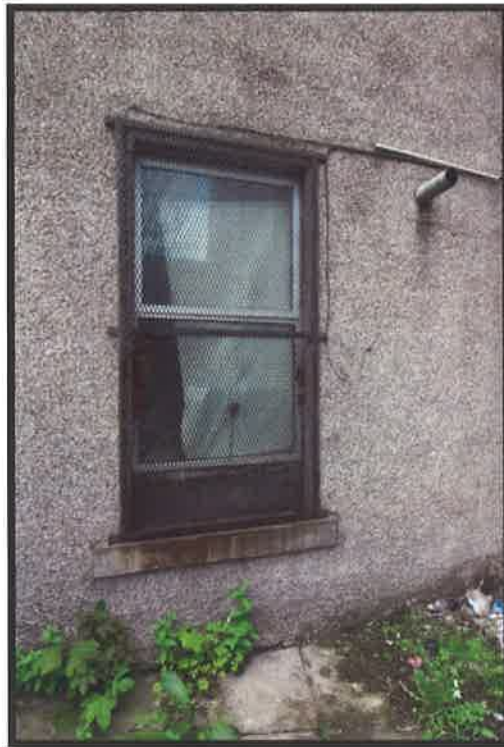
Figure 16 Rear window and bathroom vent.
