Statement of Decision of the First-tier Tribunal for Scotland (Housing and Property Chamber) under section 25(1) of the Housing (Scotland) Act 2006

Chamber Ref: FTS/HPC/RP/18/2946

29B Orchard Street, Renfrew, PA4 8RJ being the subjects registered in the Land Register of Scotland under Title Number REN89837 ('The Property')

Re-inspection - Photograph Schedule
29B Orchard Street, Renfrew, PA4 8RJ

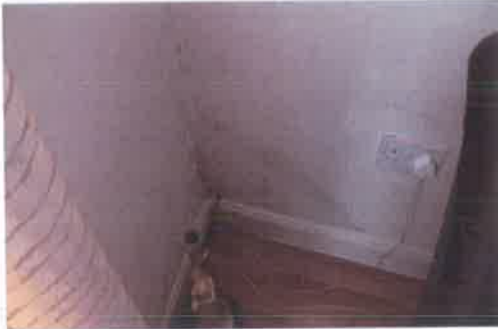
1. Repair the dampness at the following locations in the property to render the Property water tight:
 - 1.1 **Living Room** – The internal wall between the Living Room and the bedroom which was found to be saturated with dampness to a height of approximately 0.4 metres at the corner near to the bay window.

Re-inspection findings – The affected sections of wall are still completely saturated. Photographs 1 & 2 below refer.

Photo 1 – Saturated wall section

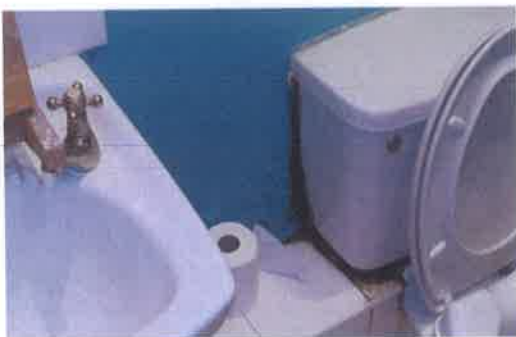
1.2 Bathroom – The party wall of the bathroom behind the whb + wc which was found to be saturated with dampness to a height of approximately 1.5 metres. The section of reinforced beam above and facing the bath which was also found to be saturated with dampness.

Re-inspection findings – The affected sections of wall are still completely saturated. Photographs 3,4,5 & 6 below refer.

Photo 3 – Saturated wall section

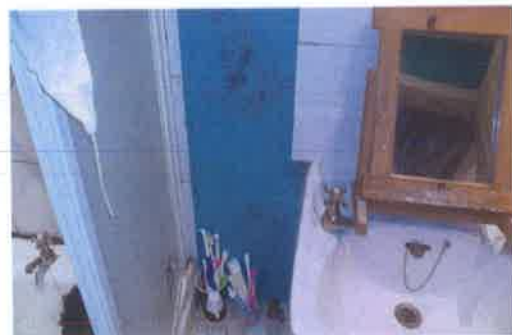
Photo 4 – Saturated wall section

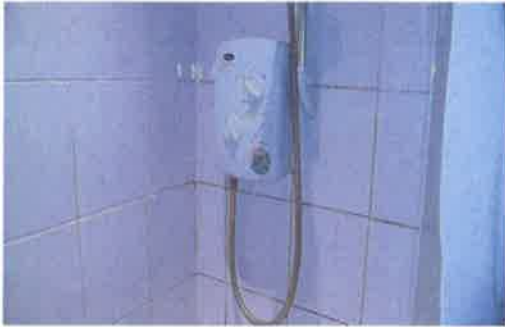
Photo 5 – Embedded damp in wall

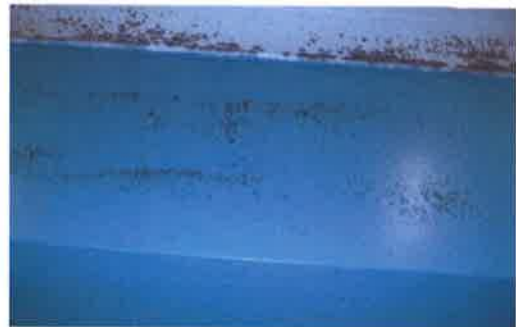
Photo 6 Embedded damp in beam

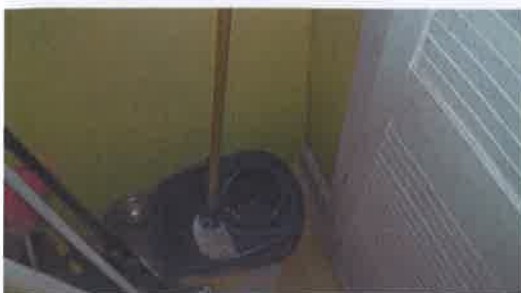
Re-inspection findings – The affected sections of wall (a & c) above are still completely saturated. The section of wall (b) above remains significantly damp. Photographs 7,8,9 & 10 below refer.

Photo 7 – Saturated wall section

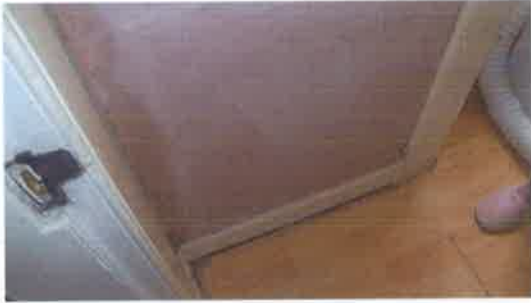
Photo 9 – Saturated wall section

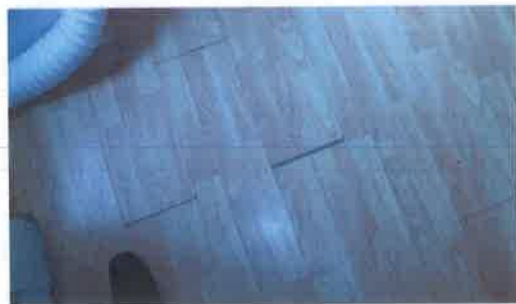
Re-inspection findings – The affected sections of floor have been Made secure Photograph 12 below refers.

Photo 12 – Secured flooring
