Repairing Standard Enforcement Order

Case Reference Number: PRHP/RP/16/0295

Re: 1 Essex Road, Greenock PA16 0JJ ("the house")

REF: RP/16/0295 DATES: 17 NOV 2016, 12 APR 2017

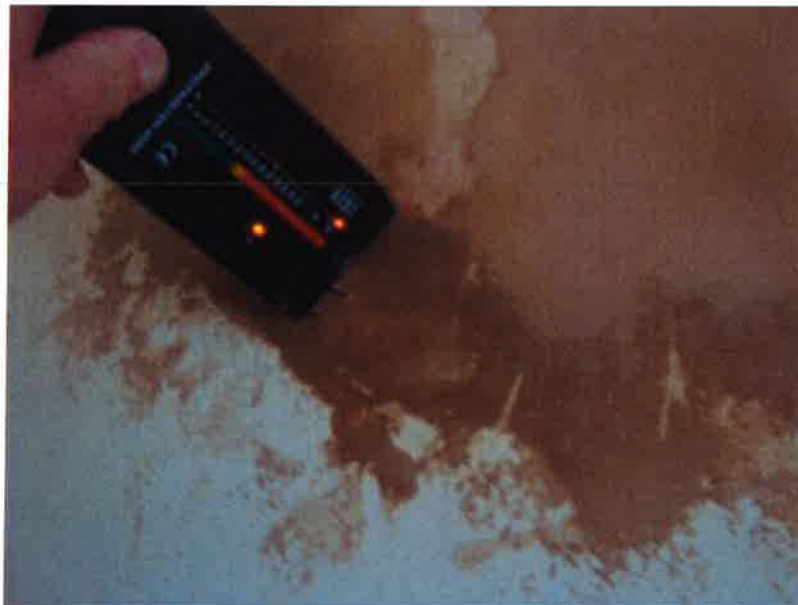
- vi. The tribunal took dampness readings on the wall in the main bedroom (3rd left) which was next to the chimney. It found high damp readings along that wall.

55. At its first inspection, the tribunal took dampness readings on the wall in the front bedroom (3rd left) which was next to the chimney. It found high damp readings along that wall. Mr Boparai told the tribunal at that inspection that repairs had been carried out to the chimney a few days earlier, and that the plaster was still drying out. At the continued hearing on 12 April 2017, he told the tribunal that the plaster had now dried out. At its second inspection immediately following that hearing, however, the tribunal again found high dampness readings along the same wall.

HIGH DAMP READINGS AT CHIMNEYBREAST OF FRONT BEDROOM (17/11/16)

1. Instruct a suitably qualified contractor to investigate the cause of the dampness along the bedroom wall next to the chimney, and to carry out such works as are

necessary to treat the dampness, in order to ensure that the bedroom is wind and watertight and otherwise reasonably fit for habitation.

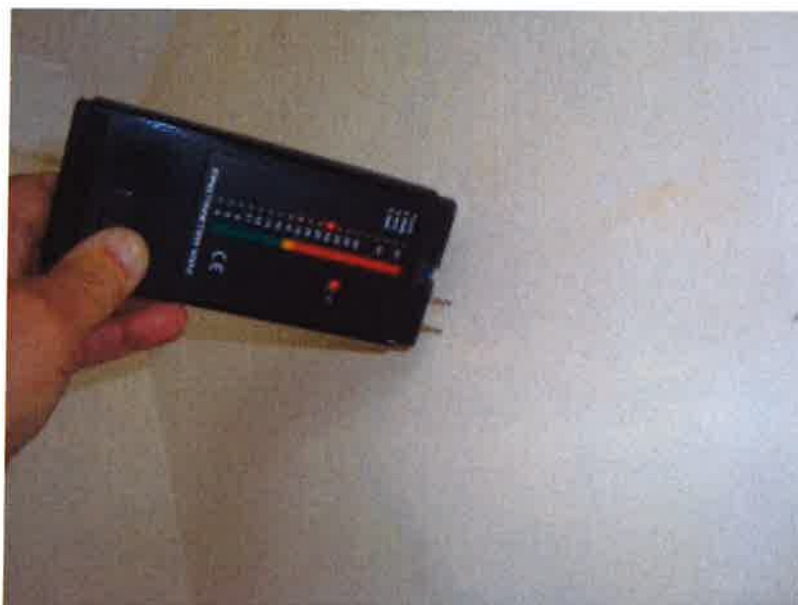
- i. A hardwired smoke detector had now been installed in the living room.
 - ii. Dampness readings were taken on the wall in the main bedroom (3rd left) which was next to the chimney. High damp readings were found along that wall.

58. While the dampness readings were indeed lower at the second inspection, the wall did not meet the repairing standard at the time of inspection, as it was not wind and watertight. While therefore the recent works may have resolved the problem, the tribunal cannot be sure that this is the case until a period of time has passed, and the plaster has dried out. The tribunal must therefore issue a repairing standard enforcement order in the meantime, which will be lifted once the wall is found to meet the repairing standard.

STAINING AND HIGH DAMP READINGS AT FRONT BEDROOM CHIMNEYBREAST (12/04/17)

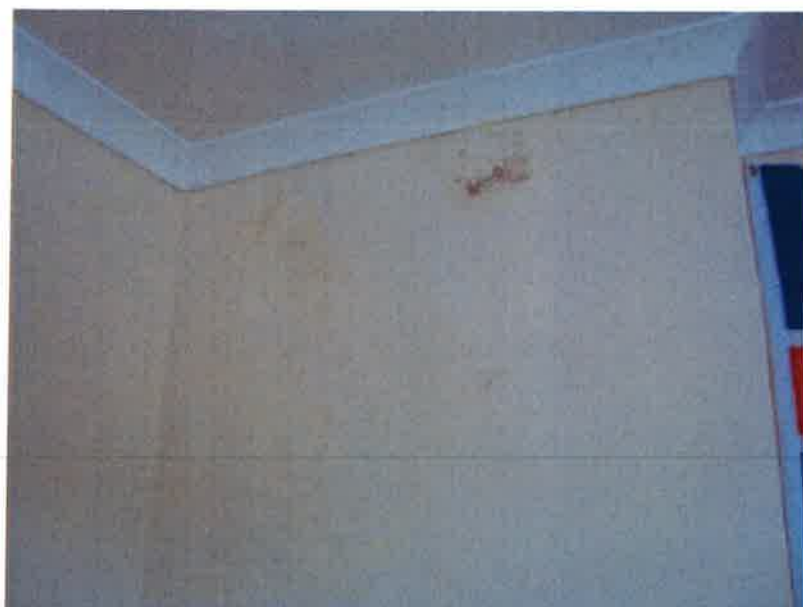
STAINING AT FRONT BEDROOM CHIMNEYBREAST (12/04/17)

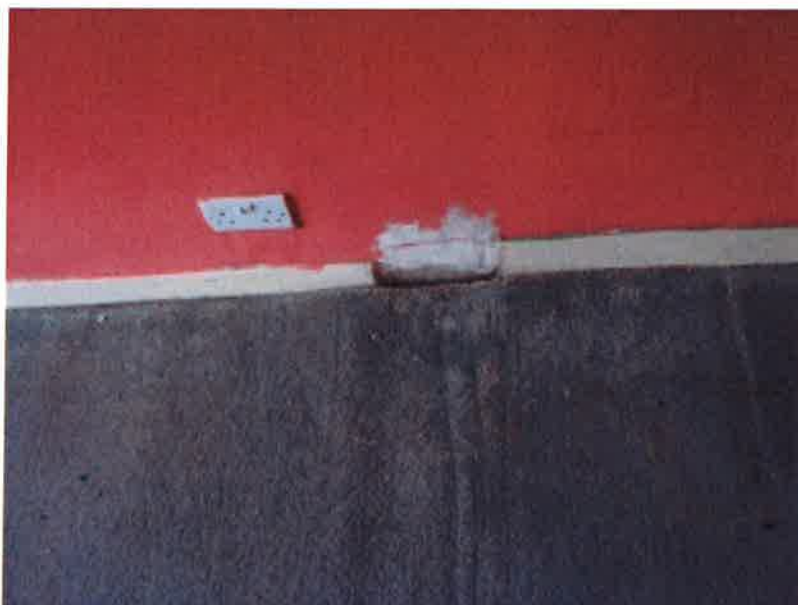
59. The tribunal observed at its initial inspection that there was a small section of skirting missing in this bedroom. Mr Boparai told the tribunal at the continued hearing that this had been removed by the tenant. The tribunal considered that this was a very minor issue, and did not affect the state of repair of the house to any significant degree. It therefore determined that, at the date of its initial inspection, the skirting was in a reasonable state of repair and in proper working order.

SECTION OF MISSING SKIRTING BOARD (BED 2ND LEFT)

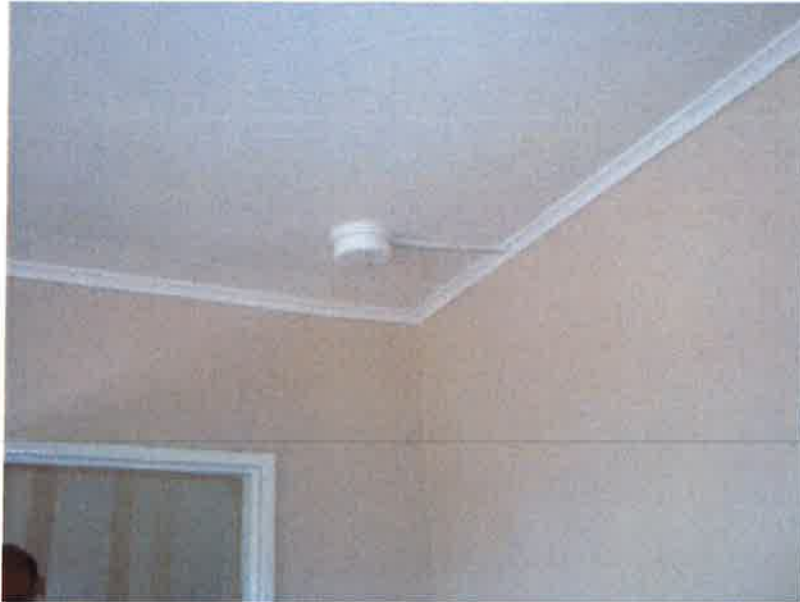
SMOKE ALARM IN LIVING ROOM (12/04/17)

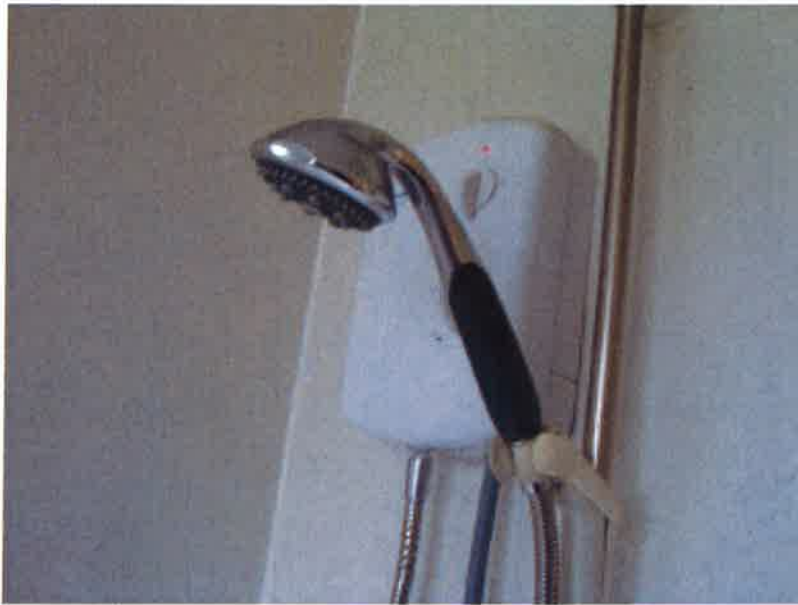
SHOWER

60. When the shower was tested by the tribunal at its initial inspection, by running it for several minutes, no signs of leakage were observed. Neither was any evidence observed of any previous fire. No issues were raised with the shower in the EICR dated 7 April 2017. Mr Boparai told the tribunal that it was not true that the shower had previously gone on fire; this was just a rumour. The tribunal determined that, on the basis of the evidence before it, the shower was in a reasonable state of repair and in proper working order as at the date of its initial inspection.

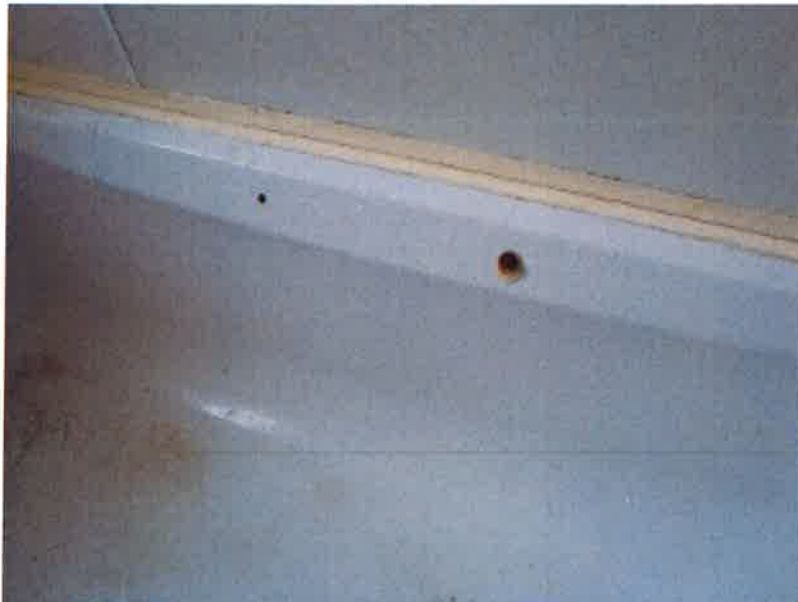
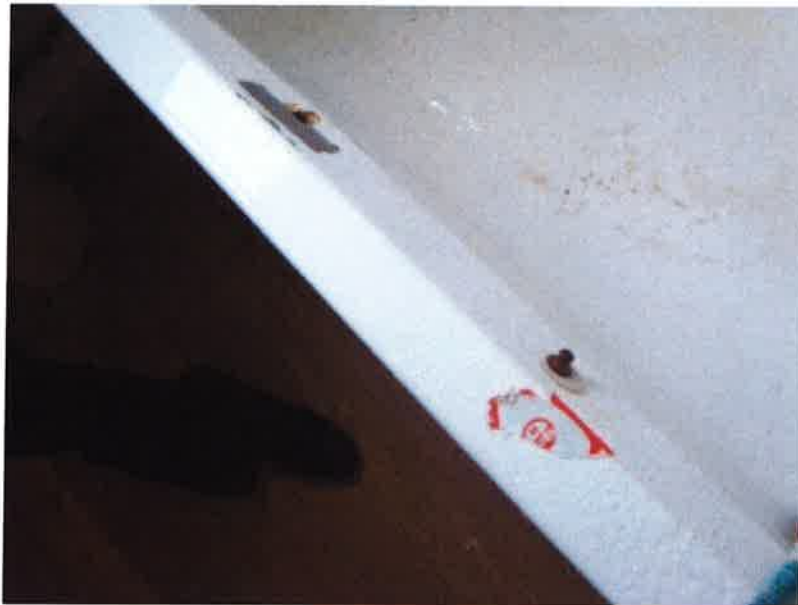
62. The tribunal observed at its initial inspection that the bath handles were missing. Mr Boparai told the tribunal at the continued hearing that these had been removed by the tenant, and had not been replaced. While noting that regardless of whether the tenant had removed these (which it was unable to ask the tenant about, as he was no longer a party), the landlord had a duty to ensure that the house met the

repairing standard in any future tenancies. It noted, however, that on moving in, the new tenant appeared to have accepted the bath as it was. The tribunal also noted that the bath was still capable of being used for its primary function without the handles in place. It therefore determined that, on the balance of probabilities, the bath was in a reasonable state of repair and in proper working order.

MISSING HANDLE AT BATH

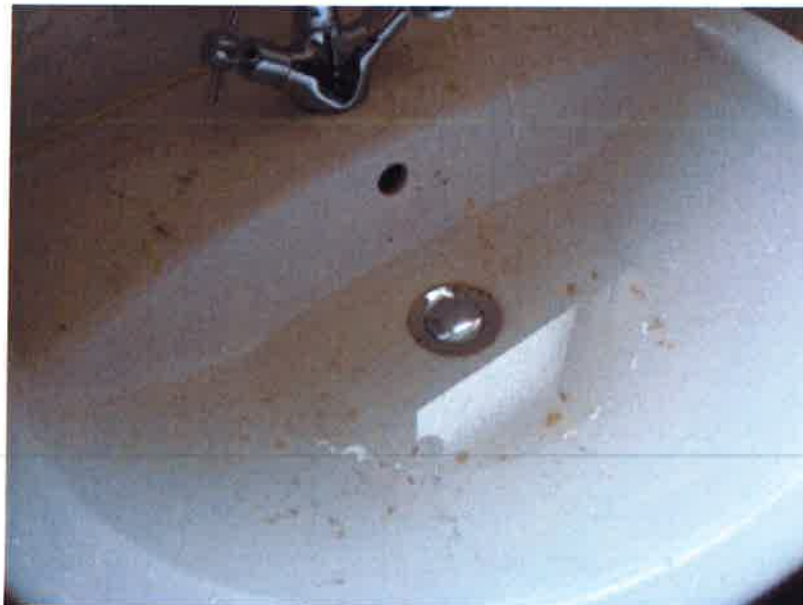
64. At its initial inspection, the tribunal observed that the plug on the wash hand basin failed to come back up when the plunger was pushed down. Mr Boparai told the tribunal at the continued hearing that the plug had been repaired since then. The tribunal accepted his evidence, and noted that this was a relatively minor repairing standard issue. It therefore determined that, on the balance of probabilities, the plug was now in a reasonable state of repair and in proper working order.

DEFECTIVE MECHANISM AT PLUG

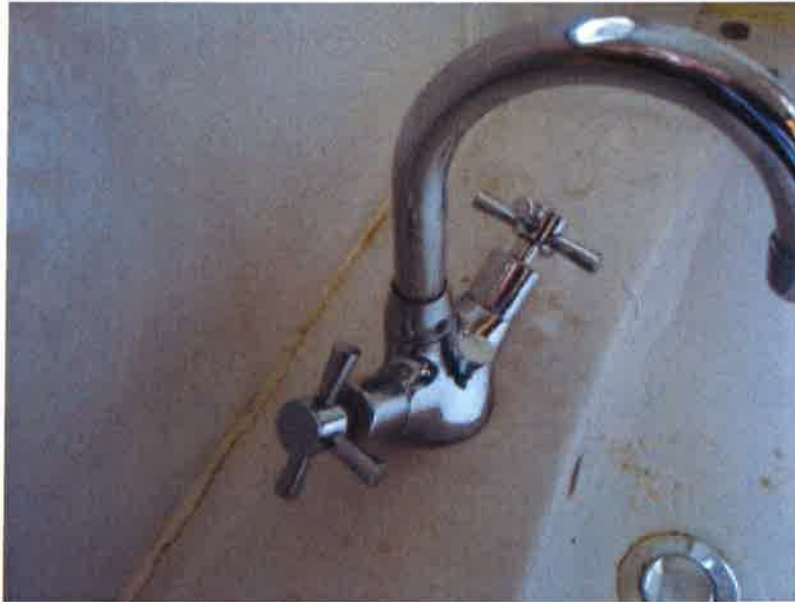
65. At its initial inspection, the tribunal observed that the tap unit on the wash hand basin was loose and when pressure was put on it, it was observed to move around. Mr Boparai told the tribunal at the continued hearing that the tap unit had only moved when someone tried to move it around, and said that it had now been tightened up. The tribunal accepted his evidence, and noted that this was a relatively minor repairing standard issue. It therefore determined that, on the balance of probabilities, the tap was now in a reasonable state of repair and in proper working order.

LOOOSE TAP AT WASH HAND BASIN

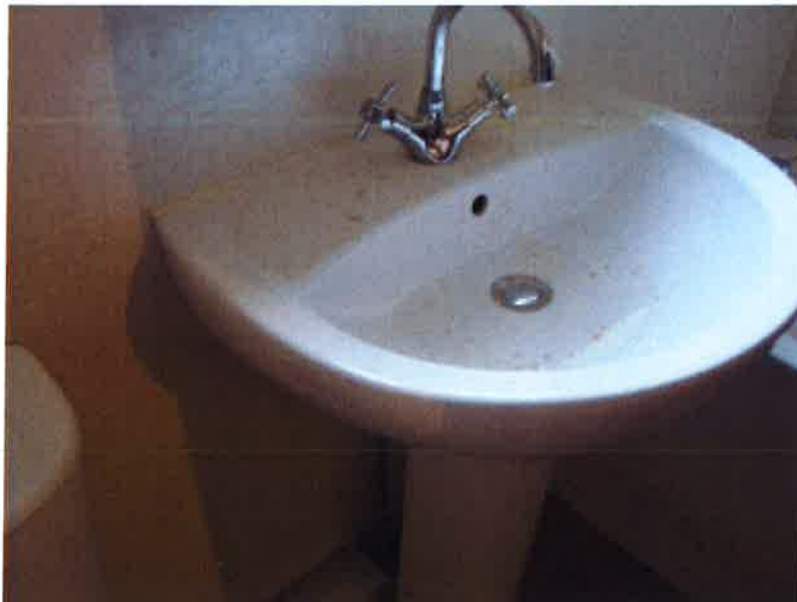
66. At its initial inspection, the tribunal observed that the wash hand basin moved slightly when pushed, and that the seal around it was slightly loose on the left hand side. Mr Boparai told the tribunal at the continued hearing that the seal had now been fixed. The tribunal considered that, while the wash hand basin moved slightly when pushed, this did not in itself mean that it was not in a reasonable state of repair and in proper working order. It also considered that the slightly loose seal, which Mr Boparai said had now been fixed, was a relatively minor issue, which also did not in itself mean that the basin was not in a reasonable state of repair and in

proper working order. It therefore determined that the wash hand basin and the seal were in a reasonable state of repair and in proper working order.

INSECURE WASH HAND BASIN

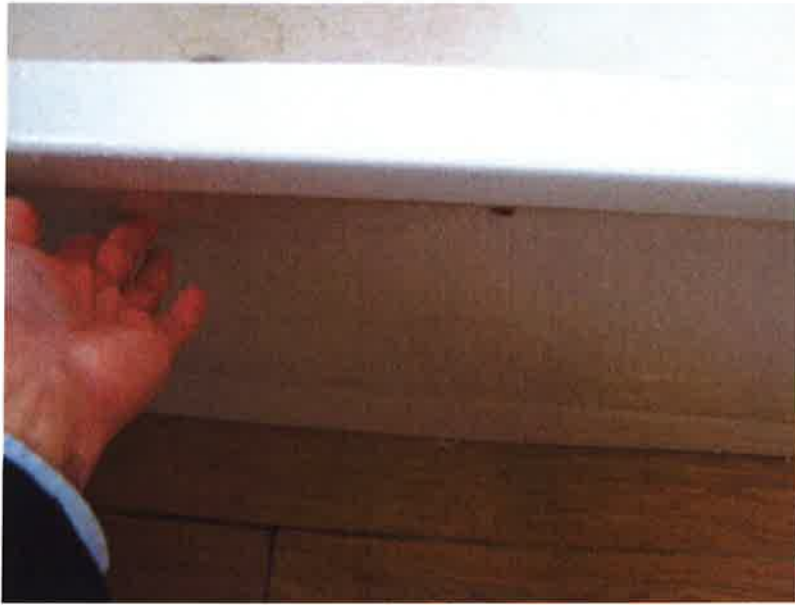
67. At its initial inspection, the tribunal observed that the bathroom skirting was slightly loose under the wash hand basin, and that the bath panel was slightly loose. Mr Boparai said at the continued hearing that the bath panel was screwed on at each end, but had no support in the middle. He said that this generally the case with bath panels. The tribunal accepted this contention. While both the bath panel and the skirting were slightly loose, it determined that both of these items were in a reasonable state of repair and in proper working order.

LOOSE BATH PANEL

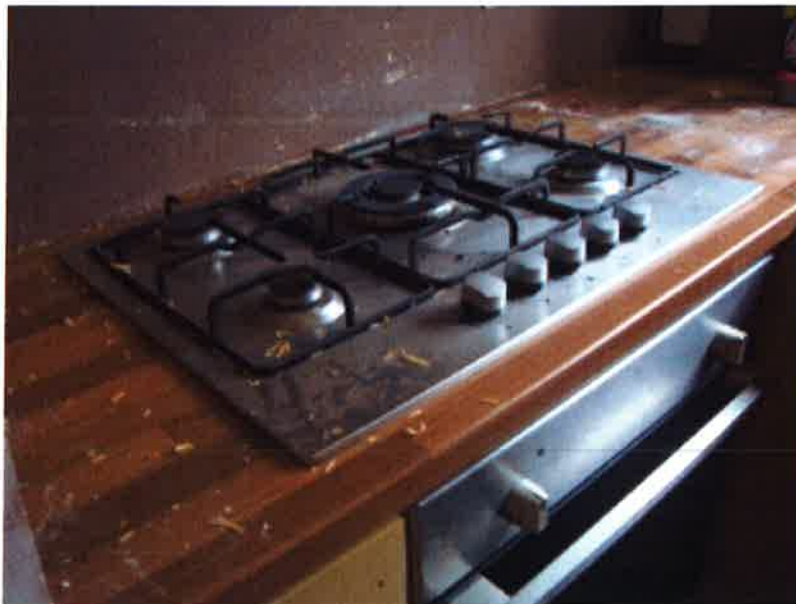
69. At its initial inspection, the tribunal observed that the oven appeared to be securely fixed, although the hob moved slightly when pressure was put on it. As it was unable to hear evidence from the tenant on this point, the tribunal made the inference that the tenant's complaint was about the hob. Mr Boparai told the tribunal at the continued hearing that the hob had now been secured. The tribunal accepted his evidence on this point, and determined that, on the balance of probabilities, the hob was in a satisfactory state of repair and in proper working order.

LOOSE HOB

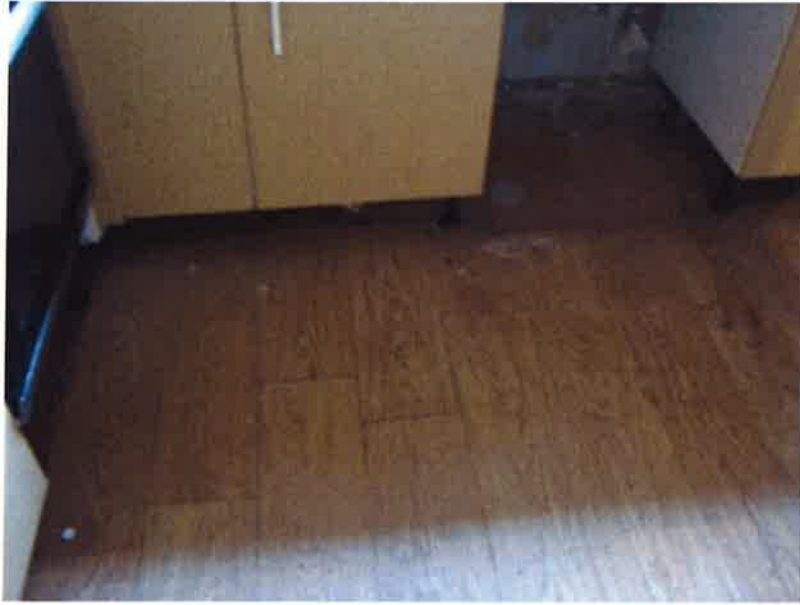
70. At its initial inspection, the tribunal observed that there were no kick plates under any of the kitchen units. Mr Boparai told the tribunal at the continued hearing that there had never been any kick plates in place since the landlord had owned the house, and that they had not been in place when the tenant had moved into the house. He said that he had previously tried to purchase kick plates, but that the kitchen units had been discontinued, and he was unable to obtain these. As it was unable to hear evidence from the tenant on this point, the tribunal accepted his evidence that the kick plates had never been in place. The tribunal therefore

determined that the kitchen units were in a reasonable state of repair and proper working order regardless of the absence of any kick plates.

NO KICK PLATES

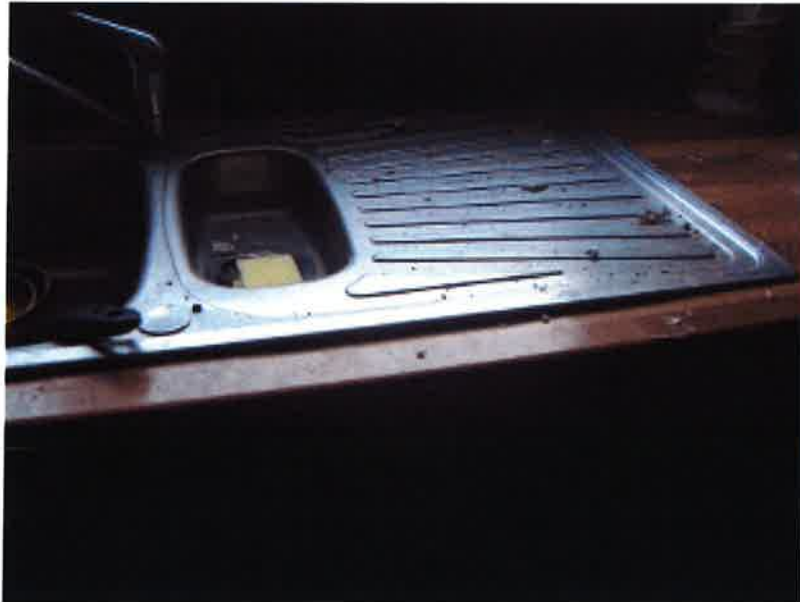
71. The tribunal observed at its initial inspection that the work top at the kitchen sink was not loose, but the sink itself appeared to be slightly loose. Mr Boparai told the tribunal at the continued hearing that he did not think this was a repairs issue, but that the sink had been sealed with silicone since the inspection. The tribunal accepted his evidence on this point, and determined that, while the sink had been slightly loose, it was in a satisfactory state of repair and in proper working order.

LOOSE SINK TOP

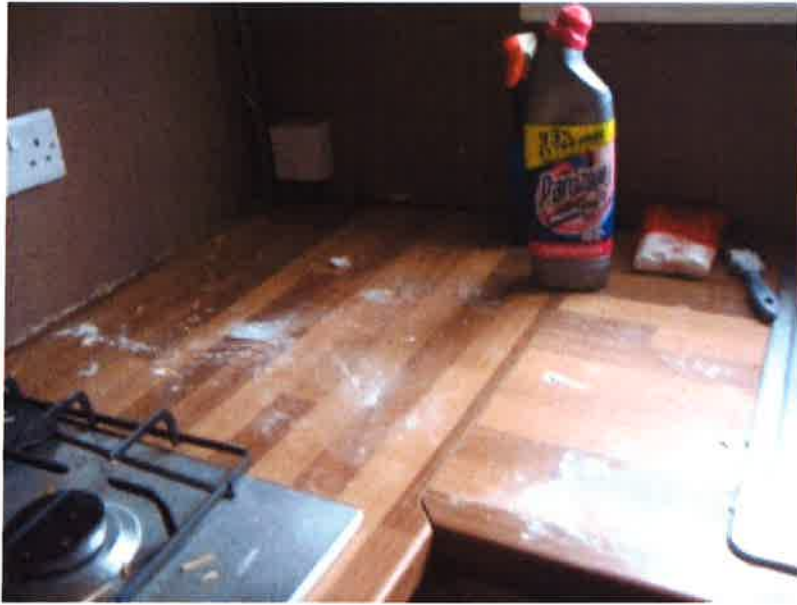
72. While it was not entirely clear from the tenant's application what this complaint concerned, the tribunal observed at its initial inspection that the only joint between the work top and the kitchen wall was slightly loose, and there were signs of water ingress through this. Mr Boparai said at the continued hearing that he did not view this as a disrepair issue, but had now applied silicone to the joint. He said that the water ingress appeared to have resulted from the tenant having poured water over it. The tribunal accepts that, given its location in the kitchen, water ingress through the joint would not normally be expected to be an issue. The tribunal determined that, while the joint had been slightly loose, it was in a satisfactory state of repair and in proper working order.

DEFECTIVE JOINT—KITCHEN TOP

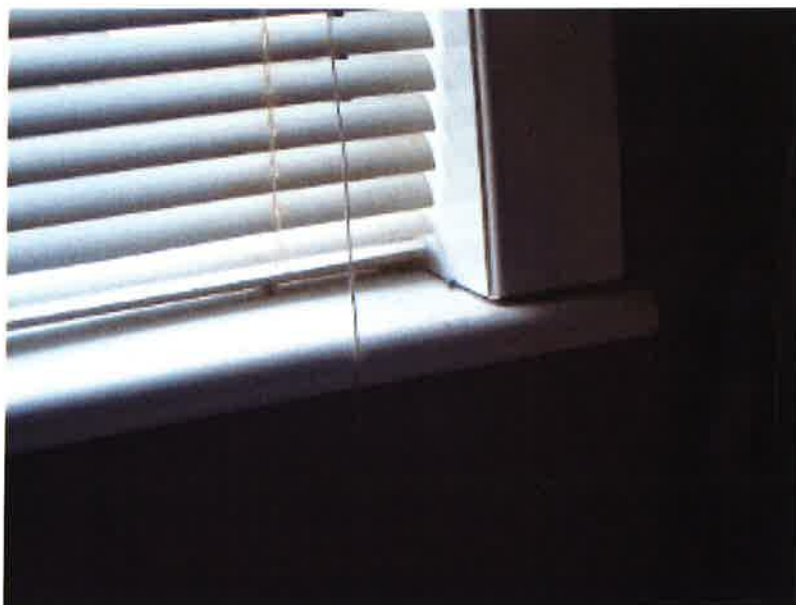
74. The tribunal observed at its initial inspection that the window sill in the kitchen was loose when pressure was applied to it. Mr Boparai told the tribunal at the continued hearing that the window sill had now been secured. The tribunal accepted his evidence on this point, and determined that, on the balance of probabilities, the window sill was in a satisfactory state of repair and in proper working order.

LOOSE KITCHEN WINDOW SILL

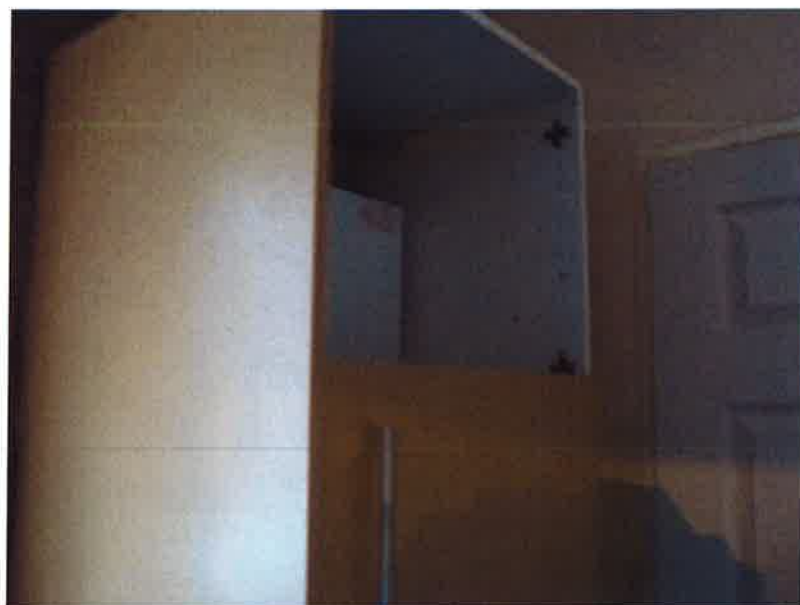
75. The tribunal observed at its initial inspection that the top door of the kitchen cupboard housing the boiler was missing. Mr Boparai told the tribunal at both its initial inspection and the continued hearing that this had been removed by the tenant. He said at the continued hearing that the door had been replaced, albeit with a door that was slightly too big, as the kitchen units had been discontinued. The tribunal accepted his evidence on this point, and determined that, on the balance of probabilities, the boiler cupboard was in a satisfactory state of repair and in proper working order.

MISSING DOOR AT BOILER CUPBOARD

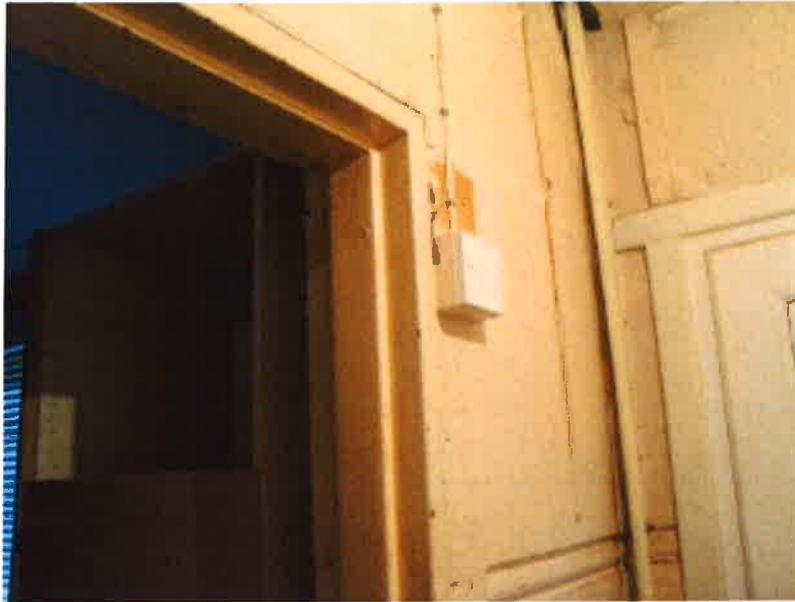
LIGHT SWITCH – PORCH

- xxiv. There was a hole in the ceiling of the cupboard in the porch.
 - xxv. The light fitting in the back porch had been replaced, and the switch was operational.

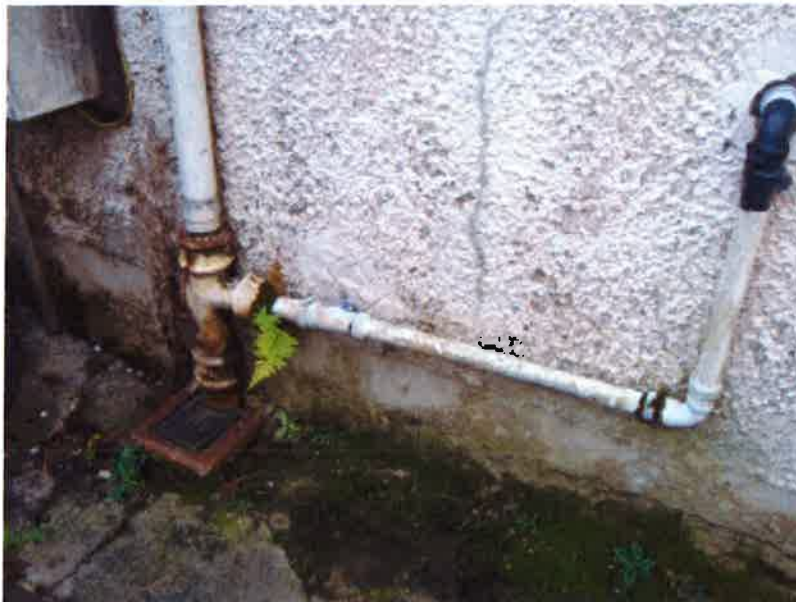
EXTERNAL DRAINAGE PIPE FROM BATHROOM

61. At its initial inspection, the tribunal observed no obvious signs that the bath drainage had been overflowing onto the back patio. It therefore determined that, at the date of its initial inspection, the bath drainage was in a reasonable state of repair and in proper working order.
