**First-tier tribunal for Scotland (Housing and Property Chamber)**

**Repairing Standard Enforcement Order (RSEO): Housing (Scotland) Act 2006  
Section 24**

**Chamber Ref: PRHP/RP/16/0343**

**Property at 2 South West Street, Buckie, Moray, AB56 1BR  
("The House")**

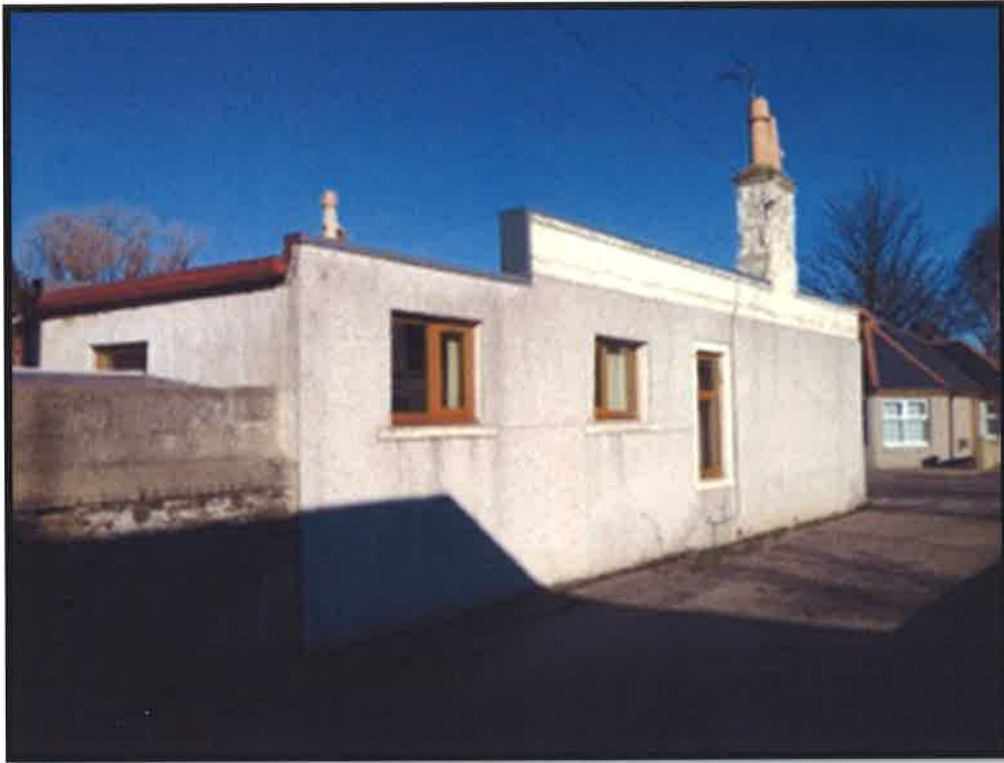
Figure 2 Left Side Elevation, utility room, kitchen and middle bedroom windows

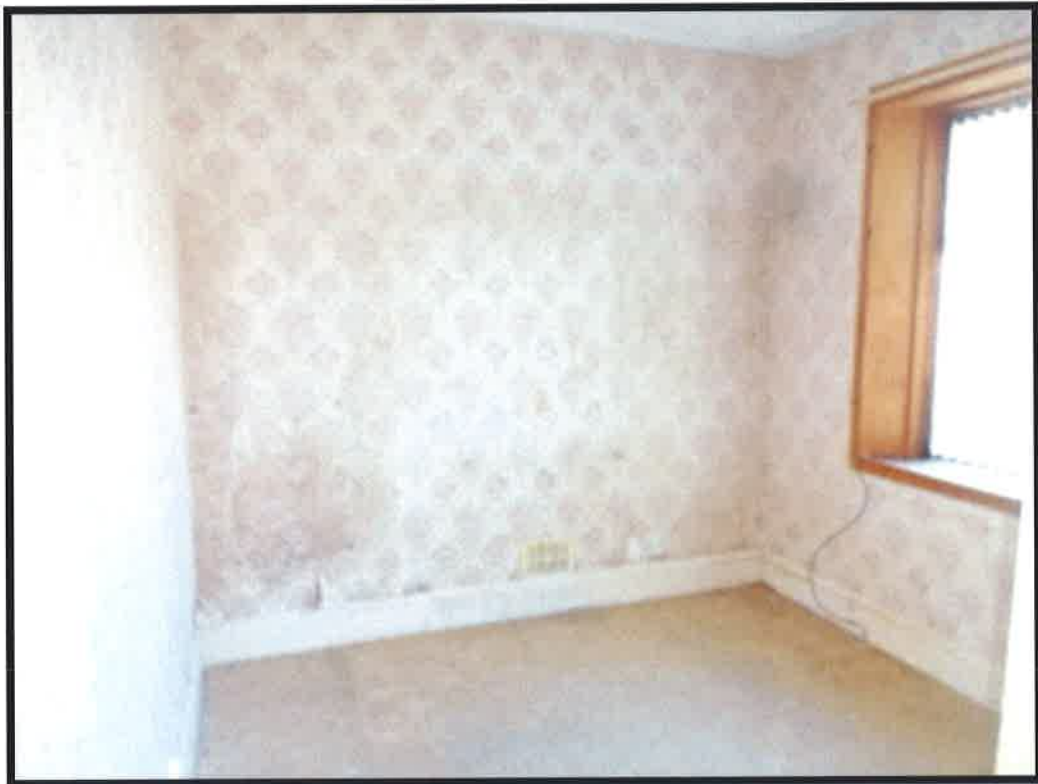
Figure 3 Front Bedroom

9. The house was vacant and unfurnished, although floor coverings were in place. The heating was not operating and the property was relatively cold.
10. The front bedroom was inspected first. Mould growth and black staining through the wallpaper was apparent to the outside walls. The wallpaper was peeling and lifting at the seams. Mould residue was apparent to the window glass and there were watermarks to the timber window cill. There was residue from parcel tape on the window frame. The window frames had top vents which were closed. Moisture meter readings were taken to the outer wall surfaces at various heights and locations. Generally, the readings were consistently around 15 - 18%, a normal or acceptable level. There were no obvious water marks or other visible indications of water ingress. A fireplace had once been present; the opening had been boarded over and an air vent was present.

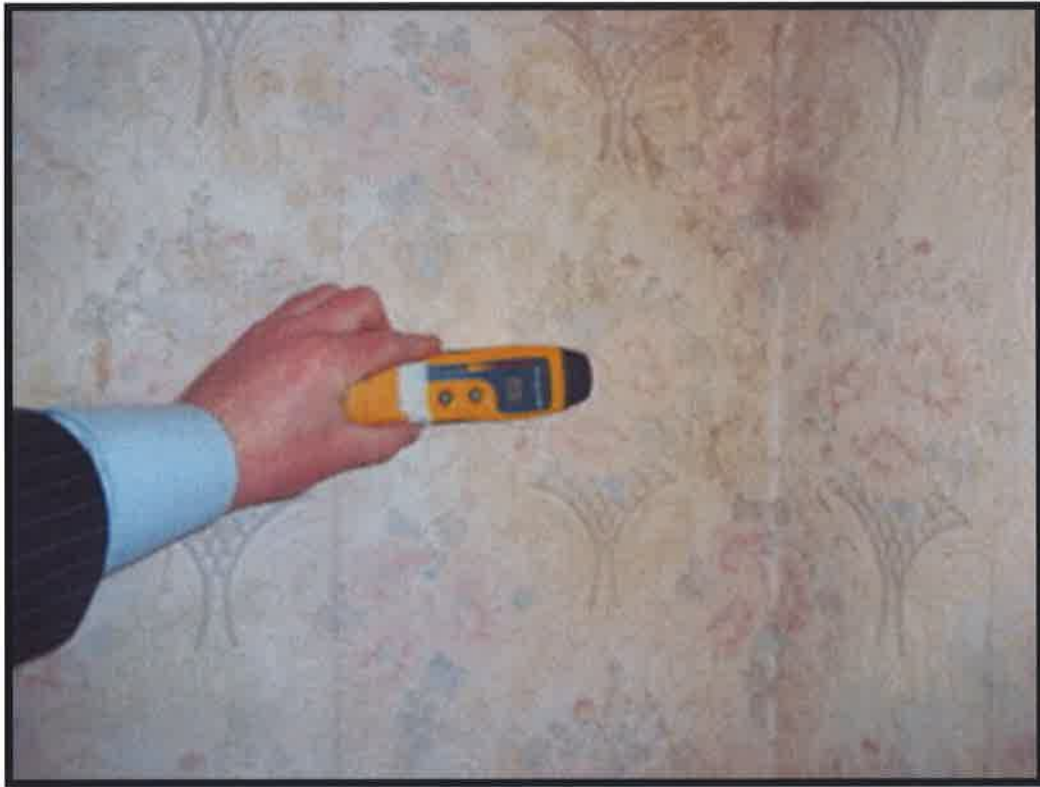
Figure 4 Front Bedroom typical moisture meter reading (15%)

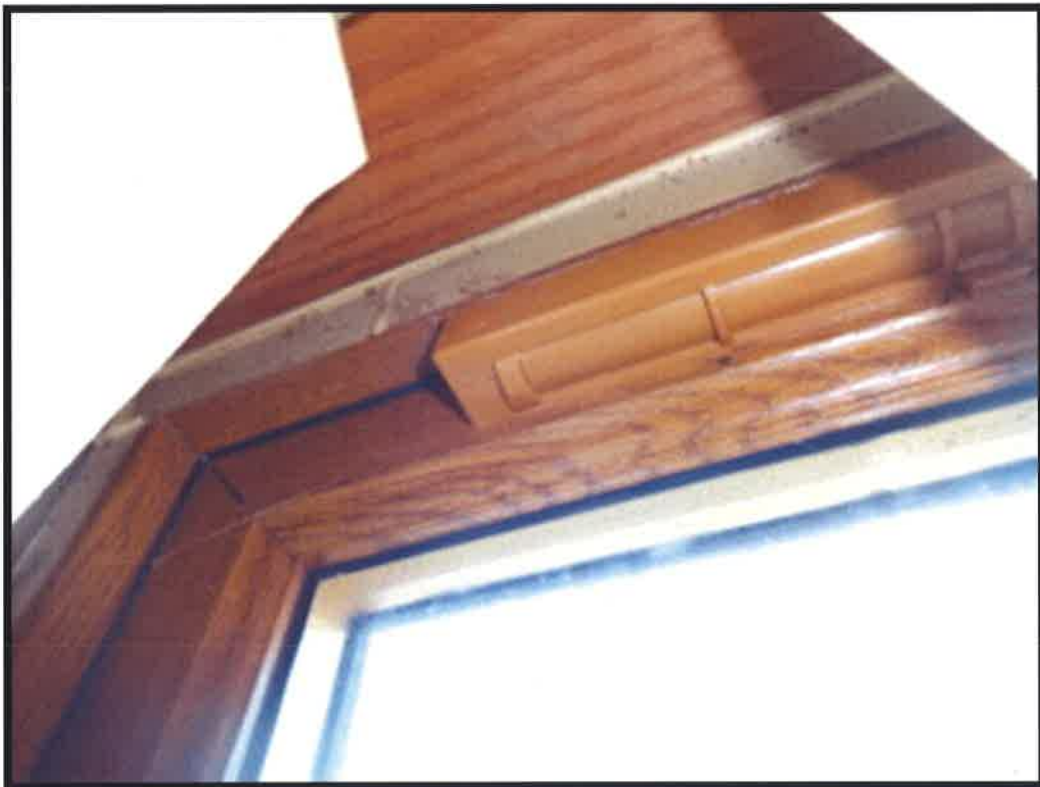
Figure 5 Front Bedroom top vent.

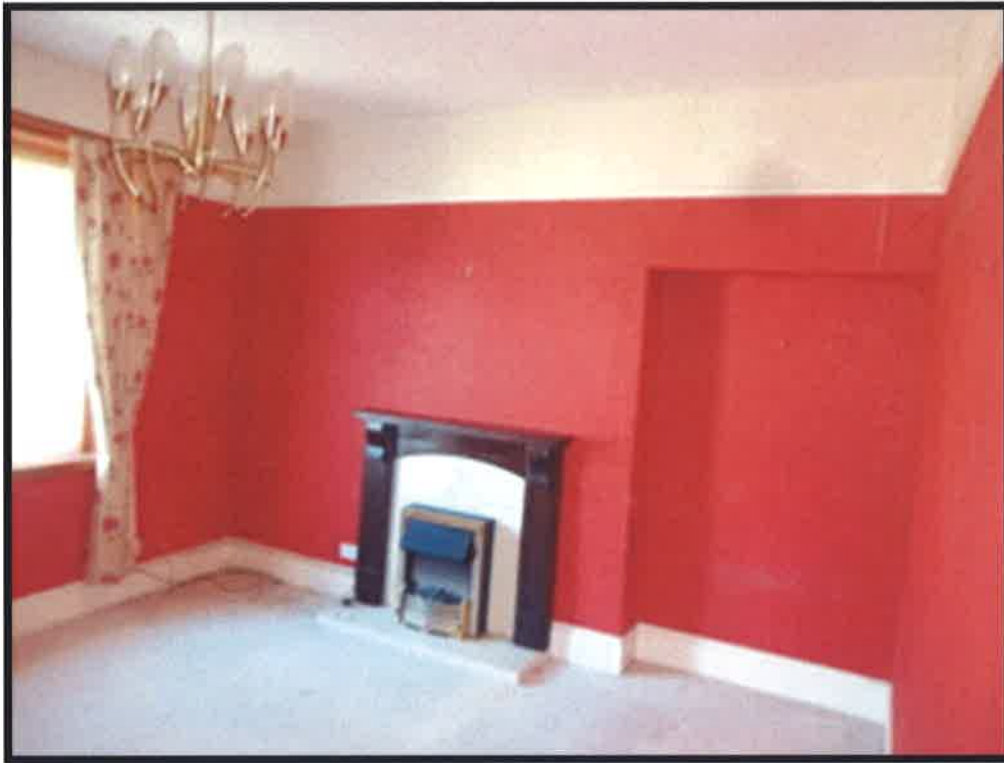
Figure 6 Lounge.

11. The lounge was inspected. Mould growth, black staining and lifting wallpaper were again present, but to a lesser extent than the front bedroom. Again, moisture meter readings were taken to the outer wall surfaces at various heights and locations. Generally, the readings were consistently between 15 and 18%. The windows were in a similar condition, with mould residue. There were no obvious water marks or other visible indications of water ingress. The fireplace appeared to have been sealed and a decorative electric fire in modern surround had been fitted.

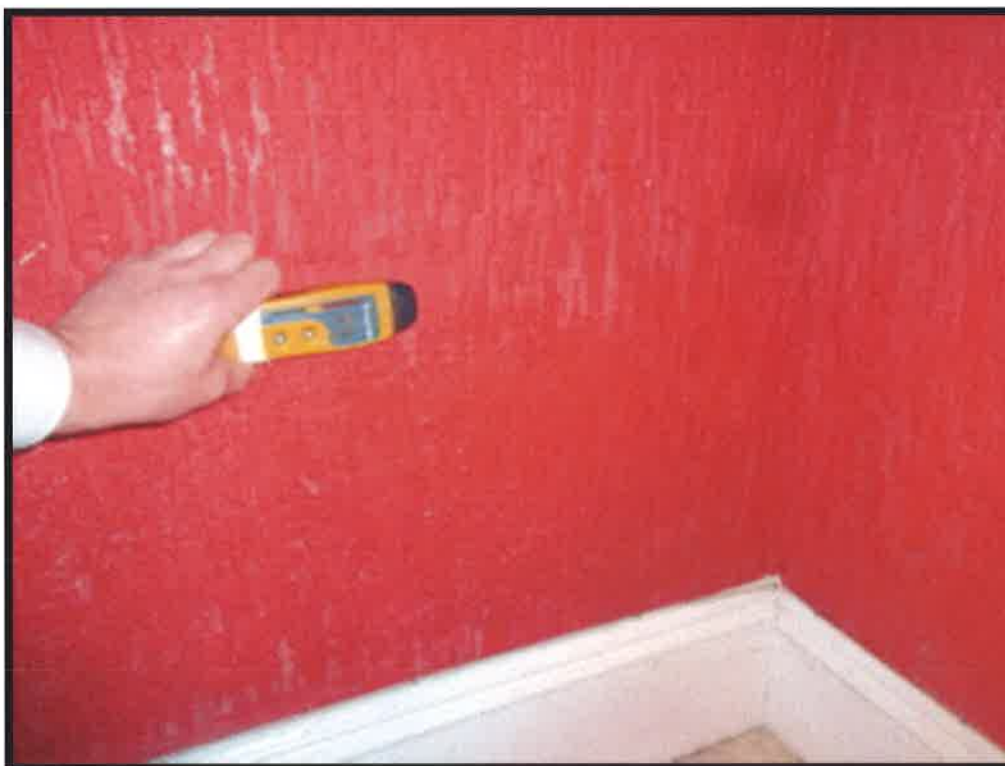
Figure 7 Lounge - typical meter reading (17%).

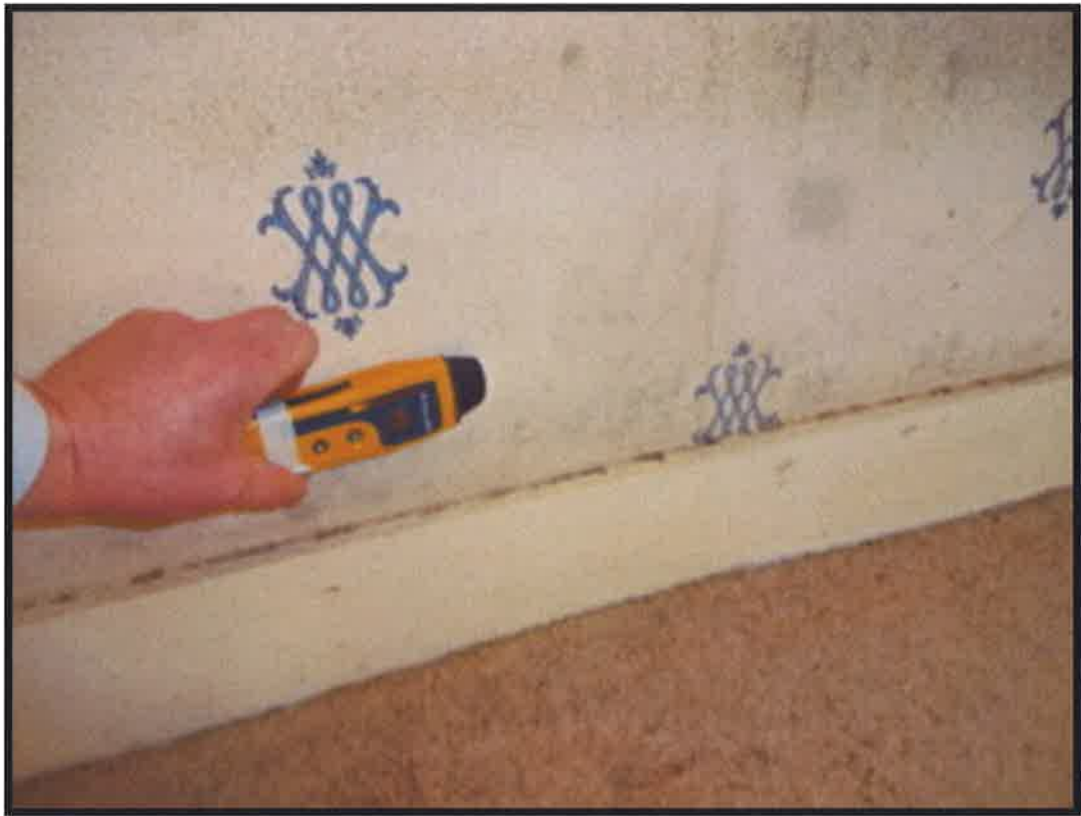
12. The middle bedroom was inspected. Again, there was a degree of mould growth and black staining, but to a lesser extent than the lounge. The walls were soiled from rub marks not related to damp or condensation. Moisture meter readings were similar to those obtained in the lounge. Again, the windows had mould residue and watermarks to the cill. There were no obvious water marks or other visible indications of water ingress.

Figure 8 Middle Bedroom - Meter reading (18%) and soiled decorations

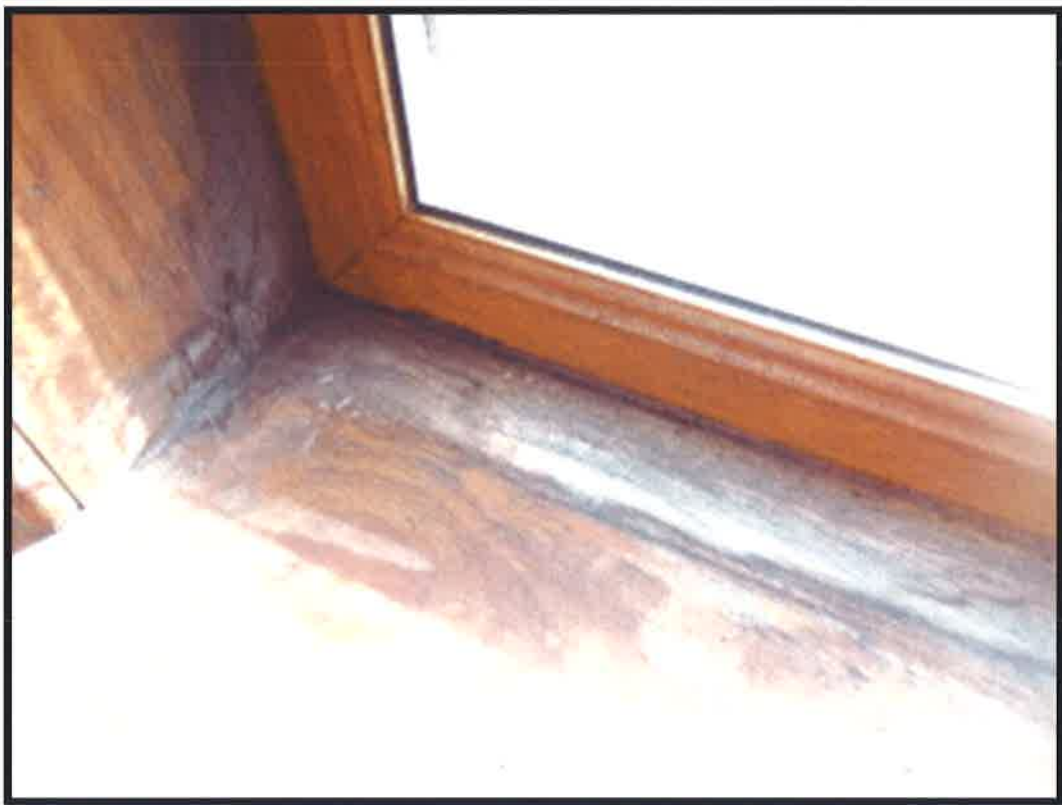
Figure 9- Middle bedroom - water marks to timber window cill.

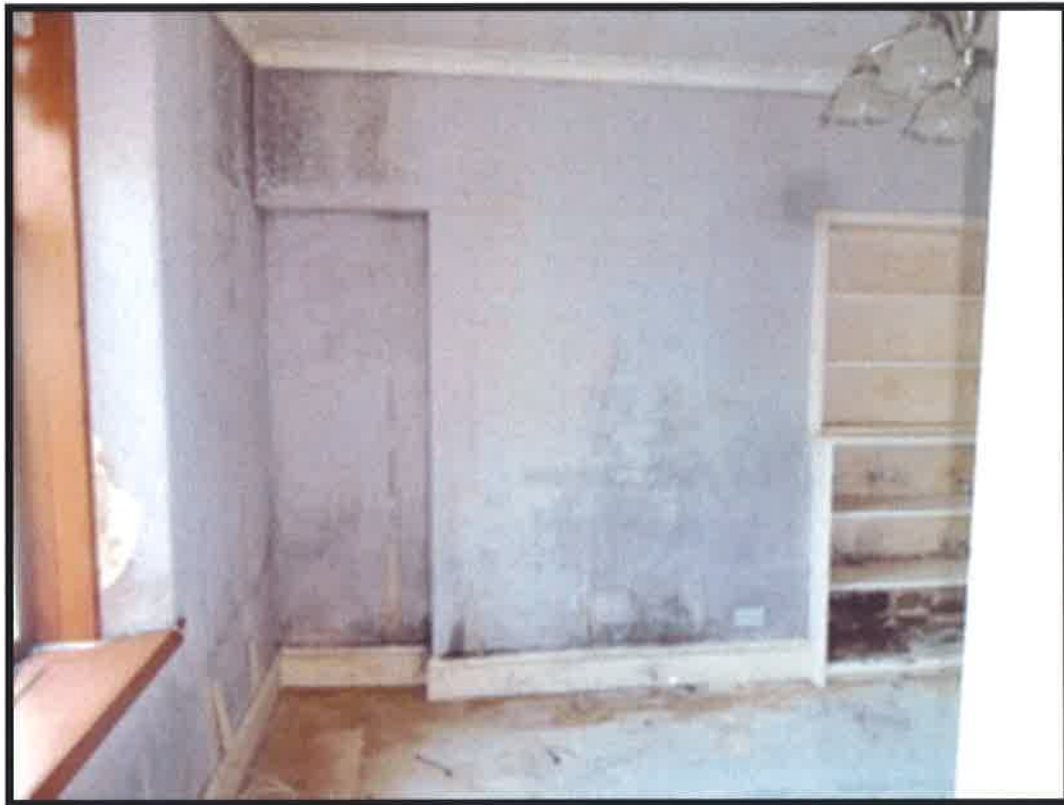
13. The rear bedroom was inspected. Heavy mould growth, black staining and peeling wallpaper was present to the outside walls. There was damage to the decorations by animals. Mould residue was apparent to the window glass. There was residue from a cardboard box in the alcove, which appeared to have been affected by damp. Moisture meter readings were taken to the outer wall surfaces at various heights and locations. Generally, the readings were consistently around 15 - 20%. There were no obvious water marks or other visible indications of water ingress. A fireplace had once been present; the opening had been sealed over but there was no air vent present.

Figure 10 Rear bedroom -extensive mould and damaged wallpaper.

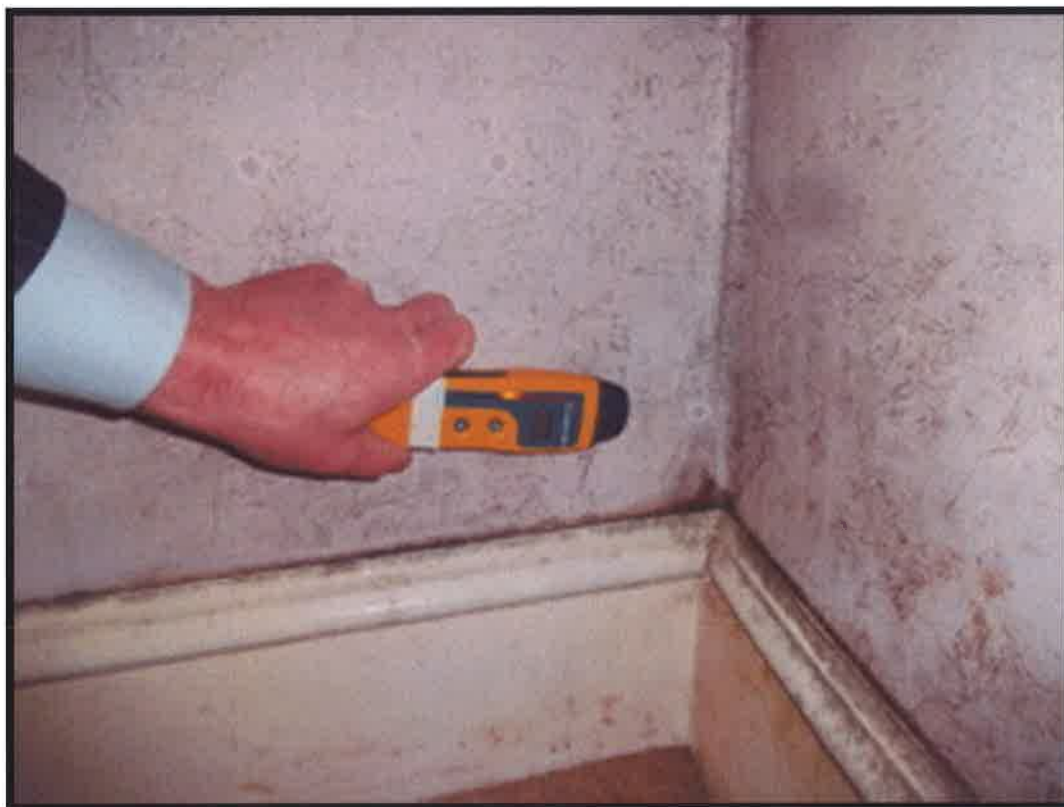
Figure 11 Rear bedroom - Meter reading (19%) rear corner at outer wall.

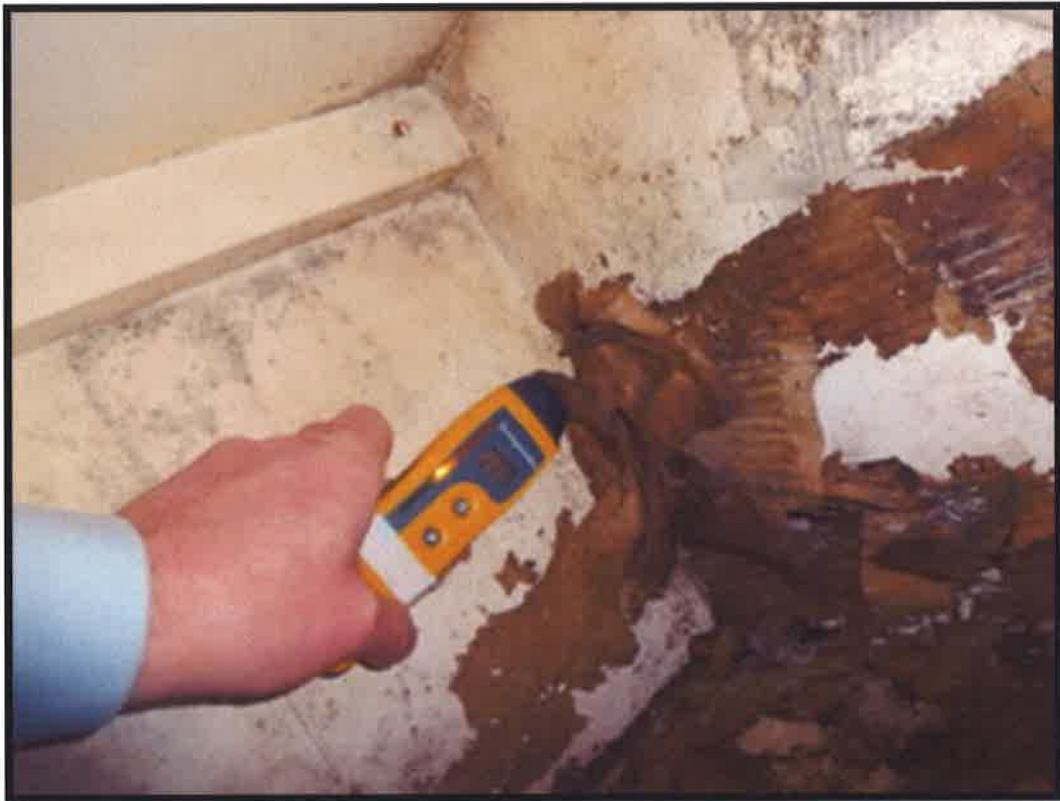
Figure 7 Rear bedroom - Meter reading (19%) within alcove and residue of cardboard box.

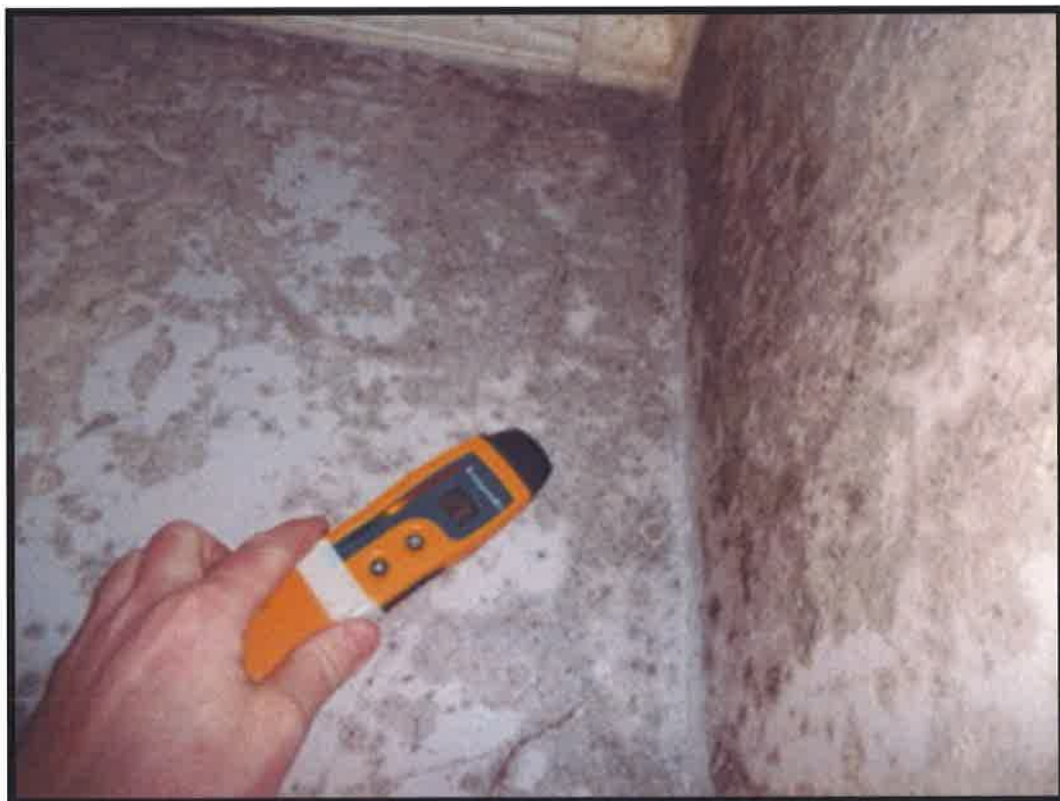
Figure 8 Rear bedroom - Meter reading (16%) high level rear corner and heavy mould growth.

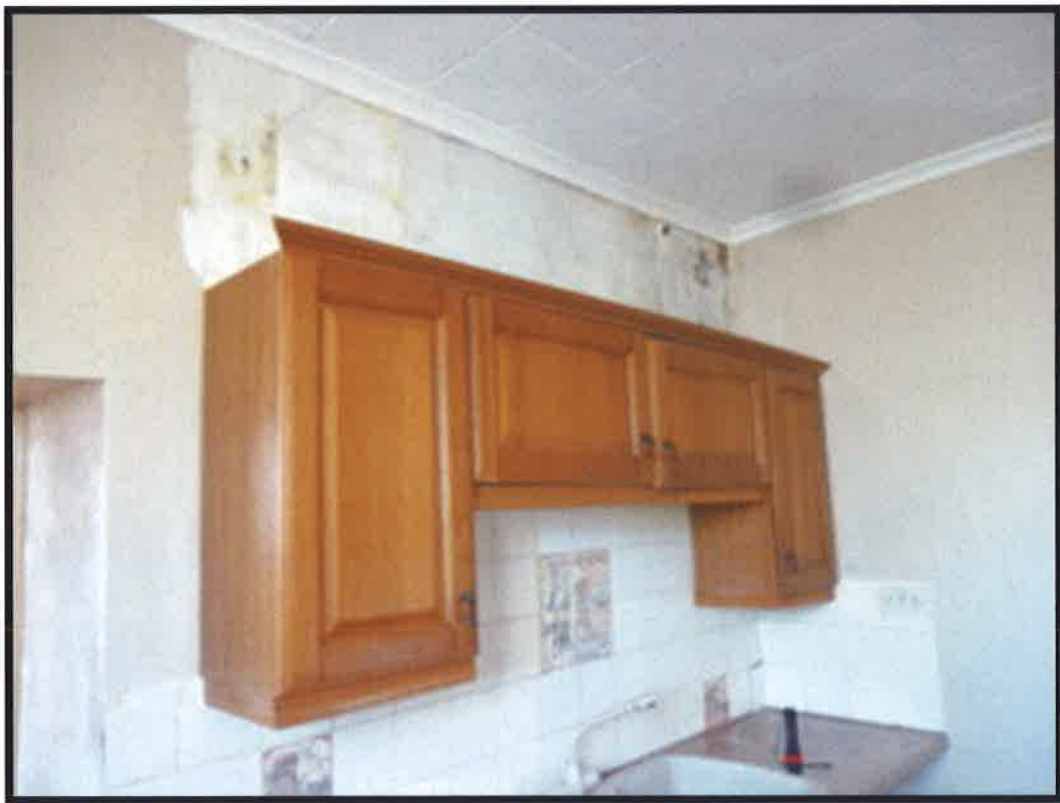
15. The kitchen was inspected. The wallpaper was missing from the area of the rear wall, adjoining the utility room, above the kitchen wall units. This area of the structure is "plastered on the hard", meaning plaster applied directly onto the masonry wall. The wallpaper was also missing at the doorway to the utility room. Staining was present to the internal wall adjoining the bathroom, with loose

Figure 10 Kitchen - rear wall and doorway to utility room.

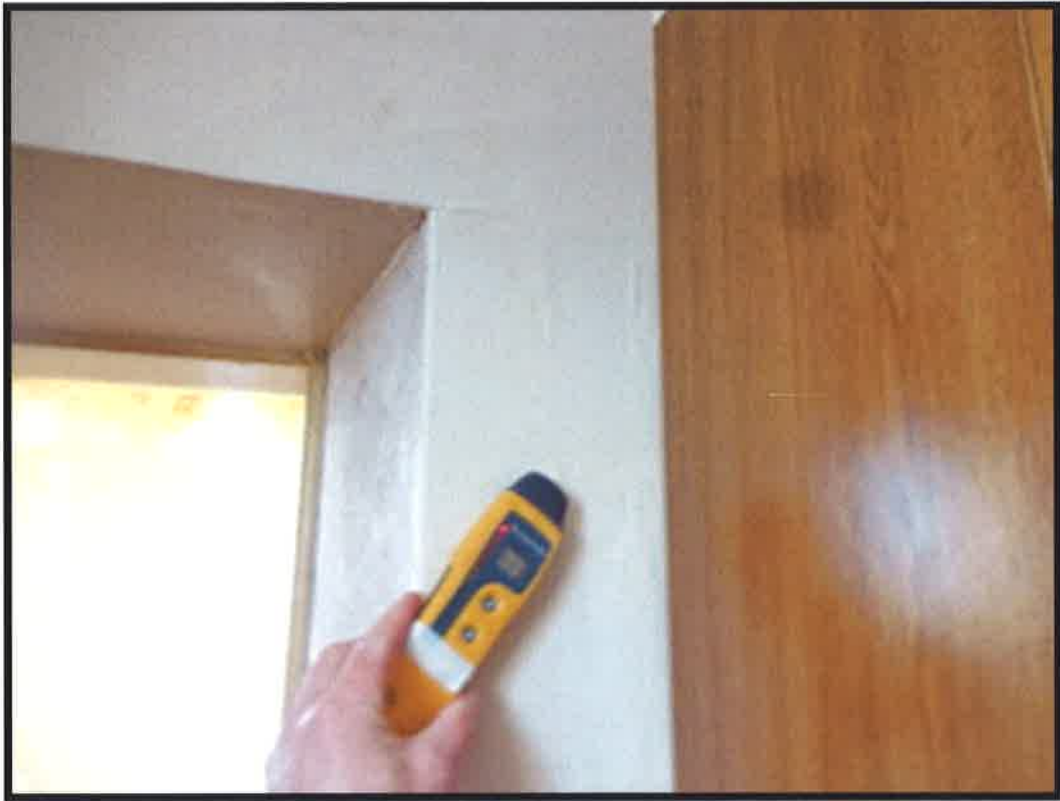
Figure 115 Doorway to utility room - Meter reading (100%).

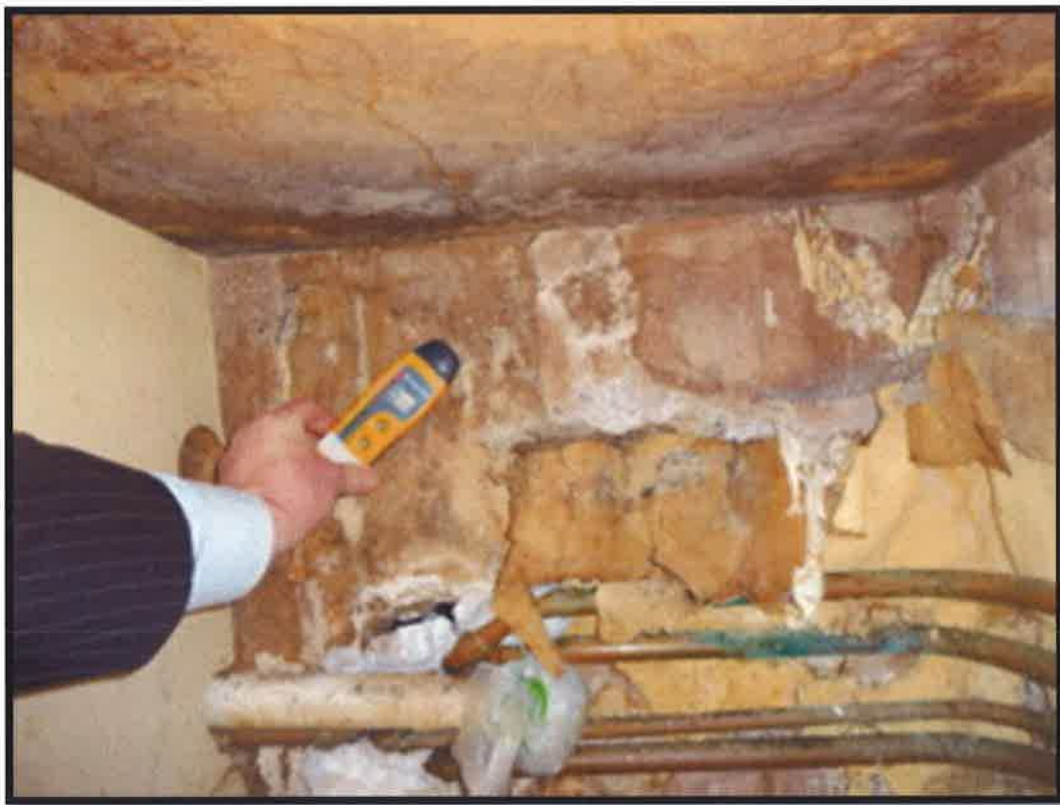
wallpaper. Moisture meter readings to these areas indicated dampness with readings of 100%. There was clear evidence of water ingress at this location.

Figure 126 Kitchen - rear wall at site of dishwasher moisture meter reading (100%)

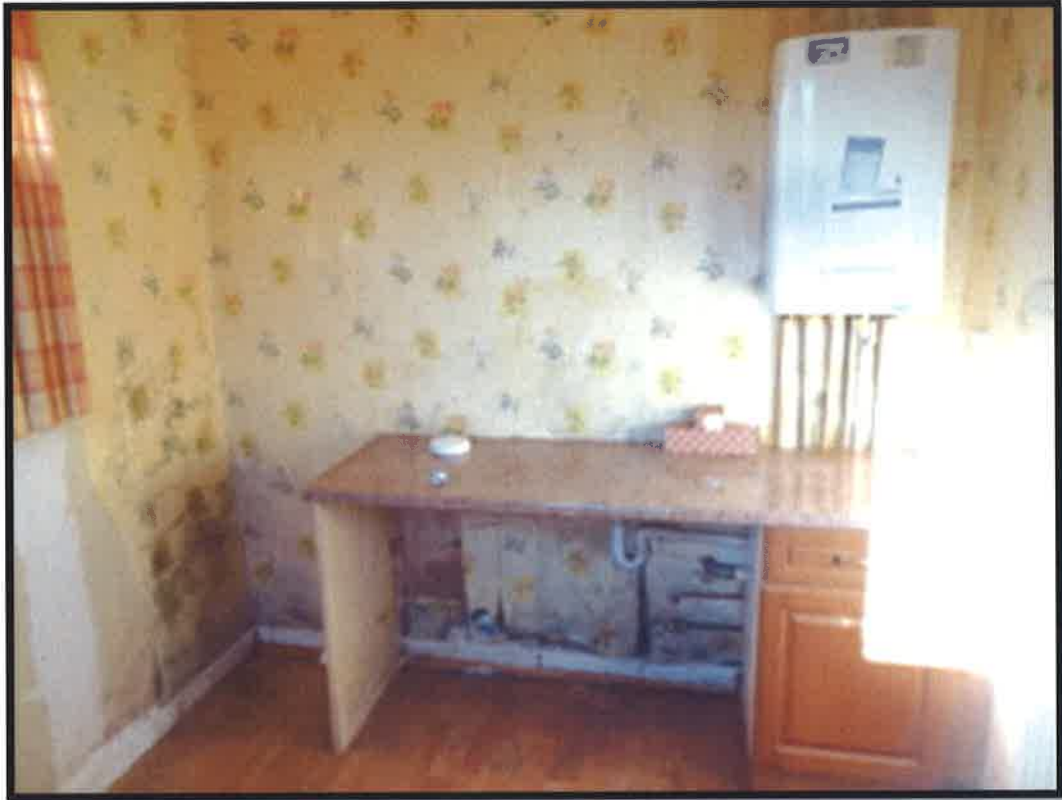
Figure 137 Utility room - right hand side wall

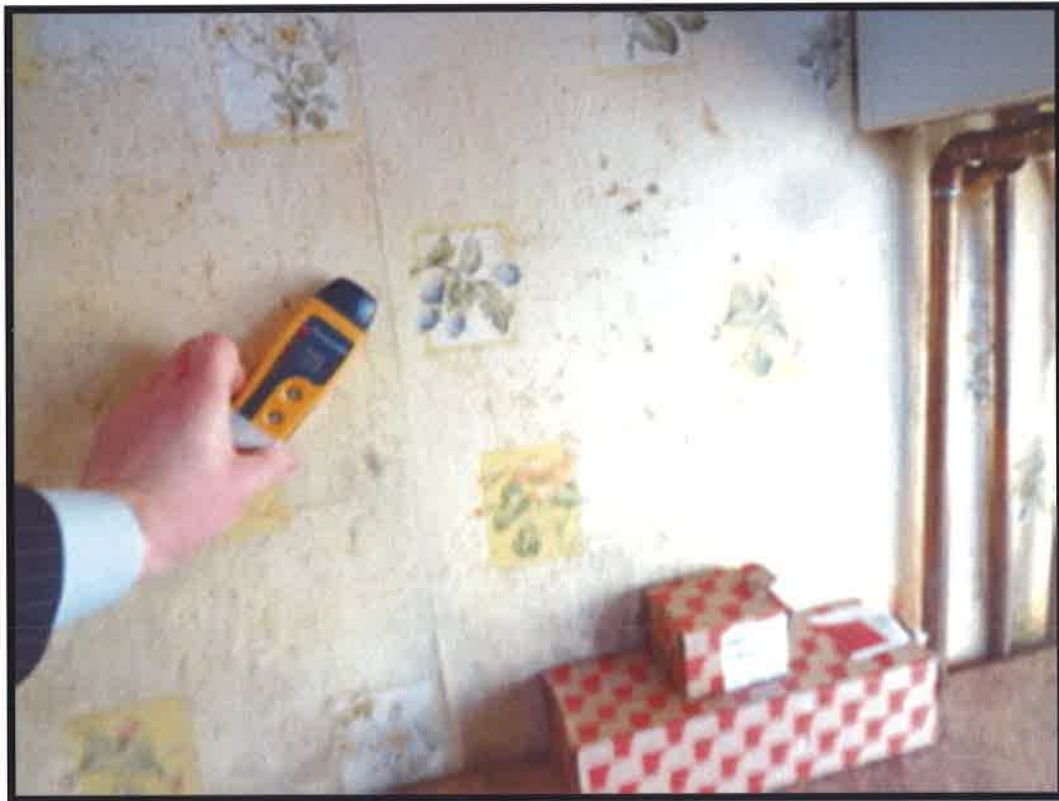
16. The utility room was inspected. The wallpaper was missing from the left side of the room. Moisture meter readings at this location were found to be normal, around 15 - 18%. Mould growth, black staining and peeling wallpaper was found to the right hand (outside) wall, below and to the left of the central heating boiler. Moisture meter readings to these areas indicated dampness with readings of 100%. There was clear evidence of water ingress at this location.

Figure 148 Utility room - moisture meter reading (100%)

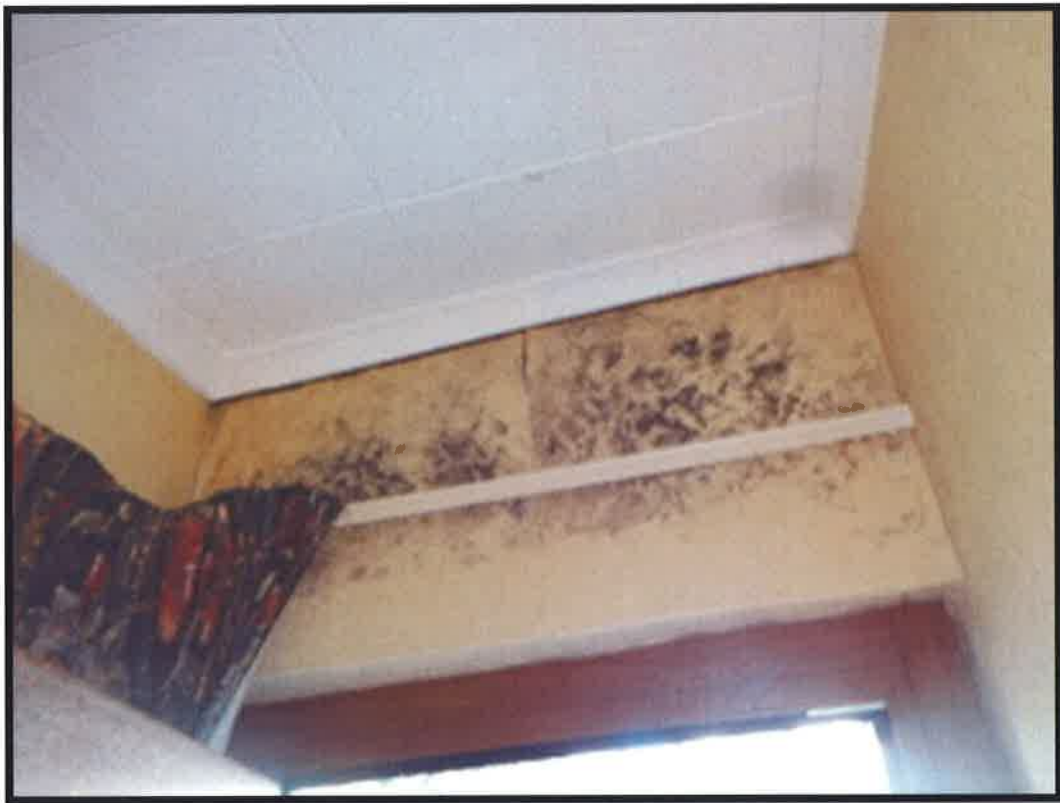
14. The rear hall was inspected. Mould growth, black staining and peeling wallpaper was present to the outside wall area above the rear entrance door. Moisture meter readings to this area indicated dampness with readings of 100%. There was clear evidence of water ingress at this location.

Figure 159 Rear hall - mould above rear entrance door.

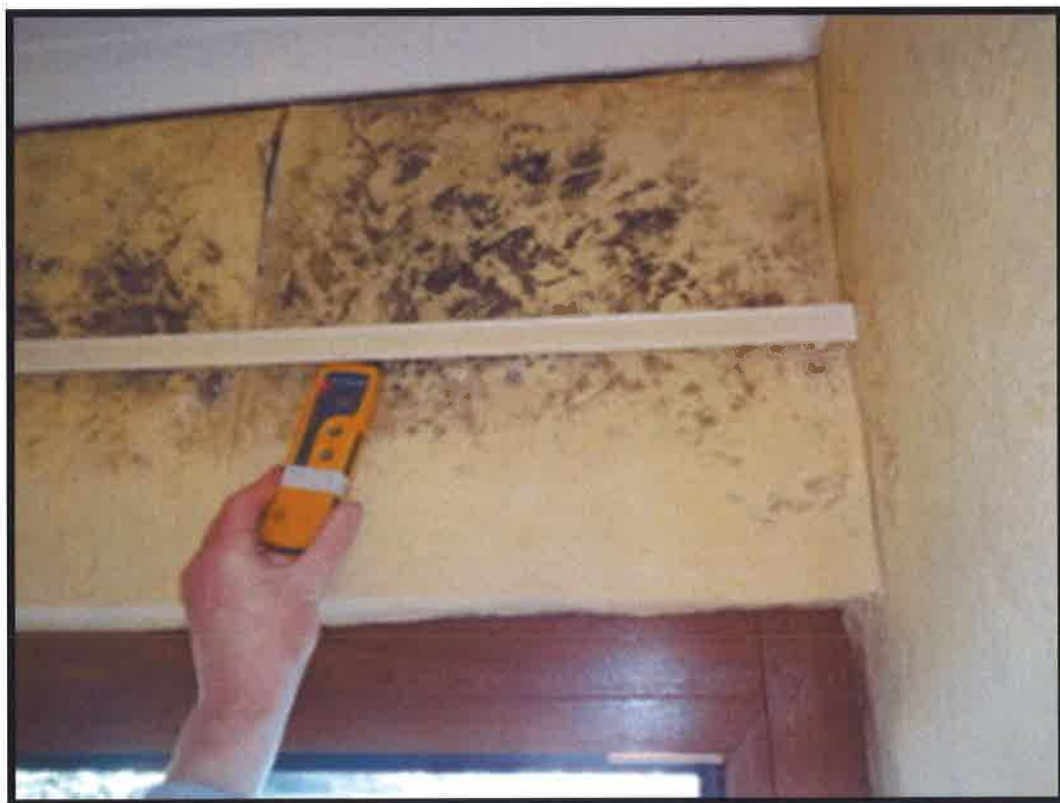
Figure 20 Rear hall - moisture meter reading (100%)

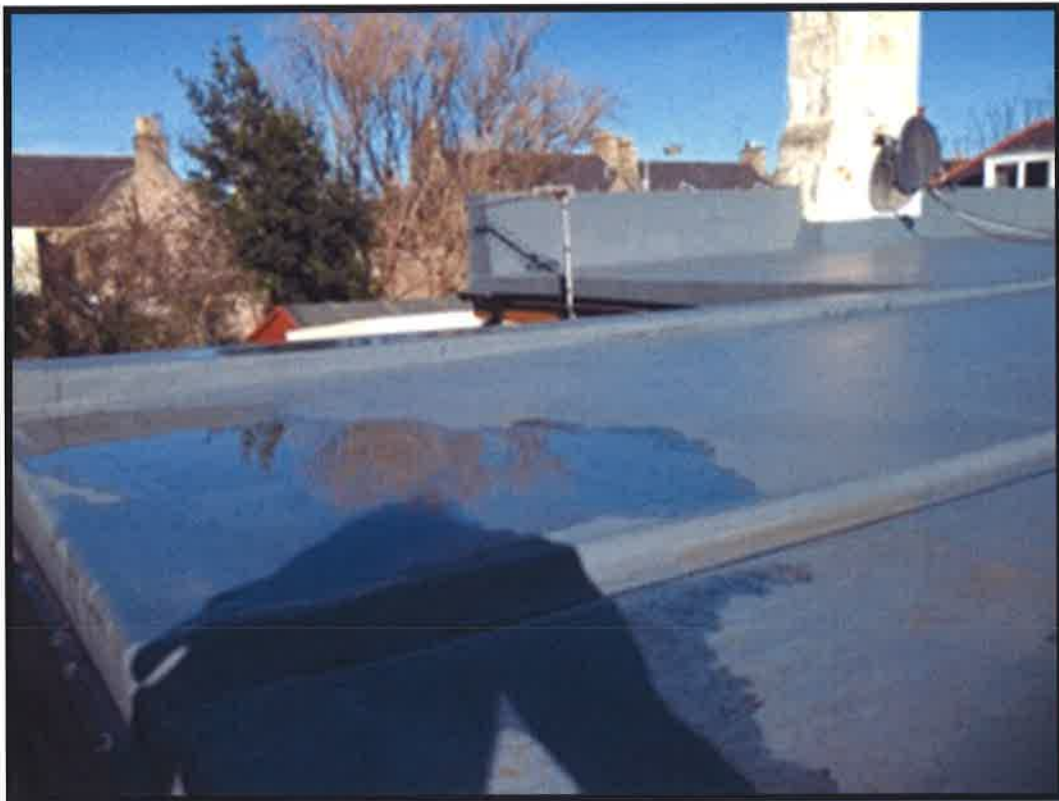
29. The Tribunal was in no doubt, from its inspection that the property did not meet the Repairing Standard. There was clear evidence of water ingress from the roof which had resulted in moisture meter readings of 100% in areas of the rear hall, kitchen and the utility room. This was observed by the Tribunal and accepted by the Landlord.

Figure 22 Rear section of flat roof with ponding over bathroom.

- (a) carry out such works as are necessary to the roof of the house and external walls to prevent water ingress;
- (b) repair or replace the damp and damaged wall linings in the kitchen and utility areas;
- (c) carry out such works as are necessary to clear all mould from the house; and
- (d) carry out internal decoration throughout the house following the completion of the aforesaid works.

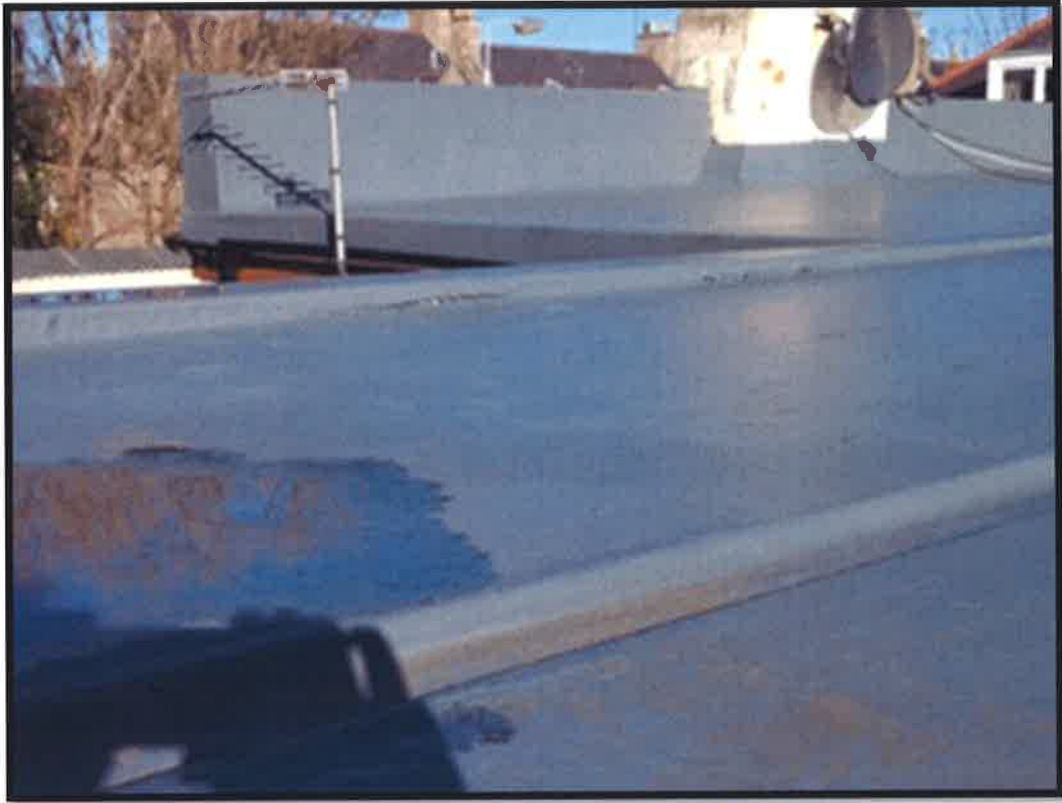
Figure 23 Rear section of flat roof with gap above rear entrance door.

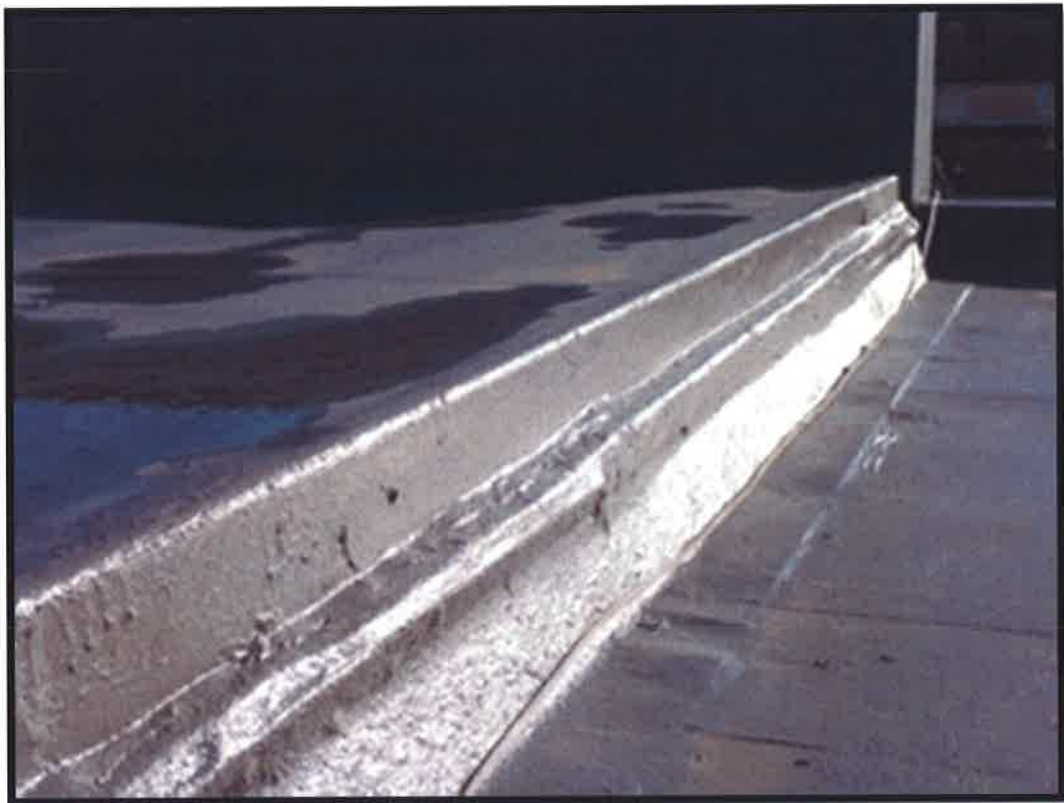
Figure 24 Rear section of flat roof at kitchen/utility room junction with ponding over kitchen.
