**Repairing Standard Enforcement Order (RSEO): Housing (Scotland) Act 2006
Section 24**

Chamber Ref: FTS/HPC/RP/16/1022

**Top Flat, Portdrishaig House, Tighnabruaich, PA21 2EB
("The Property")**

Schedule of photographs taken during the inspection of Top Flat, Portdrishaig House, Tighnabruaich PA21 2EB by the First-tier Tribunal for Scotland (Housing and Property Chamber) on 30 March 2017.

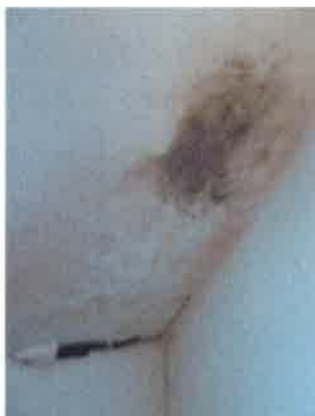
- There was significant dampness on the camceil ceiling and base of the wall to the right side of the dormer window in the bedroom to the rear of the property which was confirmed by a high moisture reading taken with the damp meter. There was a hole in the plasterboard and a build up of black spot mould. There was staining on the carpet below which Ms. Anderson confirmed had been caused by water ingress.

Back Bedroom - camceil ceiling to right side of dormer window showing water damage to plasterboard and black spot mould

- (a) To repair or replace the roof, including the roof located above the common stairwell of the property, and to repair any source of water ingress and dampness within the property whether emanating from the gable end wall or otherwise, to ensure that the property is wind and watertight and reasonably fit for human habitation.
- (b) To repair or replace the windows in the property to ensure that the property is wind and watertight and reasonably fit for human habitation.
- (c) To repair or replace the electrical socket located in the kitchen to ensure that that is in a reasonable state of repair and in proper working order.
- (d) To produce an Electrical Installation Condition Report by a suitably qualified and registered electrician, which report is to be completed after the repair of the electrical socket in (c) above is carried out.

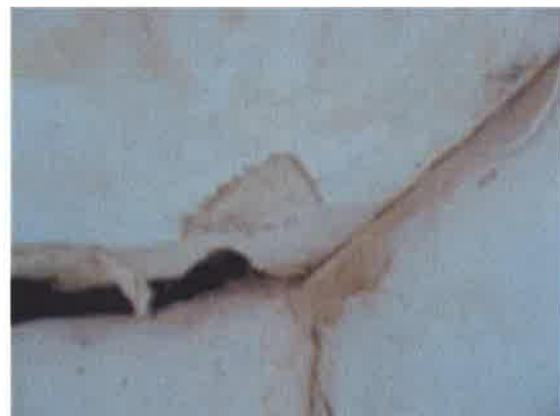
Back Bedroom - camceil ceiling to right side of dormer window showing closer view of water damage to plasterboard

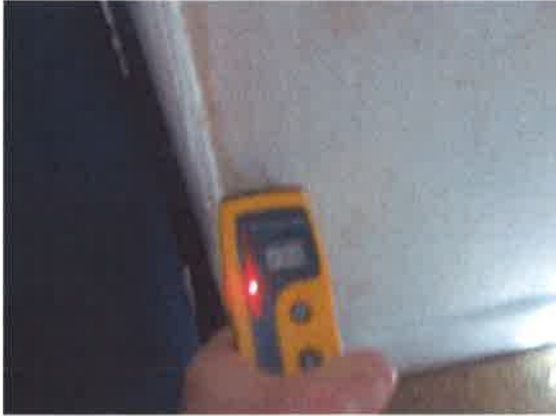
Back Bedroom - high moisture reading to base of wall to right side of dormer window

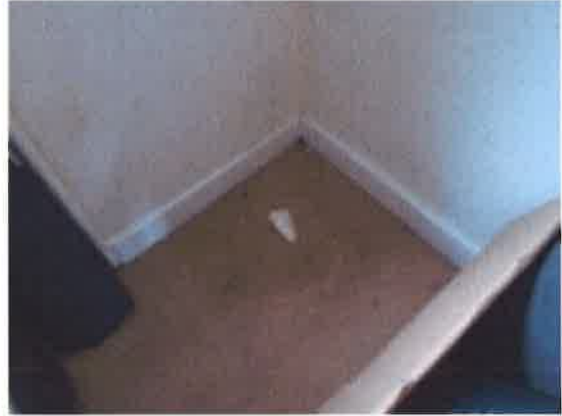
Back Bedroom - water stain to carpet under camceil ceiling on right side of dormer window

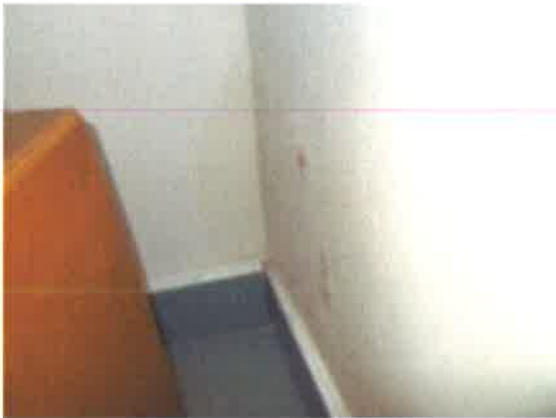
- Ms. Anderson confirmed that the window in the rear bedroom functioned well.
 - There were high moisture readings taken in the living room in the corner where the party wall to the rear bedroom meets the gable end of the property. The damp meter readings were at the top end of the scale. The walls were wet to the touch. There was a distinct damp stain just above the skirting boards in the corner and some paintwork was peeling.

Living Room - damp patch on corner of gable wall and party wall to back bedroom

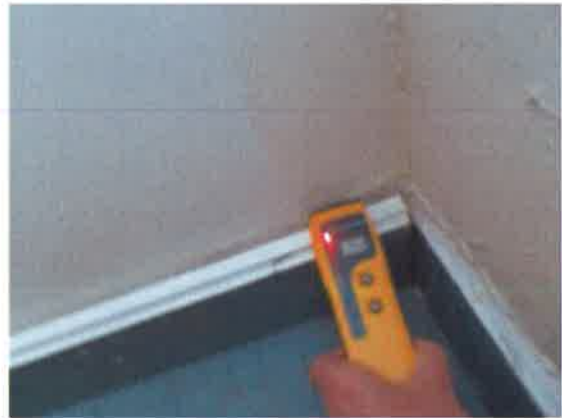
Living Room - high moisture reading to base of gable wall.

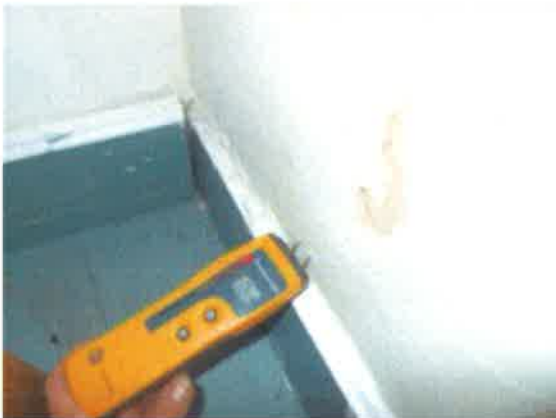
Living Room - high moisture reading to base of party wall to back bedroom

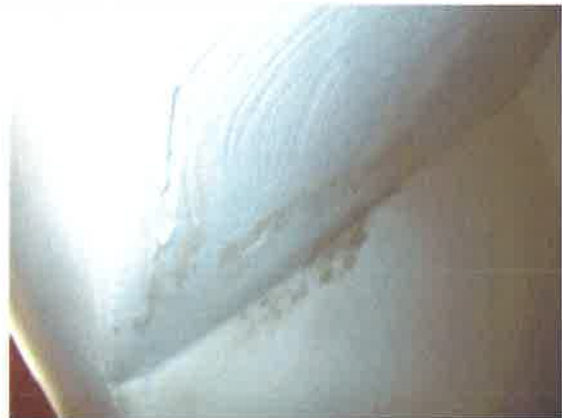
- There were high moisture readings taken and obvious staining on the camceil ceiling in the living room to the right of the dormer window.
 - The window in the living room only opened into the room as the tilt function no longer worked. Ms. Anderson confirmed that the window contractor had attempted to seal the window by putting silicone around the window but that it was still draughty and

Living Room - damp patch to camceil ceiling/wall on right side of dormer window

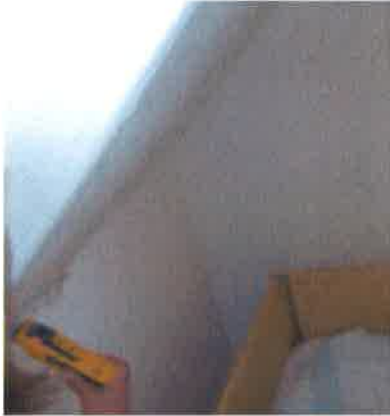
Living Room - high moisture reading to wall at right side of dormer window

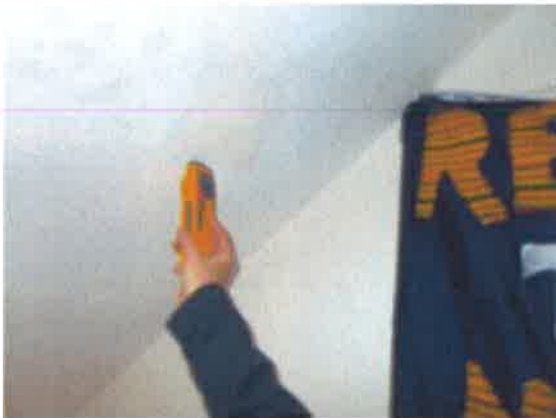
Living Room - high moisture reading at damp patch on camceil ceiling on right side of dormer window

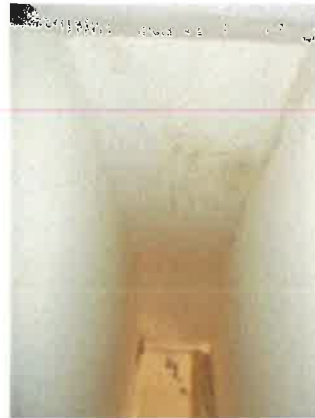
- Ms. Anderson confirmed that she and the Tenant and her two children would be moving out of the property at the end of April 2017.
- There is water damage to the ceiling over the internal staircase, Ms. Anderson said this has been evident since the start of the tenancy and had not changed.

Internal staircase - damp patch to ceiling

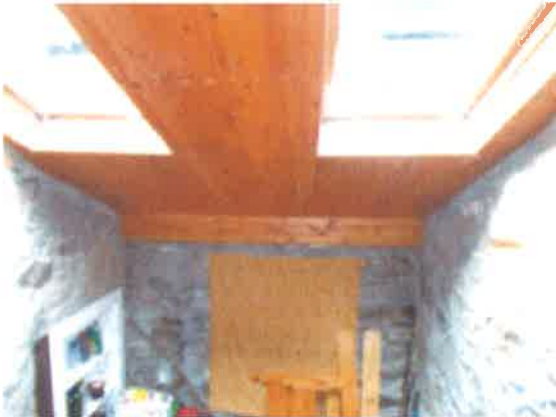
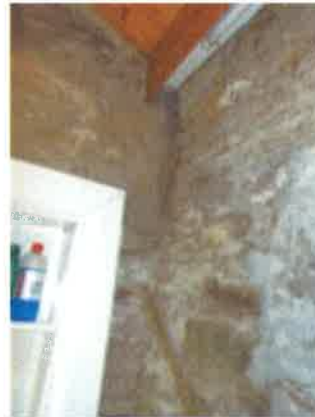
- Ms. Anderson confirmed that water ingress was still a live issue in the common stairwell. She advised that repairs had been carried out to the roof above this space but these works had caused the water ingress to move along the wall and had simply relocated the water ingress.

Communal Hall - left corner adjacent to recessed bookcase

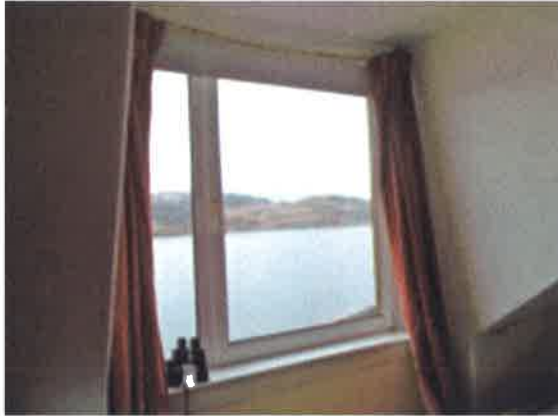
Living Room window

whistling could be heard when it was windy. She advised that the contractor had warned her not to attempt the tilt mechanism of the window as it was broken.

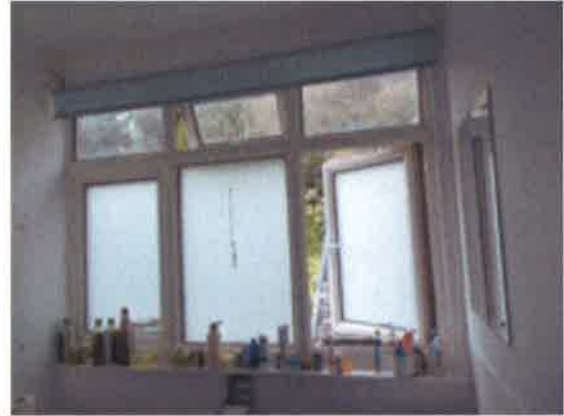
Bathroom windows

- The window in the bathroom on the left side of the room had been sealed shut and the handle removed by the contractor. This window could no longer be opened. The other windows in the bathroom could open and close. Once again, the windows had been sealed with silicone. Ms. Anderson confirmed that the draughts had improved but were still there.

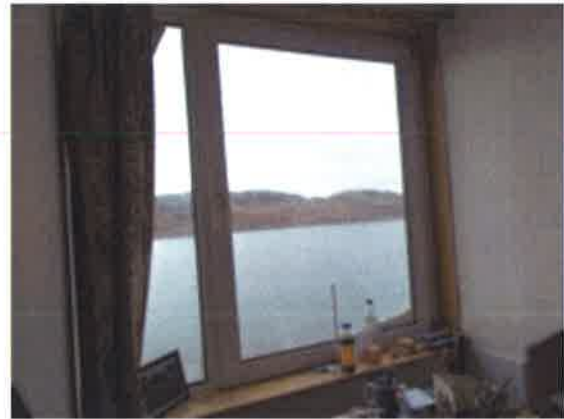
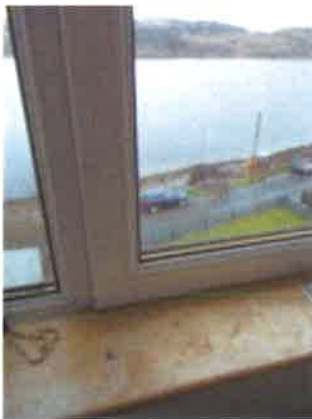
- The window in the bedroom to the front of the property could open and close and had been sealed with silicone but Ms. Anderson confirmed that water still came in from this window when it rained. There were water stains on the window sill.

Front Bedroom window - showing water staining to sill

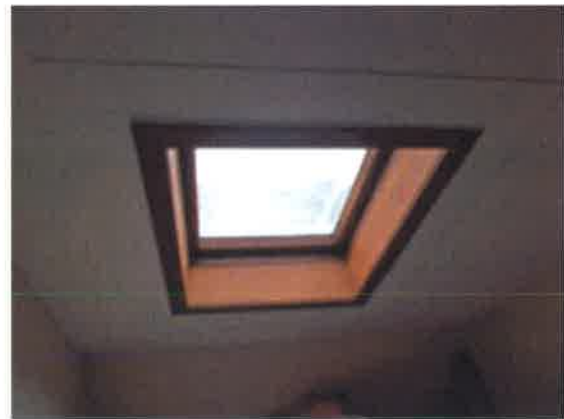
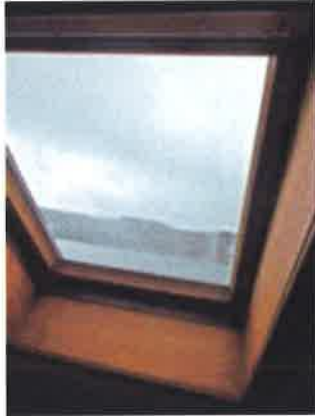
Box Room - Velux window

- The window in the box room to the front of the property had been fixed and now opened. It had also been sealed with silicone. Ms. Anderson confirmed that it was still draughty and that her younger son could not sleep in it as it was too cold and his bed used to get wet from the water ingress. The seal to the double-glazed Velux window had failed and there was extensive misting in between the panes of this window.

Box Room - Failed seal to Velux window - condensation between double glazing panes

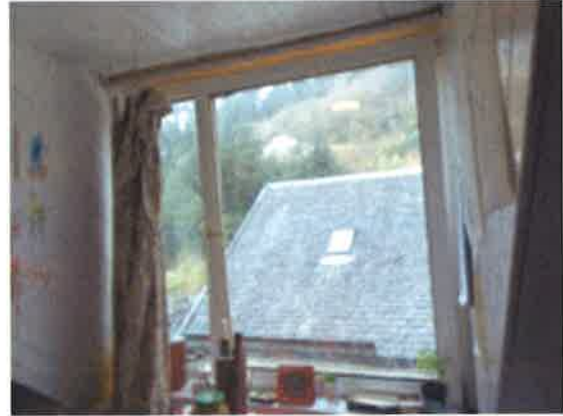
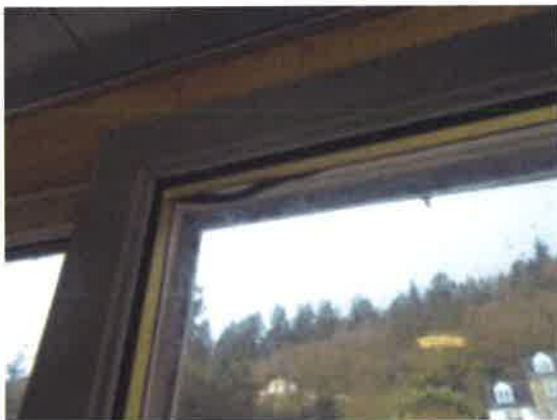
- The window in the kitchen had been fixed but Ms. Anderson confirmed that the kitchen still suffered badly from draughts which she and the Tenant believed emanated from the roof rather than the window itself.

Kitchen window - showing dislodged seal

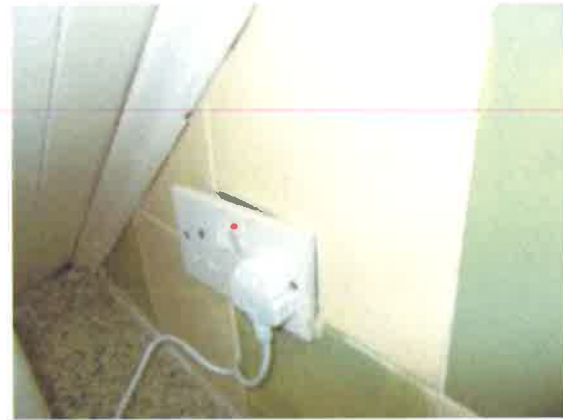
- The double electric socket above the worktop to the left of the sink unit in the kitchen was loose and coming away from the wall.
- The lock on the front door of the property had been repaired and now locked securely.

- The electric socket in the kitchen is loose and coming away from the wall.
 - The windows in the property are double glazed and constructed of UPVC. They were made in or around 1996.

Kitchen - loose double socket above worktop
