Housing and Property Chamber

**Repairing Standard Enforcement Order
Housing (Scotland) Act 2006 : Section 24**

**4 Balgray Avenue, Kilmarnock, KA1 4QS
("The House")**

Schedule of photographs taken during the inspection of 4 Balgray Avenue, Kilmarnock KA1 4QS by the First-tier Tribunal for Scotland (Housing and Property Chamber) on 8 May 2017.

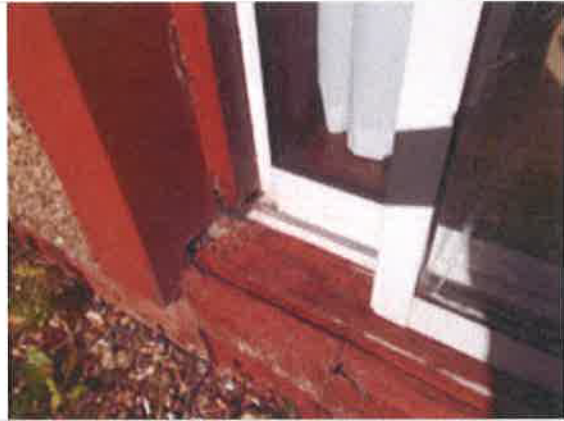
8.1 The patio doors are situated at the rear of the house and open from the living room onto the rear garden. The sliding door is not secure on its track and there is rot to the external door frame and sill. There is one missing external pane of glass. Mr Blackburn demonstrated that for the door to be locked it has to be lifted from its runners. Mr Blackburn also demonstrated that the door can be easily lifted from its runners.

13.1 The patio doors are not in an acceptable condition. There is a missing pane of glass, the external timber frame including the sill is rotten and the door does not properly operate in its runners.

Patio doors showing one door not secure on the track and rot to external timber sill

(One) The Landlord is to repair or replace the patio doors to ensure that they operate properly on their runners and that all panes of glass are intact and also eradicate the rot in the external timber frame, including the sill of the patio doors. (Sections 13 (1) (a) and 13 (1) (b) of the 2006 Act)

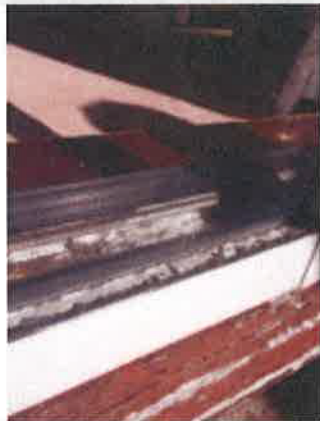
Mr Blackburn said that the pane of glass had been missing during his tenancy of the property which had been for ten years. Ms McKenzie said that an estimate for work to the patio doors had been sent to the Landlord and she understands that it is the Landlord's intention to do the work.

Patio Door showing broken/missing external pane to double glazing

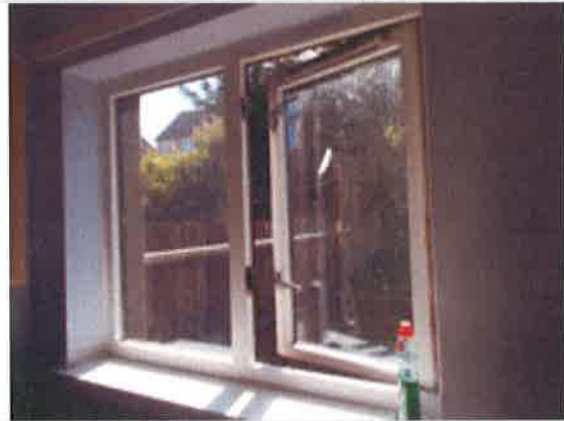
13.3 One handle in the kitchen window is loose.

Kitchen window - internal - one loose handle/one replaced and secure

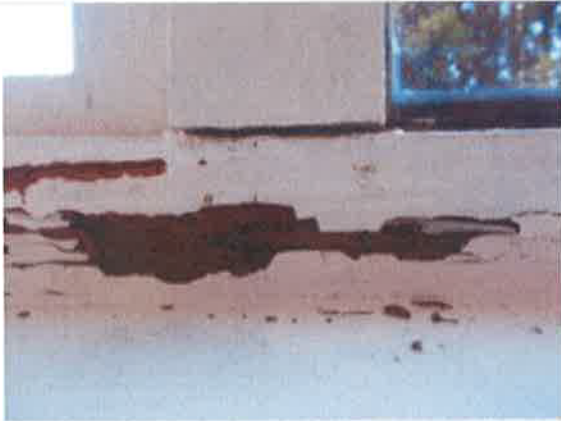
8.16 There is evidence of rot to the internal living room window frame.

Living Room window- internal - showing rot

(Two) The Landlord is to repair or replace the living room window and timber frame to eradicate all rot and ensure that it is wind and watertight and that all panes of glass are intact. (Sections 13 (1) (a) and 13 (1) (b) of the 2006 Act)

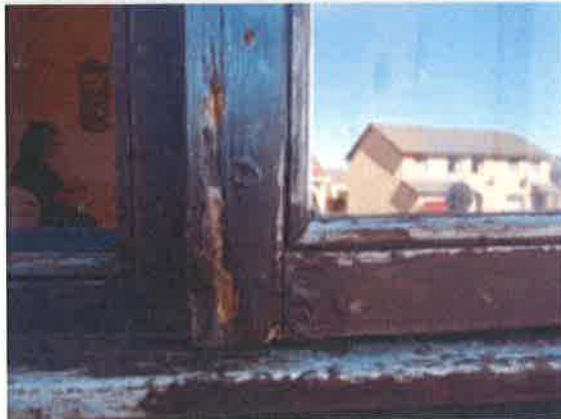
8.4 The external living room window is rotten and there is a missing external pane of glass.

13.5 A pane of glass is missing from the living room window.

Living Room window - external - showing rot and broken/missing external pane to centre window double glazing

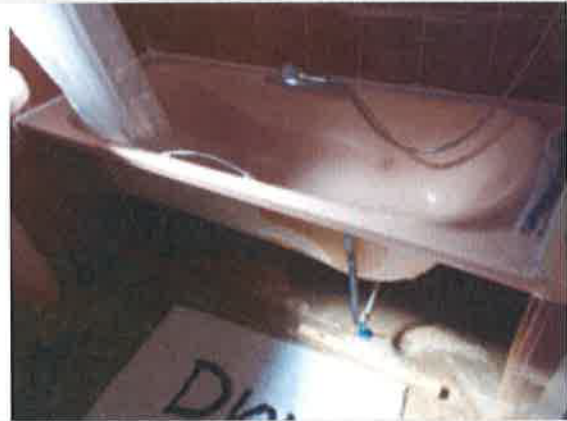
Bathroom showing missing bath panel

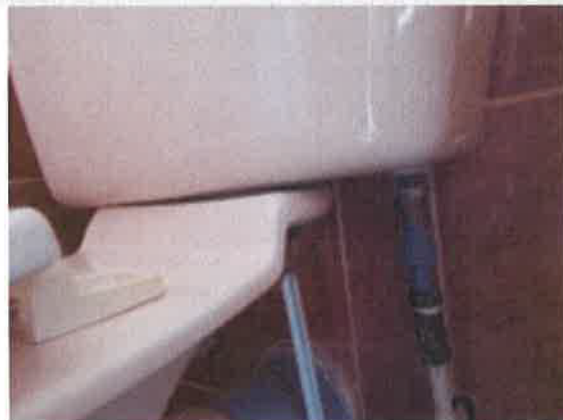
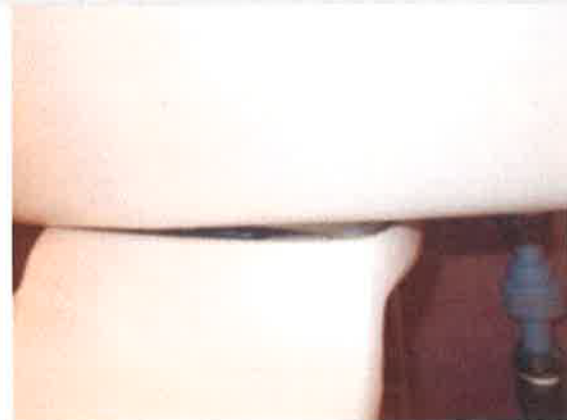
Mr Blackburn said that a new flushing unit had been fitted and that this was working effectively but that, after the repair, the WC had not been secured to the floor and the cistern and base unit had not been properly fitted.

Bathroom - showing uneven gap between cistern and toilet bowl

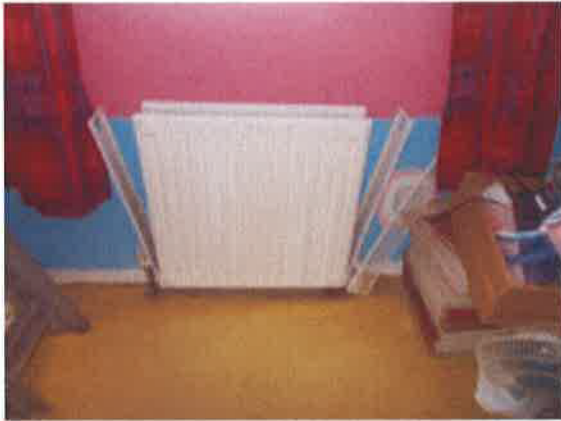
8.6 The radiator in the front bedroom is not properly secured to the wall and has loose side panels.

Mr Blackburn said that the fact that the radiator was not properly fixed to the wall had been reported on many occasions to Homesure. Ms McKenzie said that one possibility is that the damage had been caused by excessive washing being placed on the radiator by the Tenant. This was not accepted by Mr Blackburn.

Front bedroom right side - radiator not secured to right side bracket and loose side panels

(Four) The Landlord is to carry out works to secure the radiator in the righthand front bedroom and have the side panels re- fitted. (Section 13 (1) (c) of the 2006 Act).

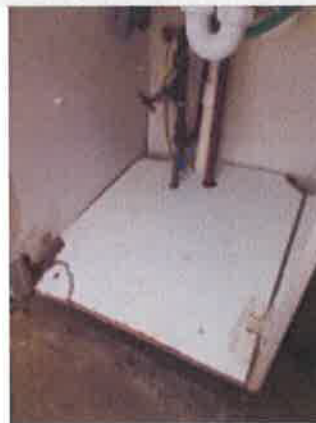
8.7 The kitchen sink base unit has no door and is damaged. There is no floor covering in the kitchen.

Mr Blackburn said that there had been a leak at the kitchen sink and, when the plumber called at the Property, he had removed the kick boards and taken up the vinyl flooring in an attempt to locate the water mains. Mr Blackburn said that he had supplied the vinyl flooring himself. He said that the leak had been fixed and new taps fitted but nothing had been done with regard to the damage caused to the sink base unit which now has a missing door and was rotten in part as a result of the leak. He said that the flooring and kick plates had not been replaced.

Kitchen sink base unit - dilapidated/water damage and missing door

**(Ten) The Landlord is to carry out works to reinstate items damaged as a result of the leak at the kitchen sink and the works carried out to trace and repair the leak. The works are to include the repair or replacement of the kitchen sink base unit and ensure that it is fitted with a door, fitting of kick plates and supplying and fitting an appropriate floor covering.
(Section 13 (1) (d) of the 2006 Act).**

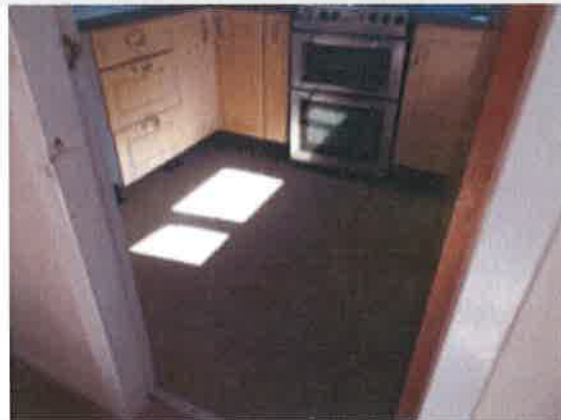
Kitchen - no floor covering

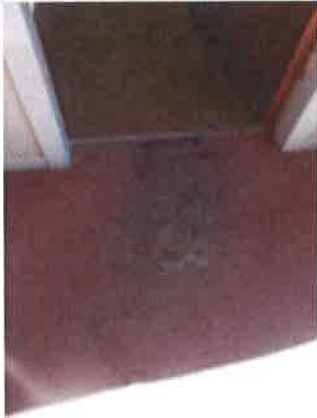
8.9 The living room carpet is stained at the entrance to the kitchen,

Living Room - showing worn/stained carpet at entrance to kitchen

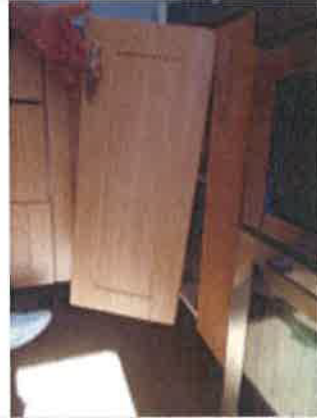
Mr Blackburn said that many of the cupboards have hinges that need adjustment and some handles are also loose.

Kitchen - showing defective/loose hinges to corner base unit

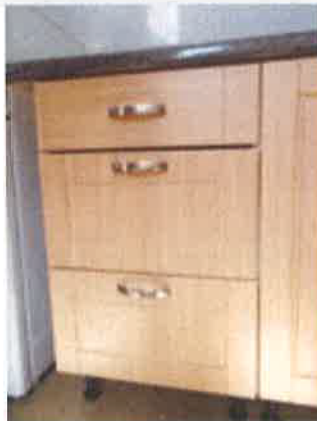
Kitchen - showing gap at doors to drawer

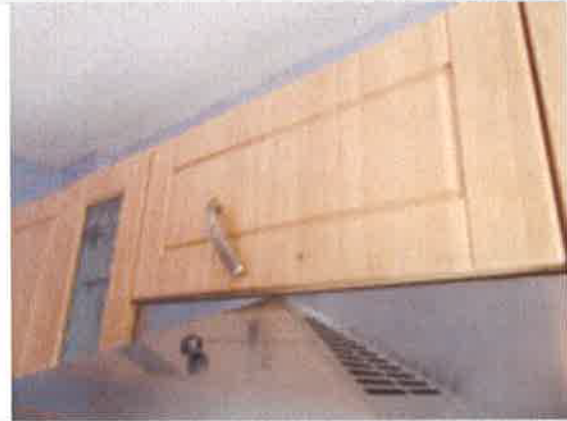
13.11 Some of the kitchen unit doors are loose and some kitchen unit handles are loose. The kick plates are missing.

Kitchen - showing defective/loose handle to unit above cooker hood

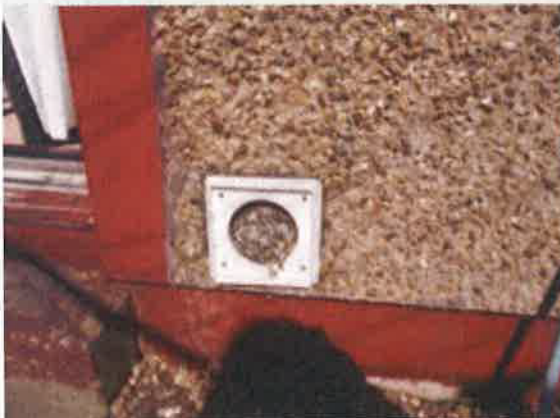
Tumble dryer vent - missing cover/hole packed with paper - external view

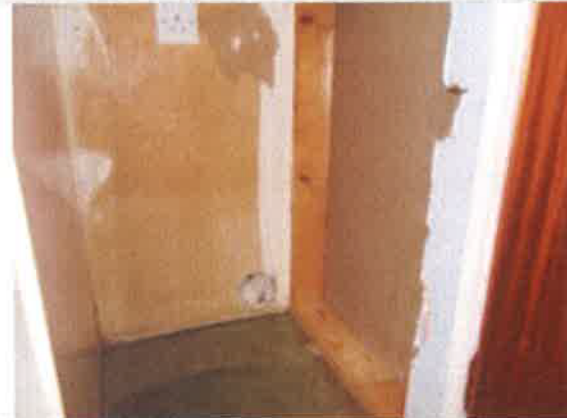
Tumble dryer vent - exposed hole packed with paper - internal view

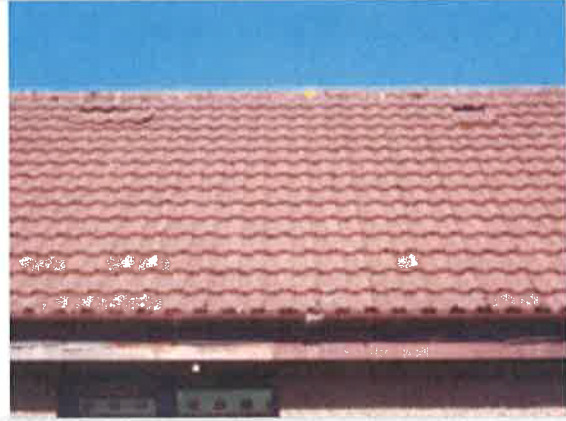
Ms McKenzie said that the Landlord is aware of the missing tiles.

13.12 There are three roof tiles missing to the rear pitch.

Roof - rear pitch - 3 roof tiles dislodged

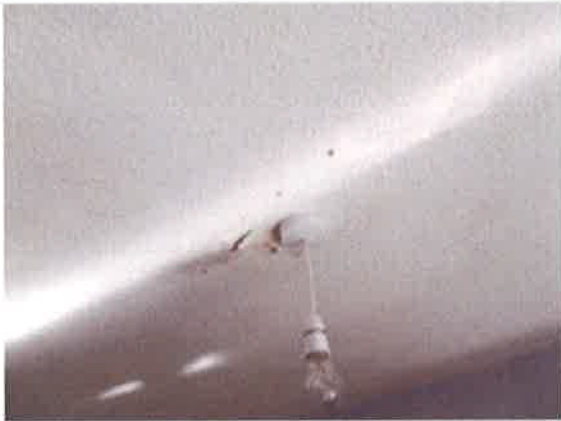
8.15 The kitchen ceiling shows signs of water damage.

13.14 There is water damage to the kitchen ceiling.

Kitchen - ceiling damaged by leak from bathroom
