**First-tier Tribunal for Scotland (Housing and Property Chamber)**

**Property at Top Floor, 21D Court Street, Dundee, DD3 7QS  
("The House")**

**Determination under section 24(1) of the Housing (Scotland) Act 2006**

**Case Ref: PRHP/RP/1/0084    31st May 2017 @ 10am**

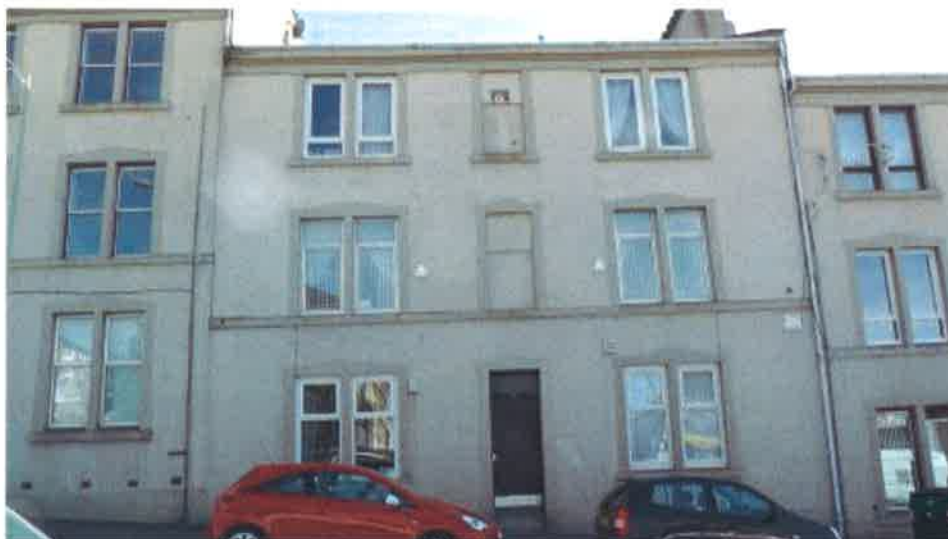
(Ph1) – Front elevation

3. It was noted that the adjoining property to the North has a missing downpipe on its front elevation, and that the rainwater run-off from its roof is discharged into the guttering of 21 Court Street via a short section of pipe that has been fitted by way of an addition. It is questionable if this arrangement, and the guttering on 21 Court Street, could satisfactorily cope with the combined heavy rainwater run-off from both roofs. In addition, there is evidence from street level of a potential blockage at this junction of pipe/guttering. Please refer to Photographs 1 + 13 above.

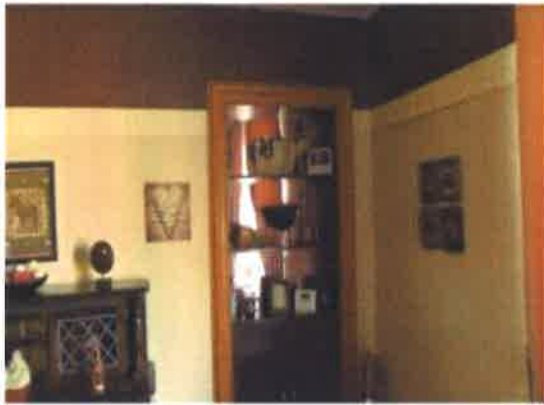
(Ph2) Corner of Lounge – Front elevation

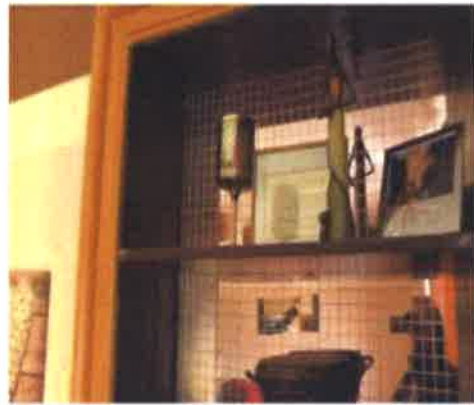
(Ph3) Location of high dampness levels

a) **Lounge** - Readings ranging between 400-600 were obtained at a wall height level of approximately 1.5-2m. These readings were obtained within the open mirrored press shown in Photograph 3 above. These readings indicate a serious level of moisture present below the internal wall surface.

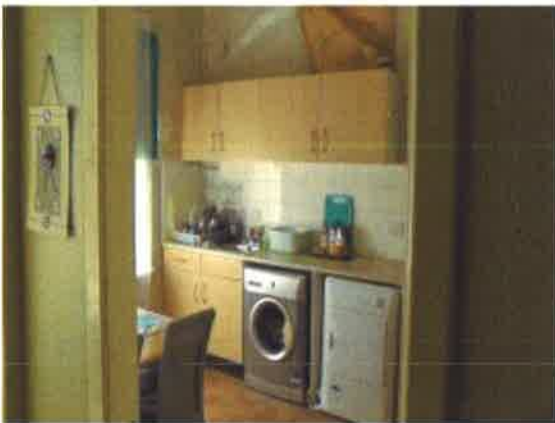
(Ph4) Corner of kitchen – Rear elevation

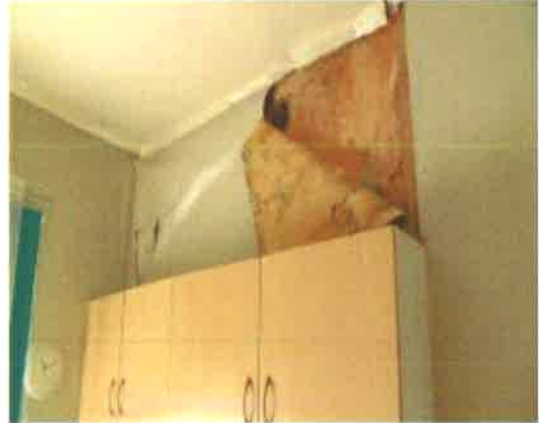
(Ph5) Previous water damage + wall vent

existence of a wall vent below the detached wallpaper suggests the presence of a cavity, possibly a former press.

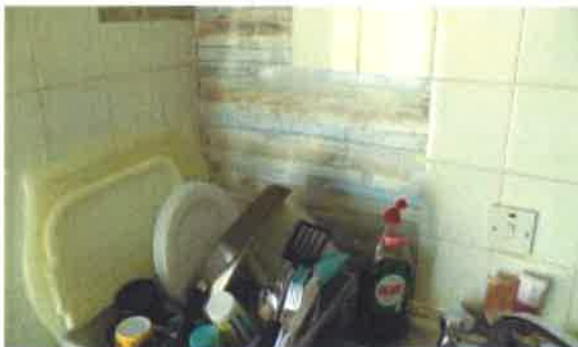
(Ph6) Point of highest dampness readings

b) **Kitchen** – Readings between 400-999 were obtained at a wall height level of approximately 1-1.4m. These readings were obtained from the internal wall to the left of the sink unit where the tiled surface has become detached. The area in question is shown in Photograph 6 above. These readings indicate a significant level of moisture present below the internal wall surface. The wall surface area above the kitchen units, where the wallpaper has partly peeled off due to a previous water penetration issue, did not produce any dampness readings. The

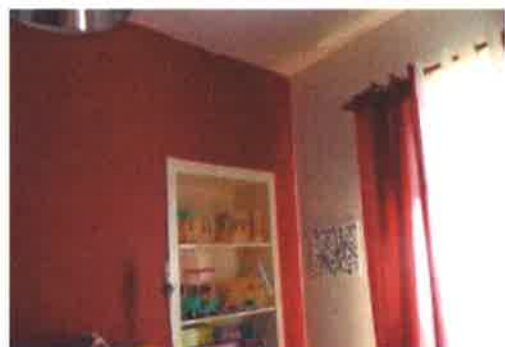
(Ph7) Bedroom 3 – Rear elevation

d) **Bedroom 3** – No dampness readings of any concern were recorded in this room.

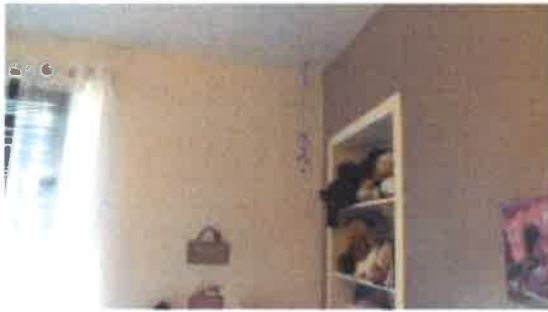
(Ph8) Bedroom 2 – Front elevation

c) **Bedroom 2** – No dampness readings of any concern were recorded in this room.

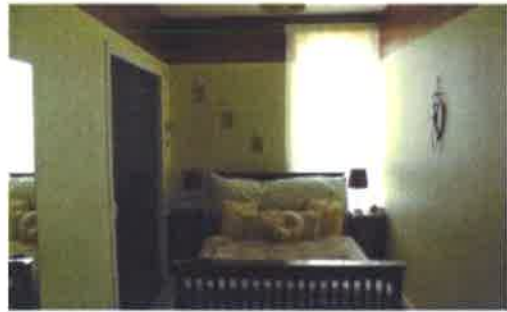
(Ph9) Bed 1 – Gas boiler in cupboard

6. It was noted that a new gas boiler had been installed very recently and that the Gas Safety Certification held on file related to the previous boiler.

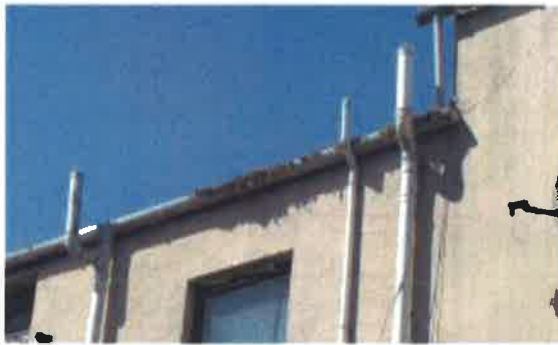
(Ph10) Adjoining property – Rear/South gable

4. It was noted that the guttering on the adjoining properties to the South and North on their rear elevations appears to be blocked, or clogged, with debris/vegetation. It was also noted that the guttering section on 21 Court Street above the kitchen window of Flat D, has been extended via a small downpipe to discharge into the guttering of the adjacent property. Please refer to Photographs 10 + 12 above.

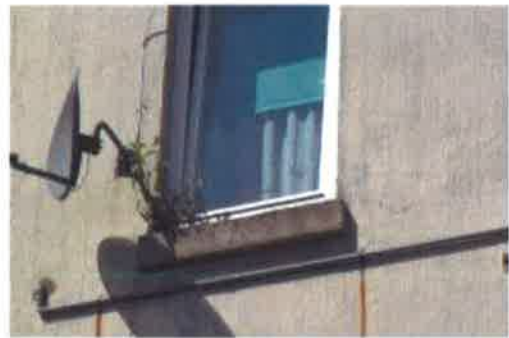
(Ph11) Kitchen window – Vegetation

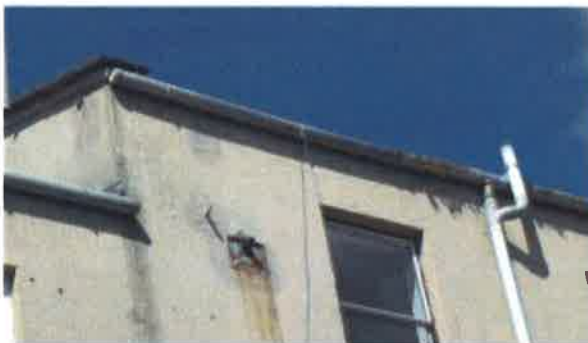
(Ph12) Adjoining property – Rear/North gable

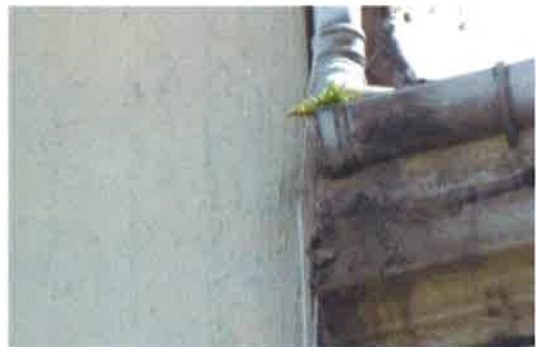
(Ph13) Guttering – Front/North gable

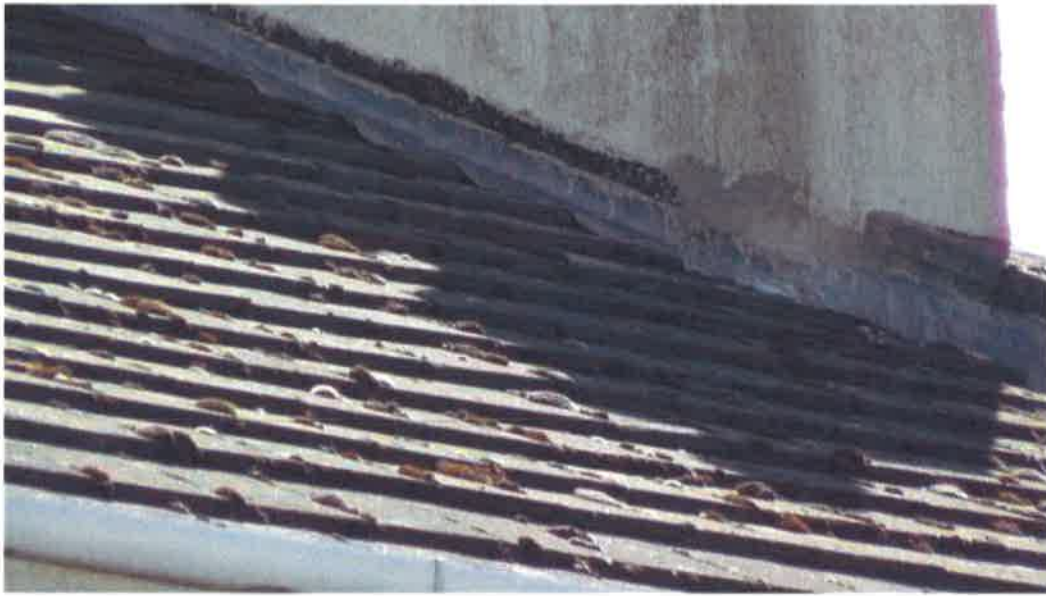
the downpipe on the rear elevation and the flashing detail to the chimney head which appeared to have been incorrectly fitted.

(Ph14) Flashing detail – South gable chimney head

5. It was noted that the flashing detail to the chimney head on the South gable/front elevation appears to have been incorrectly fitted, with gaps between the tiles and flashing clearly visible. Please refer to Photograph 14.
