Repairing Standard Enforcement Order

52 Loch Road, Kirkintilloch, G66 3EB ("The property")

SCHEDULE OF PHOTOGRAPHS

CASE REF: FTS/HPC/RP/17/0193

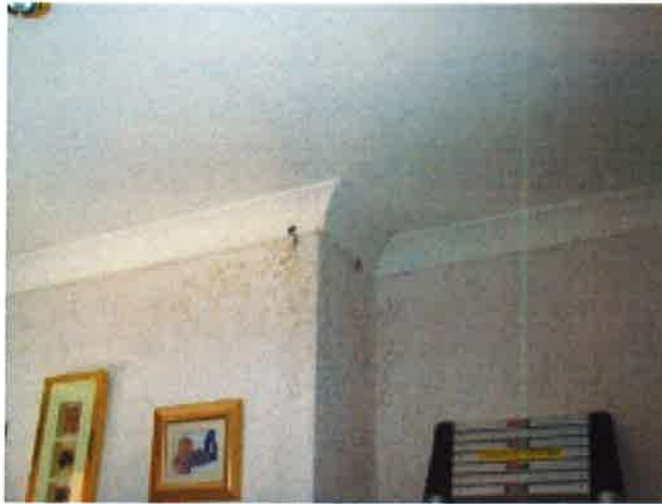
- 13.** There is staining to the wall and ceiling at the chimney breast in the living room of the property. Moisture readings indicate that the area of staining is dry. Immediately above the chimney breast, in the roof space of the property, the timber surrounding the brickwork of the chimney head are damp.

Staining at chimneybreast in Living Room

- (a) The Landlord is to repair or renew the roof covering so that the roof is made wind and watertight in terms of Section 13(1)(a) of the Act; and
 - (b) The Landlord is to repair or renew the living room, bathroom and hall windows within the property so that they are in a reasonable state of repair and in proper working order, in terms of Section 13(1)(b) of the Act; and

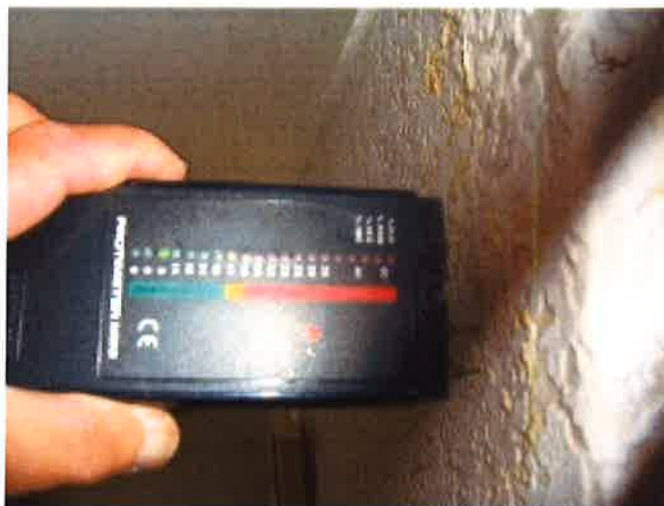
“Green” reading on moisture meter at LR chimneyhead

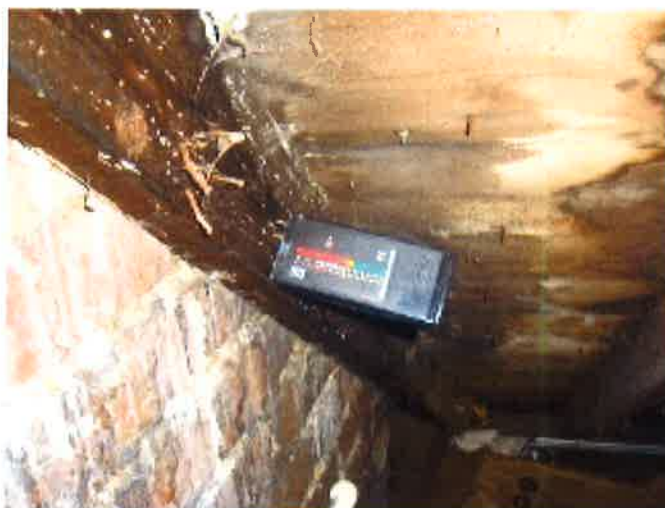
22. The Tribunal made its findings based upon what it found at the Inspection and after considering the evidence and representations of the parties and the Tenant's Representative. There is dampness in the timber surrounding the brickwork of the chimney head in the roof space of the property immediately above the chimney breast in the living room of the property. The gutter to the roof at the front of the property is not collecting water at one section. The masonry has been worn away at that part of the roof. Two out of the three catches on the left hopper window in the living room are missing which prevents that window from being shut tightly. The bathroom window is catching and ill fitting within its frame. There is evidence of a slight draught on the bottom left hand corner of the window in the hall. The dimmer switch in the living room is incomplete, the turning knob being absent. The lights controlled by that switch are not working. The thermostat and timer control unit for the water and heating within the property works intermittently. These defects were evident at the Inspection and acknowledged by the Landlord and Tenant's Representative at the Hearing.

“Red” damp meter reading in rafter adjacent to chimneyhead in roof void

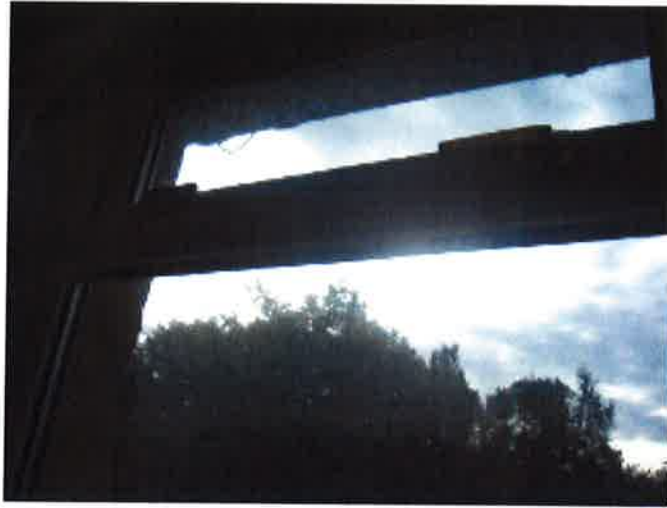
- 14.** The gutter to the roof at the front of the property is not collecting water at one section where the masonry has been worn away.
- 15.** Two catches in the left hopper window in the living room in the property are missing which prevents the window from being shut tightly.

Missing window handle catches in Living Room

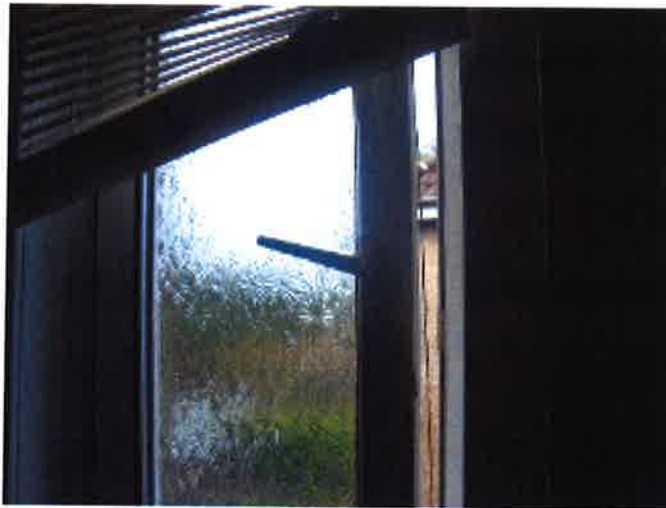
- 16.** The window in the bathroom in the property is catching and ill-fitting within its frame.

Bathroom window

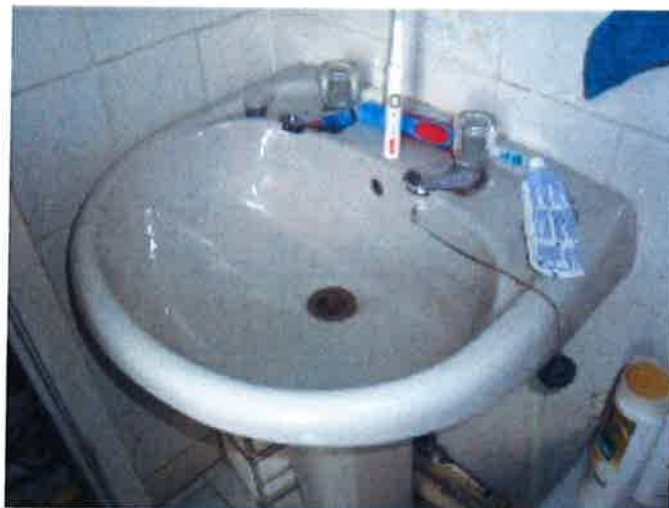
Bathroom wash hand basin

29. It was also observed that there was no provision for the detection of carbon monoxide. It is recommended that the Landlord supplies and fits a Carbon Monoxide detector compliant with the Scottish Government Statutory Guidance for the provision of carbon monoxide alarms in private rented housing.
30. The Landlord acknowledged that there has not been a Gas Safety Certificate issued in respect of the property. It is recommended that the Landlord arranges for a Gas Safety Certificate to be produced as a matter of priority.
31. The Tribunal observed that it may be beneficial to apply drain unblocker fluid to increase the drainage flow in the sink in the bathroom within the property.

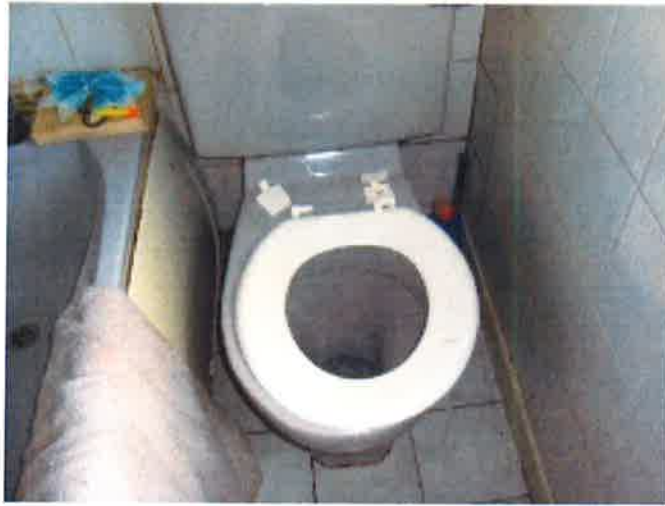
Bathroom w.c.

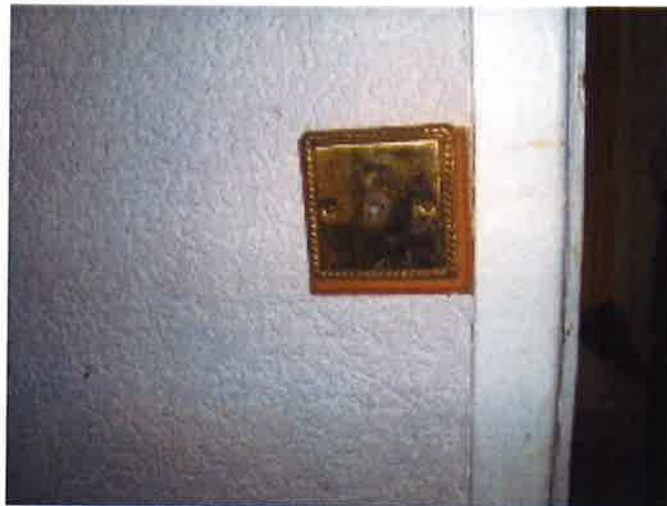
Living room light switch

- (d) The Landlord is to repair or replace the light switch and lighting within the living room in the property so that they are in proper working order; in terms of Section 13(1)(c) of the Act; and

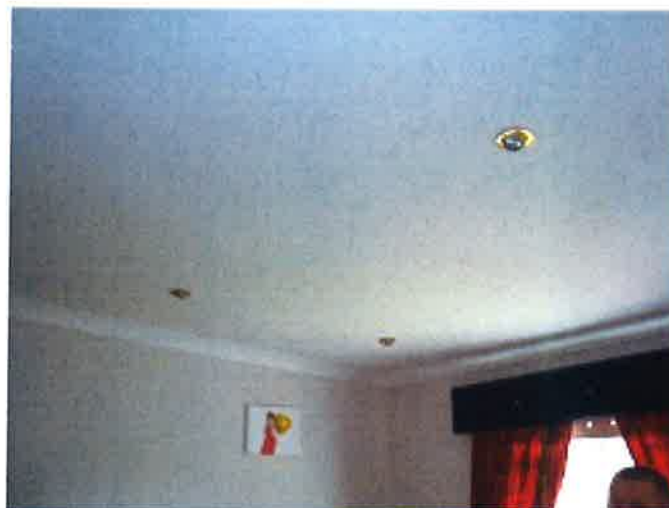
Living room lights

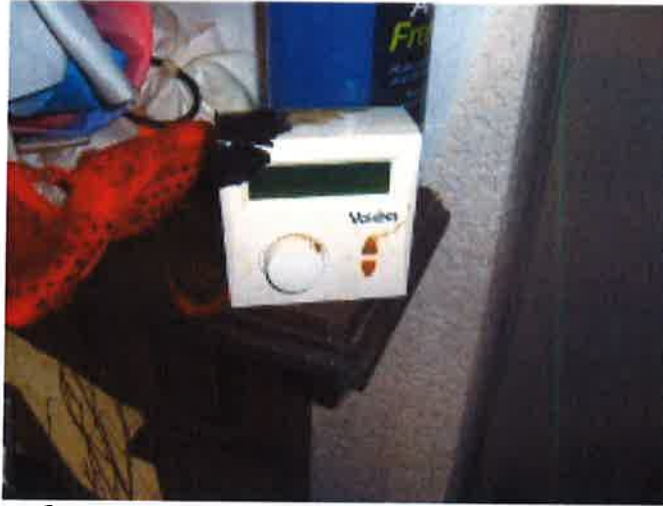
Central heating timeclock/thermostat

- (e) The Landlord is to repair or replace the water and heating control unit in the property to ensure that it is in proper working order; in terms of Section 13(1)(c) of the Act; and

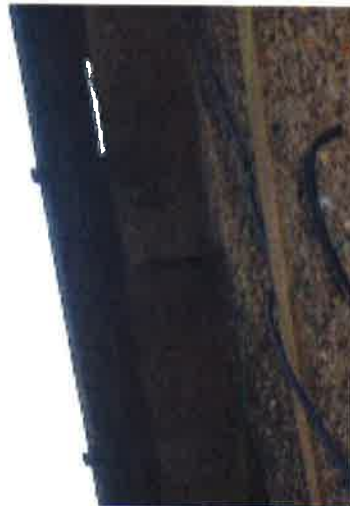
Gap between roof and gutter at front elevation

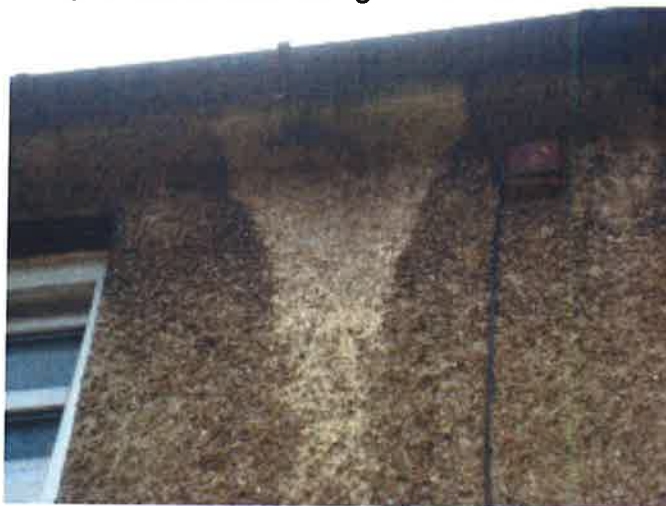
Wallhead at gap –front elevation
