Repairing Standard Enforcement Order (RSEO): Housing (Scotland) Act 2006 Section 24

Chamber Ref: FTS/HPC/RP/17/0337

Property: 23 Kirkgate, Currie, Edinburgh EH14 6AP ("The House")

Schedule of photographs taken during the inspection of
23 Kirkgate, Currie, Edinburgh EH14 6AP

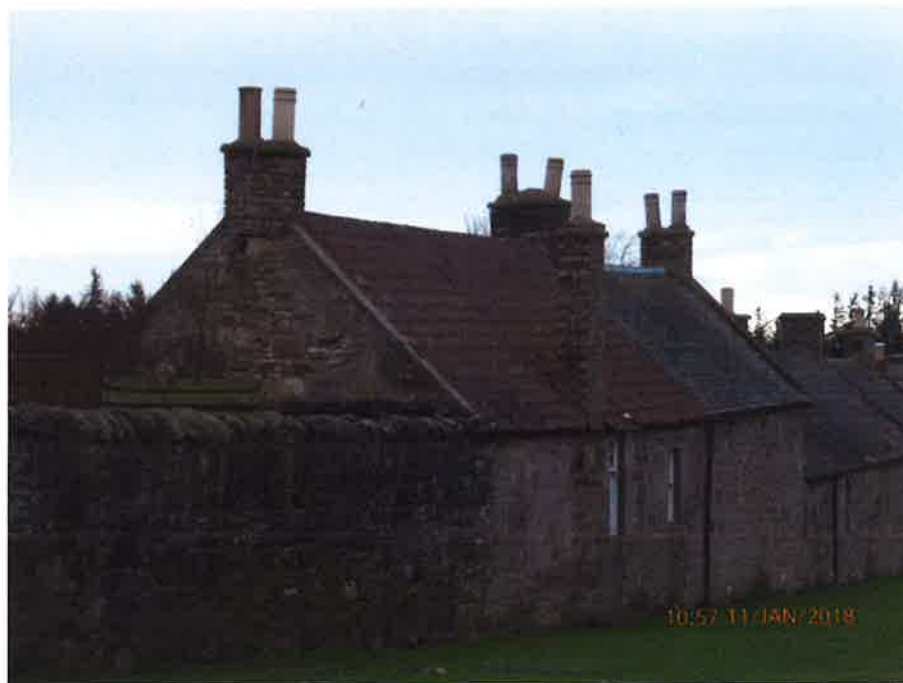
Rear

- (iv) There was an outhouse building which was in a state of collapse;
- (v) The windows in the property were not operable and frames were rotten;
- (vi) The rainwater fittings at places were leaking;
- (vii) The doors to the outside were difficult to work;
- (viii) There was damp within the building;
- (ix) There was a significant aspect of water penetration;
- (x) The tenant used one of the rooms to house rabbits. That room in itself was uninhabitable;
- (xi) The adjacent room to the back room was again showing significant aspects of damp;
- (xii) The livingroom was damp;
- (xiii) The bathroom floor was damp;
- (xiv) Inspection at the rear of the property indicated that work to the rainwater fittings needed to be done;

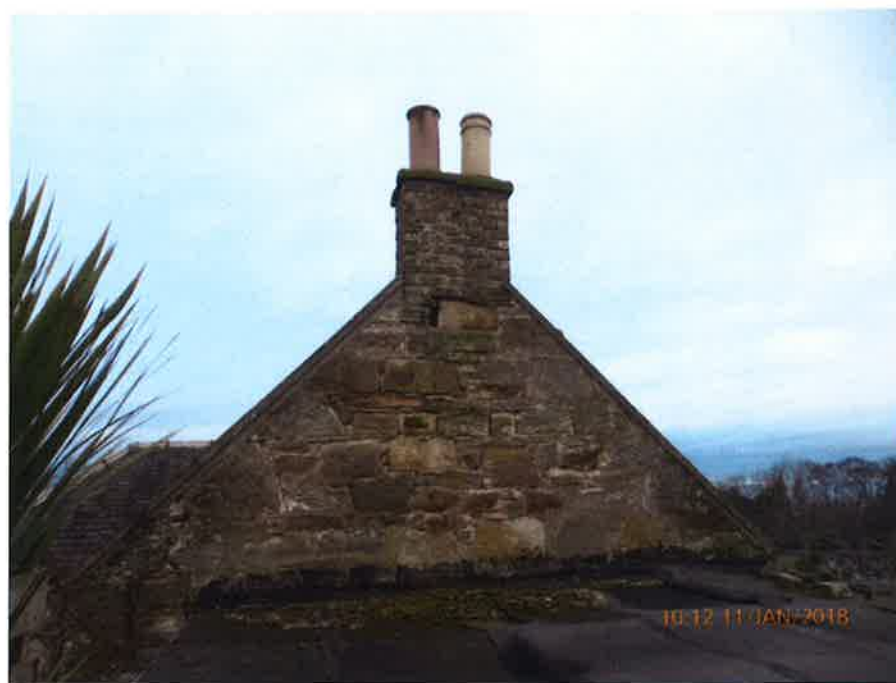
- (2) The holes in the gable wall.
 - (3) The chimney repair.
 - (4) The outhouse building being in a state of collapse.
 - (5) All windows requiring to be looked at with a view to replacement.

Hole in gable

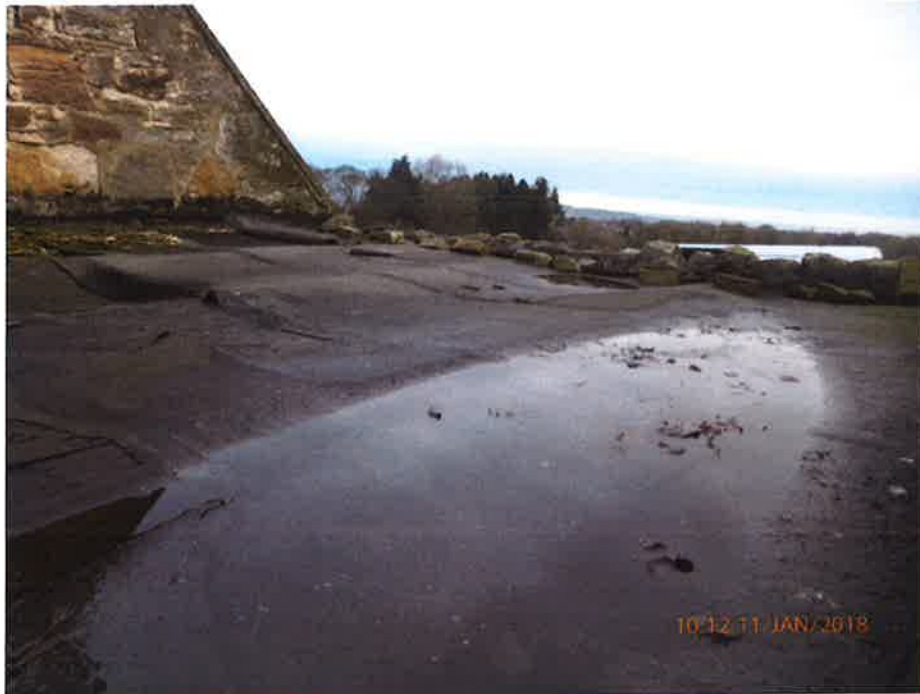
Collapsing flat roof

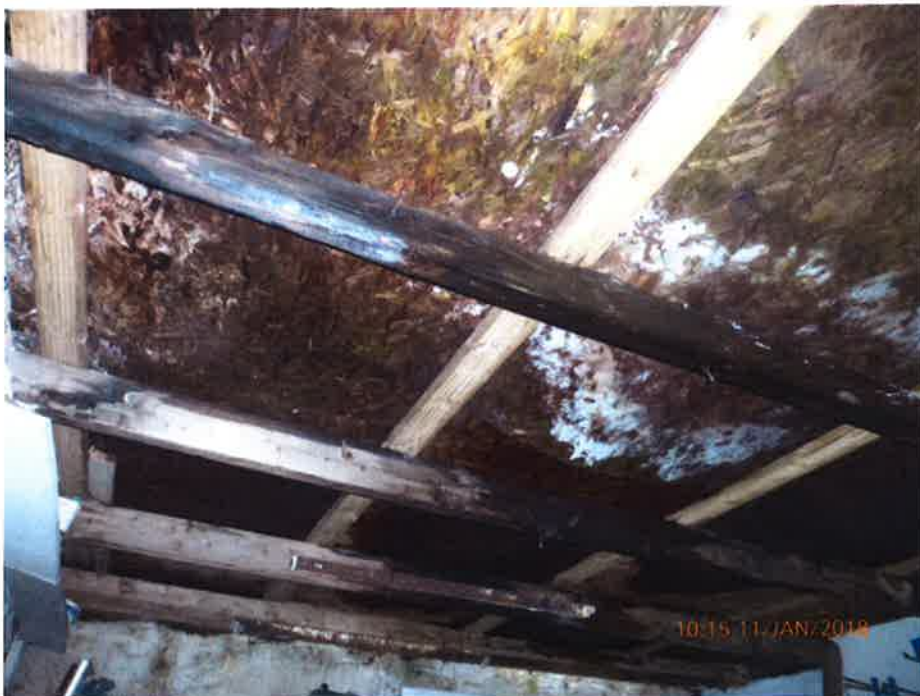
Underside of flat roof

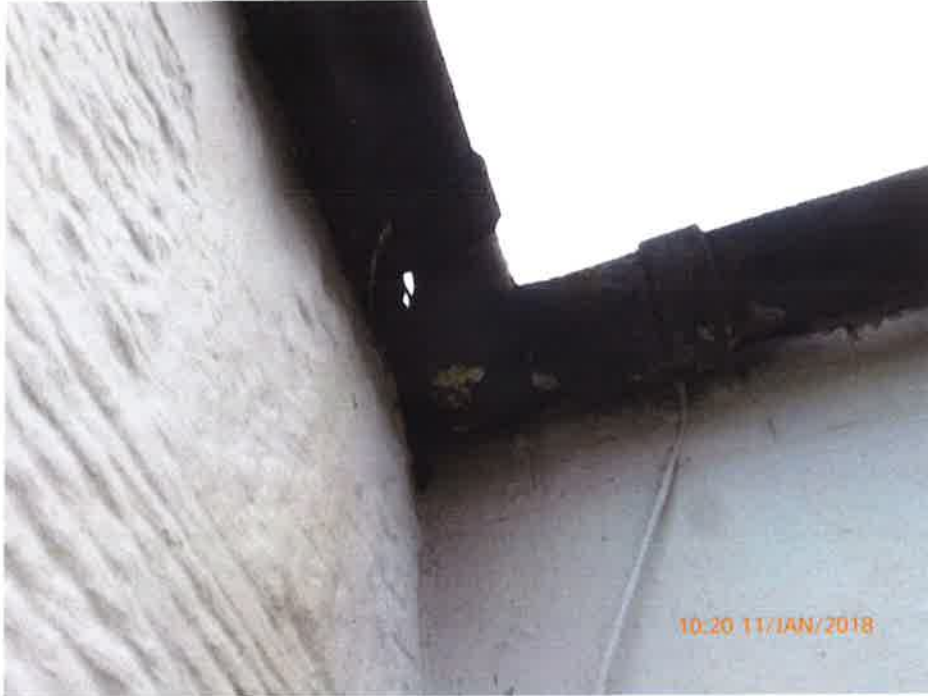
3. There is a significant amount of work to be undertaken to the property in relation to the following --
 - (1) The rainwater fittings surrounding the house.

Hole in gutter

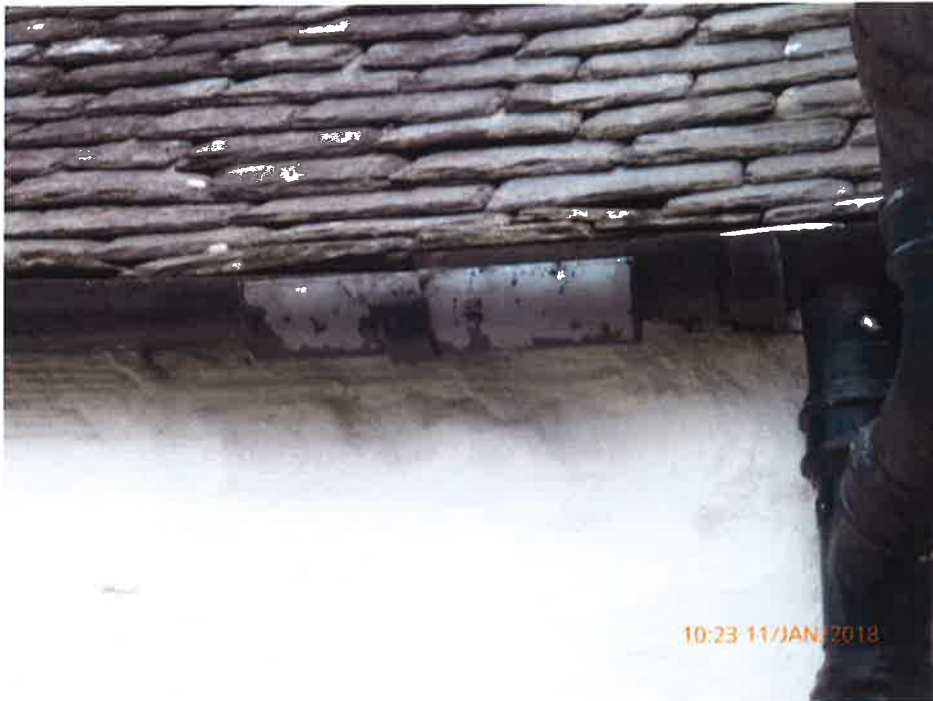
Broken/defective guttering

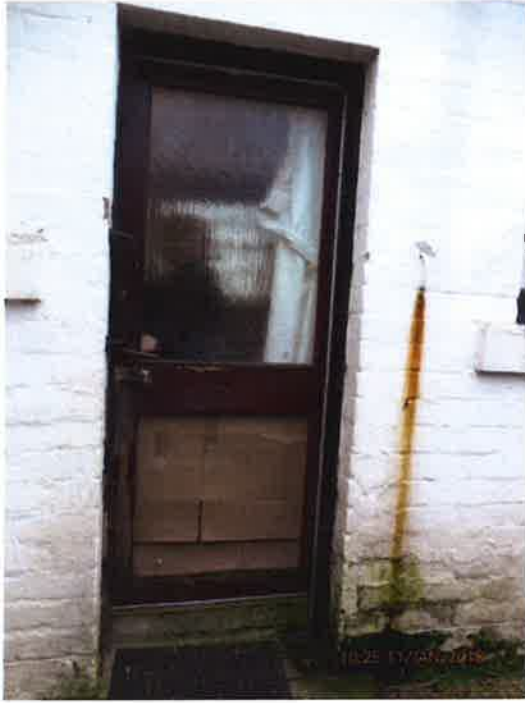
Back door

- (6) Removal of damp from all of the building.
 - (7) The property needs to be made wind and watertight.
 - (8) The doors need to be adequately fitted to ensure that they work appropriately.

- (b) To obtain a report in respect of all windows within the property from a suitably qualified expert to confirm the nature and extent of the work required to be undertaken to the windows in the premises and thereafter to attend to such work as is identified in terms of such report.
- (c) To obtain a report in respect of the roof of the building from a suitably qualified expert to confirm the nature and extent of the work required to be undertaken to the roof in order to make it wind and watertight and thereafter attend to such work as is identified in terms of such report.
- (d) To undertake such work as is necessary to the external doors in order to ensure that they fit appropriately and both open and shut as is required.

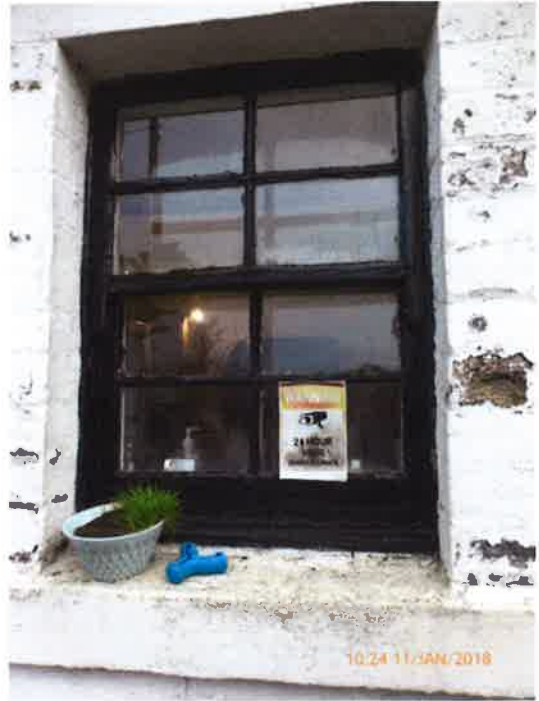
Typical window

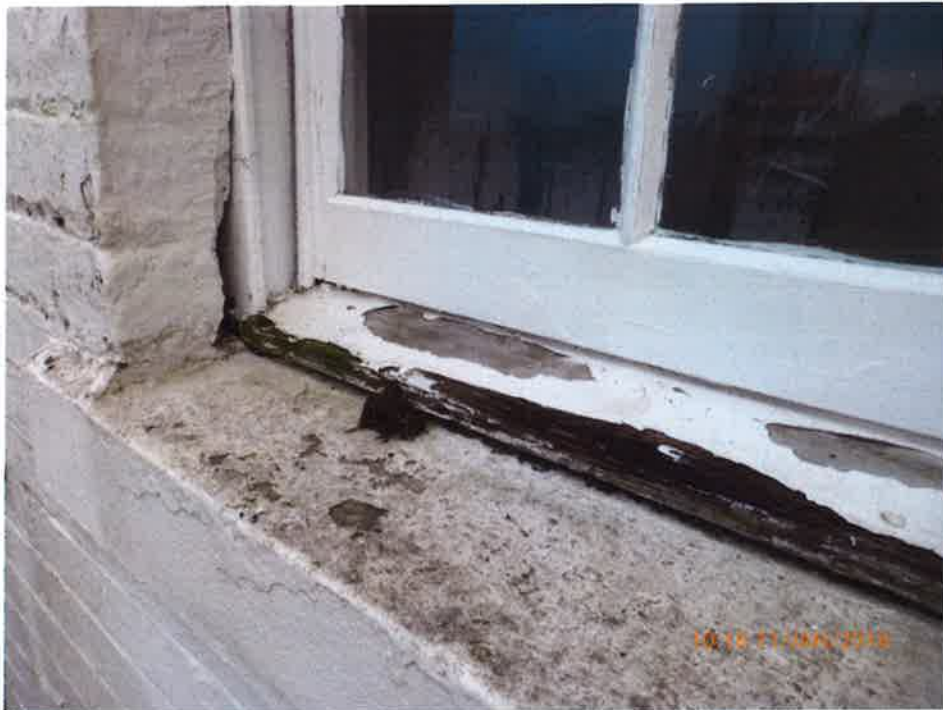
Rotten window sill

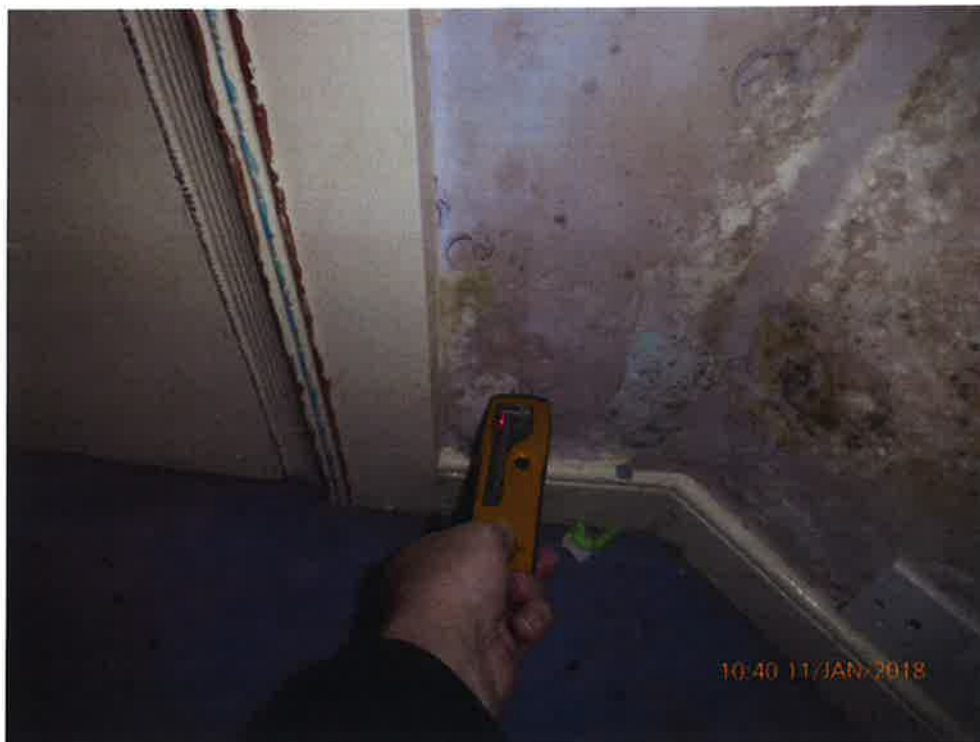
Damp meter reading

- (a) To obtain a report in respect of the dampness in the whole of the building from a suitably qualified damp specialist surveyor or other such specialist to confirm the nature and extent of the damp in the rooms within the property and thereafter to attend to such work as is identified in terms of such a report.

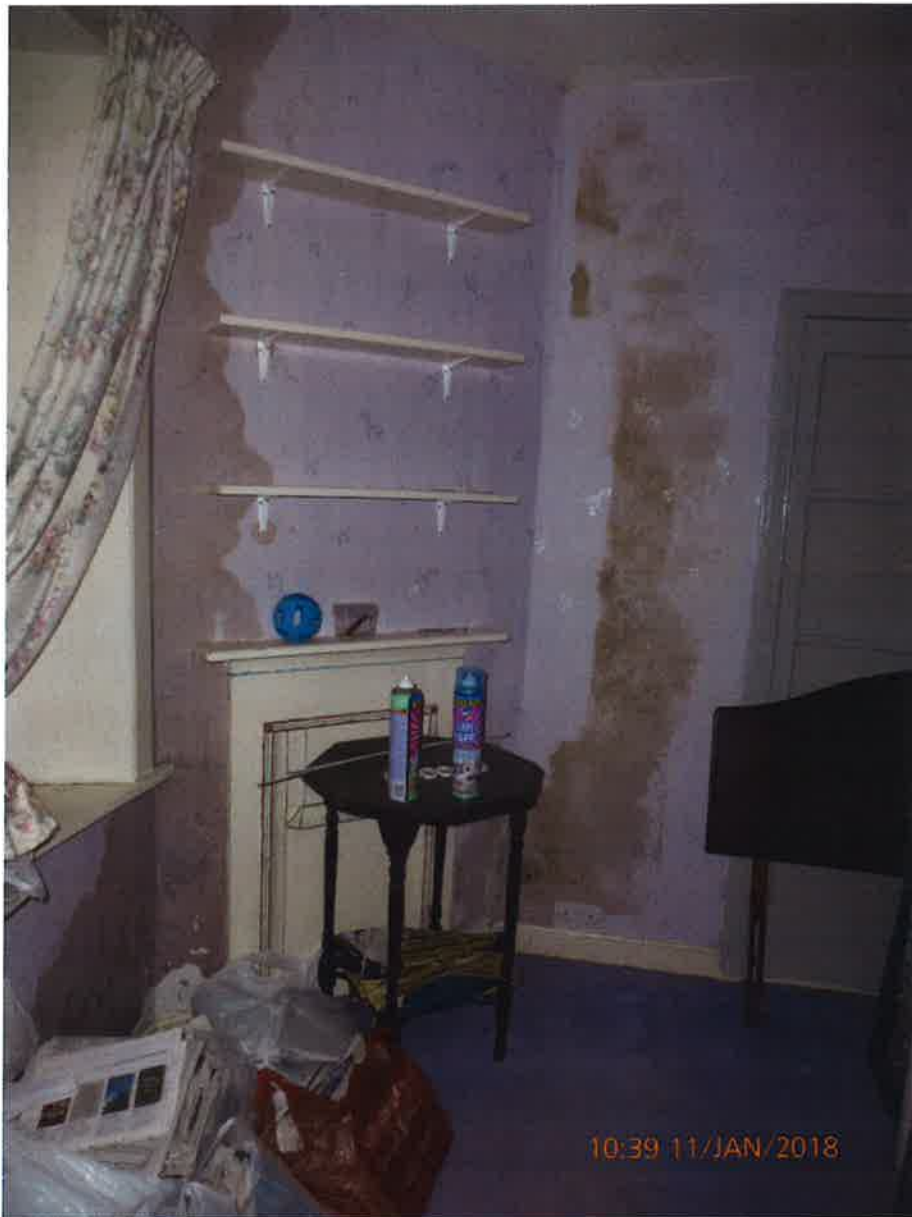
Interior dampness
