**Repairing Standard Enforcement Order (RSEO): Housing (Scotland) Act 2006 Section 24**

**Reference Number: FTS/HPC/RP/17/0376**

**RE: Property at 16 Abbey Mill, Stirling FK8 1QS**

**STATEMENT OF DECISION: Housing (Scotland) Act 2006 Section 24 (1)**

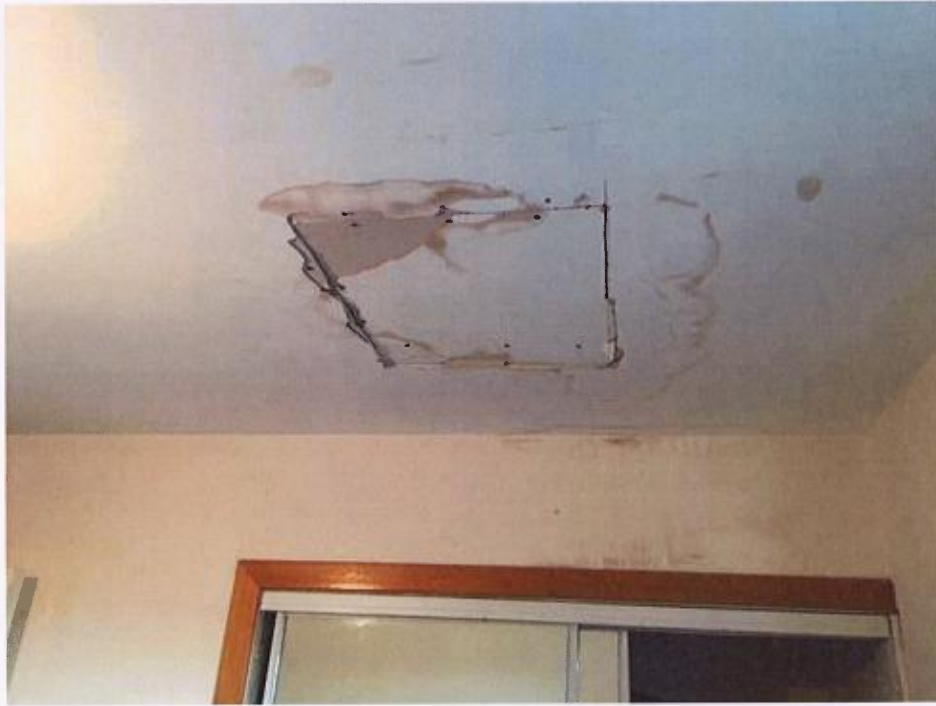
- The ceiling above the built-in wardrobe within the second bedroom is bowed, there is evidence of water ingress and a large section of the plaster board within the said wardrobe has been removed and replaced with new plaster board. As such there was no immediate evidence of mould.

*Photograph 2: Bedroom 2 ceiling and wall above mirrored wardrobe*

- To instruct a specialist Building Surveyor who should be a member of and registered with the Royal Institution of Chartered Surveyors to carry out a full and detailed survey of the roof area and roof structure above the Property to identify the cause of any water ingress (if any) and to advise on any remediation works as a result of their findings.
- To carry out all works identified in the Building Surveyor's report in order to ensure that the Property is wind and water tight and in all other respects reasonably fit for human habitation.

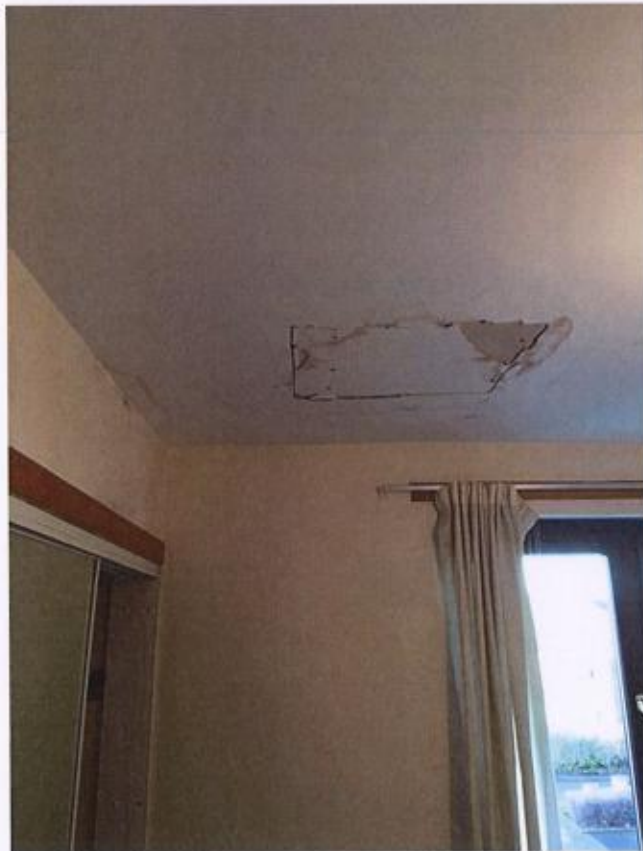
- The Property has a gas supply and gas boiler and central heating.
  - That there was evidence of significant water ingress in the second bedroom.
  - That a portion of the ceiling has been cut out and screwed back into place as part of the investigations on 5<sup>th</sup> December 2017.

*Photograph 3: Bedroom 2 – ceiling and walls*

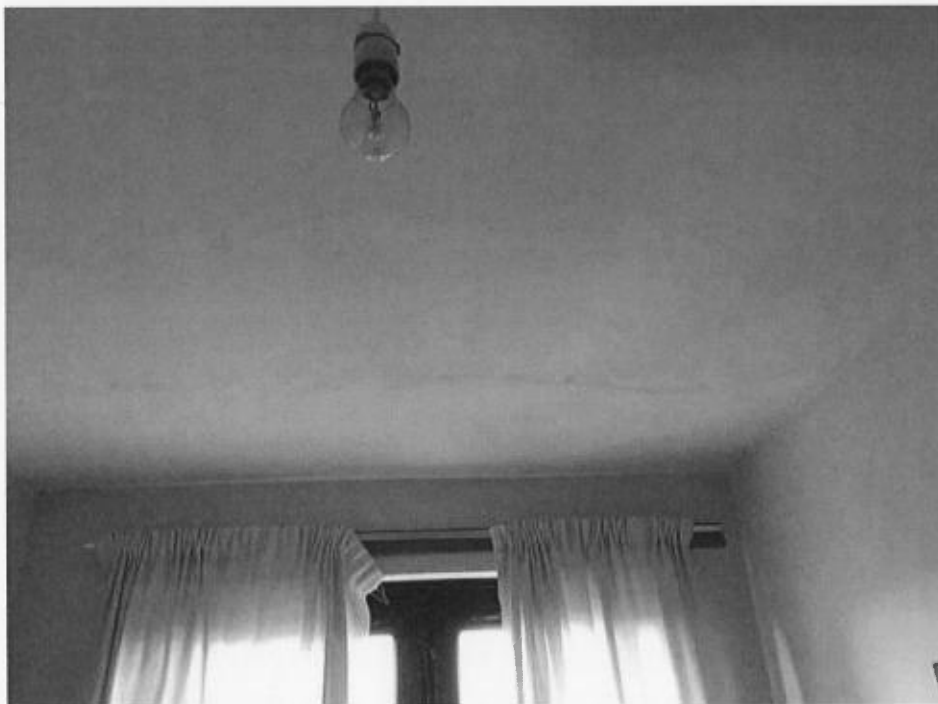
- Damp meter readings within the second bedroom did not show abnormally high levels of moisture.
  - That there was further evidence of damp staining within the third bedroom/office which appeared to follow the line of the steel beam that supported the dormer window above.

*Photograph 5: Office – ceiling*

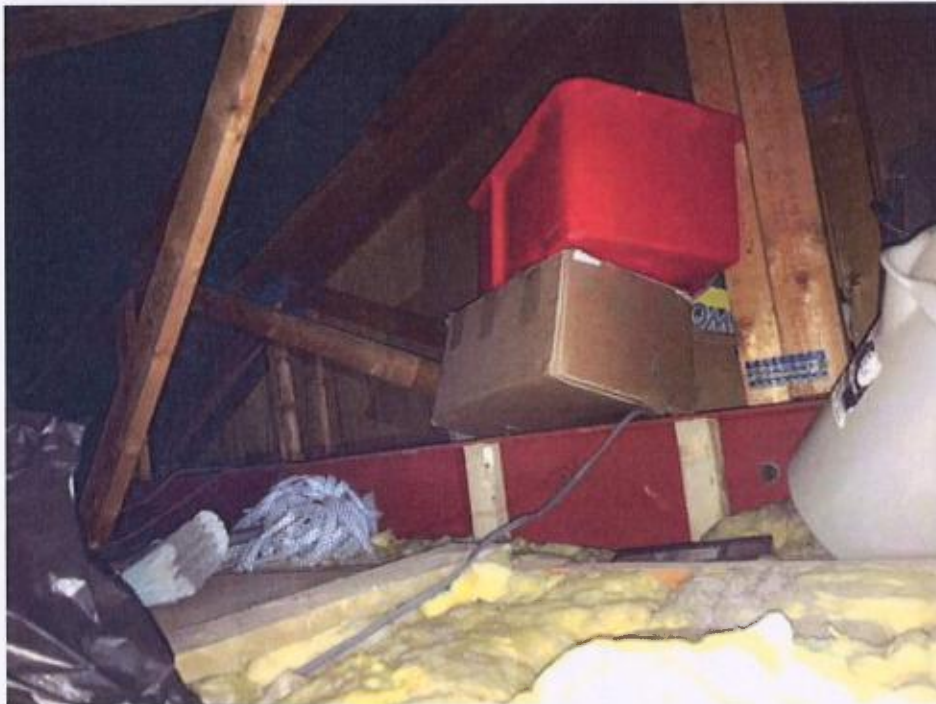
- That the Property shows signs of earlier repairs being attempted through replacement tiles and the fitting of roof vents.
  - That the steel beam within the attic space above the Property showed signs of damp staining, but did not appear wet at the time of inspection.

*Photograph 6: Attic*

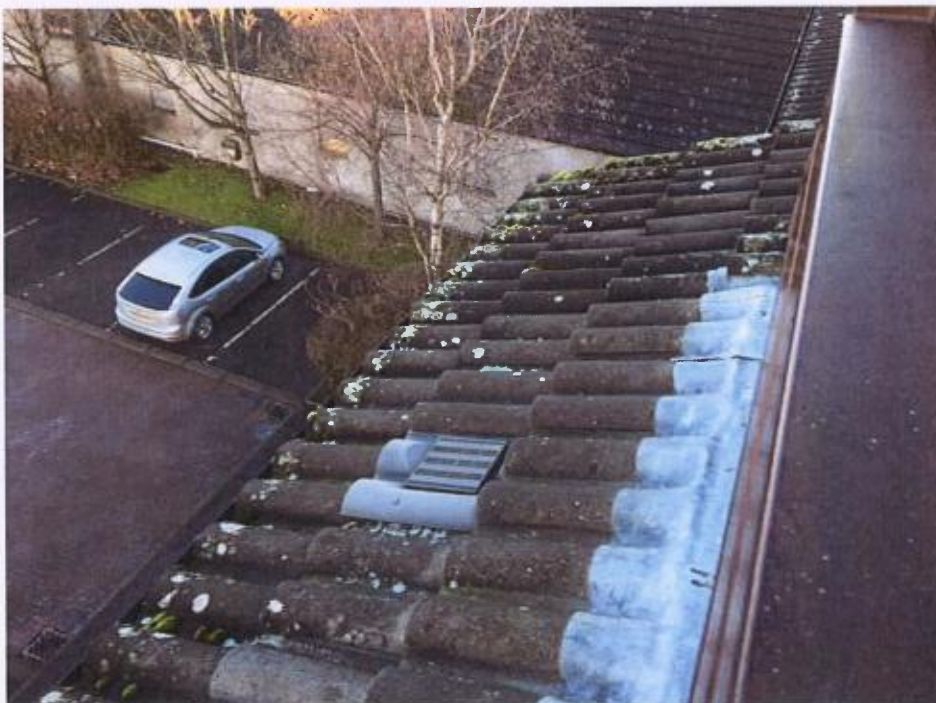
*Photograph 7: From Bedroom 1: roof below dormer with vent*

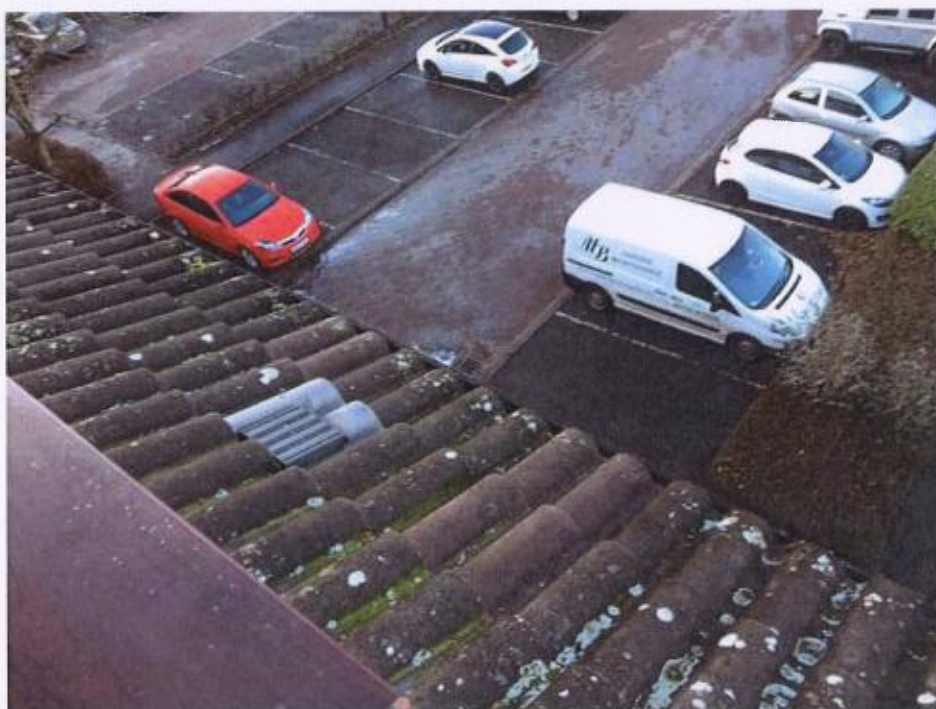
*Photograph 8: From Bedroom 1: roof below dormer with vent*

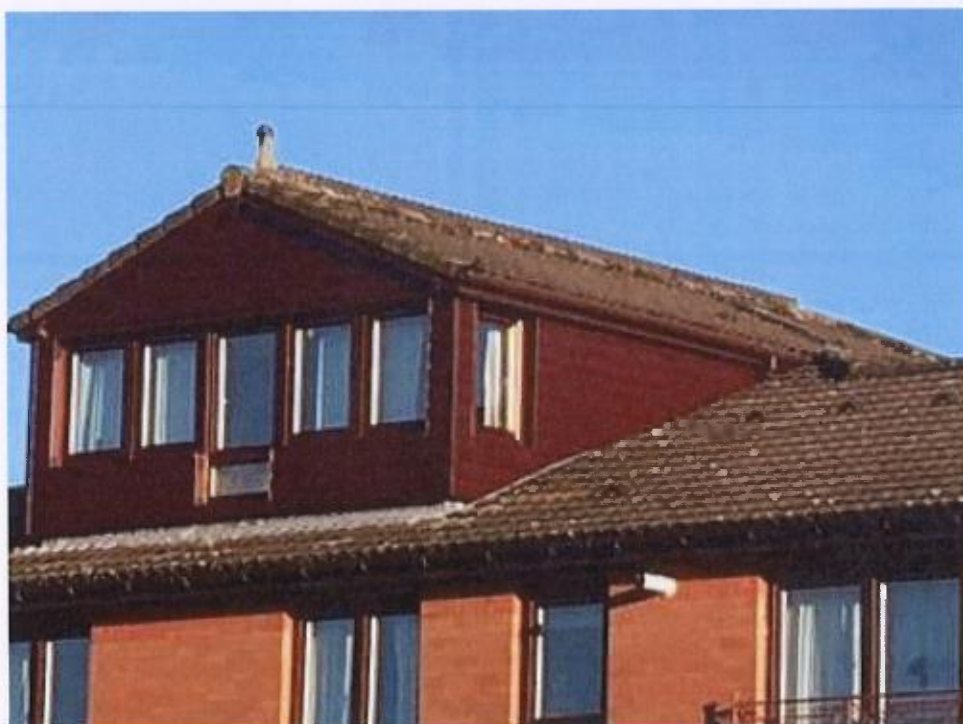
- That the problem was caused by water ingress and the recommendation in the said report was further investigation of the leadwork and tiling along the front of the dormer window above the second bedroom should be undertaken to try and identify the source of water ingress.

*Photograph 9: From ground level: dormer and roof above number 16*
