### **Repairing Standard Enforcement Order Ordered by the First-tier Tribunal for Scotland (Housing and Property Chamber)**

**Chamber Ref: FTS/HPC/RT/19/2149**

**1 Institution Street, Macduff, Aberdeenshire, AB44 1UT ('The Property')**

**Statement of Decision of the First-tier Tribunal for Scotland (Housing and Property Chamber) under Section 24 (1) of the Housing (Scotland) Act 2006.**

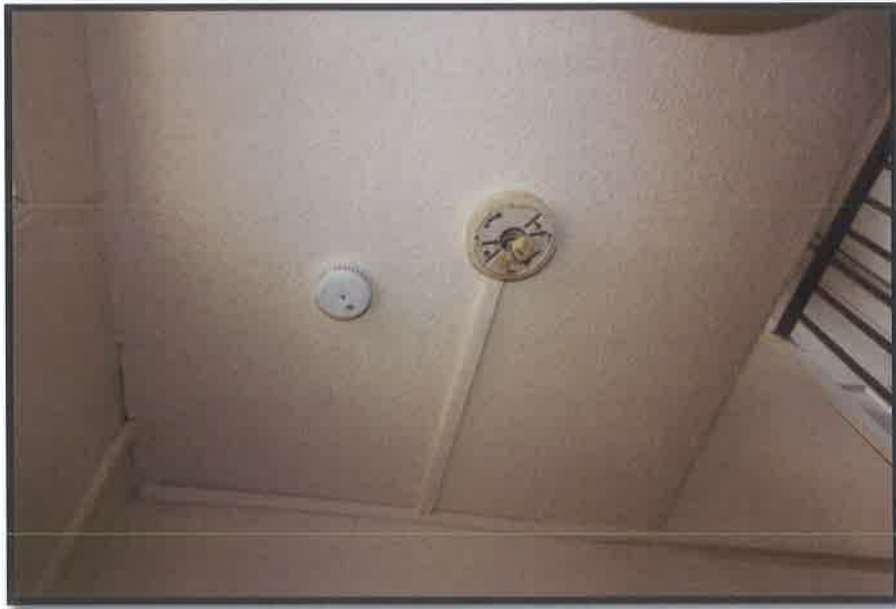
Non interconnected battery smoke alarms had been fitted by the fire service in June 2019. The Tribunal noted that there was an old hard wired smoke alarm system in

**Photograph 2 Ground floor entrance - Existing hard wired smoke alarm removed, temporary battery alarm present.**

2.2 One functioning smoke alarm in every circulation space, such as hallways and landings.

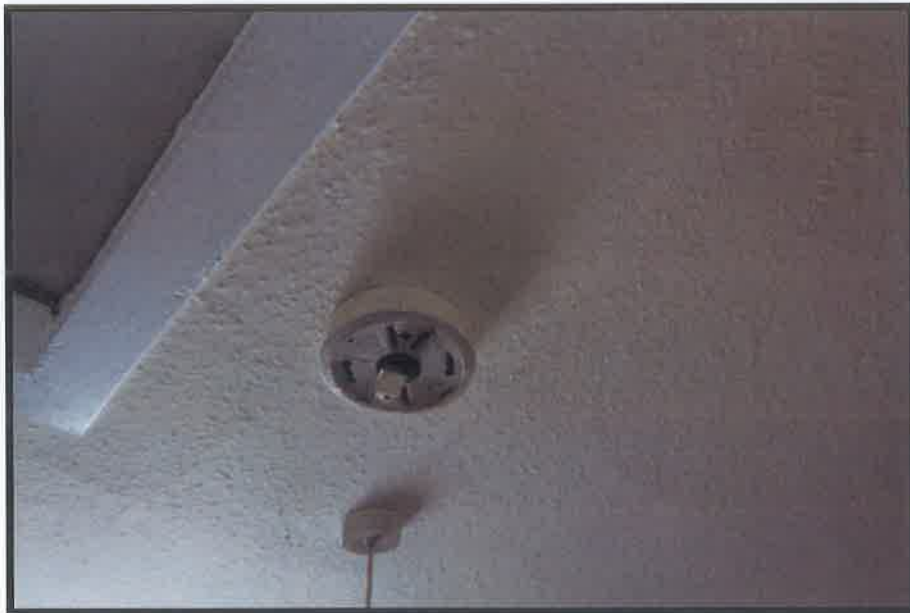
**Photograph 3 First floor landing - Existing hard wired smoke alarm removed, no CO alarm present.**

3. Replace the carbon monoxide alarm in compliance with the regulations.

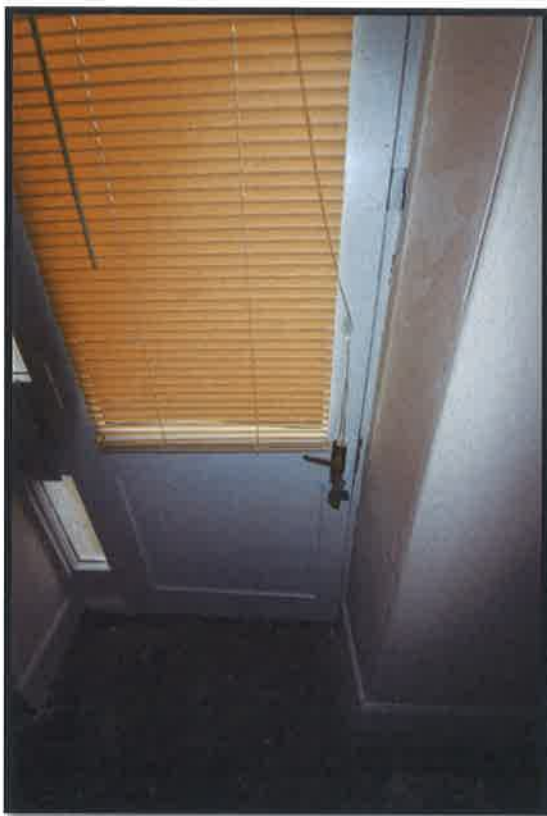
The Tribunal inspected the wooden front door. The door keep and latch had been damaged which means that the door does not close properly and it is not secure. Daylight could be seen between the door and the door frame.

Photograph 4 Overview of front door.

4. Repair or replace the front door to render it in a reasonable state of repair and proper working order.

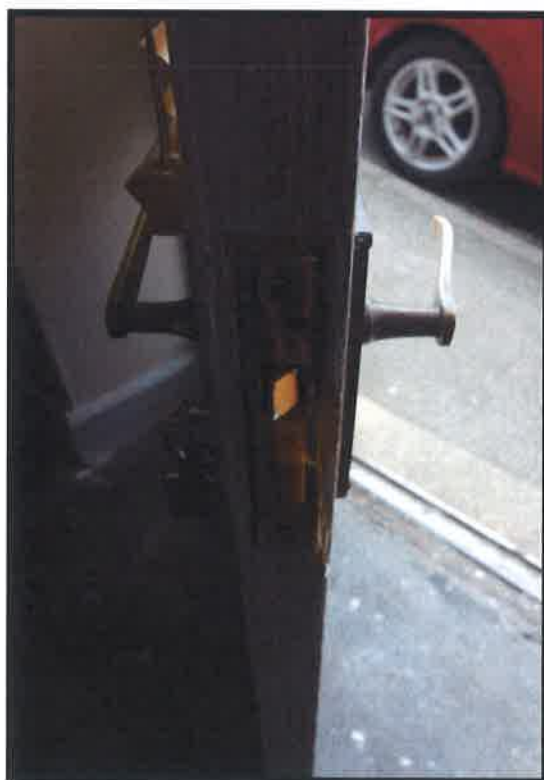
Photograph 5 Damaged sash lock.

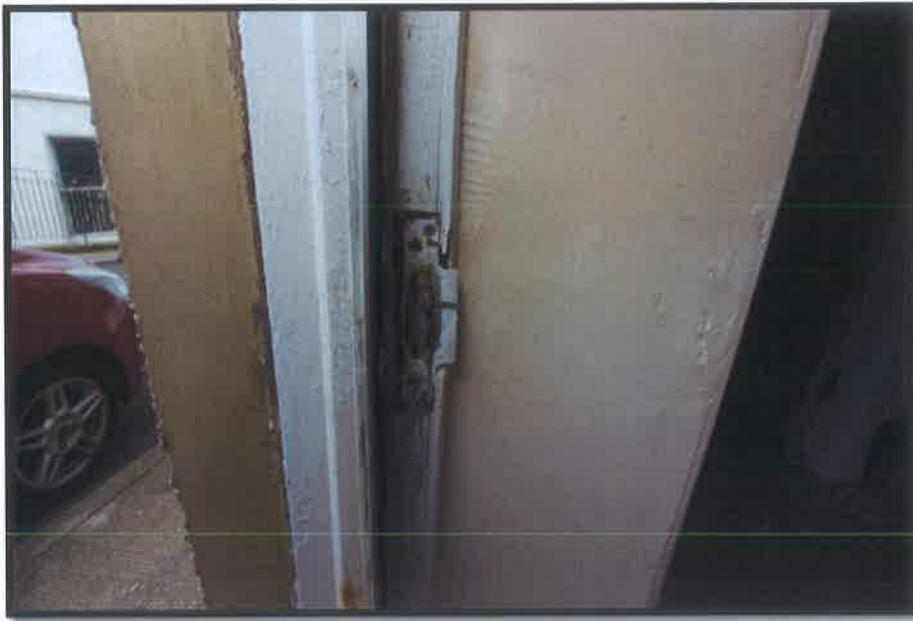
Photograph 6 Damaged lock keep.

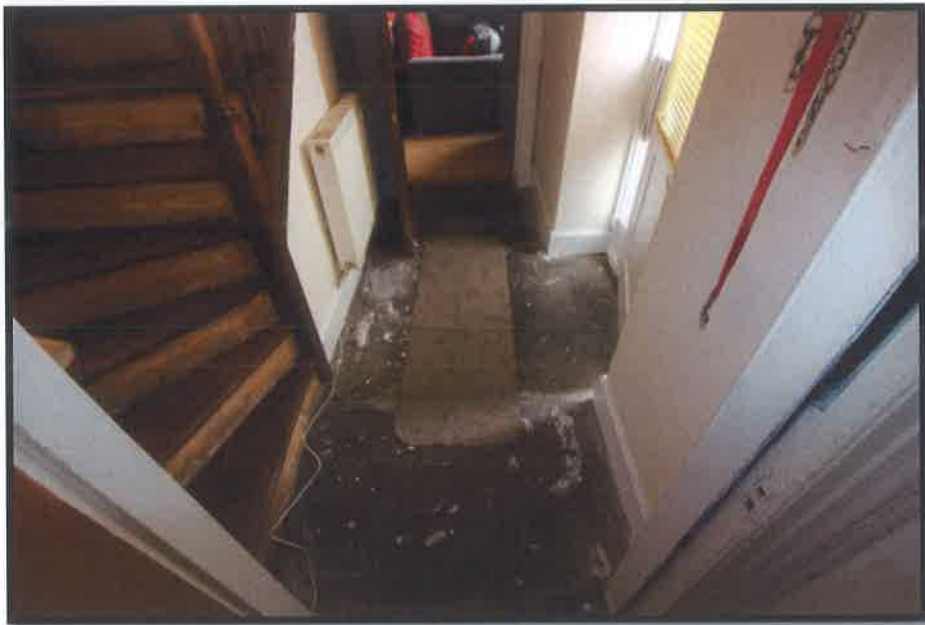
The Tenants advised that they had removed the carpet that was in the hall as it was poorly fitted and it was a tripping hazard. There was a TV aerial cable crossing the threshold of the sitting room door.

Photograph 7- Ground floor entrance - carpet now removed and cable at sitting room threshold.

5. Reinstate and repair or replace the hall carpet to render it in a reasonable state of repair.

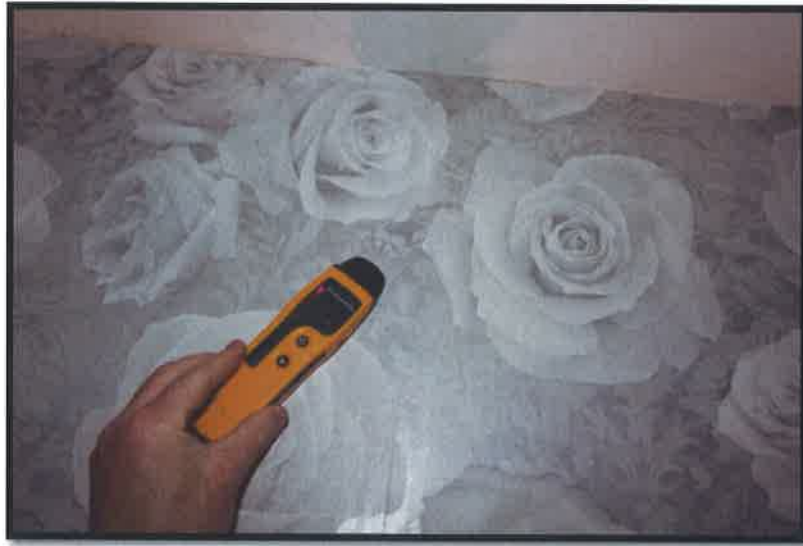
- (i) Kitchen: There was evidence of damp staining to the ceiling of the kitchen but it was dry at the inspection.
- (ii) Sitting Room: Damp treatment works had been carried out to the gable wall to a height of some two metres and to the front external wall to a height of around one metre. The areas that had been repaired were dry at the inspection. However the higher areas of the gable wall and the external wall to the left of the window (looking out of the window from inside the sitting room) were damp showing levels of 80% plus on the damp meter. There was also an area of high dampness in the wall dividing the sitting room from the bedroom.

Photograph 8 Moisture meter reading red (99%) to gable wall in sitting room, near ceiling.

6. Resolve the source of damp penetration to the Property, (including the walls in the sitting room, gas meter cupboard, lower hall, upper bedrooms, bathroom and landing) and carry out such repairs as are necessary to prevent further damp ingress followed by remedial works to damp-damaged finishes and decorations.

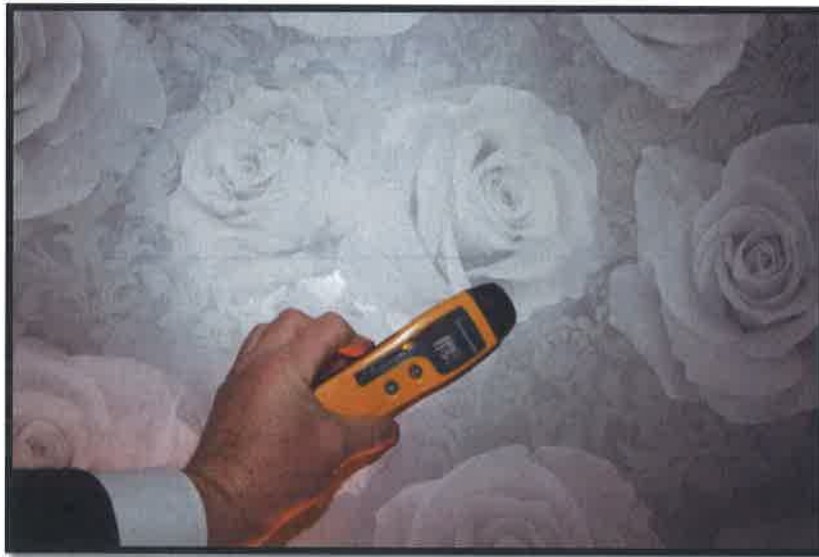
Photograph 9 Moisture meter reading amber (16%) to gable wall in sitting room, mid height.

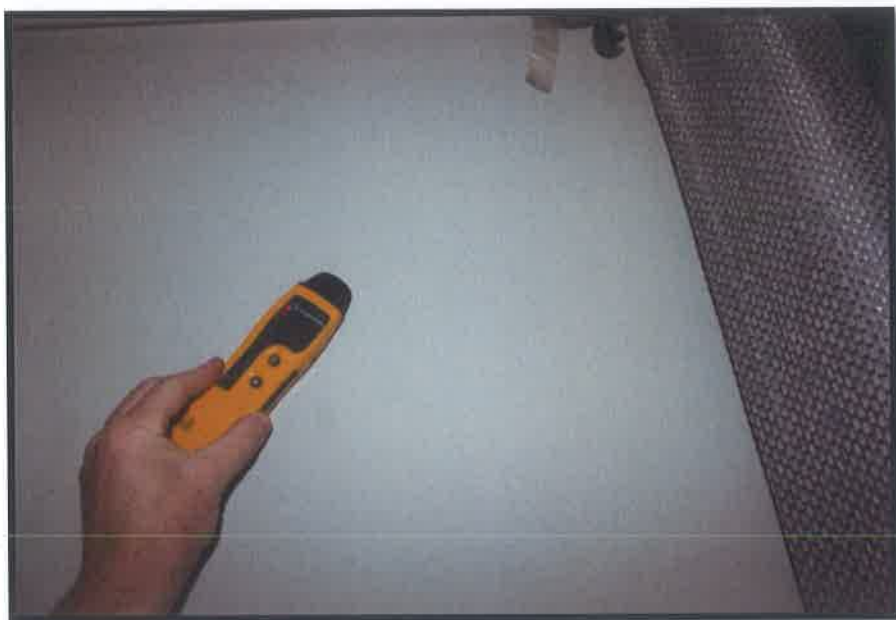
Photograph 10 Moisture meter reading red (99%) to front wall of sitting room.

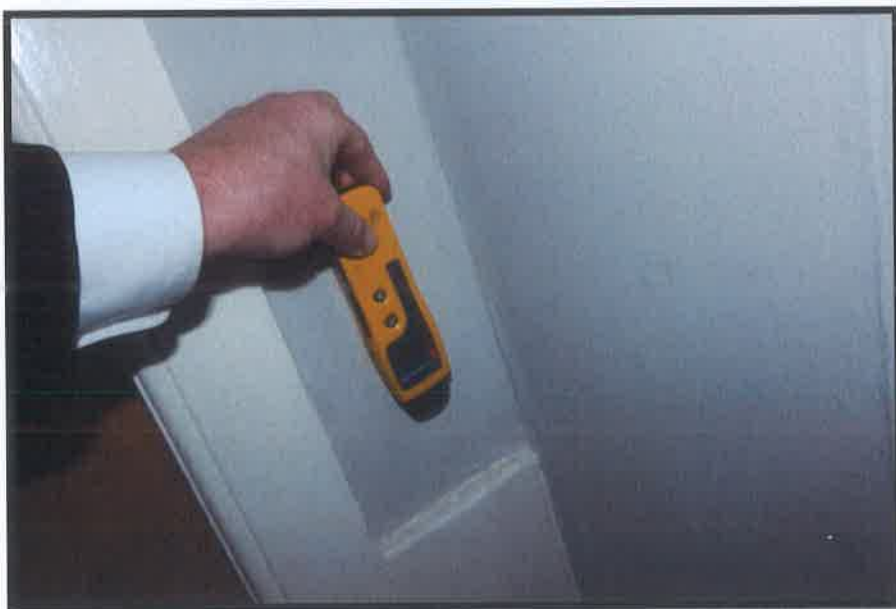
Photograph 11 Moisture meter reading red (99%) to internal wall of sitting room near bedroom door.

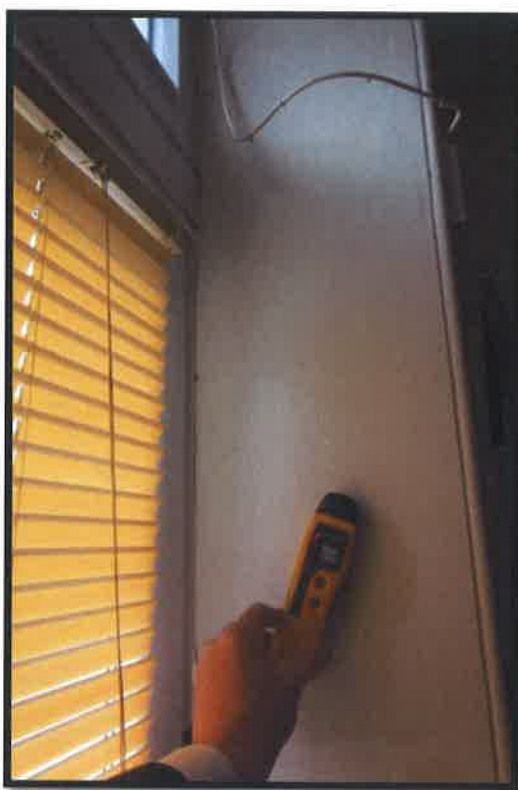
Photograph 12 - Moisture meter reading red (99%) to front wall at ground floor entrance. Both sides of door affected.

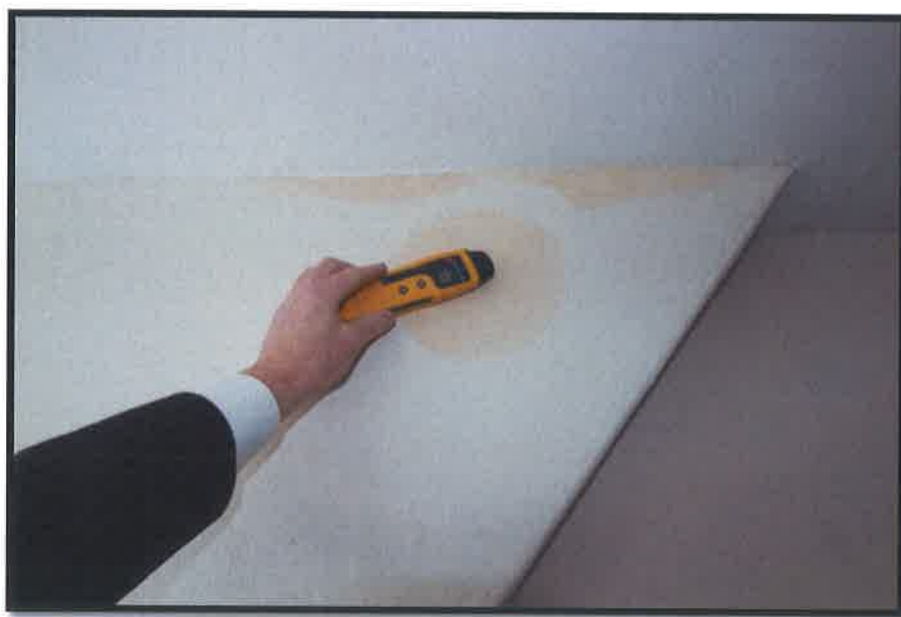
Photograph 13 - Moisture meter reading red (99%) to side of window dormer, right hand bedroom.

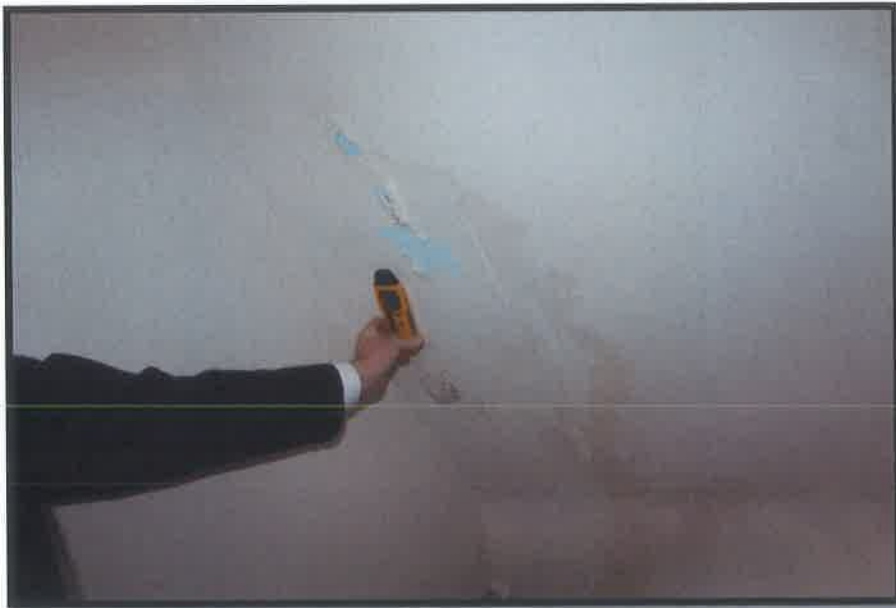
Photograph 14 - Moisture meter reading red (99%) to rear roof slope, right hand bedroom.

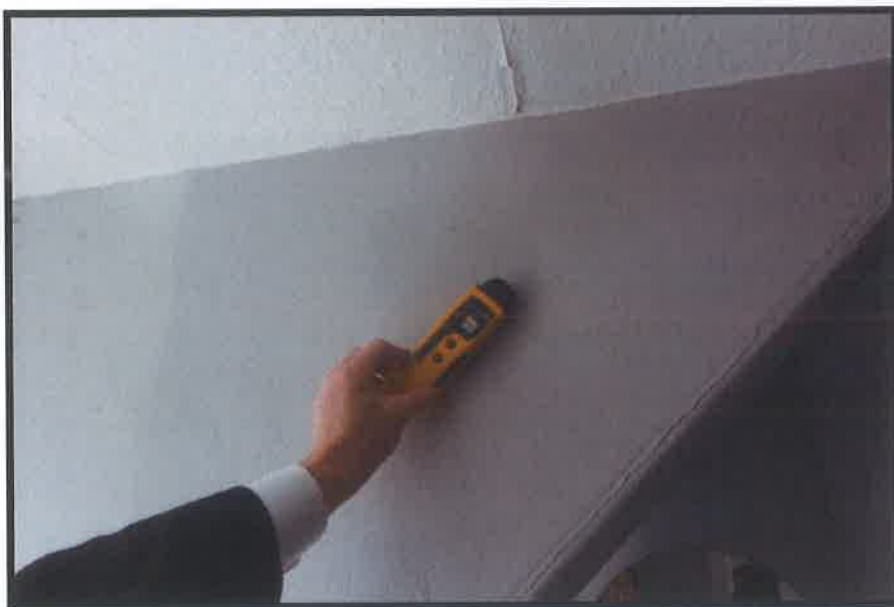
Photograph 15 - Moisture meter reading red (99%) to side of window dormer, left hand bedroom.

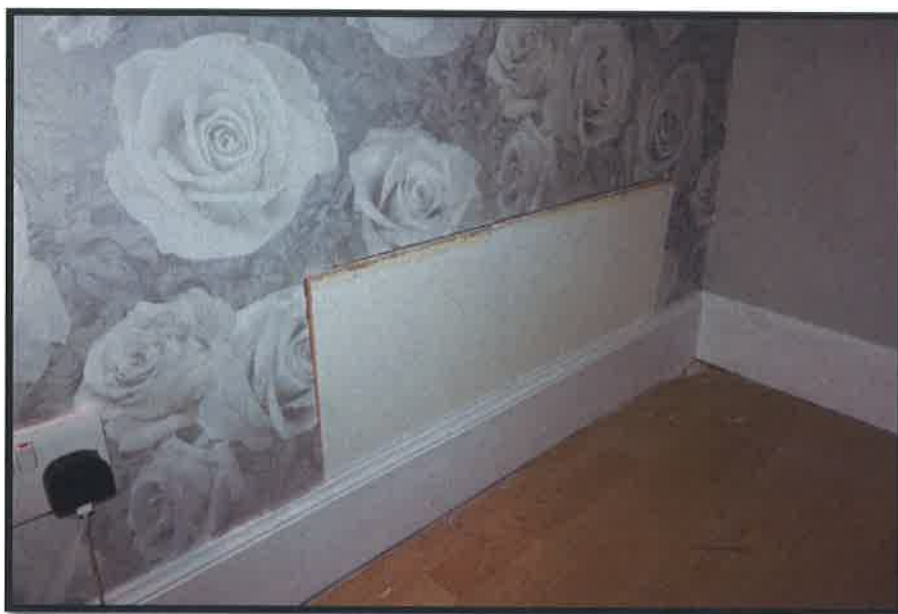
Photograph 16 - Gas meter cover, sitting room.

7. Repair or replace the gas meter cupboard door to render it in proper working order.

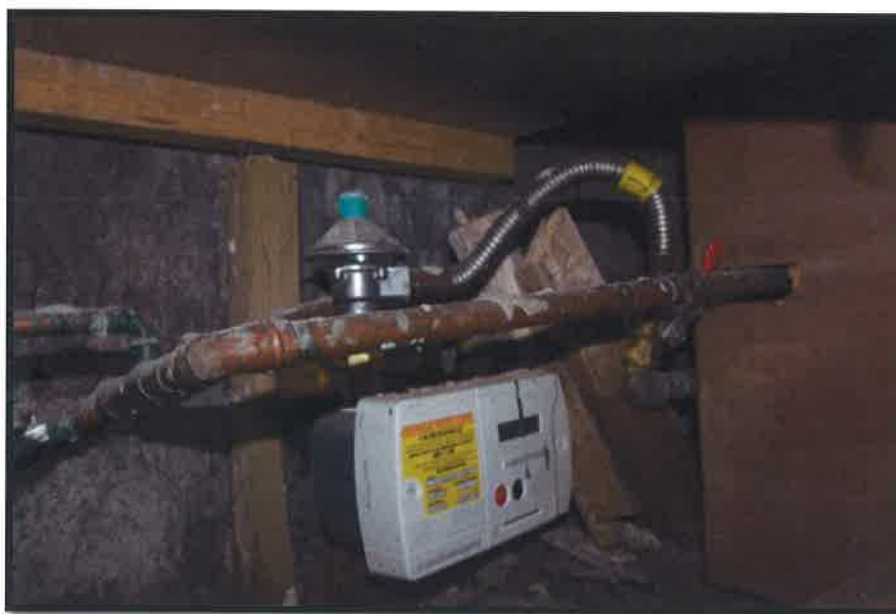
Photograph 17 - Gas meter cupboard - internal.

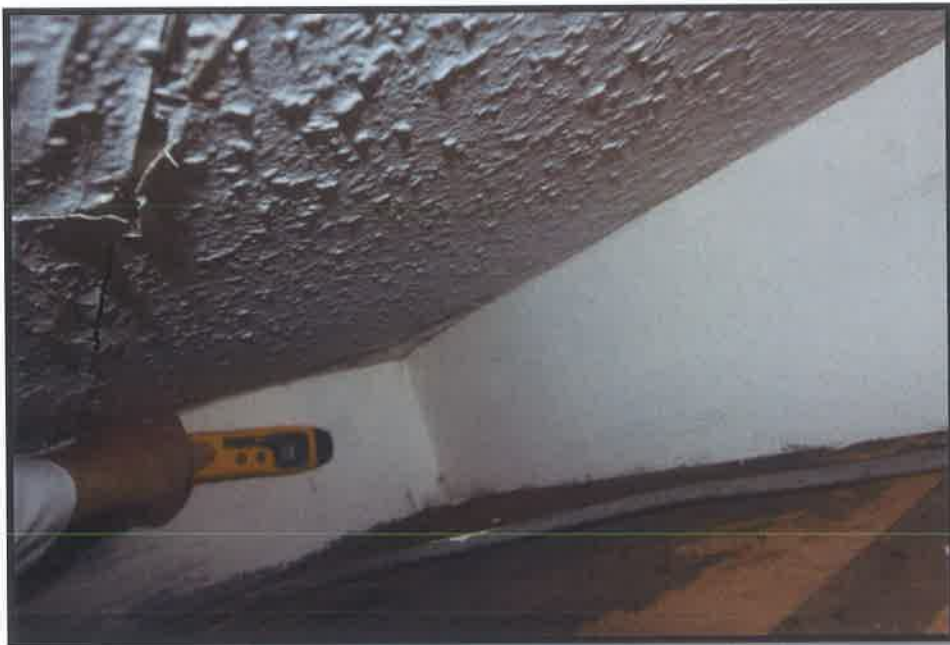
The interior of the corner cupboard, adjacent wall and ceiling surfaces and accessible parts of the tiled wall were tested for damp but only normal readings (below 20%) were observed. Attached to the kitchen is an external outhouse. The door of the outhouse is missing. Visible parts of the wall between the kitchen and the outhouse was constructed of breeze block. The outhouse was full of discarded items and it was not possible to see to the back of the outhouse or the details of the condition of the wall.

Photograph 18 Moisture meter reading amber (20% approx) to wall above corner unit in kitchen.

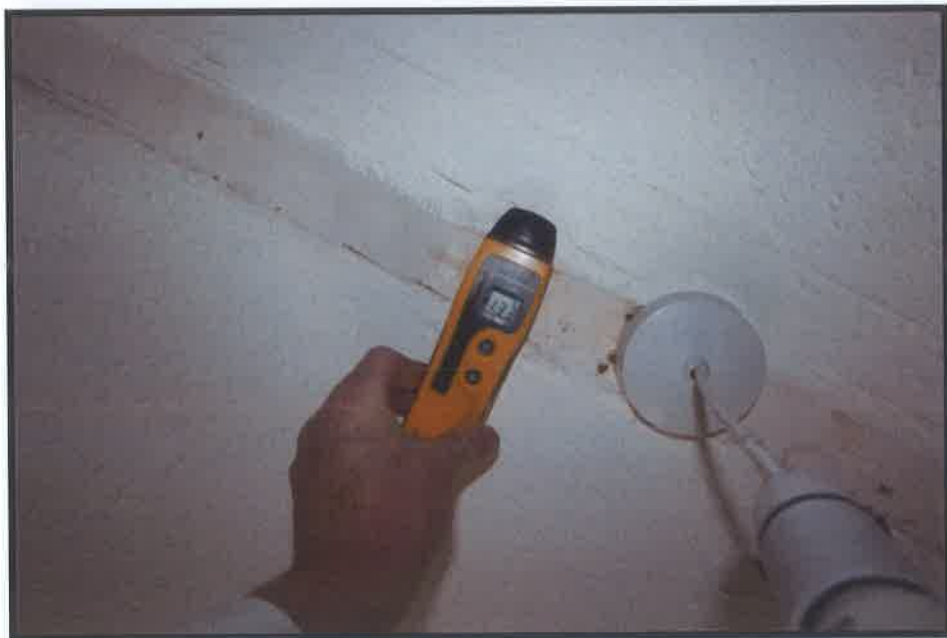
Photograph 19 Moisture meter reading green (13%) to ceiling in kitchen.

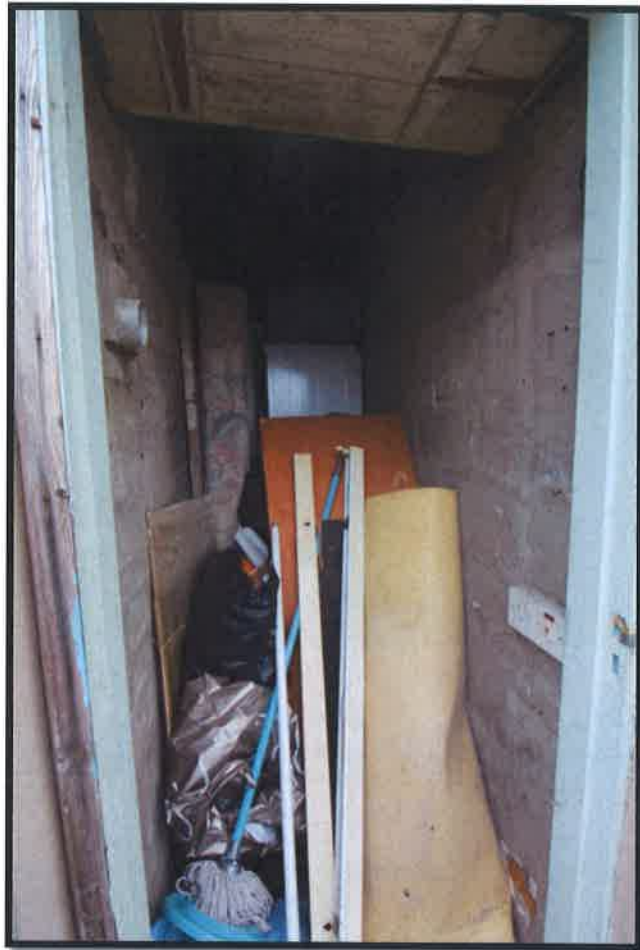
Photograph 20 External store attached to kitchen. Door missing, exposed electrical switches.

13. Repair or replace the door of the external store to render it in a reasonable state of repair and proper working order.

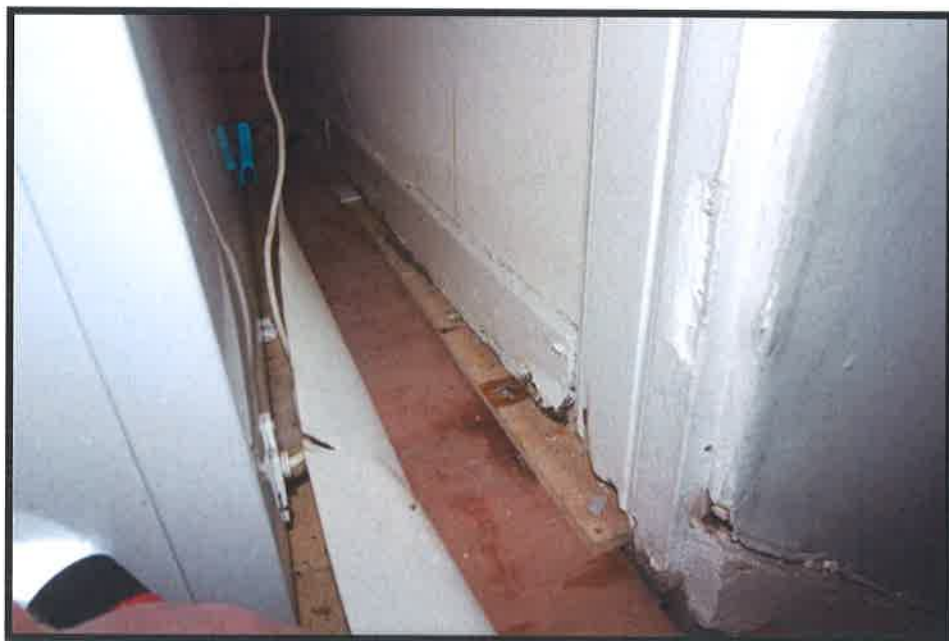
Photograph 21 Kitchen flooring behind freezer.

The Tenants moved the freezer in the kitchen and the Tribunal examined the area of floor below the freezer. New plywood flooring had been installed. The Tribunal noted that there were no gaps between the plasterboard wall behind the freezer and the floor, albeit that the skirting board was rotten in part.

The Tribunal determine that there was no evidence that the kitchen floor under the Tenant's freezer is not in a reasonable state of repair and proper working order at the inspection and the stored items within the external store are not a matter that falls within the Repairing Standard.

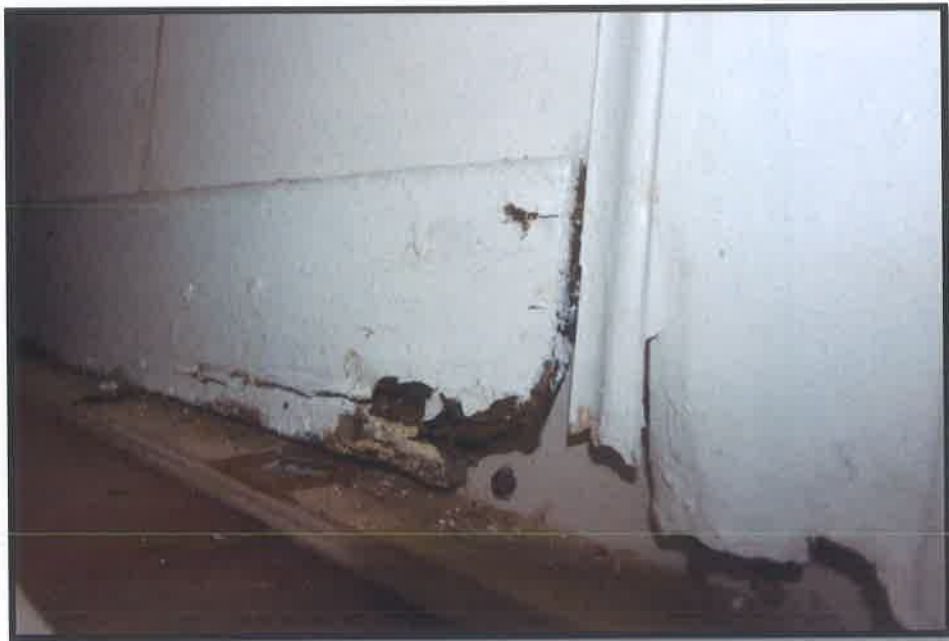
Photograph 22 Kitchen skirting and plasterboard behind freezer.

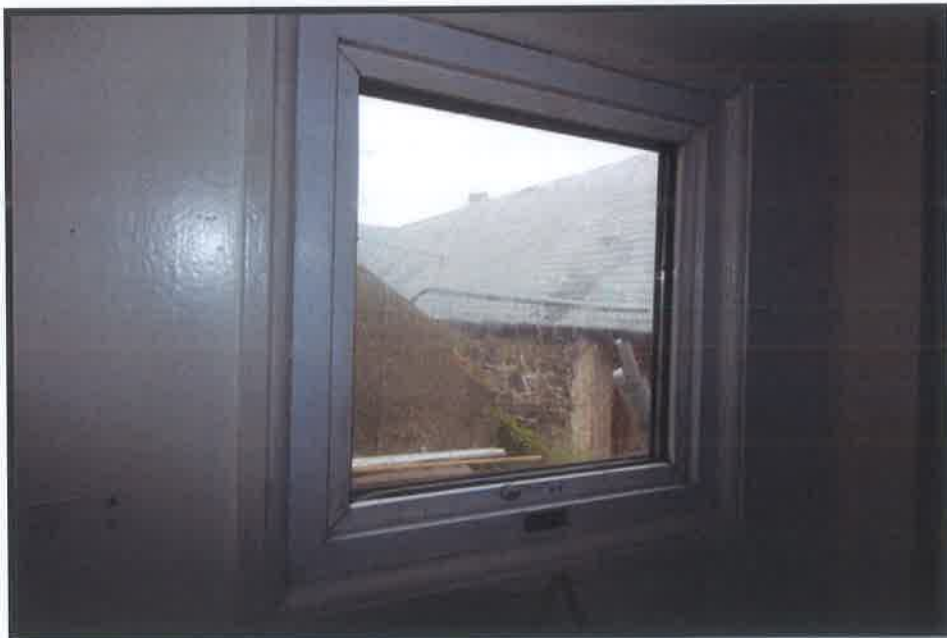
There was a glass panel in the back door. The catch and inner glass were missing from the glass panel.

Photograph 23 Rear door window - catches broken/missing.

10. Repair or replace the back door to render it in a reasonable state of repair and proper working order.

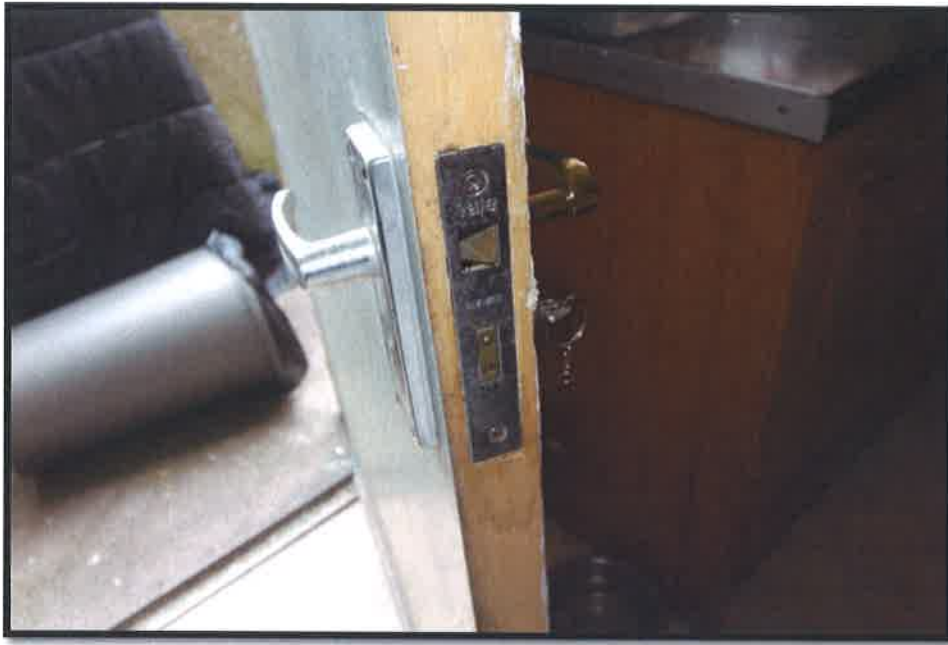
Photograph 24 Rear door latch defective.

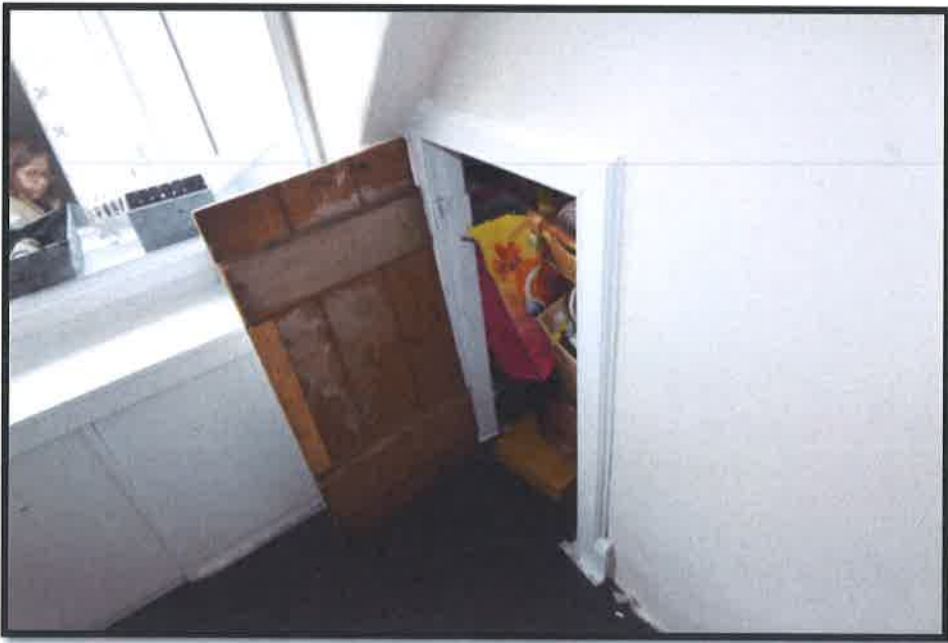
The Tribunal determine that the fact that the hinges are missing from the door of the small attic cupboard in the first floor bedroom right results in it being not in proper working order.

Photograph 25 Right hand first floor bedroom - cupboard door off hinges.

11. Repair or replace the cupboard door in the first floor bedroom right to render it in a reasonable state of repair and proper working order.

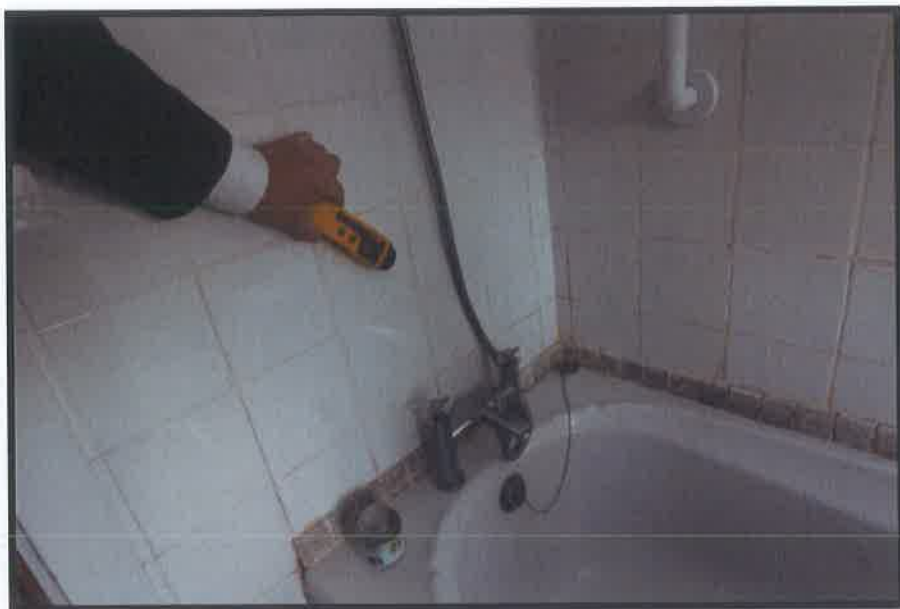
Some of the tiling around the bath had been replaced. The tiles fitted to the upper parts of the wall around the bath have not been grouted. Sections of the small tile edging around the bath are missing.

The Tribunal determine that the presence of the dampness, the missing tiling around the bath and the absence of some grouting to the tiling around the bath results in them not being in a reasonable state of repair and proper working order.

Photograph 26 - Moisture meter reading red (99%) to tiling at bath.

9. Repair the tiles around the bath.

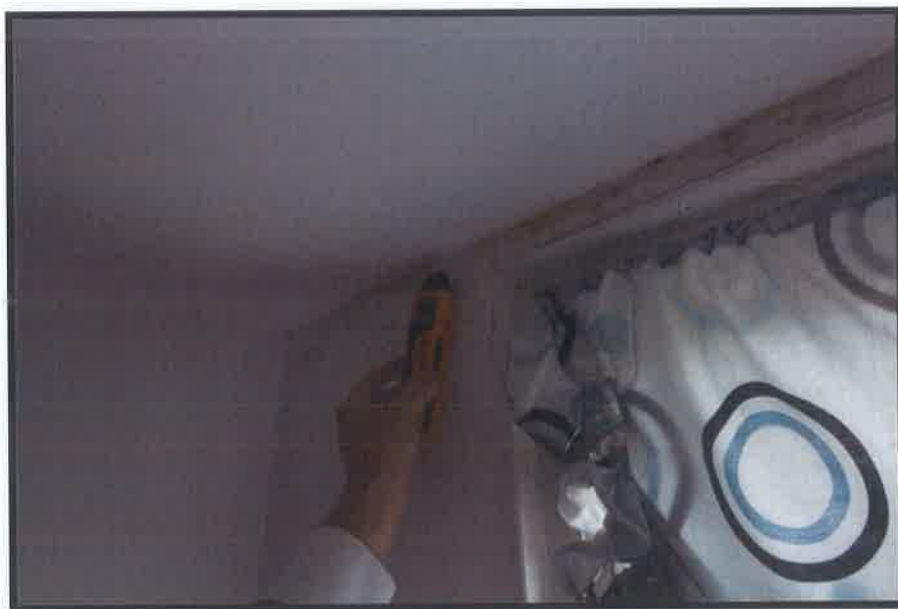
Photograph 27 - Moisture meter reading red (99%) to wall left side of bathroom window.

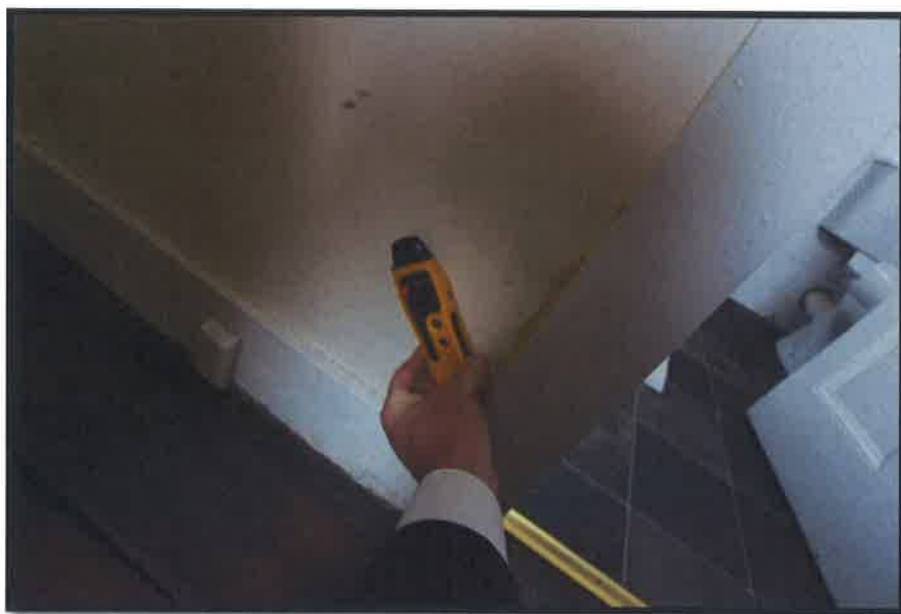
Photograph 28 - Moisture meter reading red (99%) to landing wall left side of bathroom door.

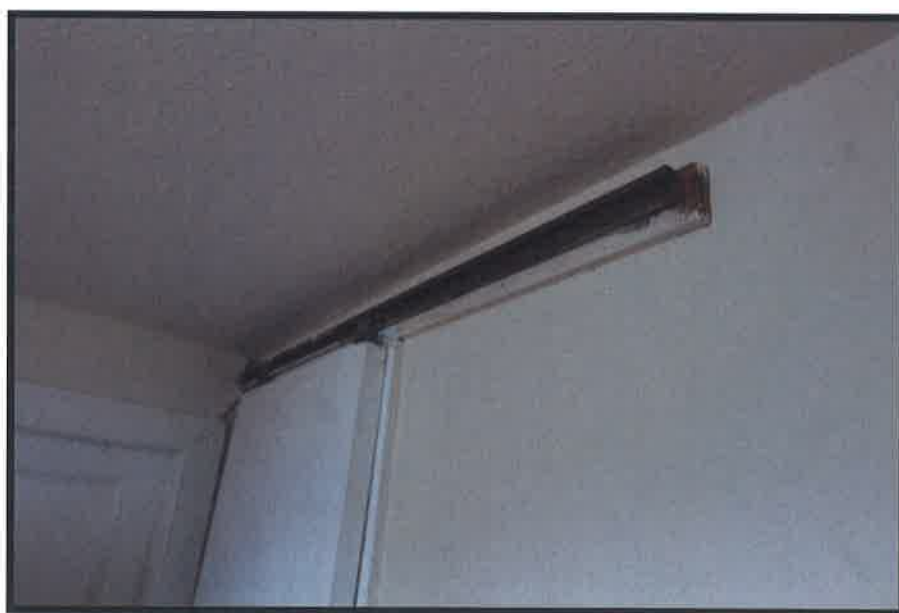
The door to the landing cupboard is a sliding door. The floor guide/ track to locate the door in position is missing in part and consequently the door does not operate correctly.

Photograph 29 - Sliding door to boiler cupboard at first floor landing.

12. Repair or replace the door of the landing cupboard to render it in a reasonable state of repair and proper working order.

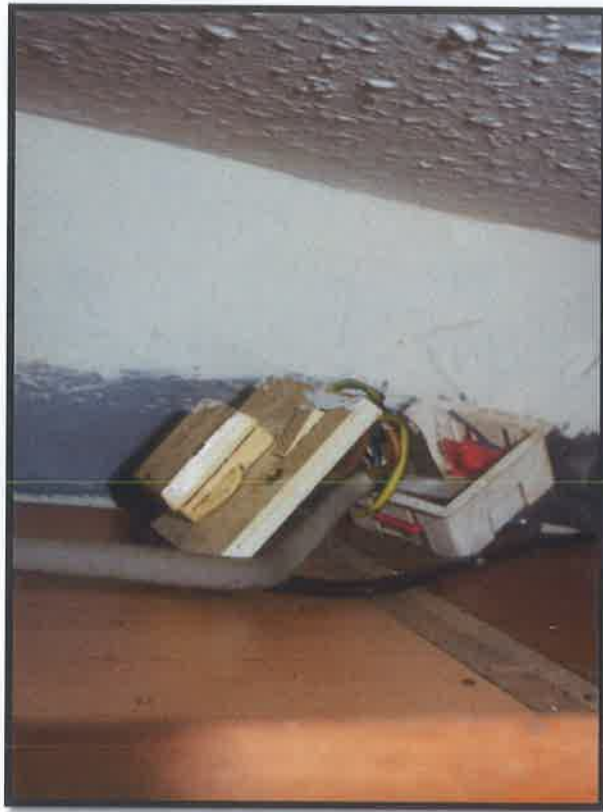
Photograph 30 - Electrical connection to cooker hood in kitchen.

1. Carry out such repairs as are necessary to render the electrical installation in a reasonable state of repair and exhibit a valid and compliant EICR Certificate.
