Repairing Standard Enforcement Order **Ordered by the First-tier Tribunal for Scotland** **(Housing and Property Chamber)**

Chamber Ref: FTS/HPC/RP/18/1534

Lambsha Cottage, Cluny, Kirkcaldy, Fife, KY2 6QX being the subjects registered in the Land Register of Scotland under Title Number FFE6232 ('The Property')

This is the Schedule of Photographs
referred to in the foregoing decision
dated 19/10/11
J Taylor

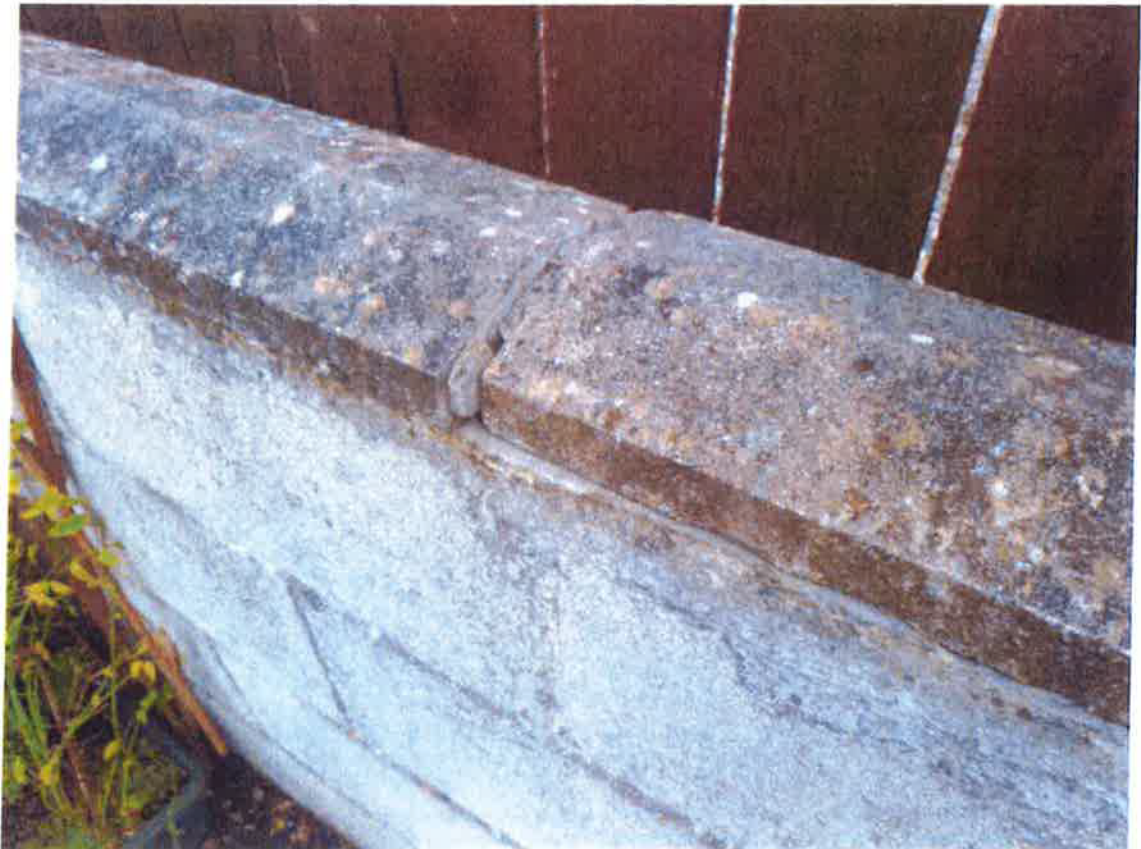
The coping stones on the top of the wall in the rear garden are loose.

8.2.5 That the condition of the front door (namely the rotten door panels and door frame) and the loose coping stones on the wall in the back garden results in them not being in a reasonable state of repair and proper working order.

Loose coping stones to wall at rear

5. Repair the coping stones on the wall round the back garden to render them secure.
6. Repair or replace the external light at the rear of the Property to render it in proper working order.

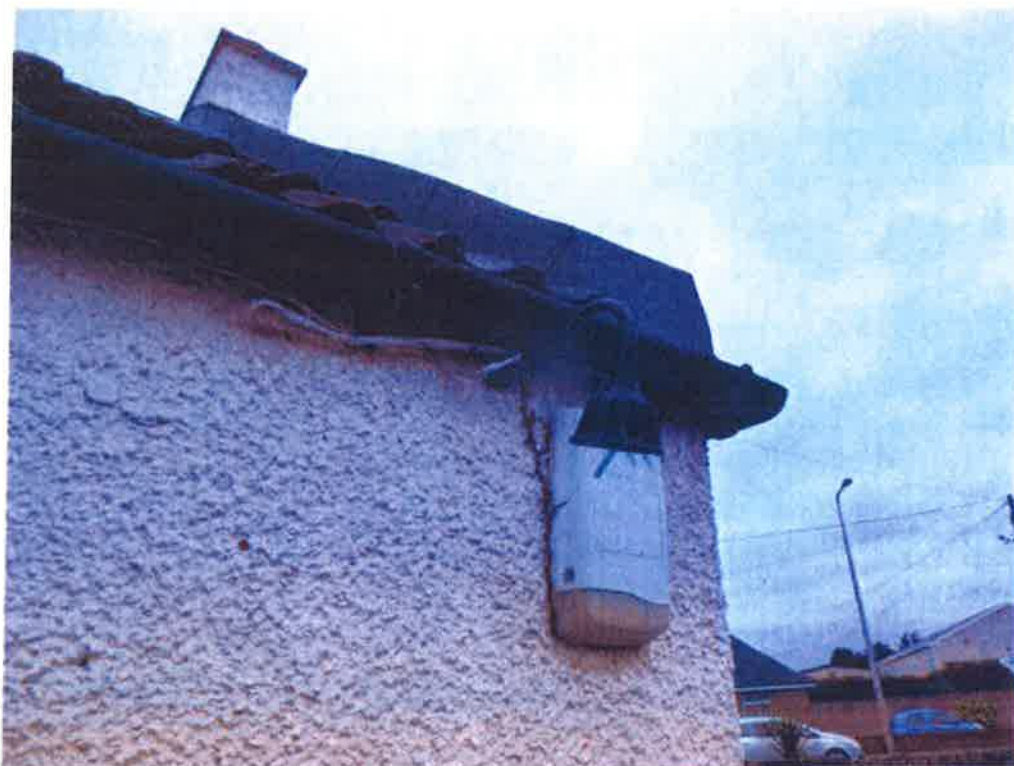
The Tribunal determine that the absence of a cover to the outside light results in it not being in a reasonable state of repair and proper working order.

Defective light fitting at rear

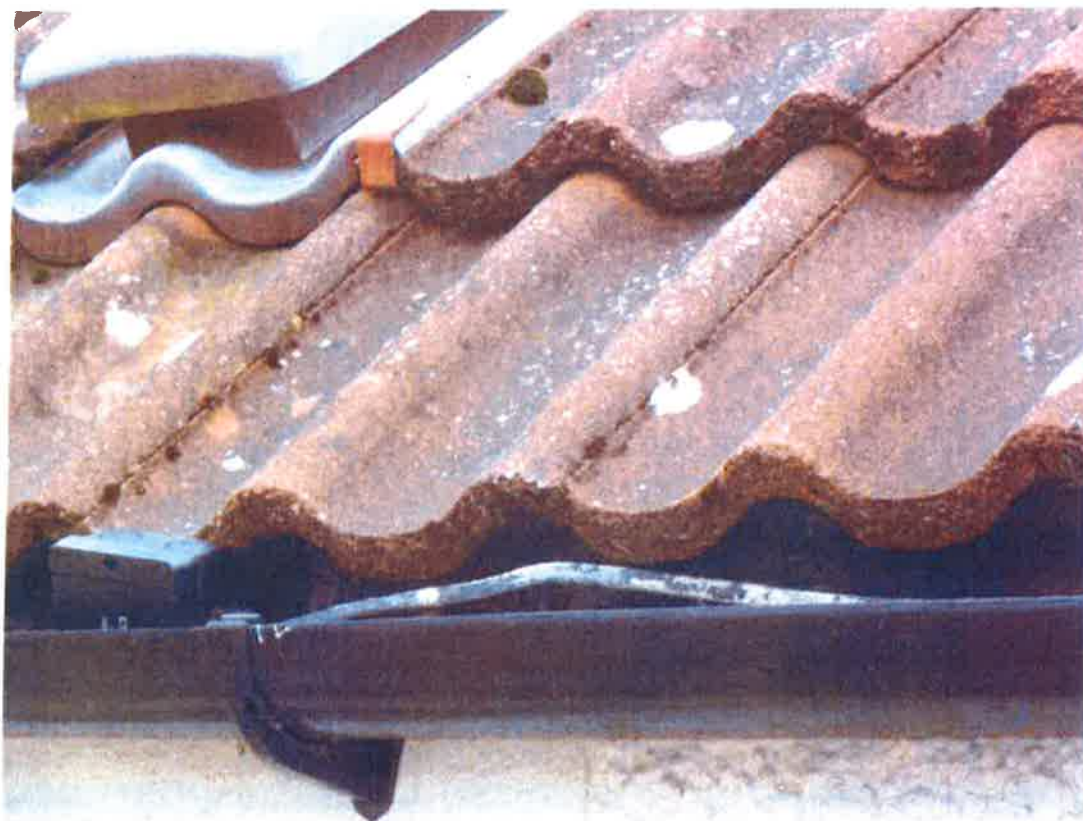
Cable in gutter at rear

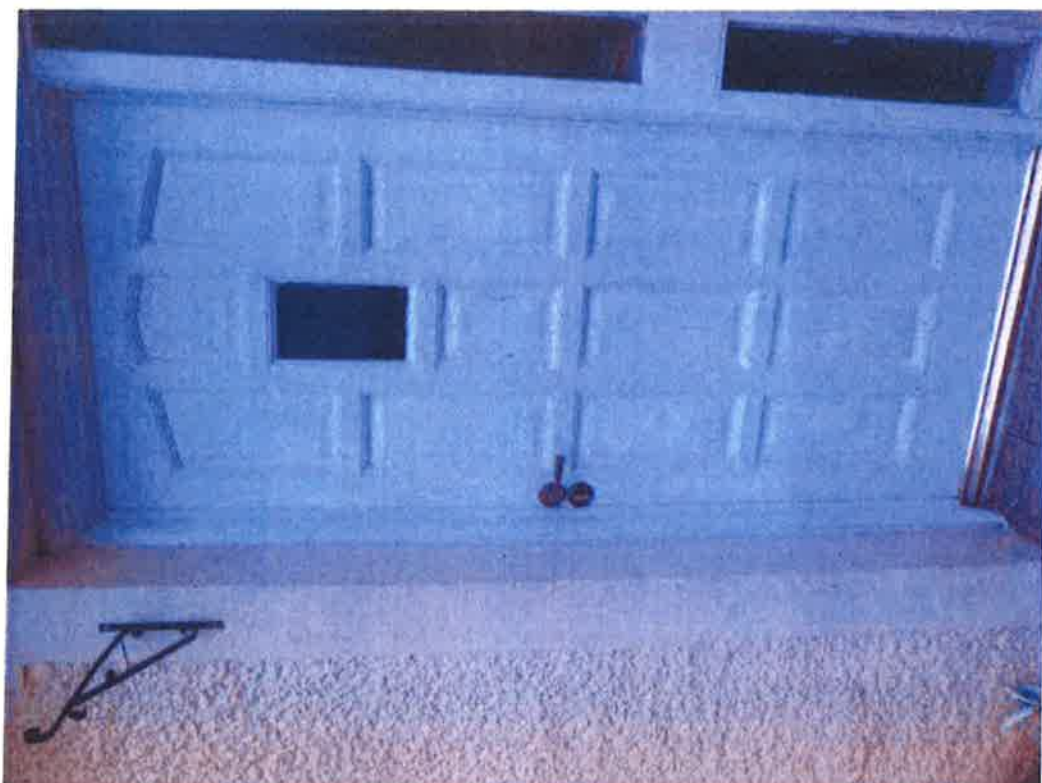
5.15 The front door is in a poor condition and is draughty. It is badly rotten and there is a very large gap under the front door.

Main entrance door in poor condition

3. Repair or replace the front door and door frame in the Property to render them wind and watertight and in proper working order.
4. Repair or replace the defective double glazed unit to the dorma window at the top of the stairs.

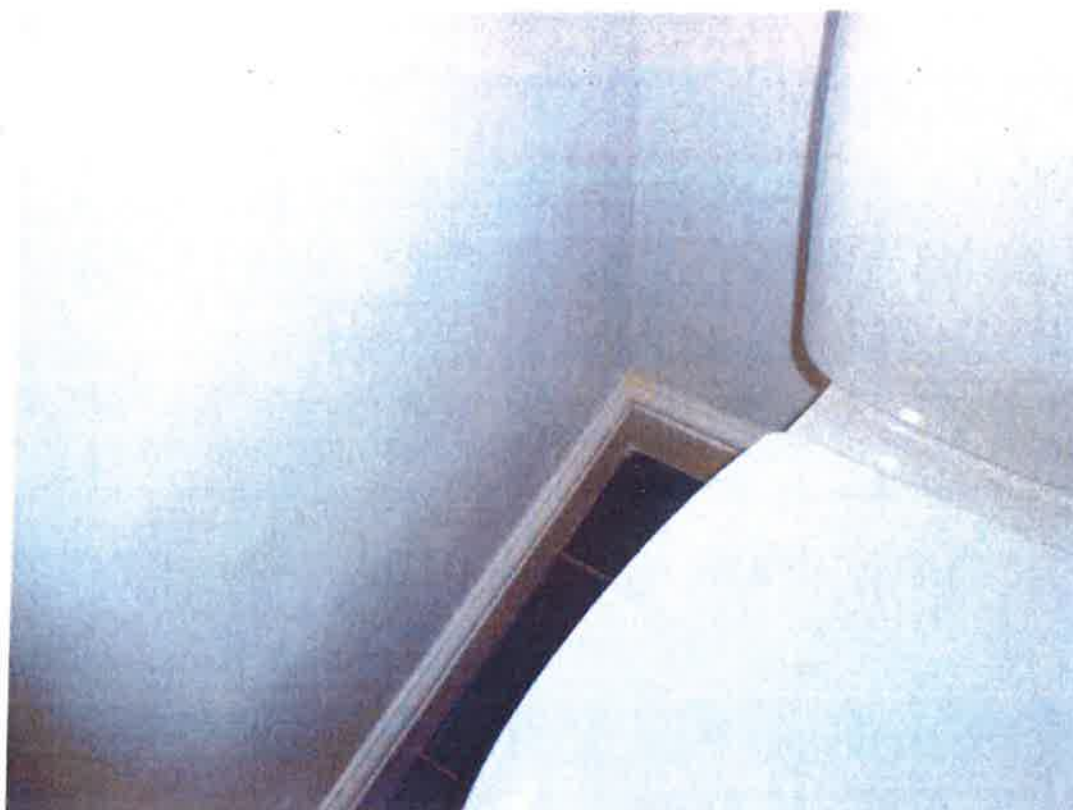
The Ordinary member of the Tribunal tested the walls of the bathroom with a damp meter and found that they were dry, with the exception of the wall to the side of the wc, approximately 300 mm from the floor, which was damp. The damp meter read 27% indicating that there is dampness present in the wall.

The Tribunal determine that the dampness in the wall of the bathroom near to the toilet and the presence of water/ moisture within the double glazed dormer window results in these items not being wind and water tight. They also determined that the evidence of vermin in the Property results in the Property not being reasonably fit for human habitation.

Wet area inside bathroom at low level – only around WC bowl

1. Repair the dampness to the wall situated to the left of the toilet in the bathroom to render it water tight.
2. Install a tap/ valve to enable the stop cock to be easily opened and closed.

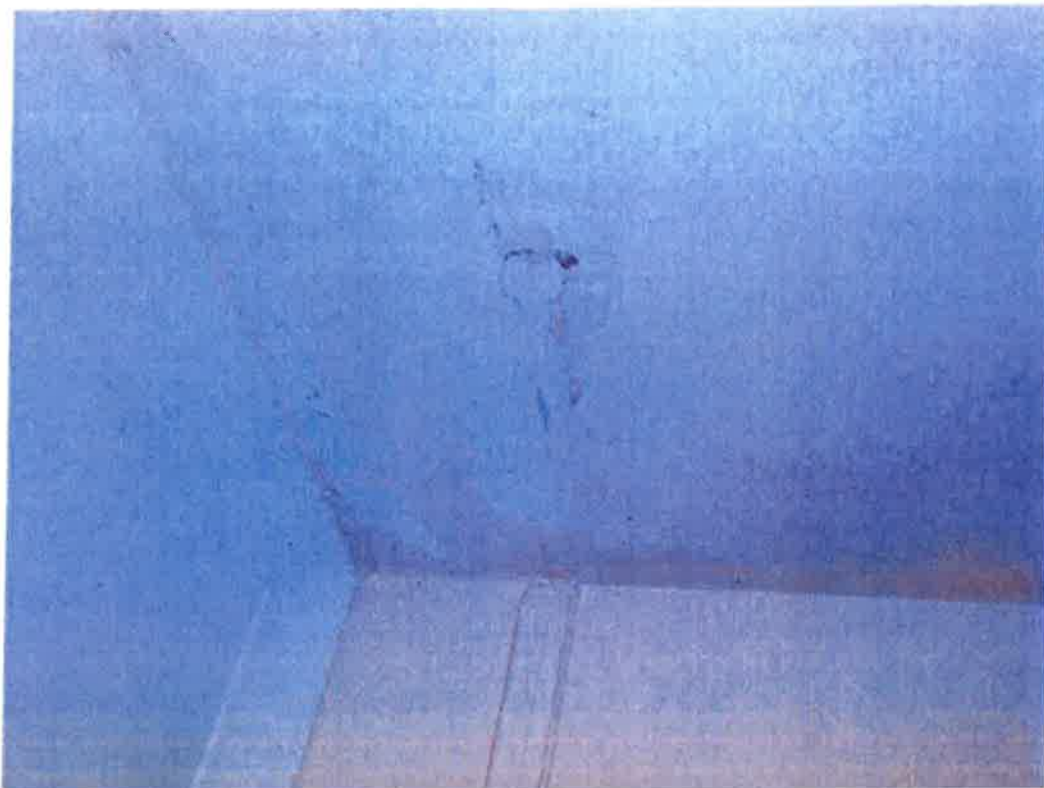
There is an area of loose plaster and paint on the internal wall of the living room.

Flaking and peeling plaster and paint – high level sitting room

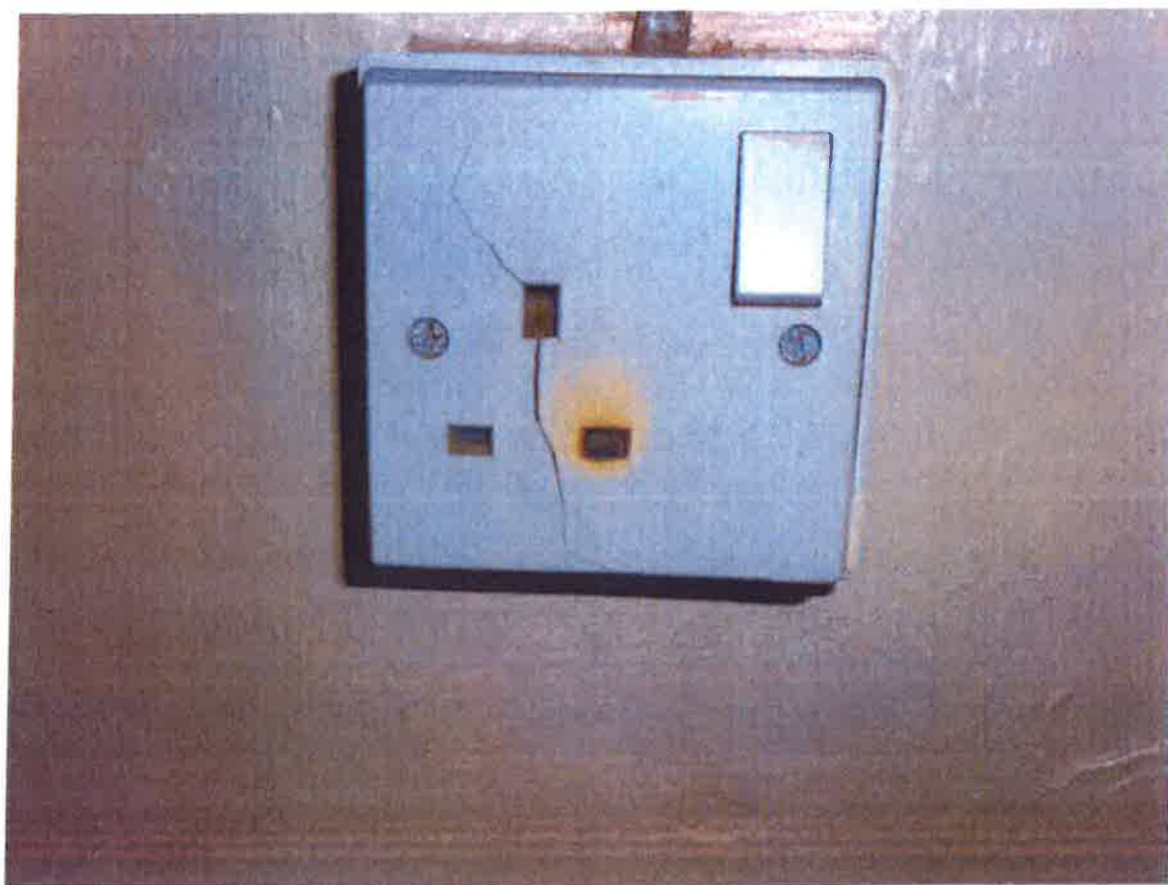
Defective broken socket in kitchen – signs of scorching

7. Implement a rodent eradication strategy to effectively eradicate the vermin in the Property.
8. Exhibit a valid and compliant EICR and PAT Certificate.

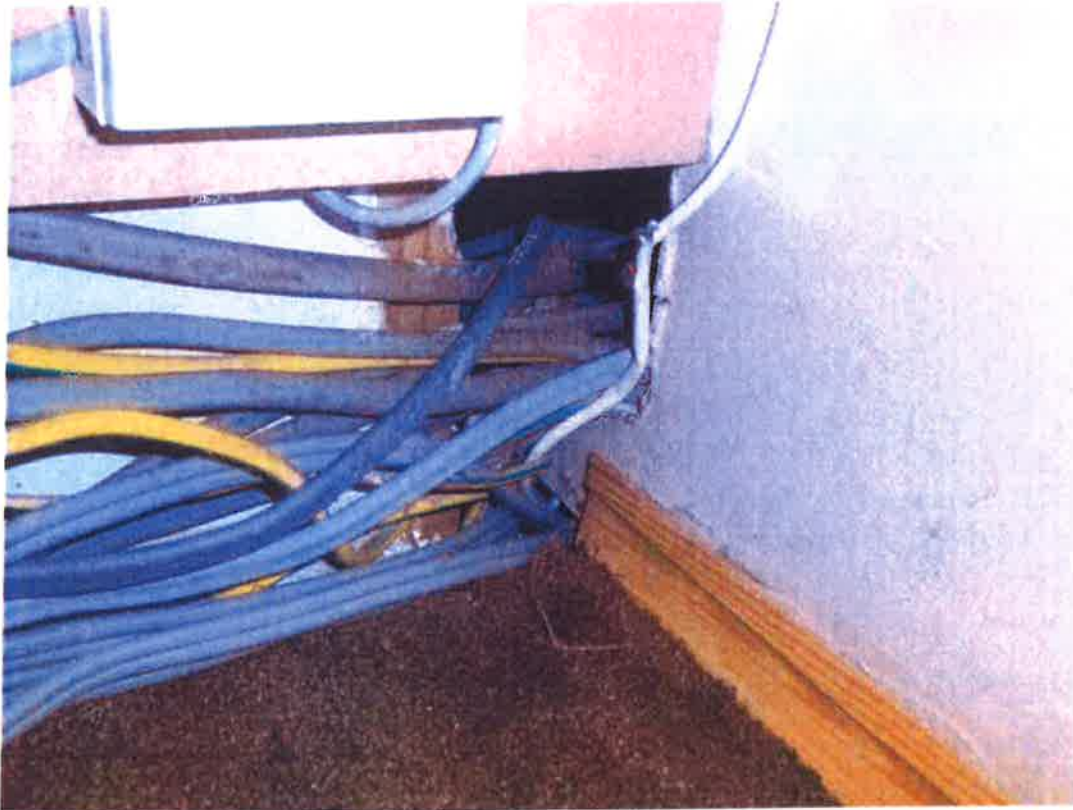
Chewed and frayed mains electrical cables

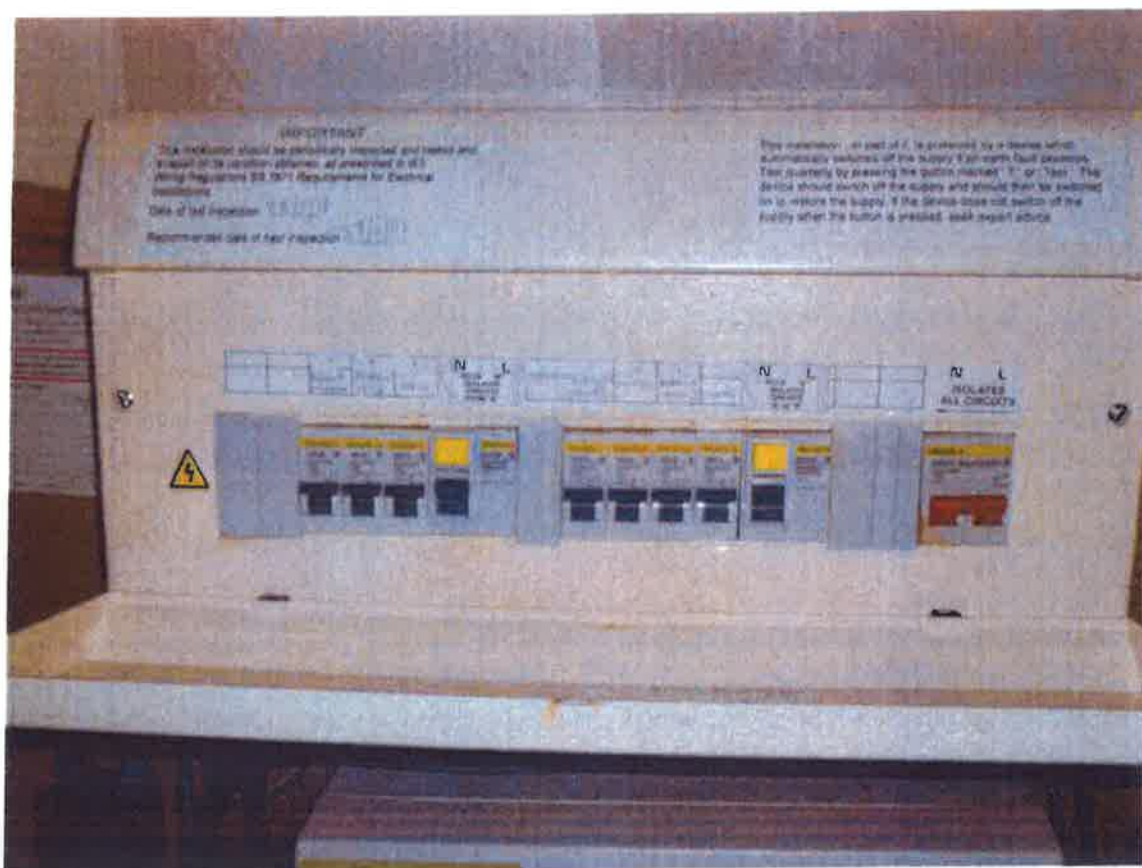
Mains distribution board

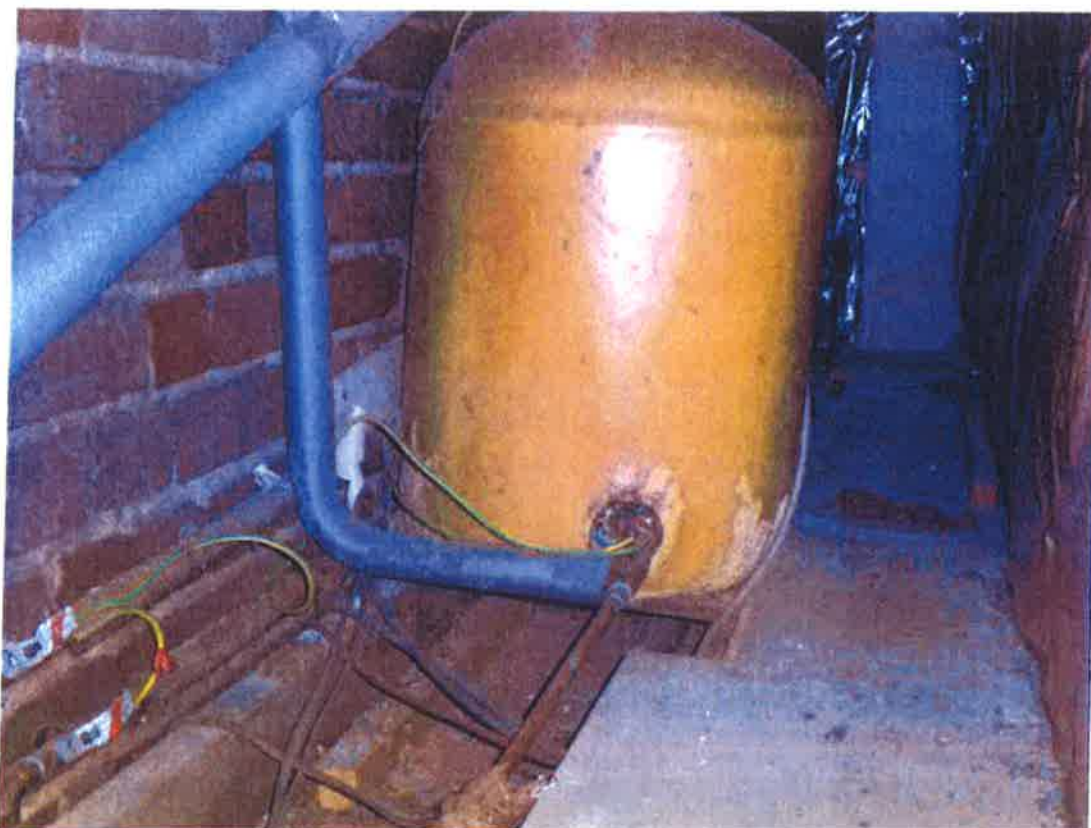
The Tribunal note that the hot water tank is small but they determine that this fact does not result in it not being in a reasonable state of repair or proper working order.

600mm x 450mm hot water cylinder to loft area

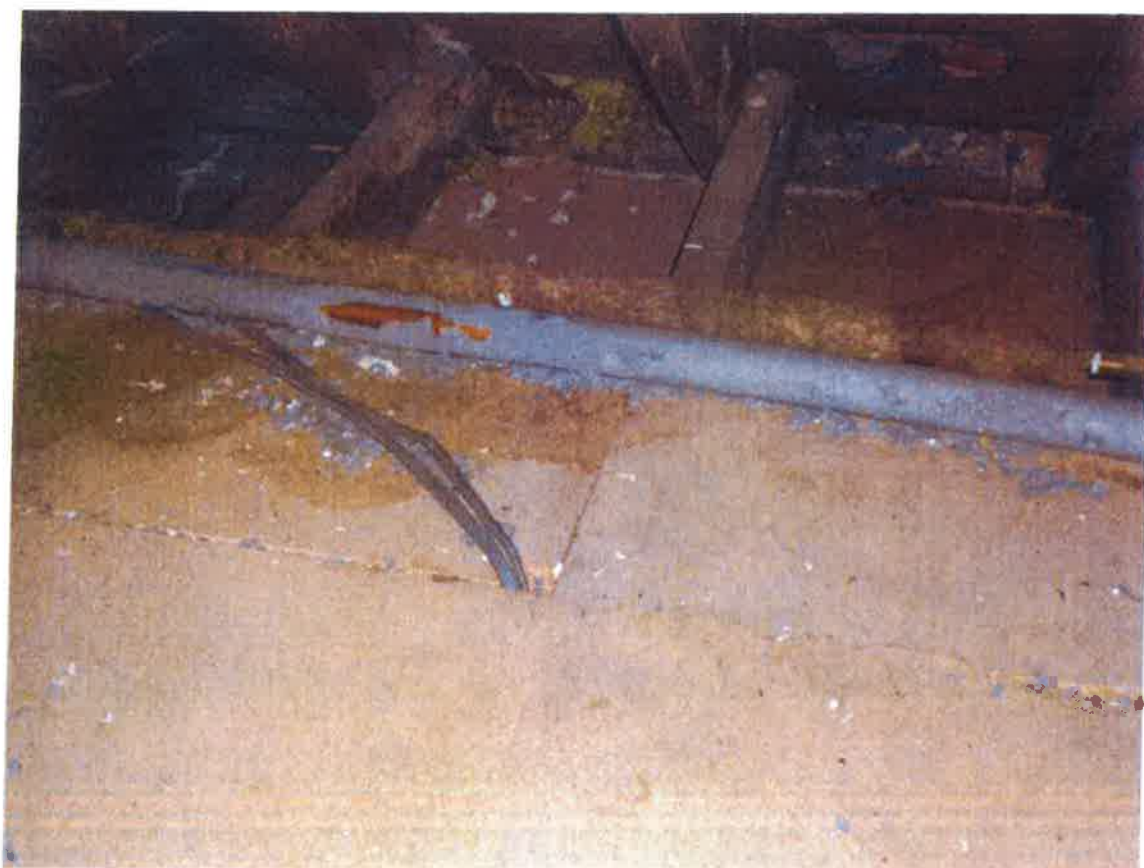
Rodent and vermin damage to loft space

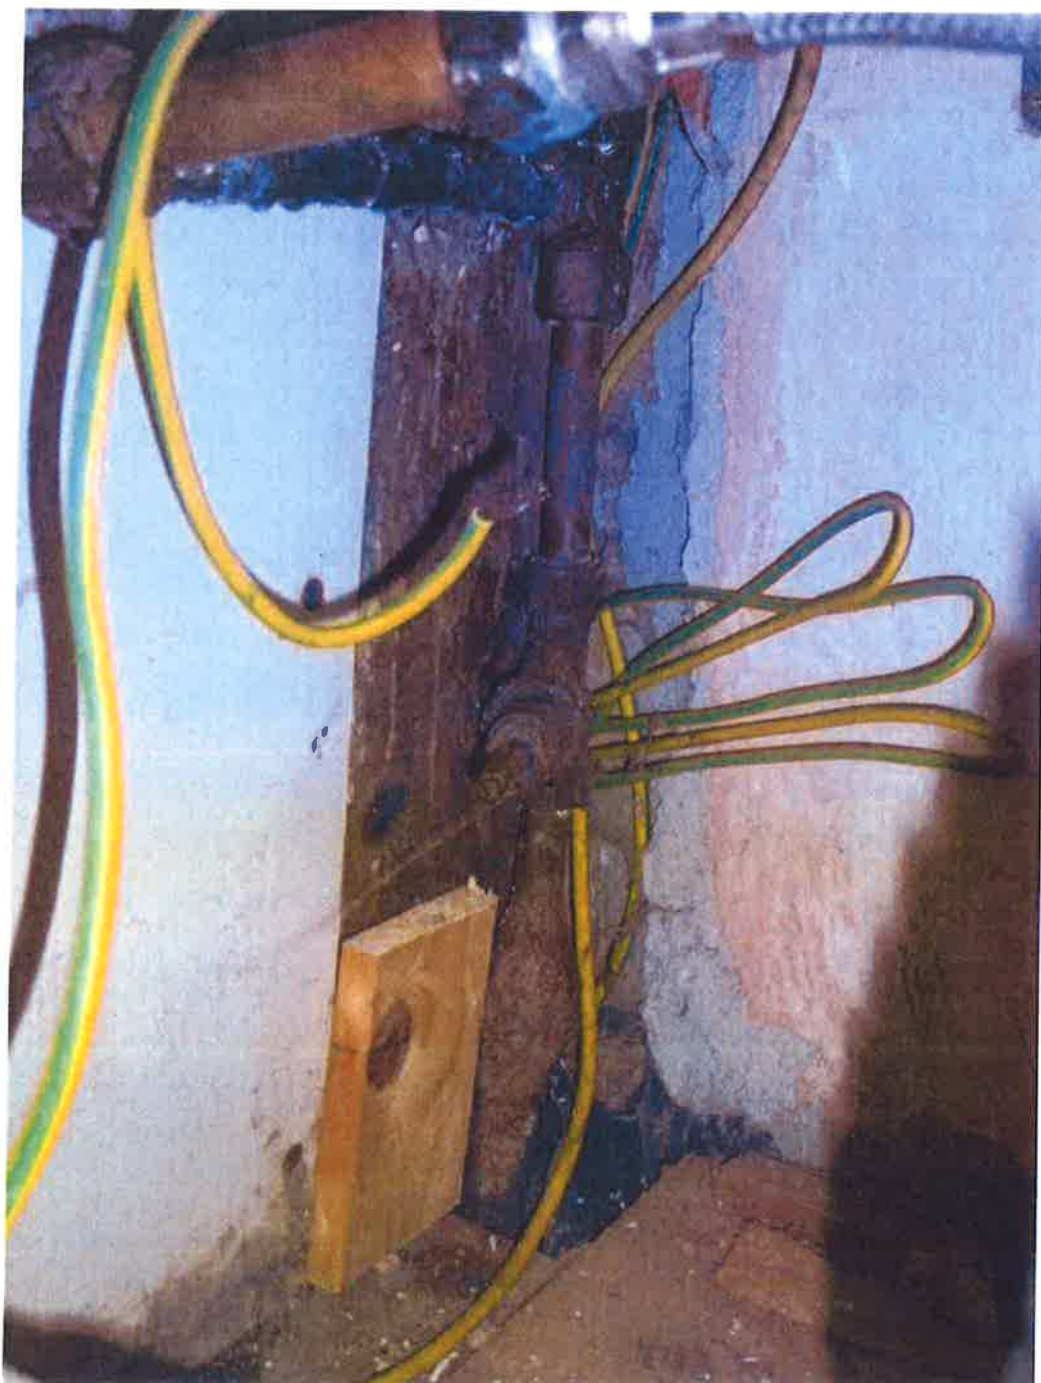
The Tenant explained that the stop cock valve is missing. To turn off the water supply to the Property it is necessary to pull away the front panel of the bath and use pliers to turn off the stop cock.

The Tribunal also determine that the absence of a tap/ valve fitting to enable the stop sock to be easily turned off does result in the stop cock not being in a reasonable state of repair and proper working order.

Mains top cock below bath – missing valve top and poor access
