**Statement of Decision under section 25(1)(a) of the Housing (Scotland) Act 2006 (“the 2006 Act”)**

**Chamber Ref: PRHP/RP/16/0343**

**Subjects at 2 South West Street, Buckie, Moray, AB56 1BR (“the Property”)**

Housing (Scotland) Act 2006: Re-inspection Report

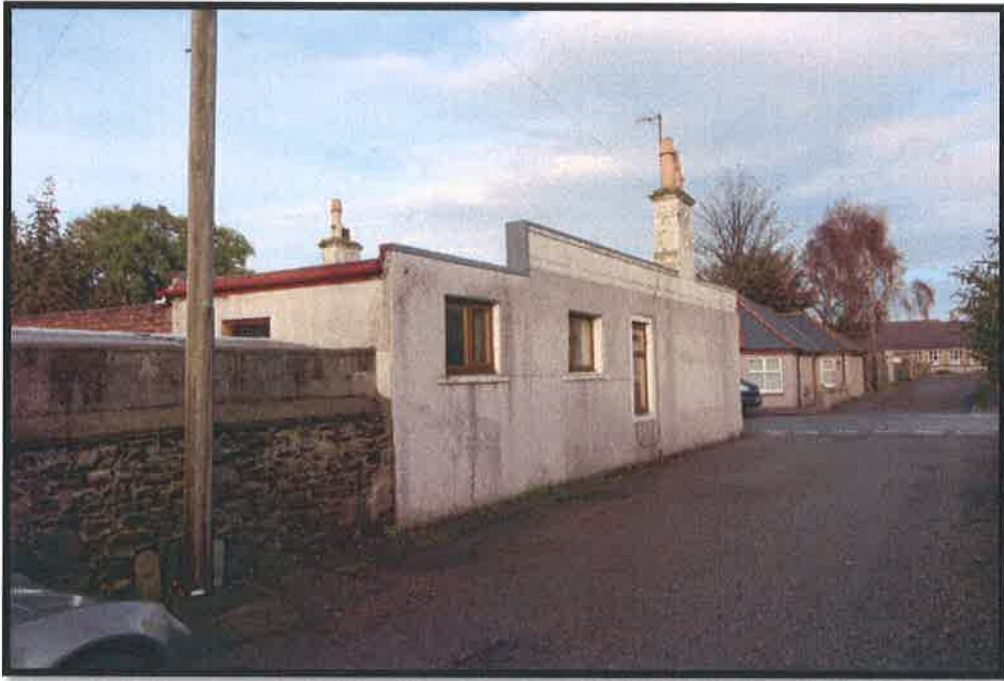
Figure 2 Left Side Elevation, utility room, kitchen and middle bedroom windows

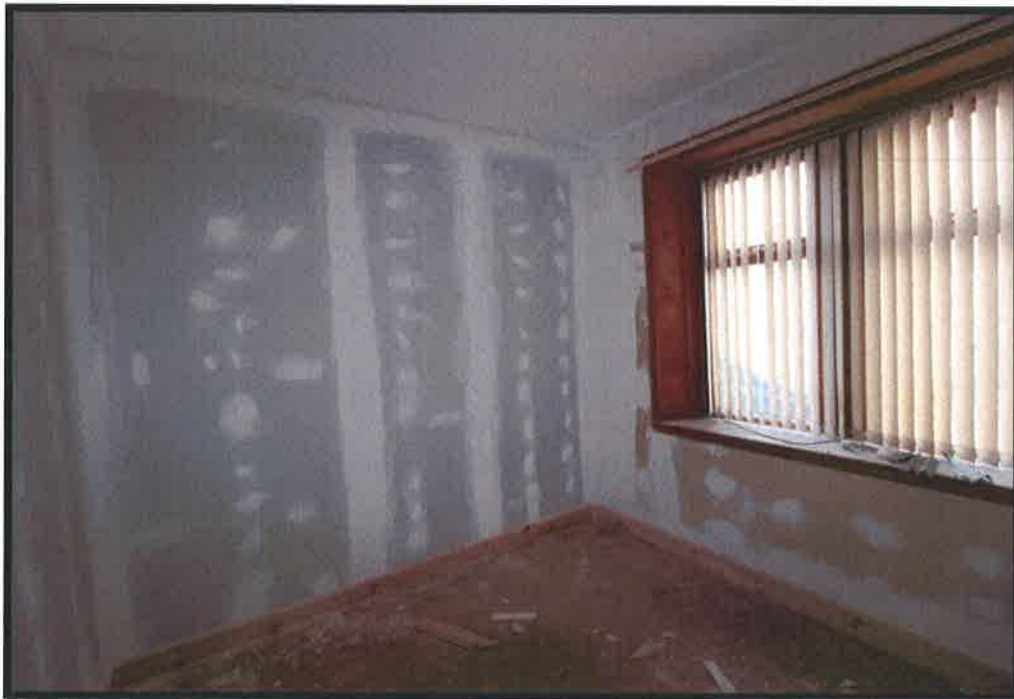
Figure 3 Front Bedroom -new plasterboard

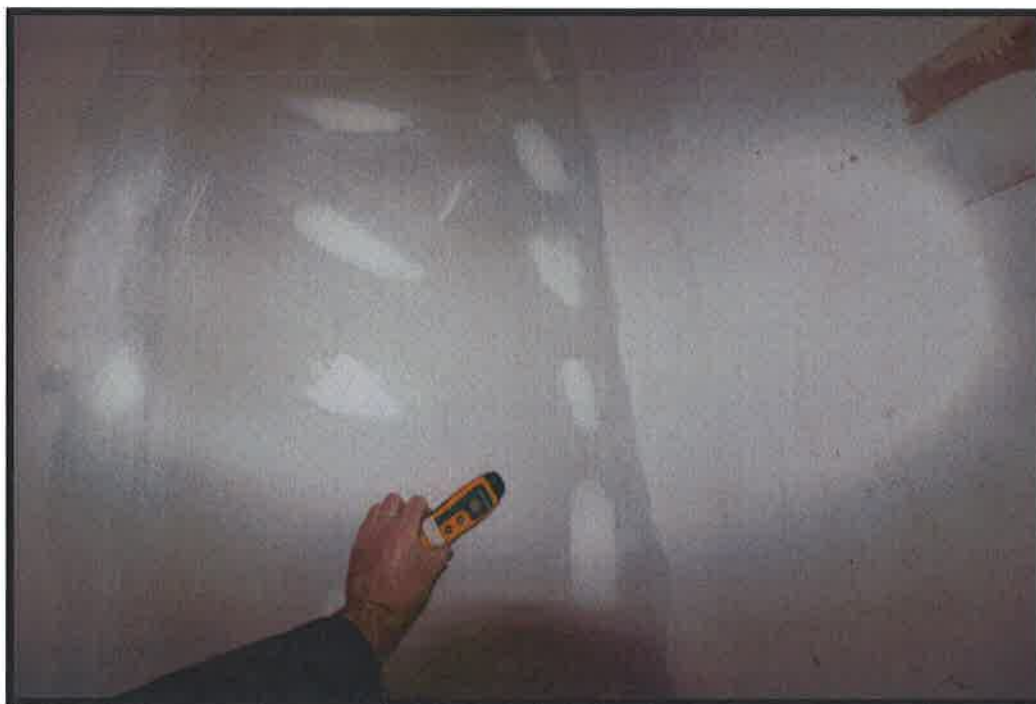
Figure 4 Front Bedroom typical moisture meter reading (12%) (previously 15%)

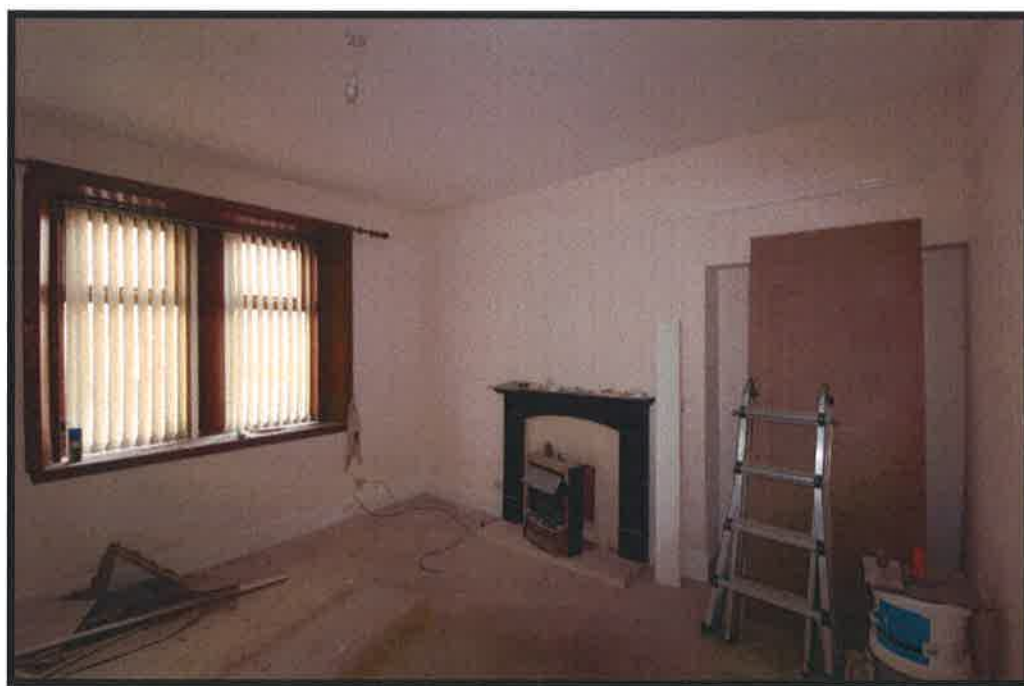
Figure 5 Lounge.- walls repainted.

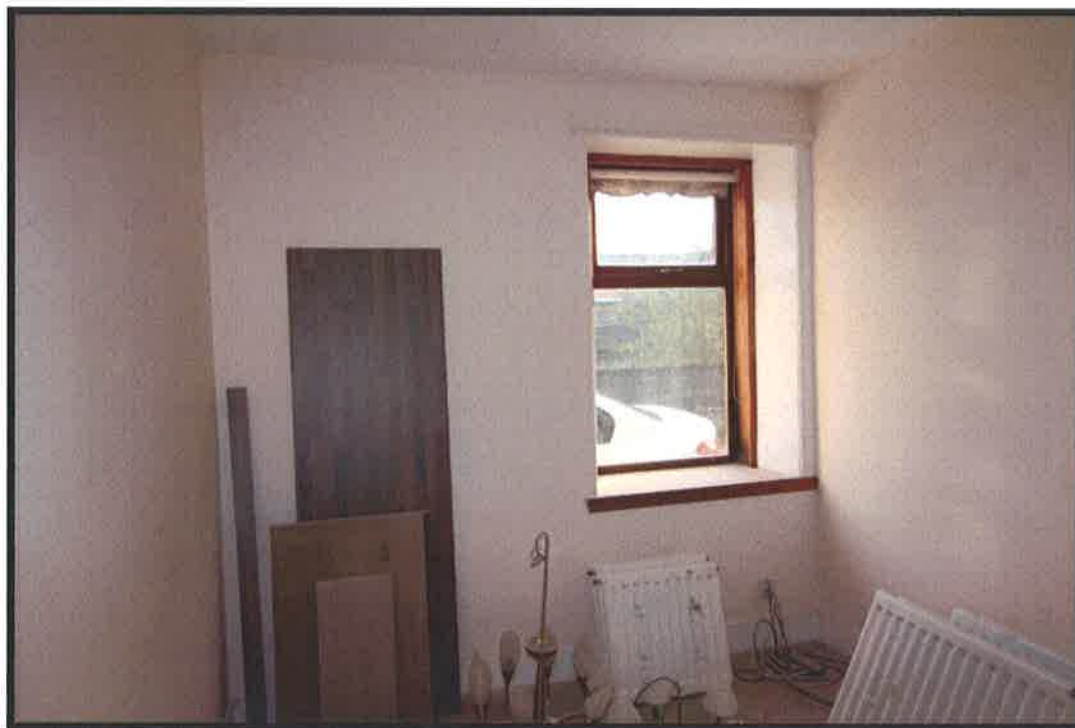
Figure 6 Middle Bedroom - Overview, repainted.

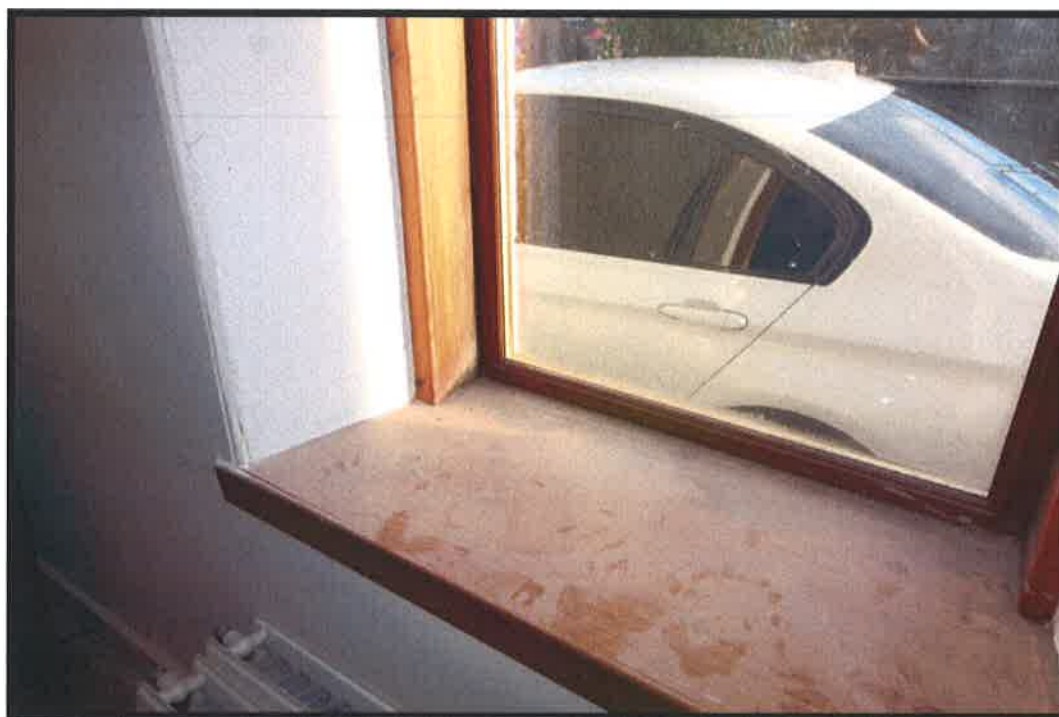
Figure 7- Middle bedroom - water marks to timber window sill.

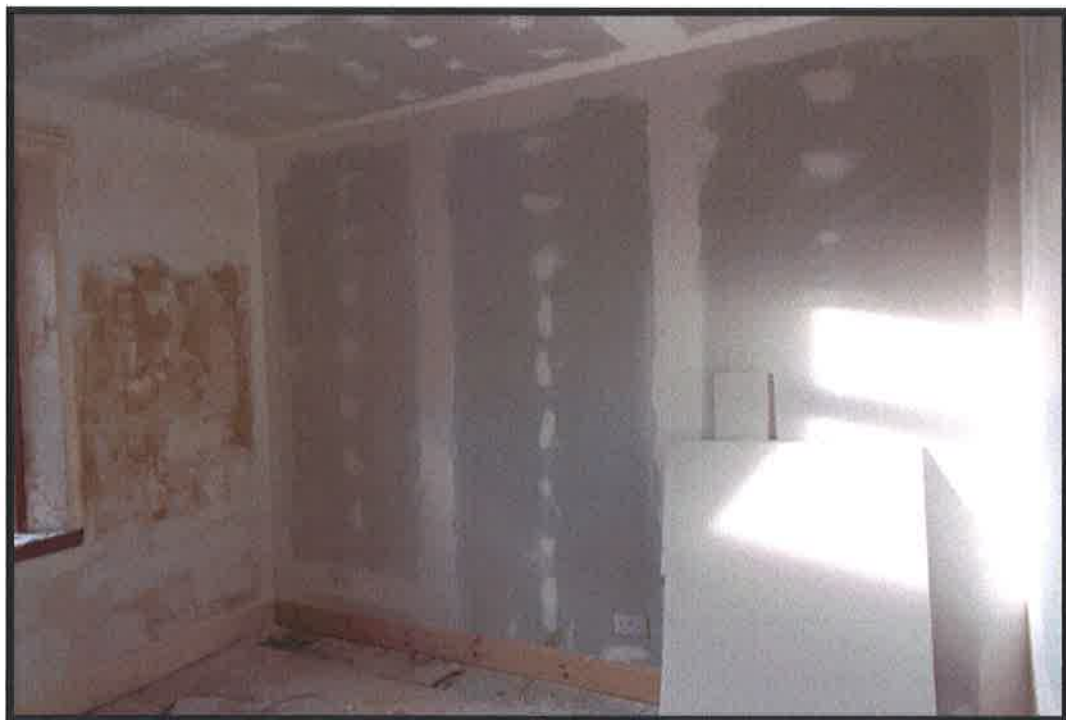
Figure 8 Rear bedroom - new plasterboard. In course of redecoration.

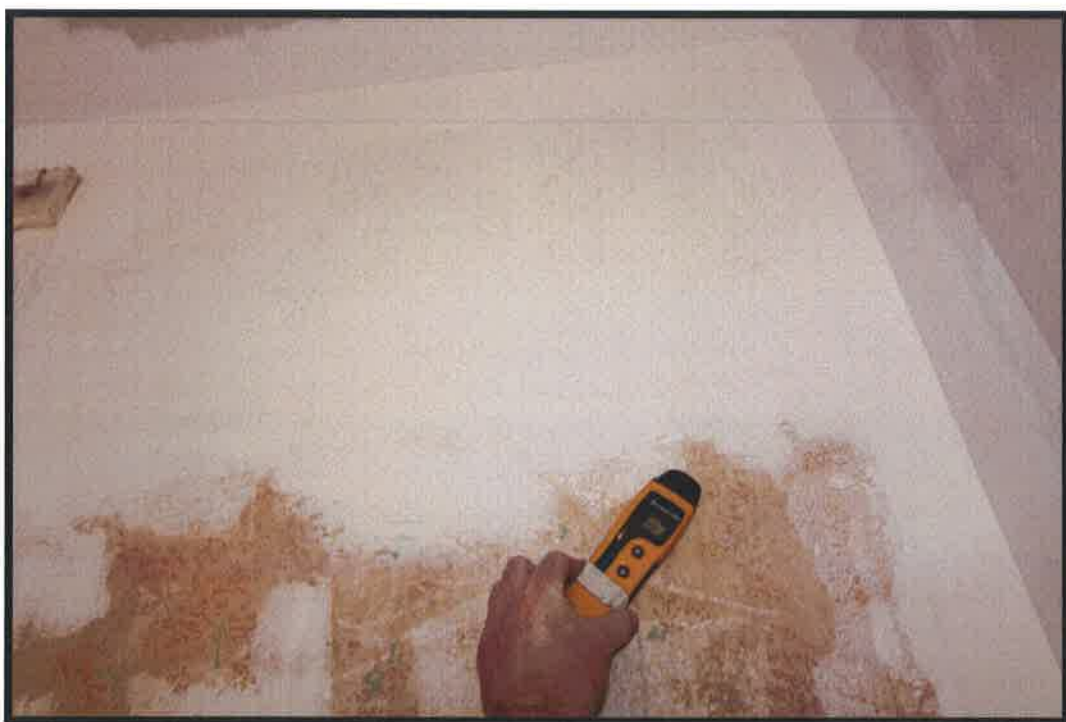
Figure 9 Rear bedroom - Meter reading (16%) rear corner at outer wall (as before).

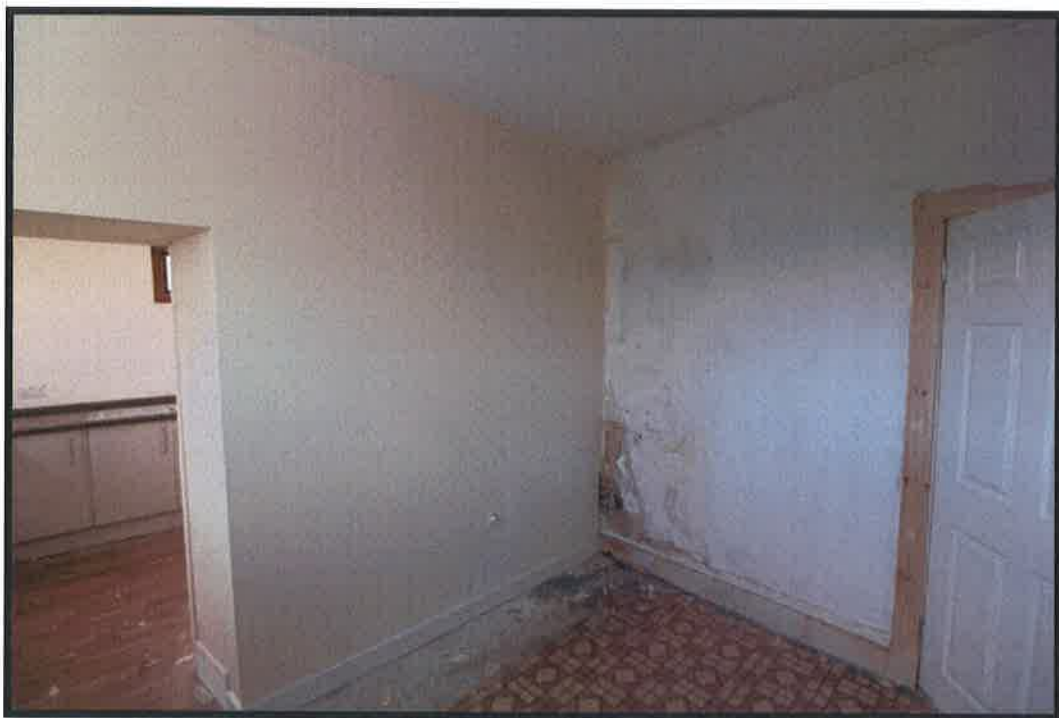
Figure 10 Former kitchen overview. Cabinets removed, linings part renewed.

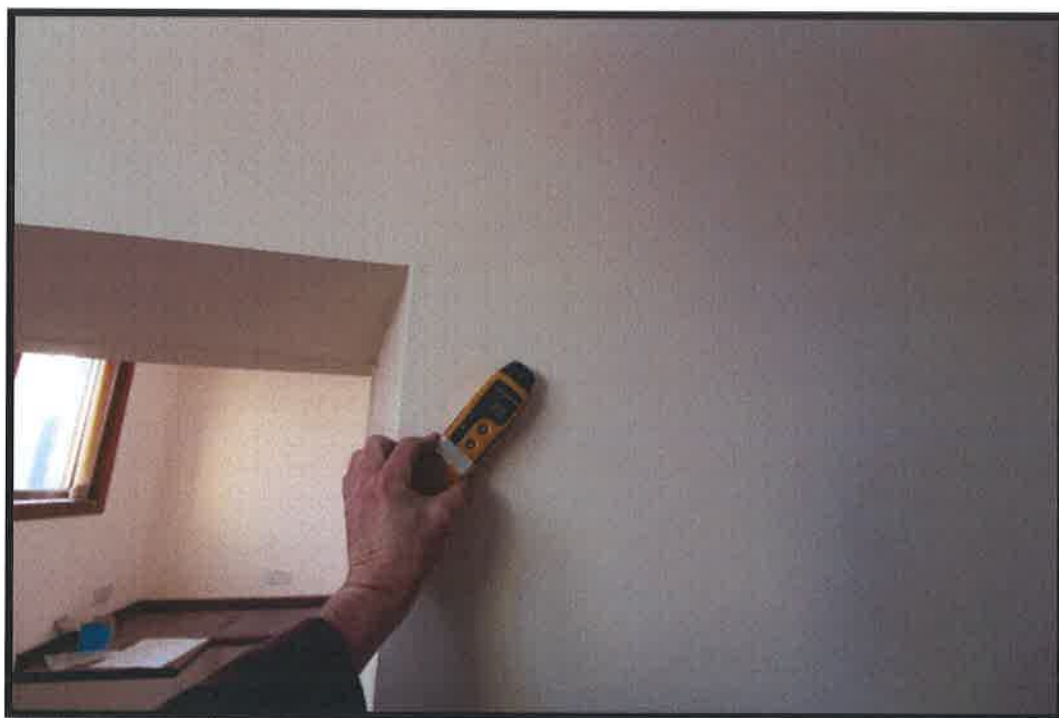
Figure 11 Doorway to utility room(new kitchen) - Meter reading (9%)(previously 100%).

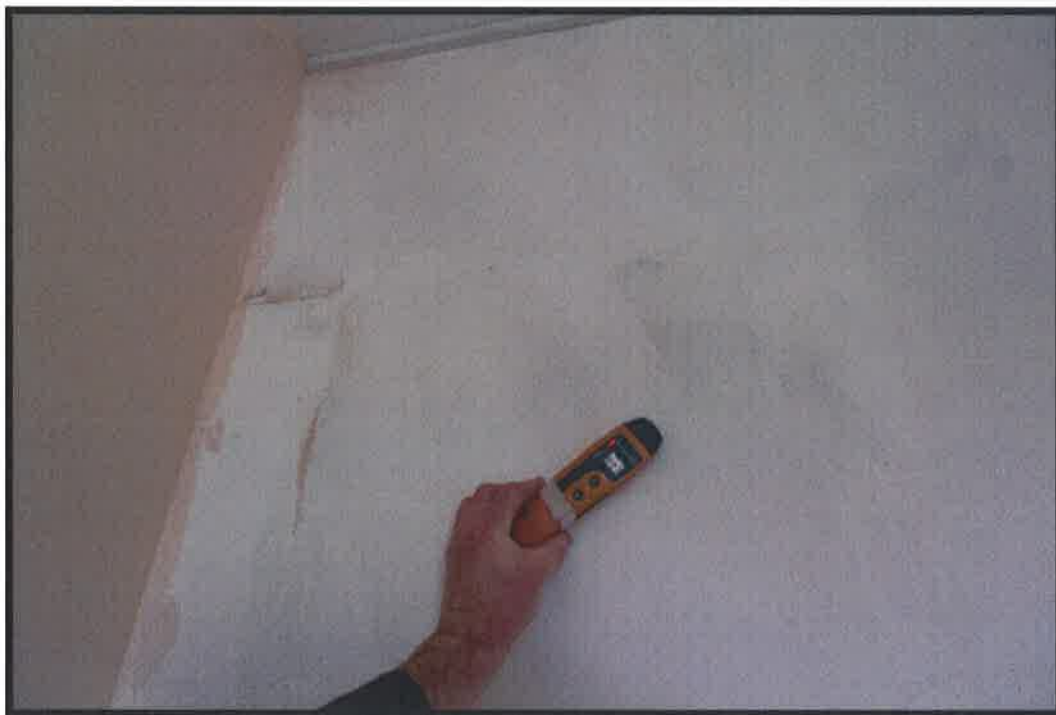
Figure 12 Kitchen - side wall adjoining bathroom, high level. Moisture meter reading (100%)

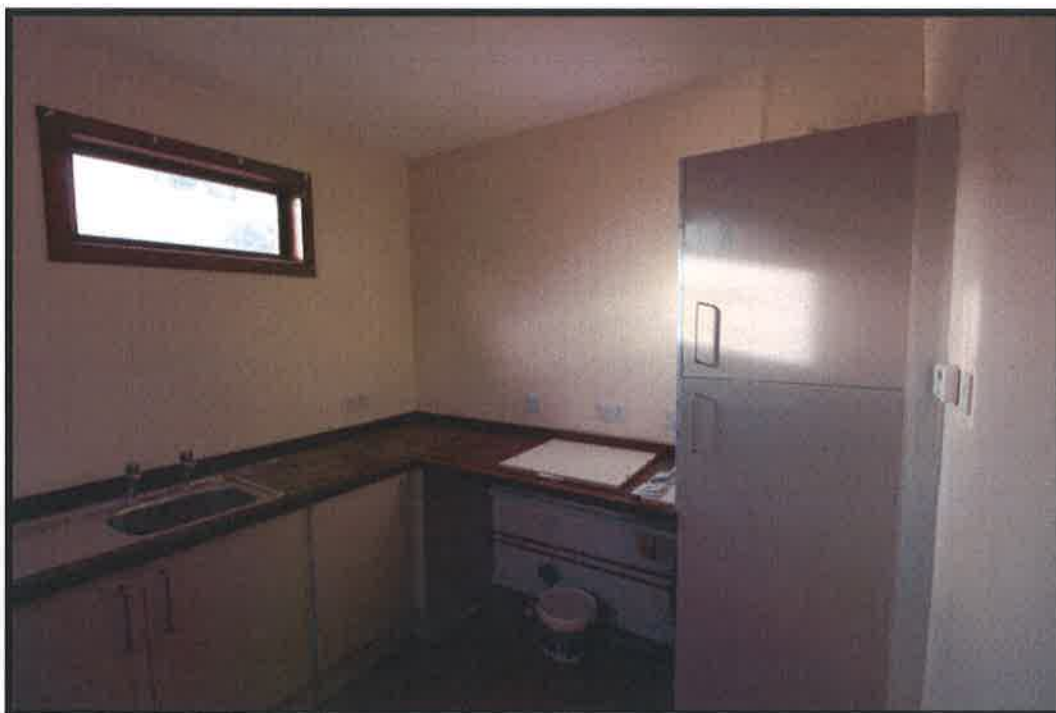
Figure 13 Former utility room, now kitchen overview

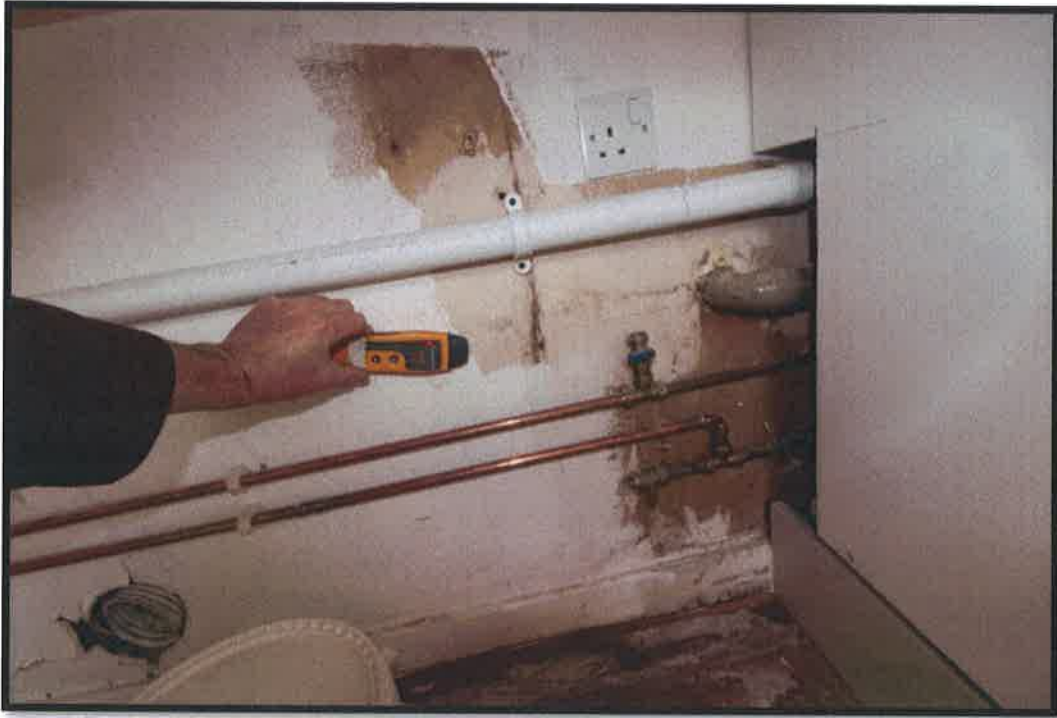
Figure 14 Former utility room/new kitchen - moisture meter reading (100%), as before.

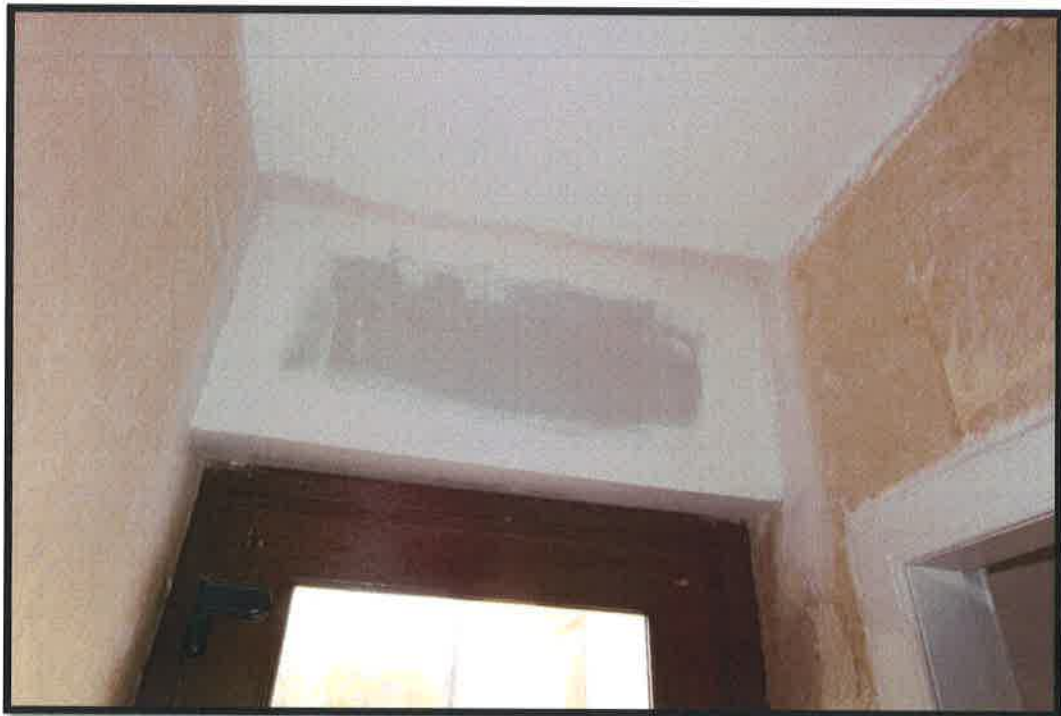
Figure 15 Rear hall - new plasterboard above rear entrance door.

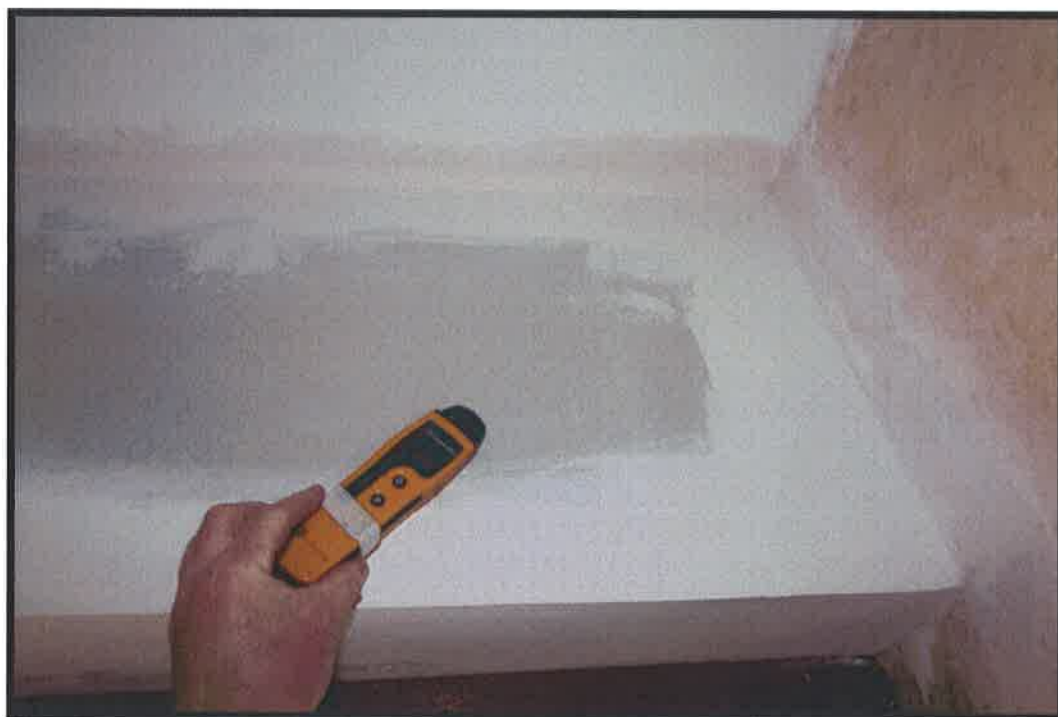
Figure 16 Rear hall - moisture meter reading (8%) (previously 100%).

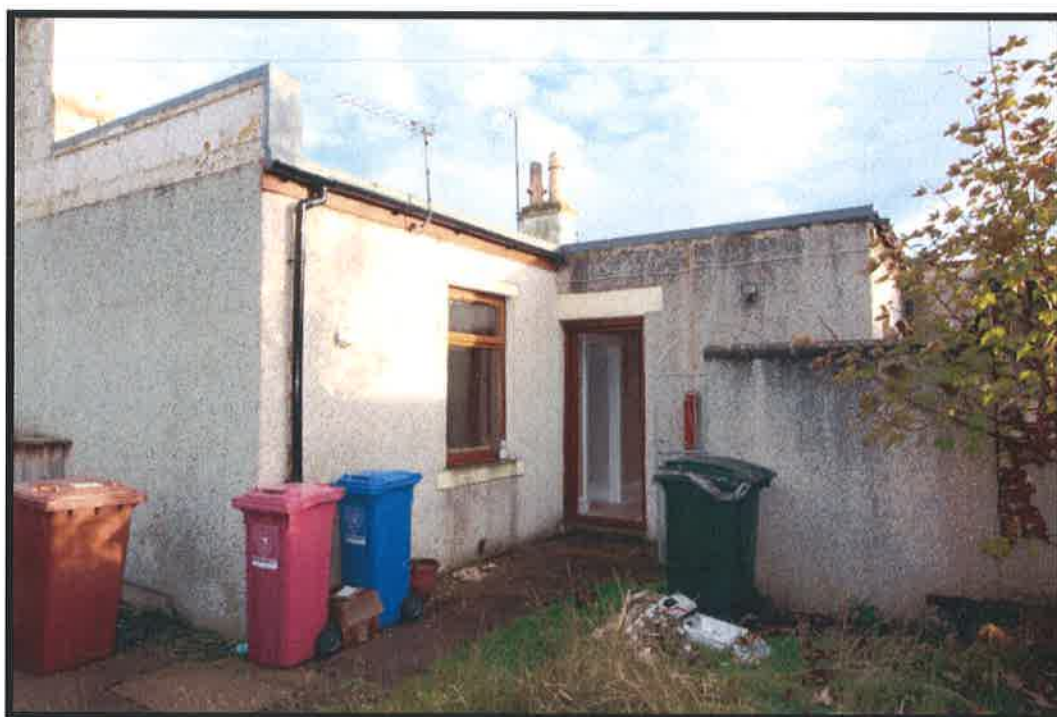
Figure 17 Rear entrance - as before.

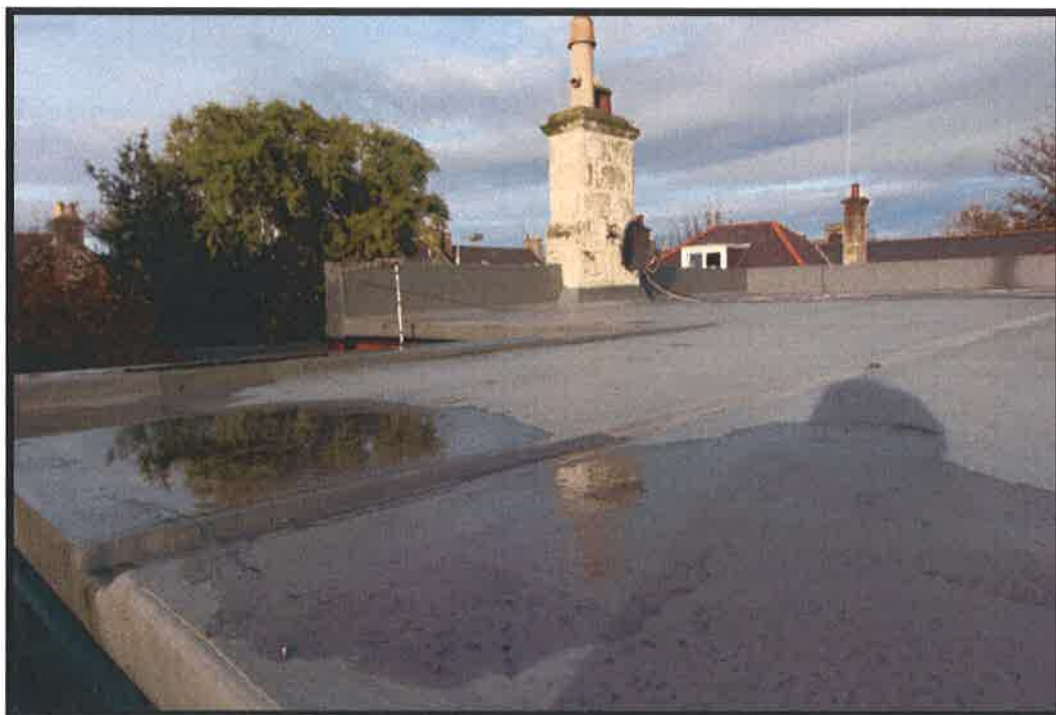
7. The Tribunal noted that some works had been carried out to the property however the majority were outstanding. This included the repairs to the roof which in the opinion of the Tribunal was the most significant aspect of the RSEO, being the root cause of the high moisture readings at the rear of the property.

Figure 18 Rear section of flat roof with ponding over bathroom, as before.

- (a) carry out such works as are necessary to the roof of the house and external walls to prevent water ingress;
- (b) repair or replace the damp and damaged wall linings in the kitchen and utility areas;
- (c) carry out such works as are necessary to clear all mould from the house; and
- (d) carry out internal decoration throughout the house following the completion of the aforesaid works.

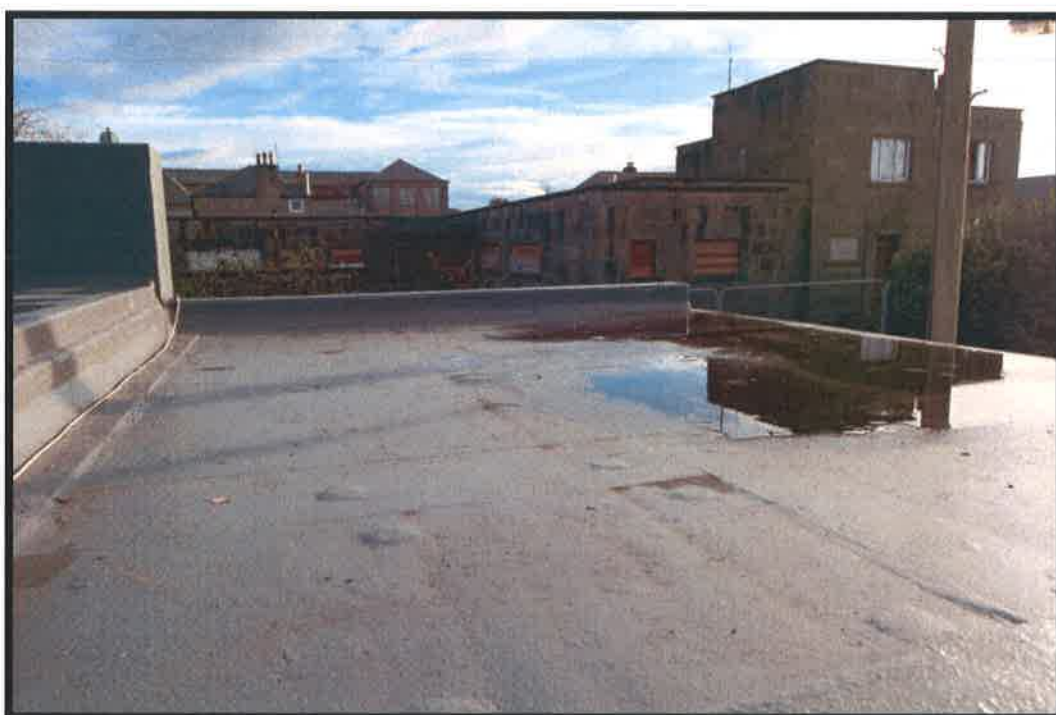
Figure 19 Rear section of flat roof over former utility room/new kitchen - as before.

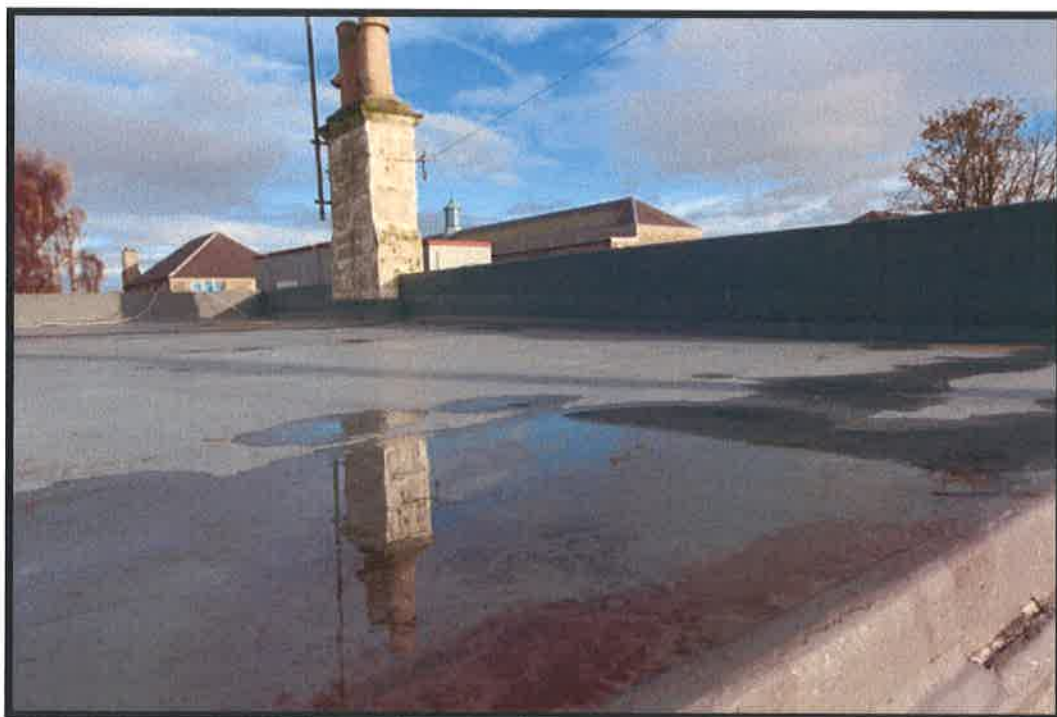
Figure 20 Rear section of flat roof at kitchen/utility room junction with ponding over former kitchen - as before.
