First-tier For Scotland (Housing and Property Chamber)

Chamber Reference: FTS/HPC/RP/17/0370

Property Address: 122/4 Duke Street, Edinburgh EH6 8HR

Inspection Report 18 December 2017 - Photographs

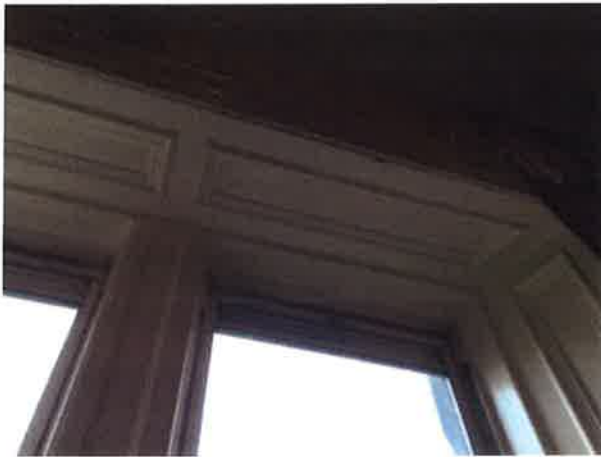
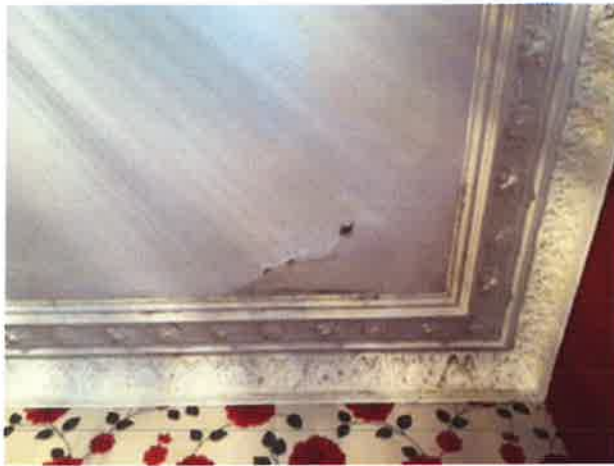
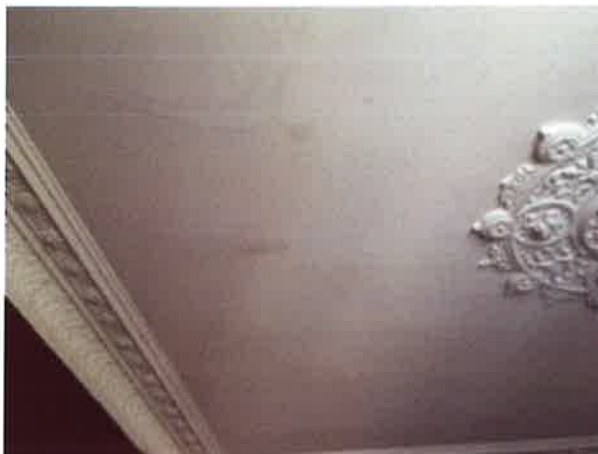
- a. That there was visible signs of water penetration in the ceiling of the livingroom and in the window surrounds.
- b. There was further evidence of water penetration in one of the rear bedrooms again around the ceiling and at the window. There was also evidence of water penetration in the remaining two bedrooms and in the hall.
- c. Damp meter readings in the livingroom confirmed an unacceptable level of dampness.

Living Room – Damp staining on timber soffit above window and on ceiling

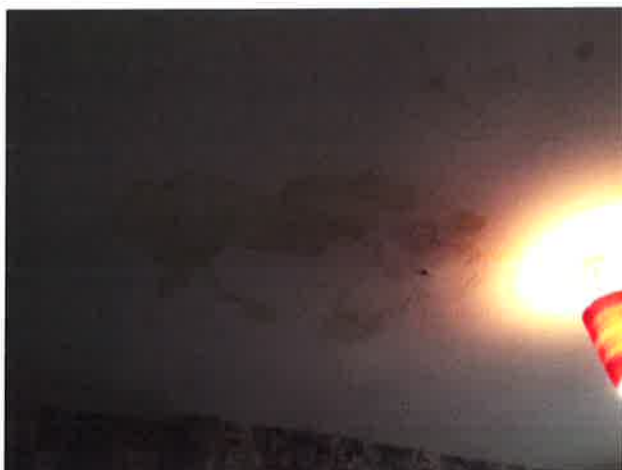
Bedroom 1 – south south west – damp staining on ceiling

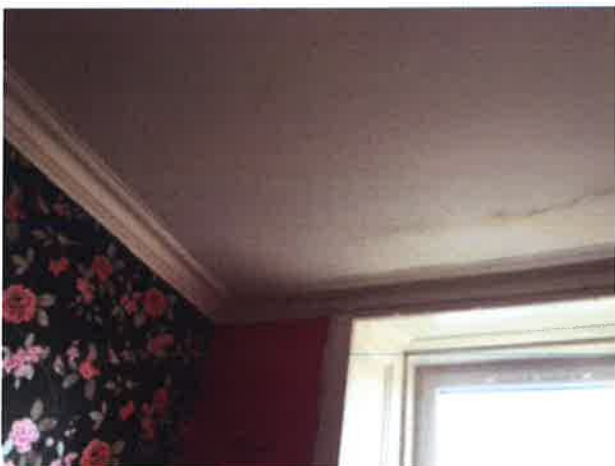
Bedroom 2 – south west – damp staining on ceiling above window

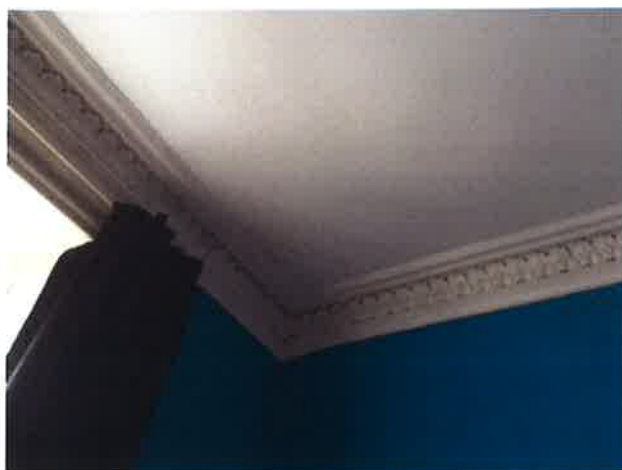
Bedroom 3 – north east – damp staining on ceiling in corner

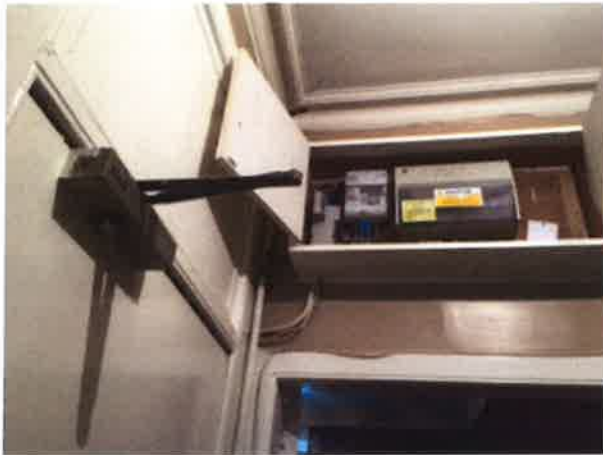
Hall – damp staining at ceiling corner above consumer unit at front entrance door
