First-tier Tribunal for Scotland (Housing and Property Chamber) ("the Tribunal")

STATEMENT OF DECISION OF THE TRIBUNAL UNDER SECTION 24(1) OF THE HOUSING (SCOTLAND) ACT 2006

**Property at 49 Bolivar Terrace, Glasgow G42 9AT (hereinafter referred to as
"the House")**

Chamber Ref: FTS/HPC/RP/17/0442

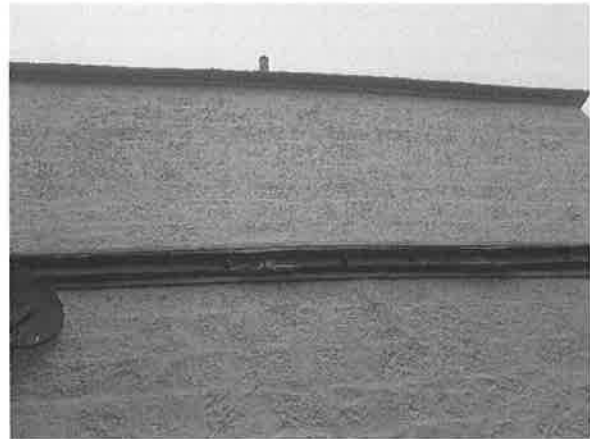
- 7 The inspection on 10 April 2018 revealed:
 - a. The House shows signs of structural movement. A steel beam has been inserted in the end gable in an attempt to address this.

1 Gable Elevation lateral restraint remedial works.

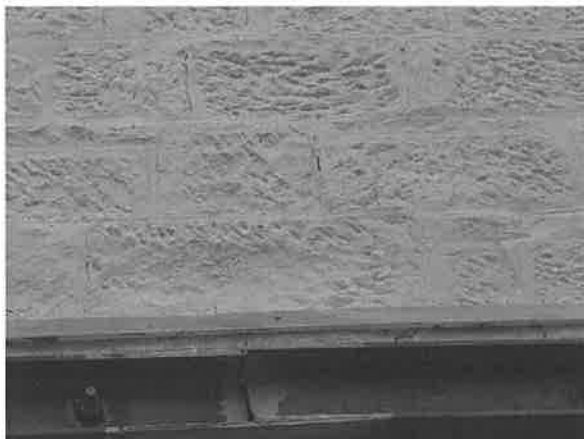
2 Cracking emanating above joint of steelwork restraint

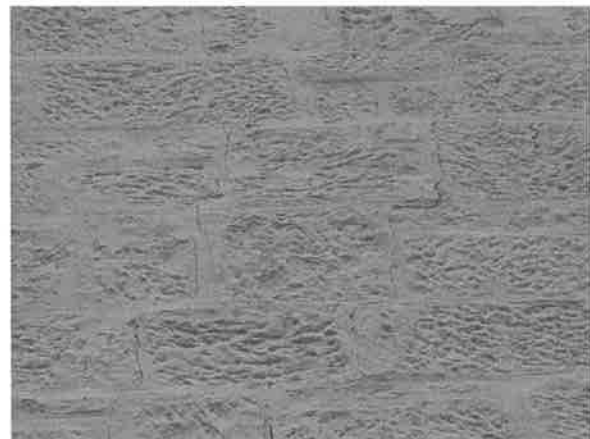
3 Stepped cracking to Gable Elevation.

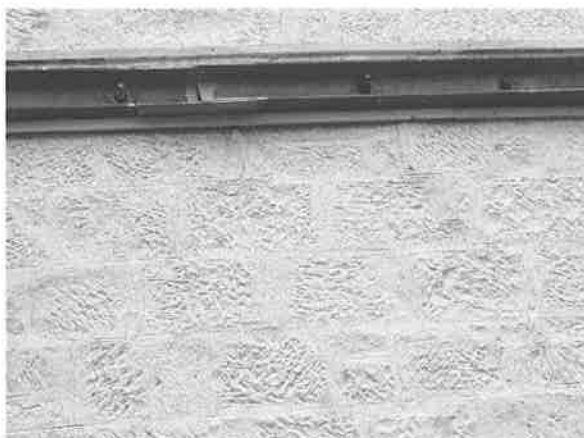
4 Further view of Gable restraint steel

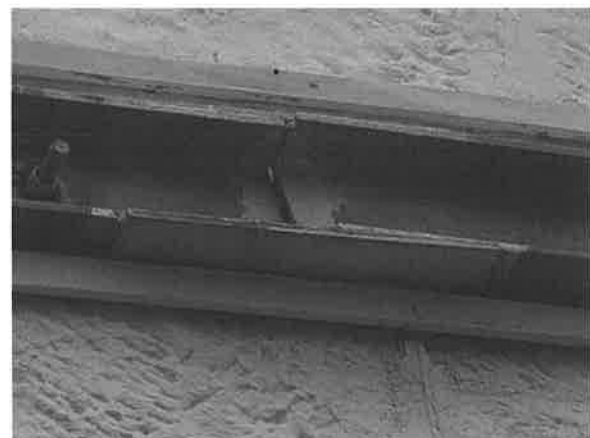
5 Joint of steel restraint.

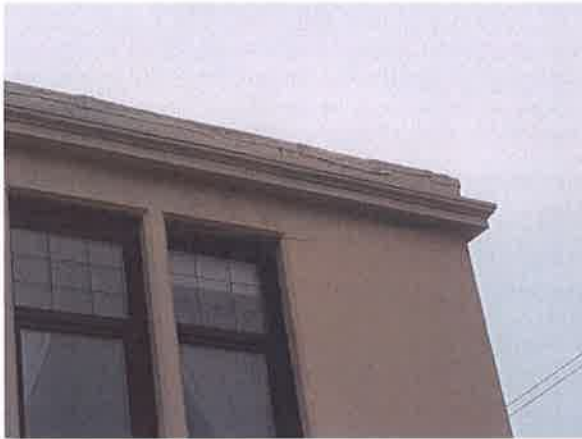
6 Uneven and poorly detailed lead to wallhead parapet.

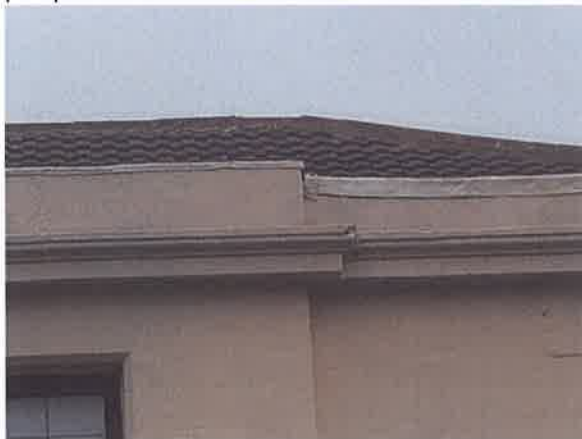
8 View of leadwork to wallhead and front roof pitch.

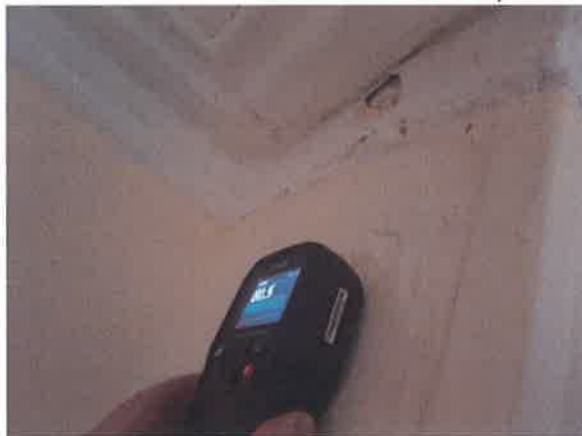
In the rear facing top level bedroom, very high moisture readings were noted in the alcove near the window.

10 High moisture readings to First Floor Rear Bedroom.

The Tribunal considers that the presence of high levels of dampness and the hole in the hall ceiling constitute breaches of the repairing standard. Accordingly, a Repairing Standard Enforcement Order should be made. Having regard to the fact that the House is unoccupied and the significant nature of the works required at the House, the Tribunal have allowed 180 days for the repairs to be carried out.

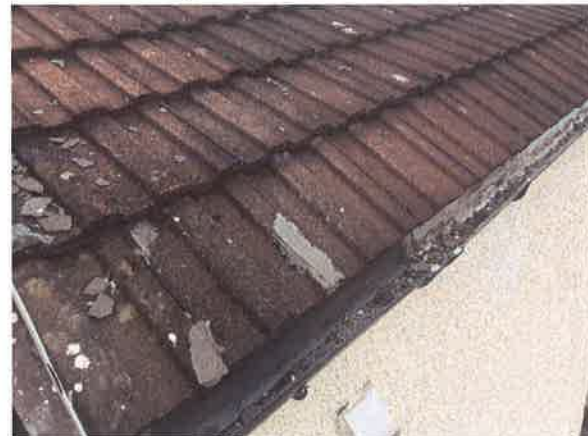
11 Interlocking tiles (patch repaired) to rear outshot.

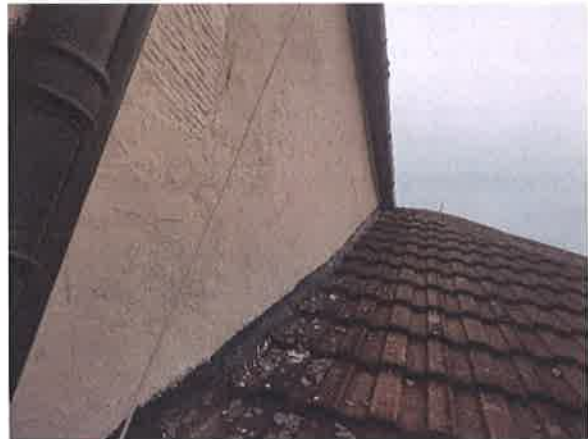
The exterior render was very poor and recent repairs seemed to be amateurish, ineffective repairs. The recent coating of water proof paint may aggravate problems as it will prevent the cement rich mortar used from "breathing".

13 Poor render to rear elevation above roof (boss under tap test).

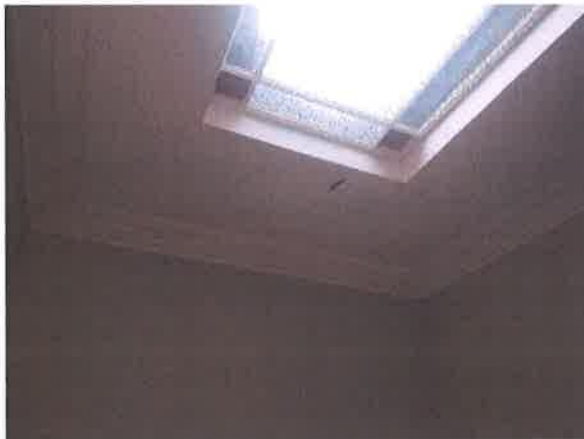
A hole is present in the hall ceiling adjacent to the sky light.

14 Damage to ceiling surmounting staircase.

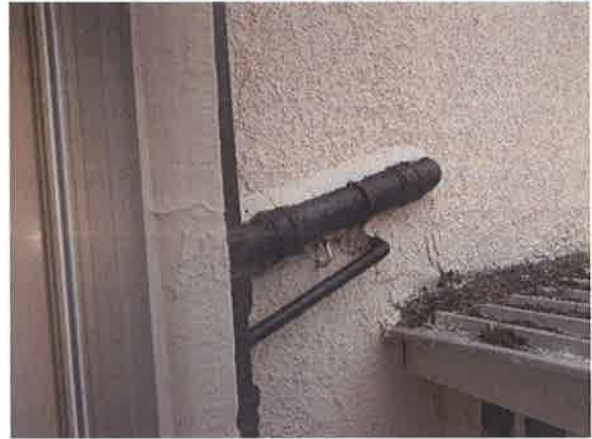
19 Cracking to render of Bathroom external wall.

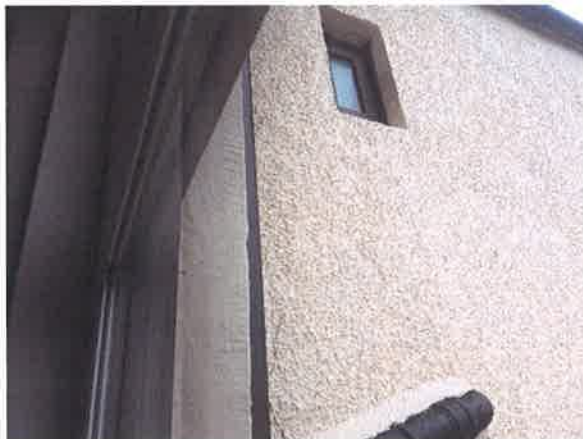
20 Cracking to render of Bathroom external wall.

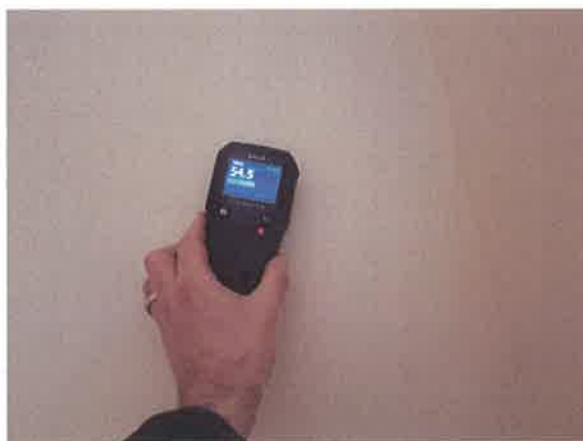
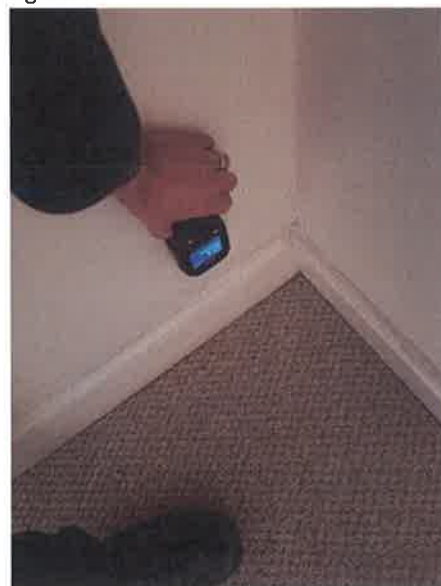
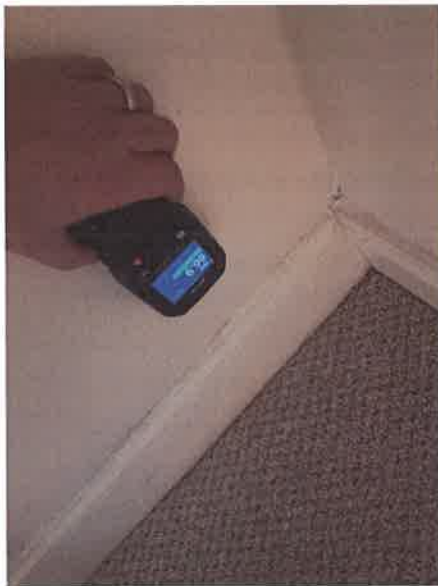
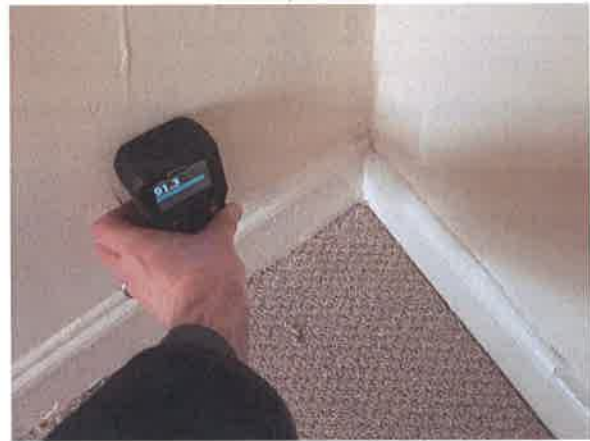
In the kitchen and dining room, high moisture readings were present at the lower levels of the walls.

22 High moisture readings within Dining Room.

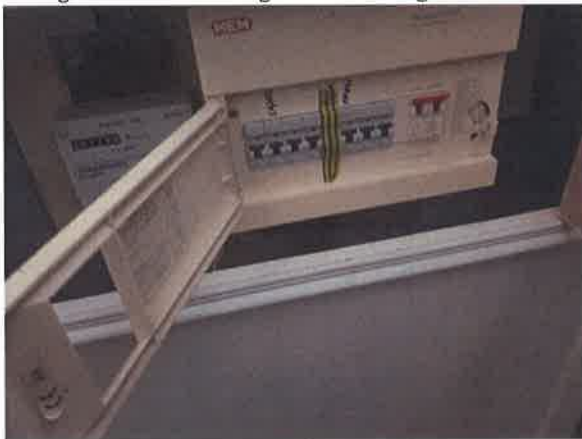
The electrical consumer unit casing is cracked; a number of double glazing units have failed; the stairs leading into the kitchen have moved and are unsafe; the outbuildings are in very poor repair and may be unsafe; controls are missing from the boiler.

26 Consumer unit – cracked/damaged.

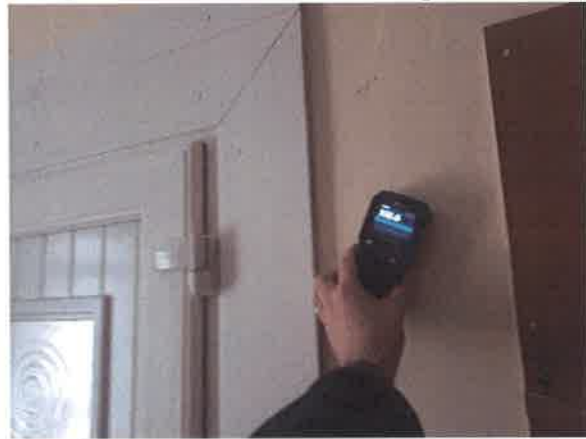
27 High moisture readings within Kitchen.

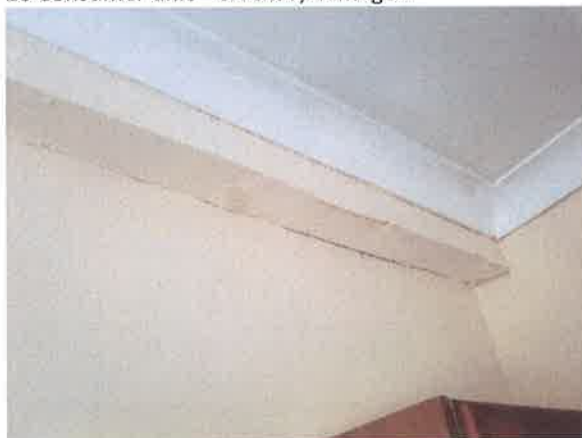
28 Water staining within Kitchen to boxing.

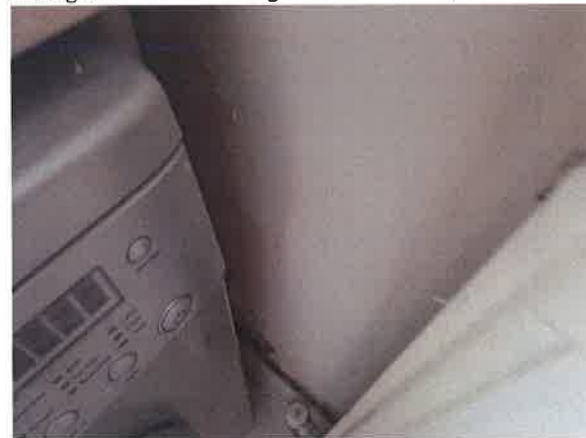
29 Low level dampness to Kitchen and defective plaster.

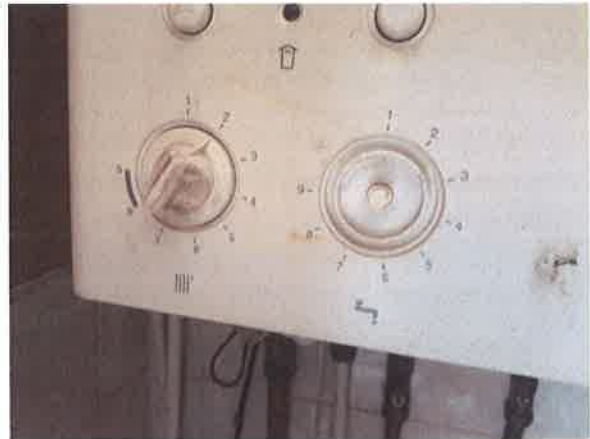
31 Damaged knob control.

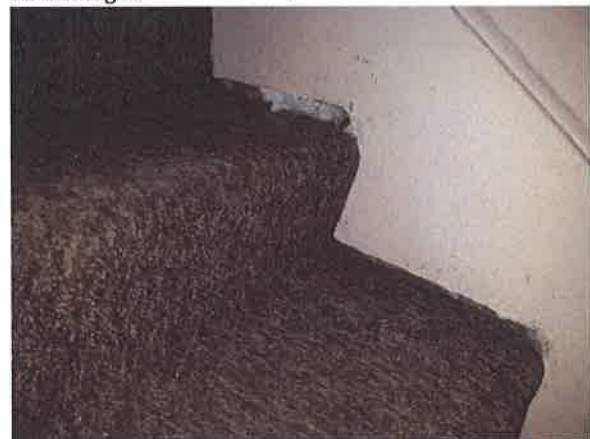
- g. The electrical consumer unit's casing is cracked.
- h. The stairs leading to the kitchen have been affected by structural movement and are unsafe.
- i. The render to the exterior walls is in poor condition.

33 Dropped staircase to Kitchen.

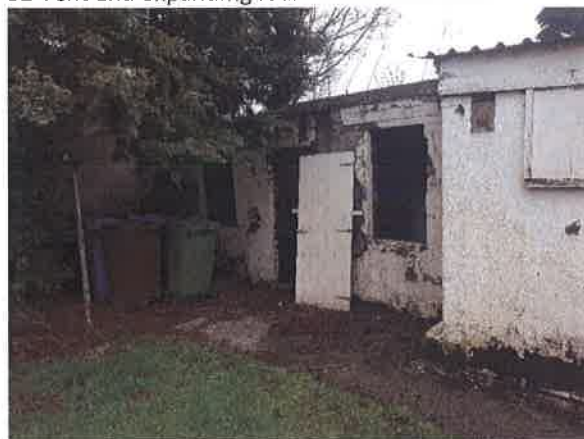
35 Outbuildings.

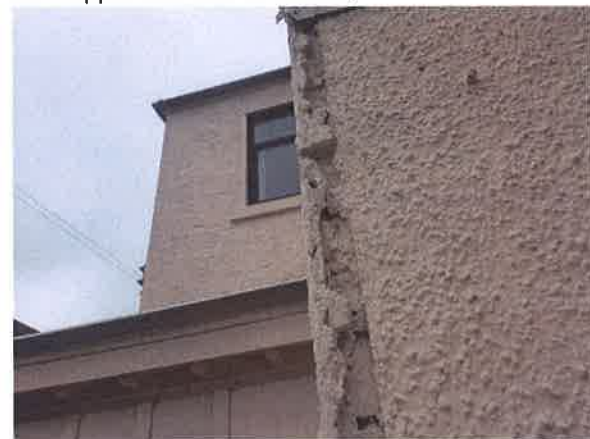
36 Damage to render.
