Statement of Decision on an application under Section 24 (1) of the Housing (Scotland) Act 2006

Chamber Ref: FTS/HPC/RT/18/3133

11 Ware Road, Peterhead, AB42 1NQ ("the Property")

Initial Inspection : Schedule of Photographs

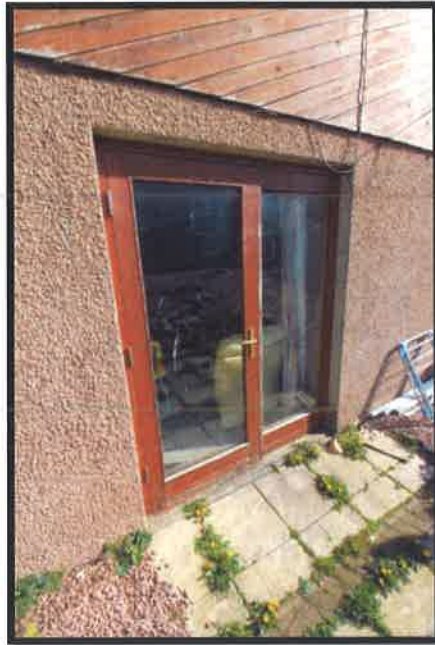
Figure 2 Lining Room French Doors - External.

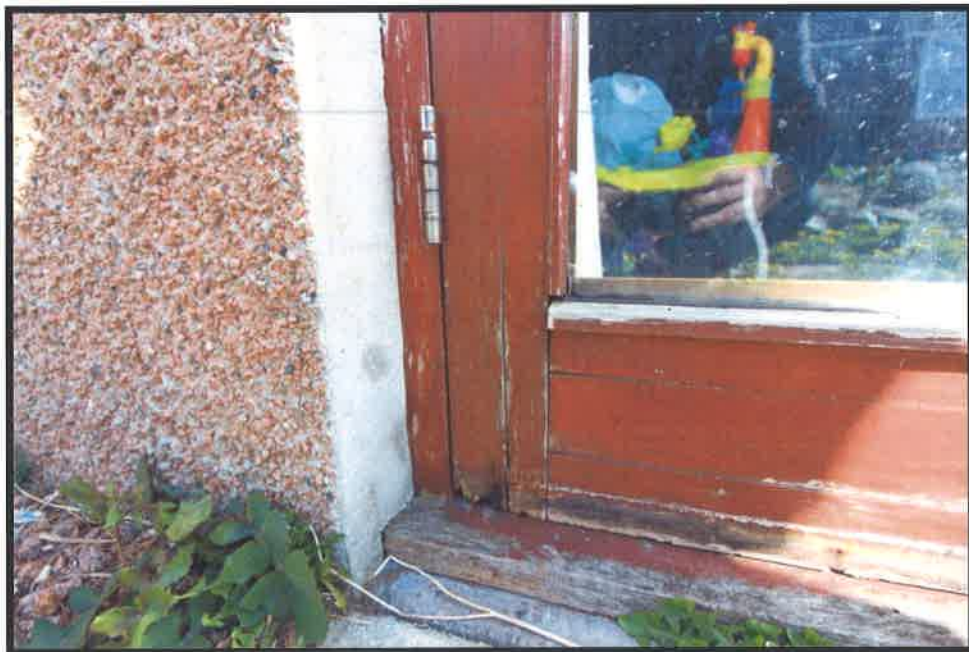
- The downstairs second bedroom window was not properly wind and watertight nor capable of being opened and closed correctly.
 - The doorframe and casement of the French windows in the living room were in poor order and there was evidence of joints opening. There was water ingress into the interior of the property, a misted pane of glass and window beading coming away.

The Tribunal inspected the French doors in the living room. These were dated and showing signs of wear and tear. There was evidence of water penetration into the internal lining of the door. The Tenant had placed a piece of flooring over a part of the bottom of the frame to try and stop wind and water coming in. An external inspection showed decay to both the frame and the casement. There was evidence of joints opening. There was also evidence of the window beading coming away internally and there was a misted pane of glass on the left hand side panel, as viewed internally. The Tribunal was satisfied that the French doors did not meet the repairing standard and that repair work would be required to ensure that they were properly wind and watertight.

Figure 3 French Doors - decay and open joints.

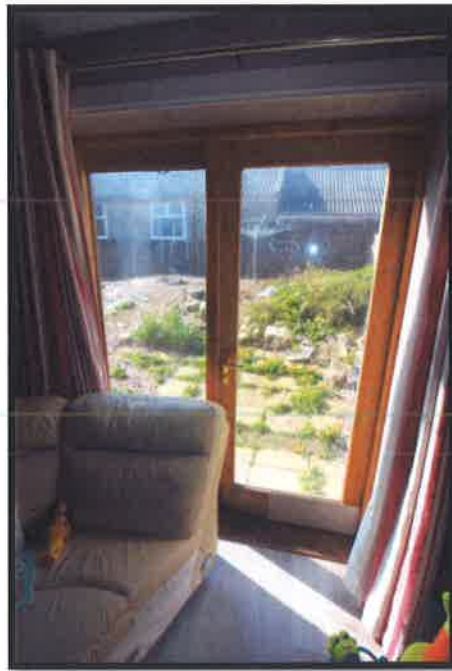
Figure 4 Lining Room French Doors internal - frame patched, misting to left pane.

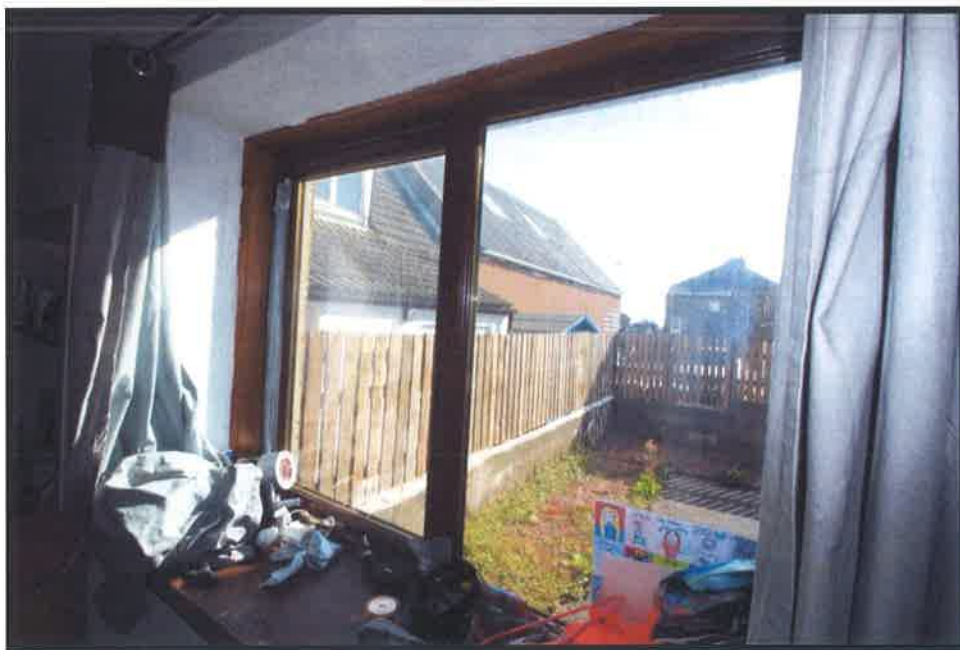
10. The Tribunal found the following facts to be established:-
- The main bedroom window downstairs was not properly wind and watertight nor in proper working order.

Figure 5 Main Bedroom window.

11. The Tribunal based its decision primarily on the evidence obtained during the course of the inspection of the Property. The Tribunal first inspected the downstairs windows. The window in the main bedroom downstairs appeared to be ill-fitting. The Tenant had attempted to seal up the various gaps with tape and silicon. The Tribunal was able to feel the air coming through the window on the day and was therefore satisfied that the window was not properly wind and watertight and would require to either be repaired or replaced to render it compliant with the repairing standard.

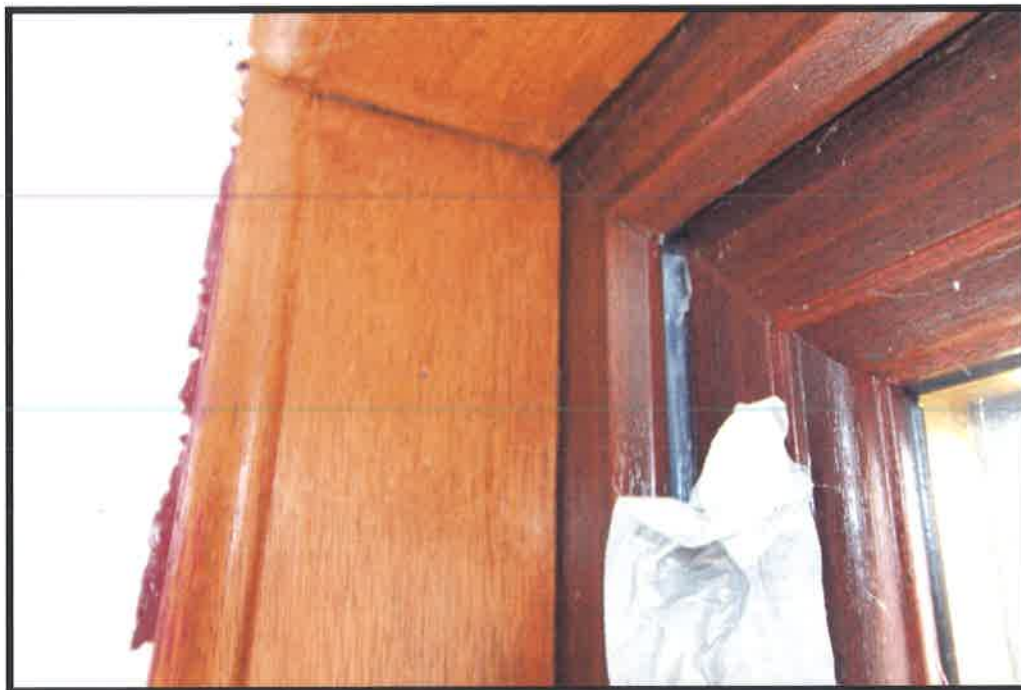
Figure 6 Main Bedroom window - gap at frame filled with silicon and duct tape

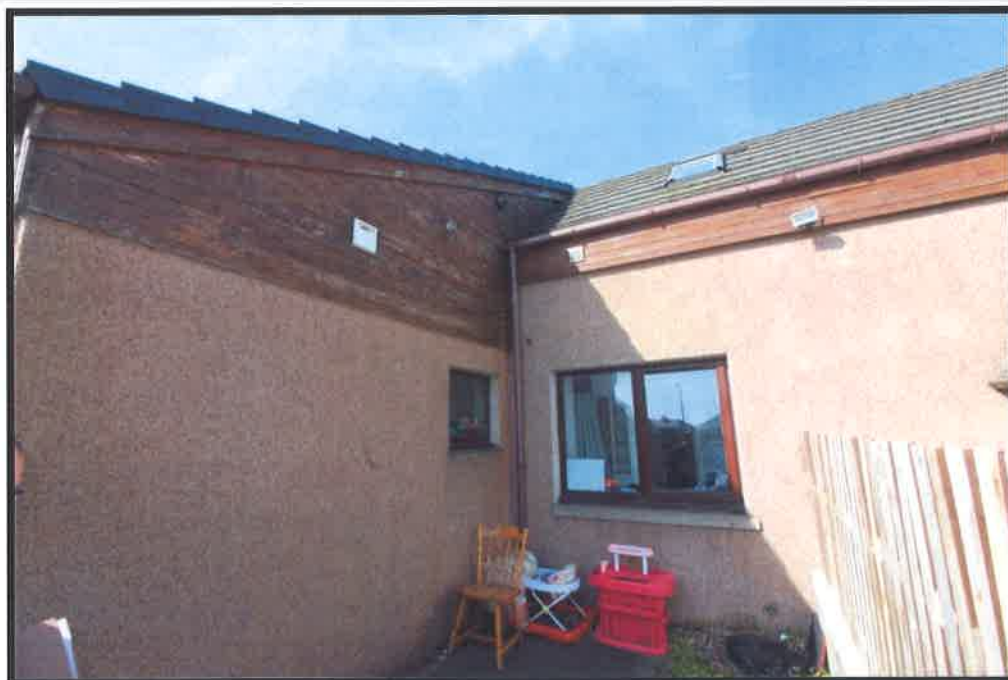
Figure 7- Main Bedroom and Kitchen windows, external.

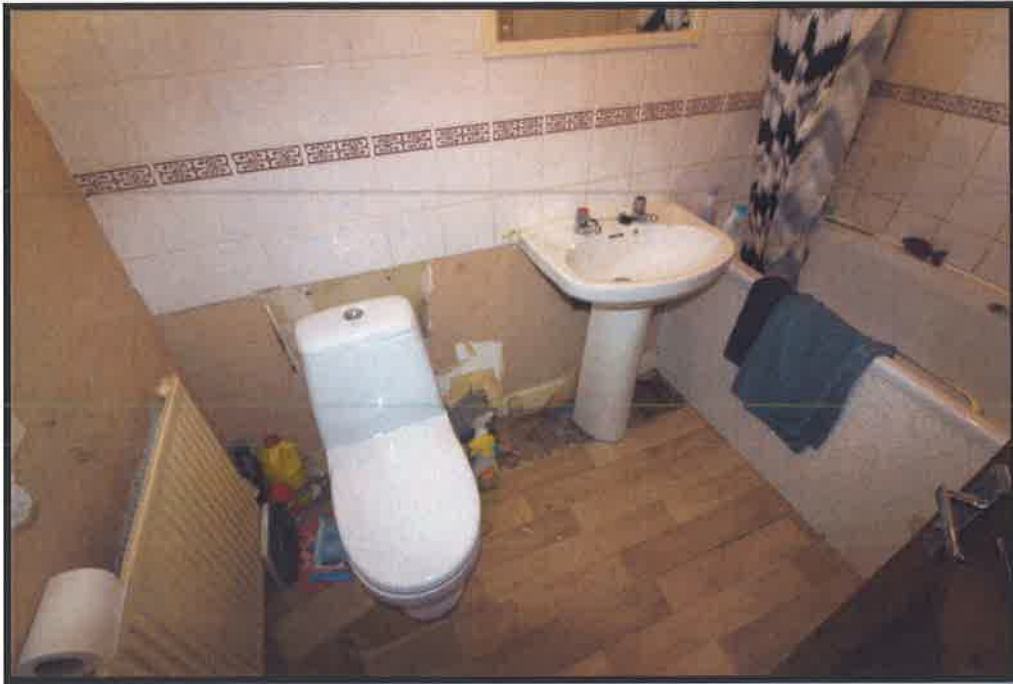
Figure 8 Main Bedroom Bathroom - overview.

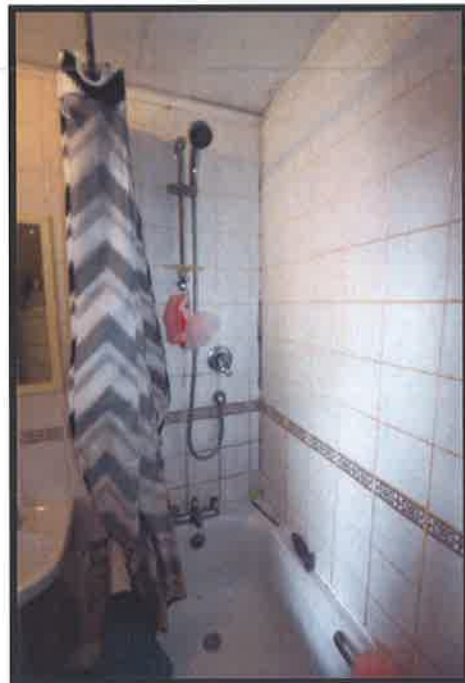
Figure 9 Main Bedroom Bathroom - bath/shower.

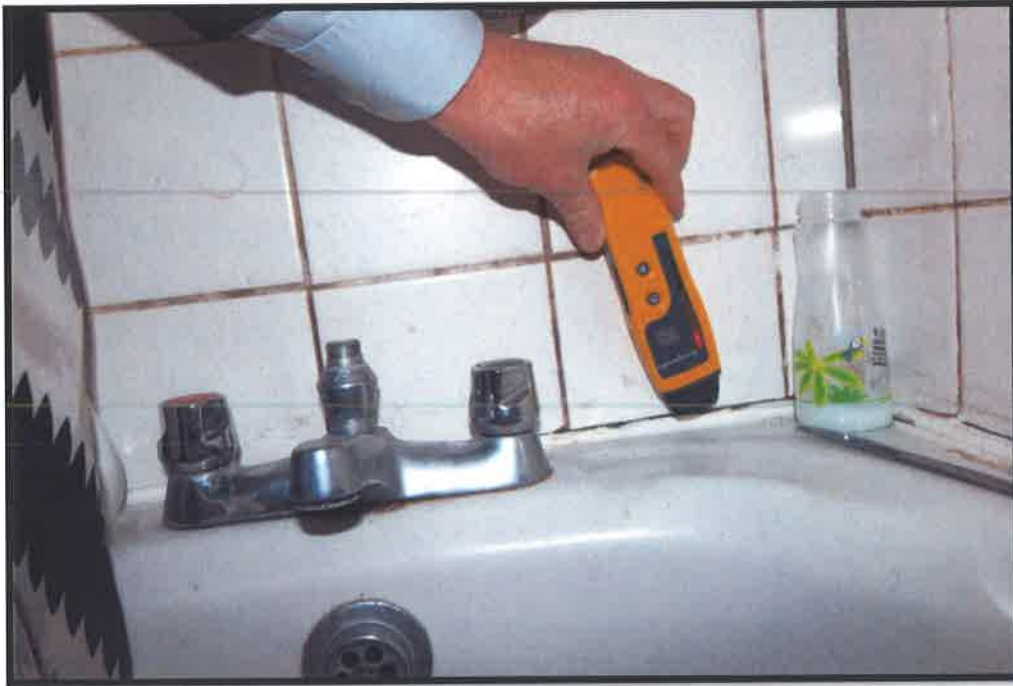
- The extractor fan in the en-suite bathroom was not working. There was mould growth and peeling paint present.
 - There was evidence of damp around the en-suite bath behind the tiles as well as evidence of insect infestation.

The Tribunal used a damp meter around the bath and this indicated that there was damp behind the tiles just above the bath. There were some small holes around the base of the bath, although the Tenant appeared to have partially sealed these up with silicon. There was some evidence of infestation by woodlice on the day and the Tribunal was satisfied that the Landlord would require to carry out further investigatory works to ascertain whether there was rot behind the bath (there was evidence from the inspection of the main bathroom, which backed on to the en-suite, that the joists beneath the en-suite bath may be rotten). Generally the Landlord would require to carry out such works as were necessary to make good the bath and to render it compliant with the repairing standard and to re-grout the area around the bath.

Figure 10 Main Bedroom bath - Moisture meter reading 81.9%/Red.

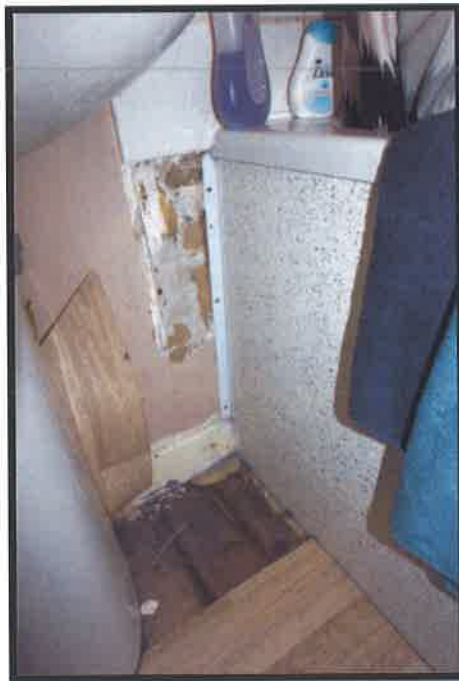
Figure 11 Main Bedroom bath - gaps sealed with silicon.

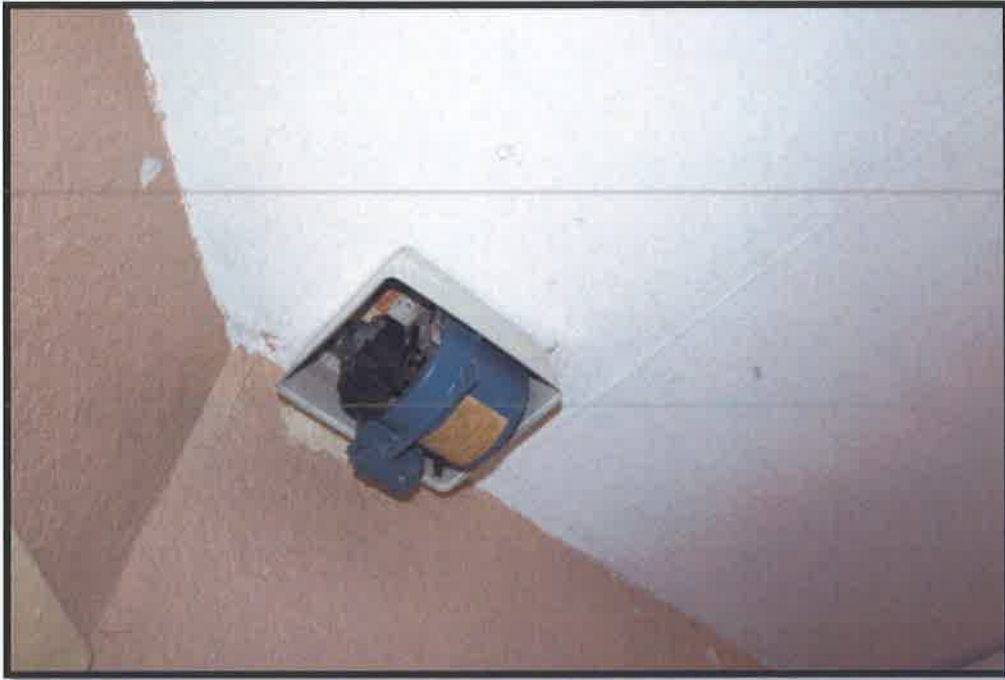
Figure 12 Main Bedroom Bathroom - extractor fan inoperative and cover removed.

The Tribunal then inspected the en-suite bathroom. The extractor fan did not appear to be in working order and it was not clear how this vented externally. The Landlord would require to ensure that the extractor fan was either repaired or replaced and put in proper working order. It would also require to be checked that it was venting properly. As a result of the fan not working combined with the lack of any other form of external ventilation, there was evidence of mould growth in the bathroom and peeling paintwork. This would require to be addressed by the Landlord when carrying out other works.

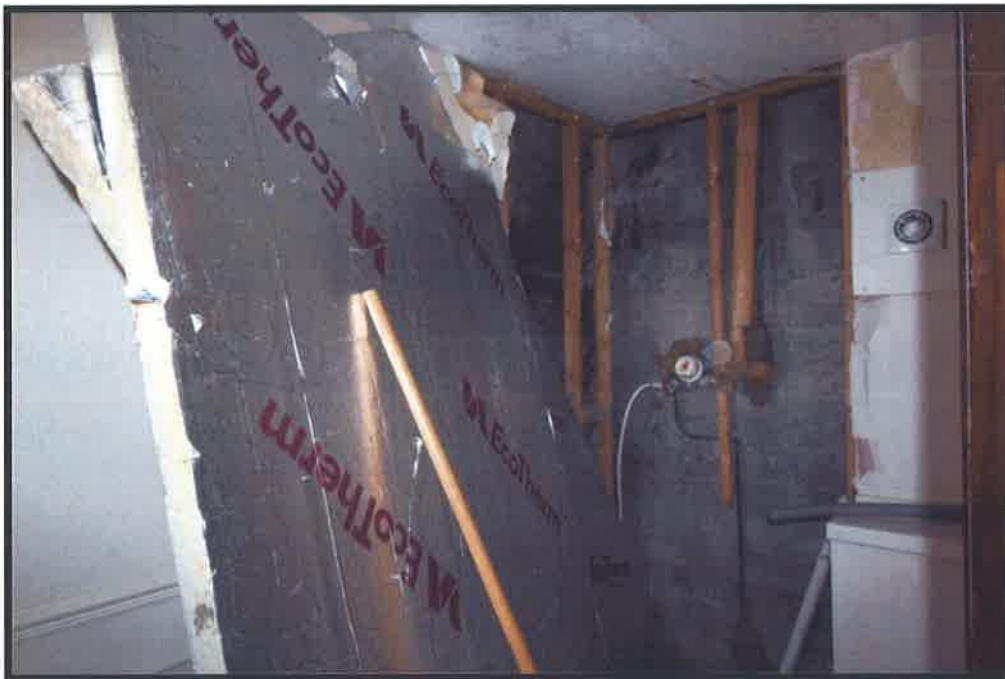
- The main bathroom fell well short of meeting the repairing standard. There were no wall linings and the shower required to be reinstated.
 - The Property did not meet the required standard for fire detection as there was no smoke alarms in the upstairs landing and lounge.

Figure 13 Main Shower Room - Shower enclosure missing, bare walls exposed.

The Tribunal then inspected the main bathroom. The Tenant indicated that when she moved in to the Property the bathroom was in its current state. There had been a flood or leak in the bathroom previously and it had been badly damaged. The Landlord had begun to carry out further works to repair it and had promised the Tenant in 2016 that he would finish off the works shortly after she moved in. The Tribunal had no reason to doubt the evidence by the Tenant in this regard and no evidence to the contrary was produced by the Landlord. The Tenant was entitled to a proper bathroom. The Tenant and her children and any visitors to the Property all required to use the en-suite in the main bedroom. This was unsatisfactory and the Tenant was entitled to a working bathroom. The wall linings were exposed in the bathroom, there were no floor coverings and the shower had not yet been installed. The toilet and sink in the bathroom did appear to be in working order. However, overall the Landlord would require to reinstate the bathroom wall linings, carry out redecoration, install the shower and generally render the bathroom compliant with the repairing standard and to decorate accordingly.

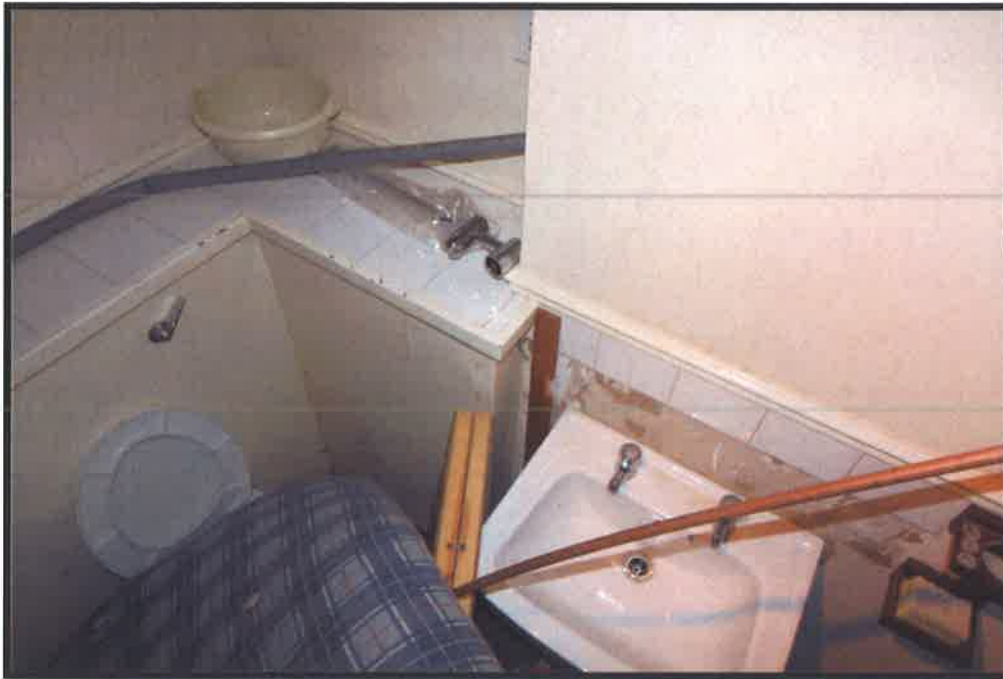
Figure 13 Main Shower Room - Overview of fittings.

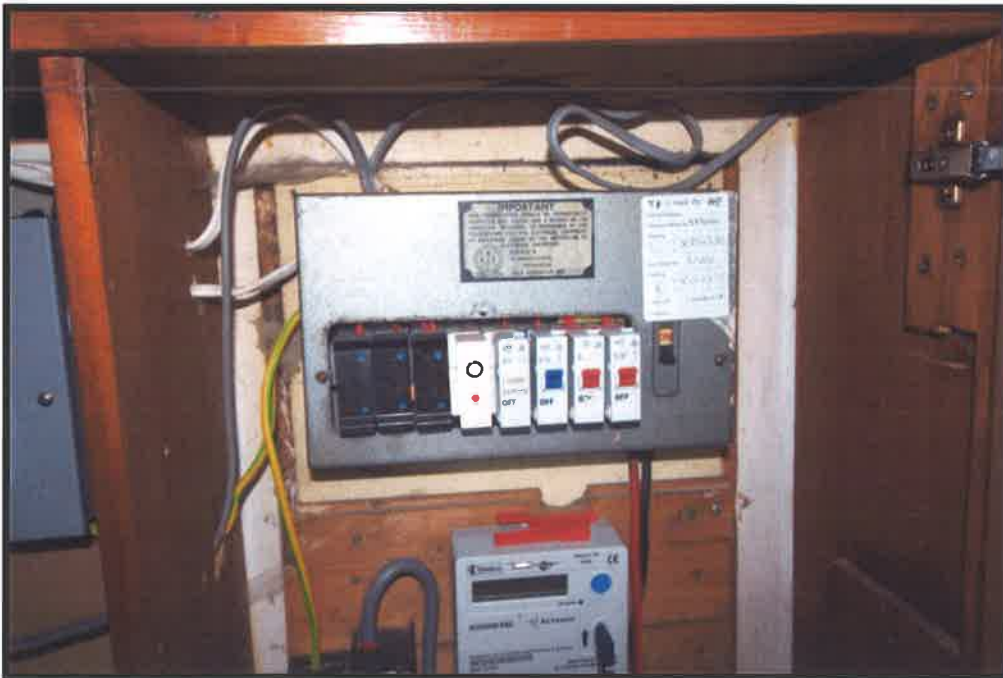
- The Tribunal found that there was insufficient evidence to show that the electrical installation within the Property did meet the repairing standard.

Figure 14 Electrical switchgear (Right Hand).

The Tribunal considered the electrical safety within the Property. Again it was a statutory requirement to have an electrical installation condition report and the Landlord did not appear to have this. The Tribunal noted evidence from the Tenant that a large number of the bulbs blew on a regular basis. They also noted that the extractor fan was not working. In the upstairs hall and bedroom the Tribunal noted that there were halogen bulbs fitted and they were very close to being flush to the ceiling. It was normal for there to be a gap between the back of the bulb and the ceiling to ensure that there was heat dissipation. This did not appear to be the case. The Tribunal noted that the fuse box was dated and that there was no RCD present. In the circumstances the Tribunal was of the view that it was not possible to say with any confidence that the electrical system within the Property was safe and in proper working order. Accordingly the Landlord would require to obtain an electrical installation condition report from a suitably qualified electrician confirming that the electrical system within the Property was safe. The certificate should not have any items that are marked "C1" or "C2". Any such items falling in to this category would require to be rectified by the Landlord.

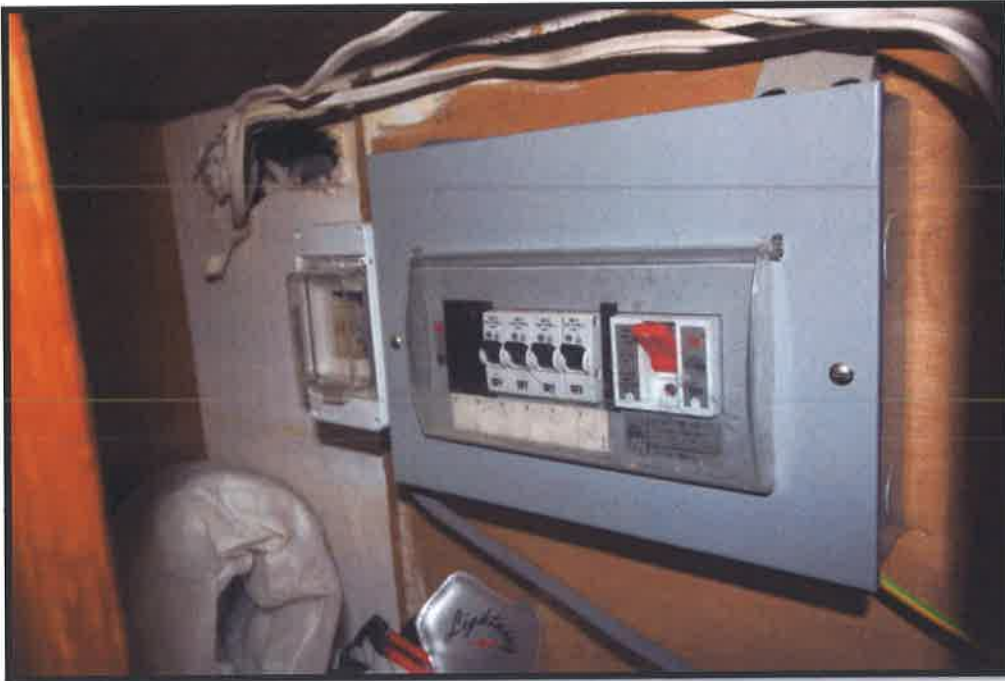
Figure 15 Electrical Switchgear (Left Hand).

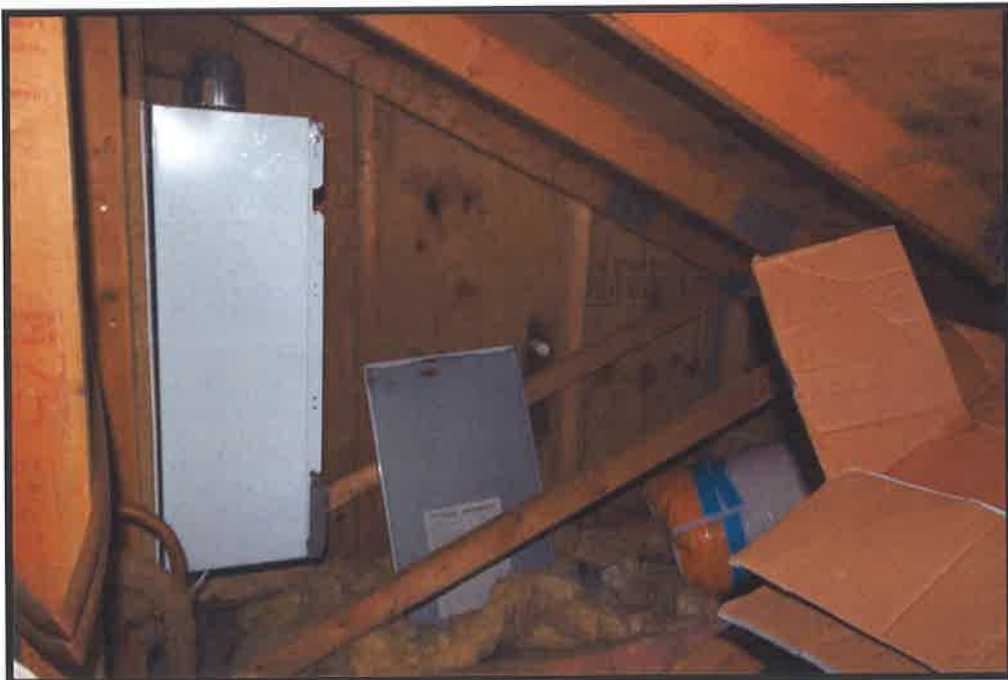
The Tribunal considered the position in relation to gas safety. The boiler was located in the eaves roofspace. It was accessed by unscrewing a small hatch. It did not appear to the Tribunal to be a safe method of access and the Tribunal was not prepared to carry out

a detailed inspection by crawling over the eaves joists. However from a visual inspection there was evidence of rust and corrosion around the boiler. The Tenant indicated that she required to top up the pressure within the boiler on a weekly basis. No gas safety certificate had been produced recently. The Tenant had obtained a quote to get a new boiler installed but the Landlord had refused to pay for its replacement. The Tenant advised that a gas engineer had previously advised that the boiler be replaced as it was extremely dated. The Tribunal accepted the evidence of the Tenant that she required to top up the pressure on a weekly basis. This suggested to the Tribunal that the boiler was not in proper working order. There was also the visual evidence of rust and corrosion around the boiler. It is a requirement to let a private rented property that a current gas safety certificate is held at all times. The Landlord did not appear to have a gas safety certificate and the Tribunal would therefore require to have sight of a current gas safety certificate showing the gas system within the property was fully compliant.

Figure 16 Central Heating boiler.

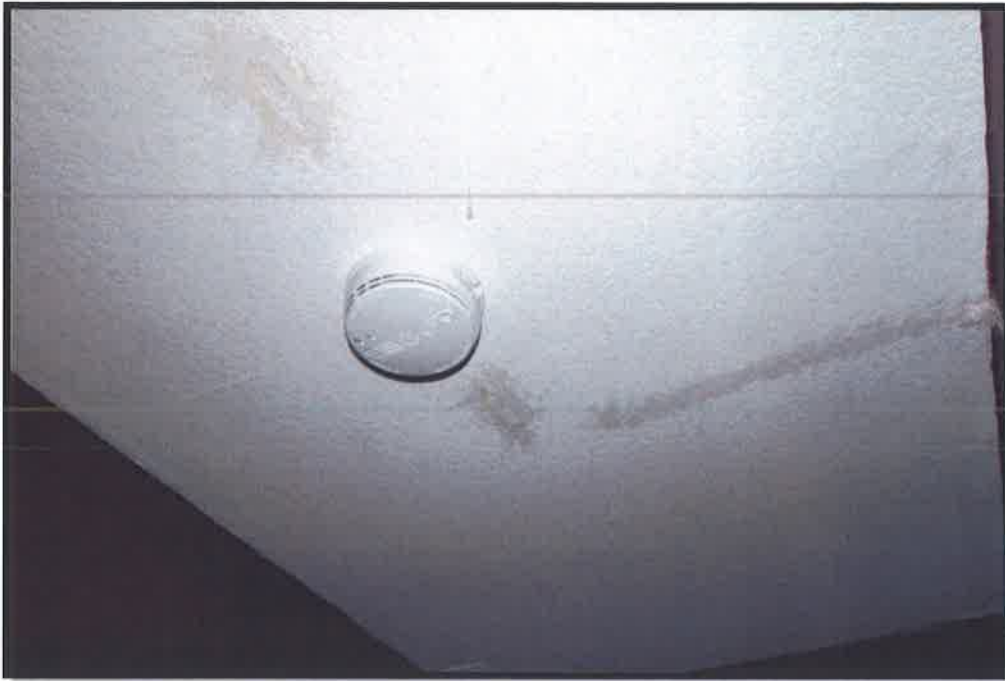
The Tribunal inspected the Property for fire detection. There was a heat detector in the kitchen and smoke detectors in the two downstairs halls. These were hardwired and interlinked. However the regulations require a hardwired and interlinked smoke alarm in both the lounge and the upstairs landing and neither of these were present. Accordingly the Landlord would require to have these installed. Although present on the application form, this item was not part of the formal complaint notified to the Landlord, the Tribunal did note that there was no carbon monoxide alarms present and would expect these would be installed in the appropriate locations as contained in the statutory guidance.

Figure 17 Inner Hall - Smoke alarm.

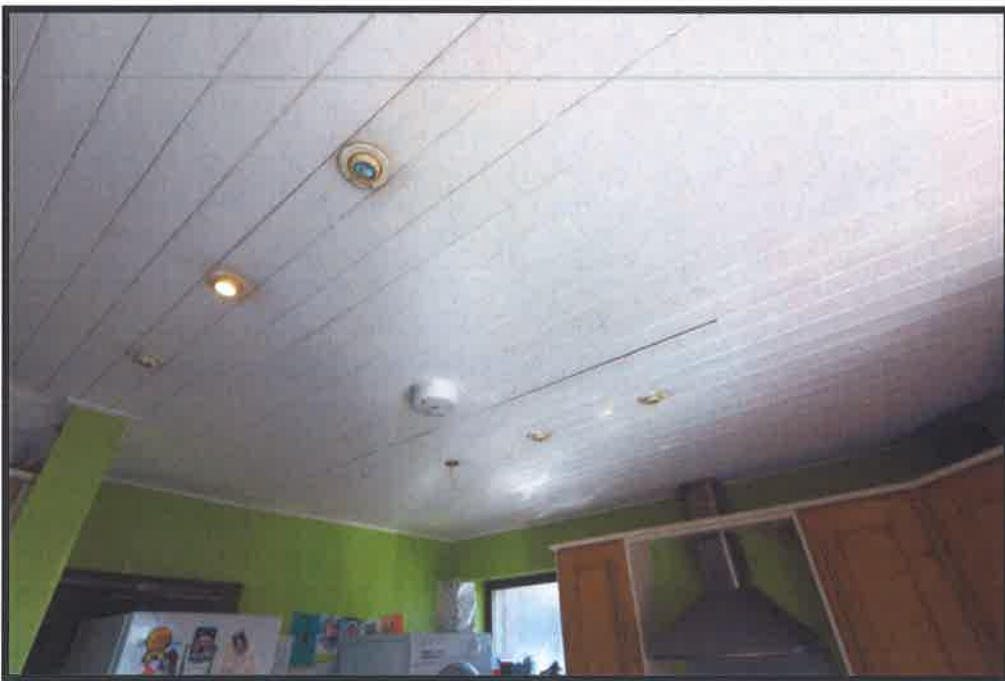
Figure 18 Kitchen Ceiling - Heat detector and lighting.
