**Statement of Decision of the First-tier Tribunal for Scotland  
(Housing and Property Chamber) under section 60(5) of the  
Housing (Scotland) Act 2006**

**Chamber Ref: FTS/HPC/RP/22/4470**

**54 Shore Road, Stevenston, KA20 3LP being the subjects registered in  
the Land Register of Scotland under Title number AYR97237 ("the  
Property")**

**Schedule of Photographs taken at the inspection on 21<sup>st</sup> April 2023**

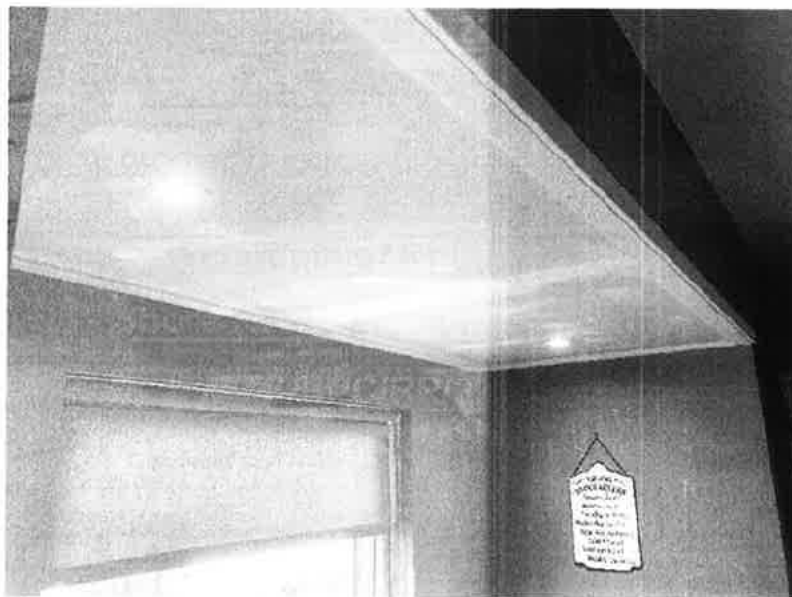
The ceiling above the sink unit had been replastered, the recessed light fittings were functional and there was no evidence of any water ingress or damp.

6.2.1 The kitchen ceiling had been repaired and it was in a reasonable state of repair.

6.2.2 Downlights had been installed in the kitchen ceiling and they were in proper working order.

The kitchen ceiling was in a reasonable state of repair.

2. Kitchen ceiling and "down-lights"

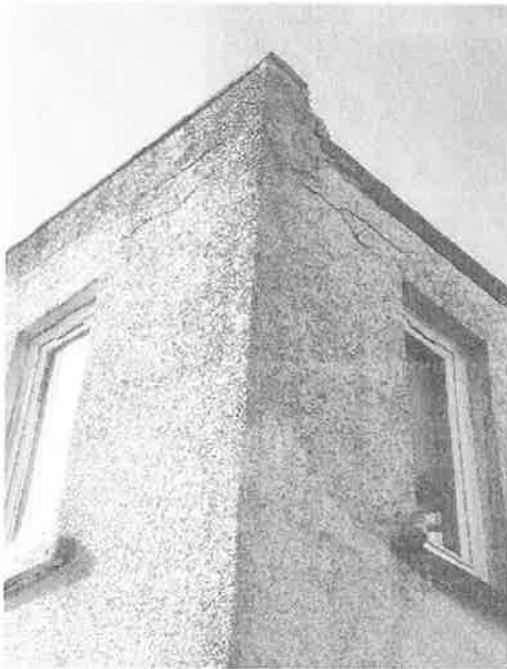
Around the first floor rear bedroom within the two storey projection, former holes and some cracks had been infilled with expanding foam. There was no evidence of water ingress in this area although externally areas of bossed and cracked render remained.

6.2.3 The render on the rear north most elevation of the Property was cracked and bossed in places. Some of the cracks had been filled with expanding foam. There was a remaining hole in the render.

3. Expanded foam filled former hole above rear bedroom

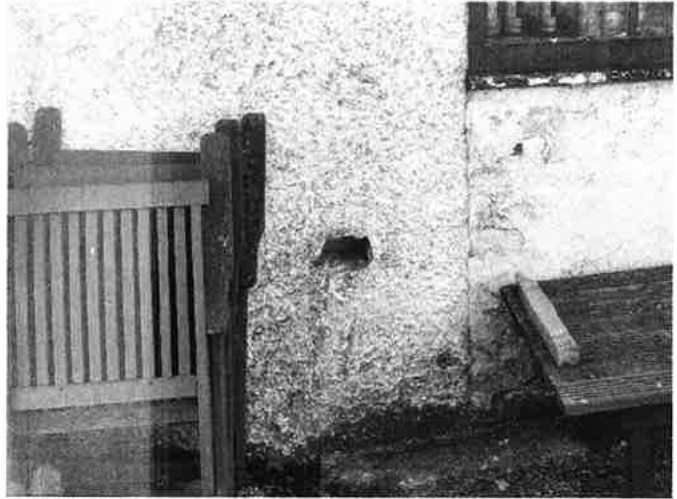
Within the utility/kitchen projection there was a missing/defective brick in the external wall although internally there was no corresponding evidence of water ingress or damp.

The hole in the external render to the rear of the Property results in the render not being in a reasonable state of repair and proper working order.

4 Hole in kitchen wall

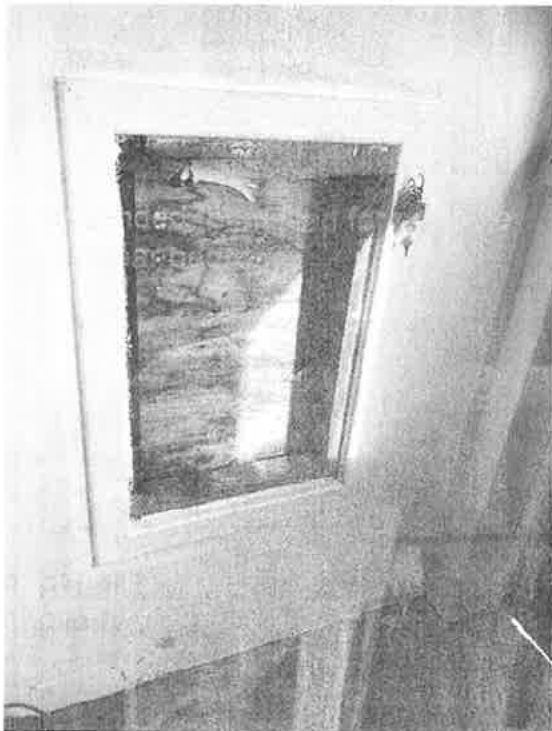
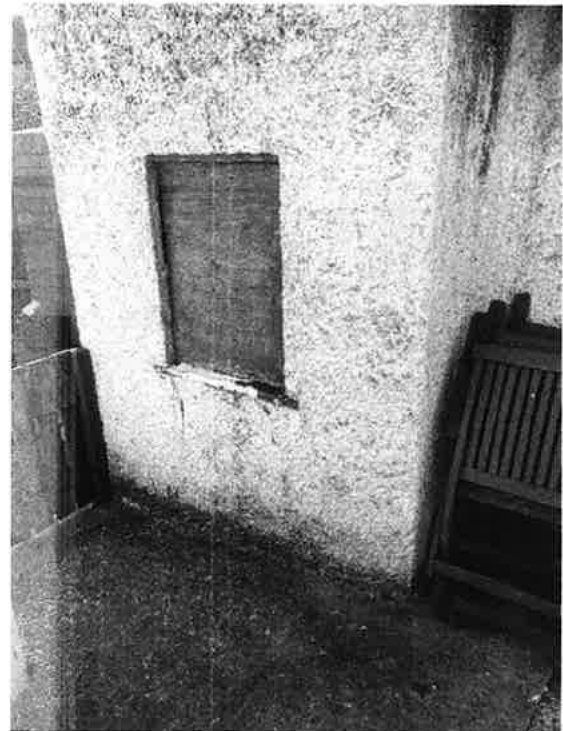
The window opening had been boarded up externally and internally. Ms Benson confirmed that it was in this condition when she took entry to the Property.

6.2.4 The wooden boarding to the former window in the utility room was in a reasonable state of repair.

The boarded up window in the utility room was in a reasonable state of repair as it was no longer used as a window and the wooden boarding kept the window aperture wind and watertight.

Photographs 5 & 6 – Low level “broken” window at utility area.

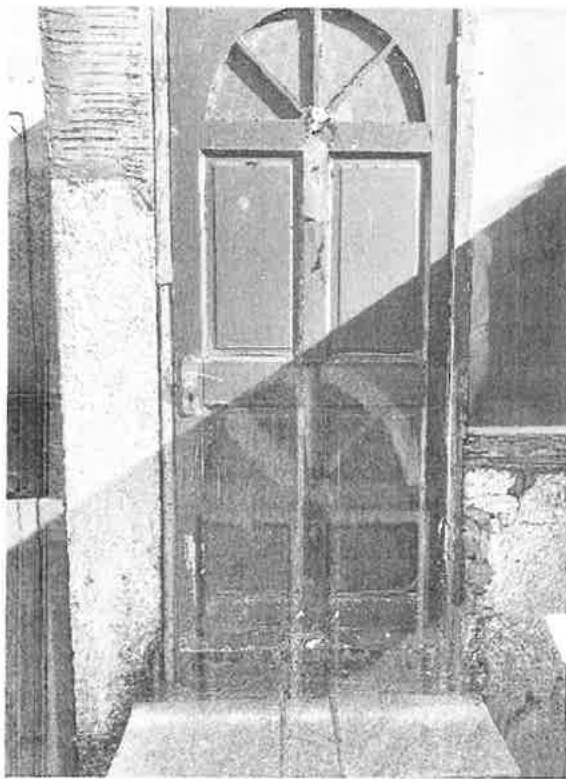
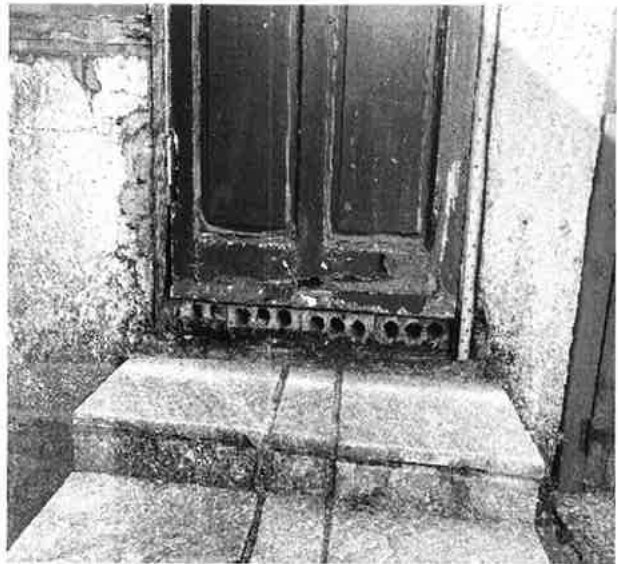
The rear door leading from the utility area to the garden displayed evidence of significant wear, localised rot and flaking paint. It was ill-fitting and there was a visible gap between internal flooring and the base of the door when in the closed position.

The condition of the utility room external door results in the door not being wind and water tight.

Photographs 7-8 – external face of rear door and timber surround

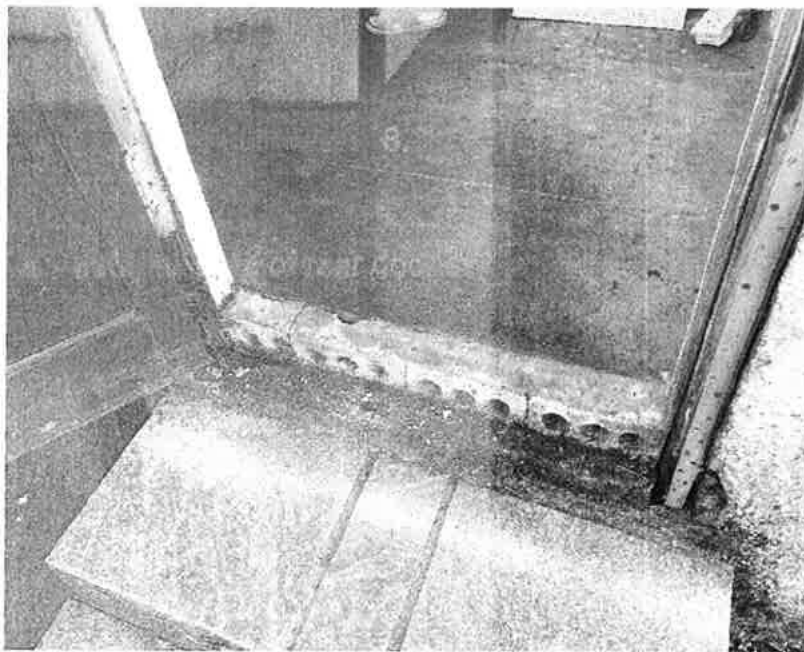
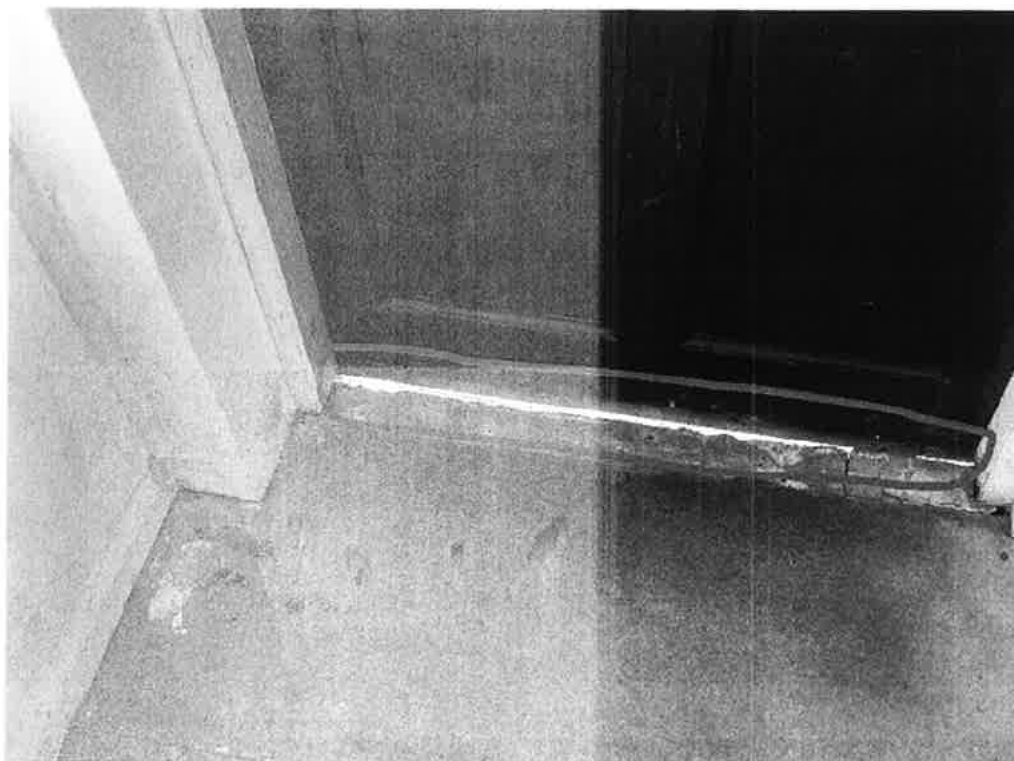
6.2.5 There was a gap under the rear door of the Property.

Photographs 9-10 – base of rear door with “gap” circled in red.

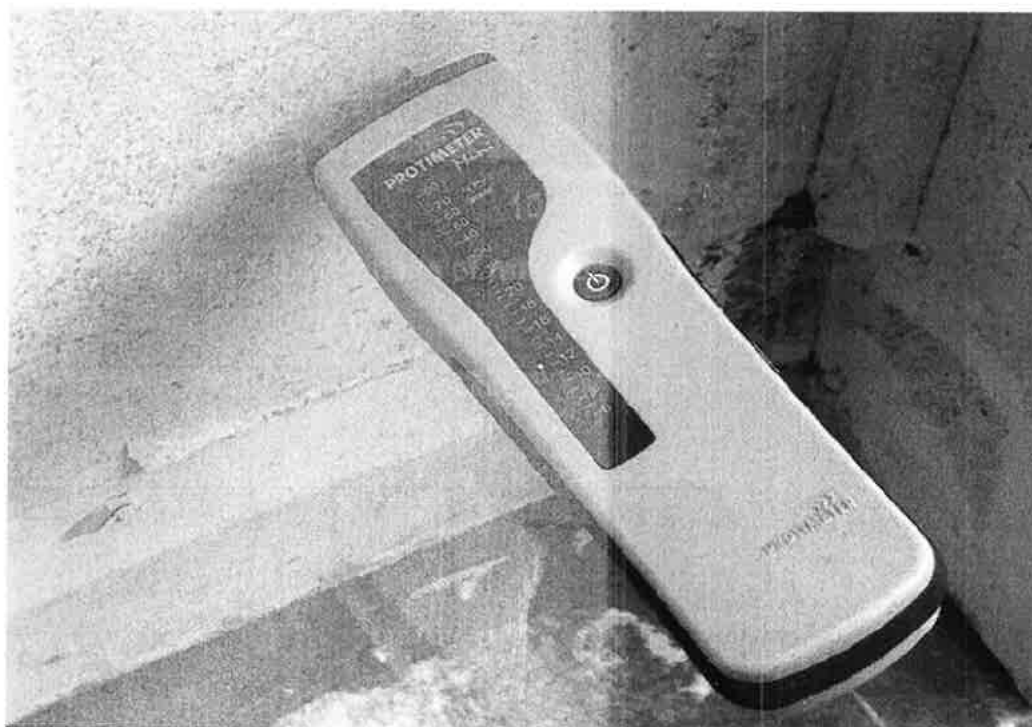
11 – Protimeter reading in utility area.

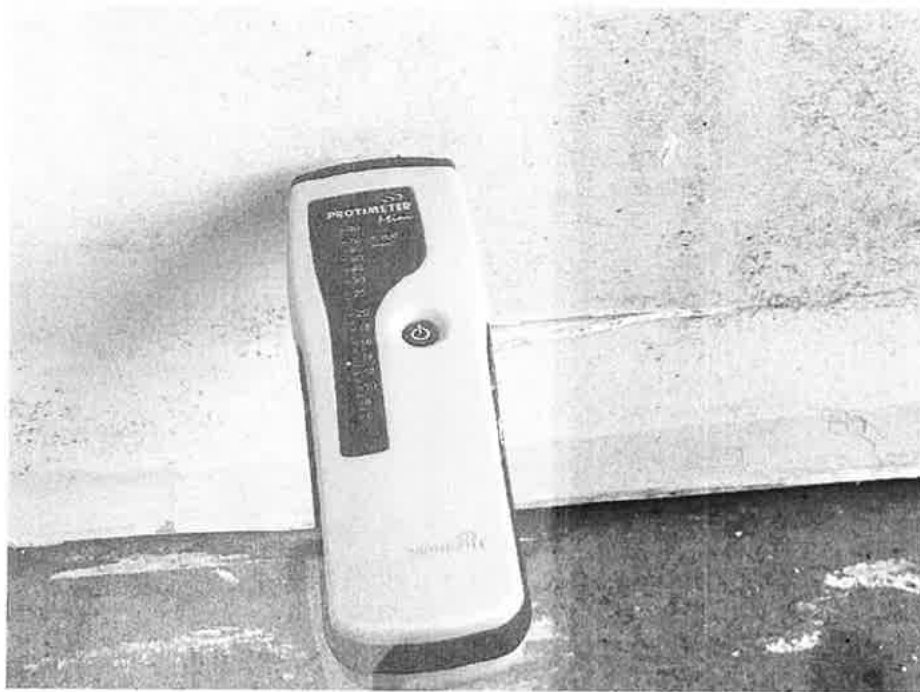
12 – “Protimeter” reading in utility area

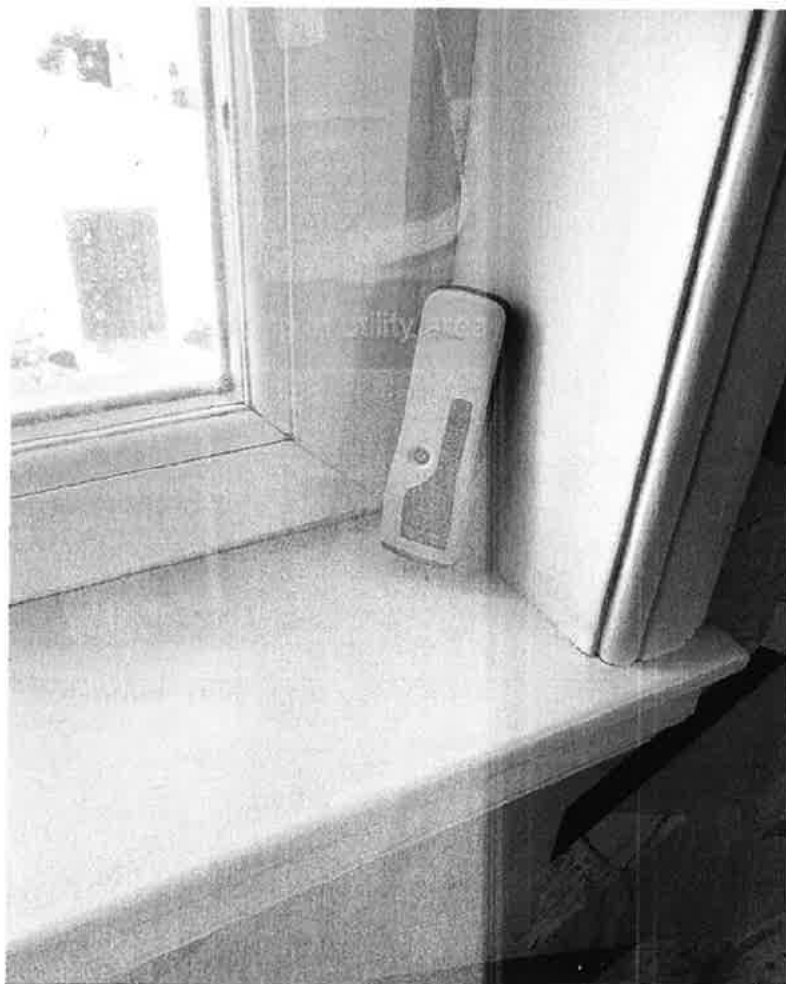
13- “Protimeter” reading at window sill rear bedroom

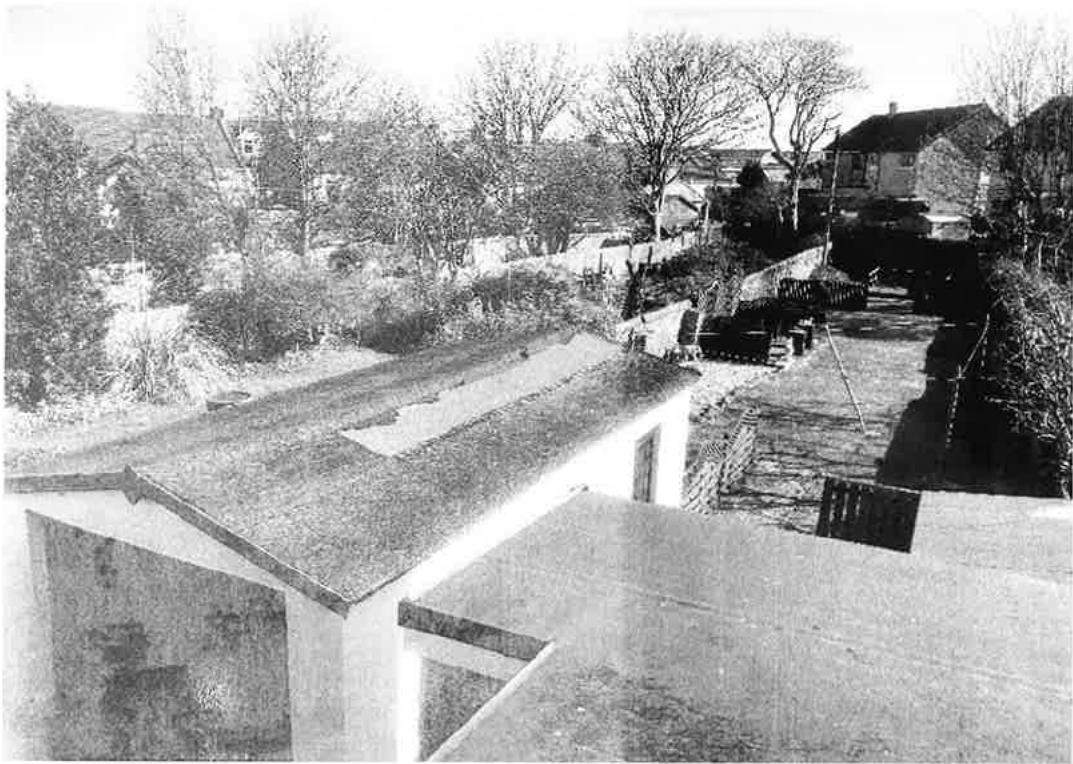
There was no longer vehicle access to the garage which was used as a store. The garage roof was viewed from the upper bedroom of the Property. The felt roof above the garage was in a relatively poor condition and displayed evidence of previous patched repairs and significant wear. Viewed internally it was of a basic design and the roof was finished with "random" sections of timber sarking. No evidence of penetrating damp or significant recent water ingress was noted although in its present condition it is likely that short/medium term repairs will become necessary. There is a slight "sag" in the roof although it is currently functional and the timber appears mostly sound. Evidence of cracking was visible, notably around an internal lintol. The building was neither structurally unsound nor in short/medium term danger of collapse.

6.2.6 The garage roof was structurally sound.

The garage roof was not in a dangerous condition it was in a reasonable state of repair for an external store.

14- Garage Roof

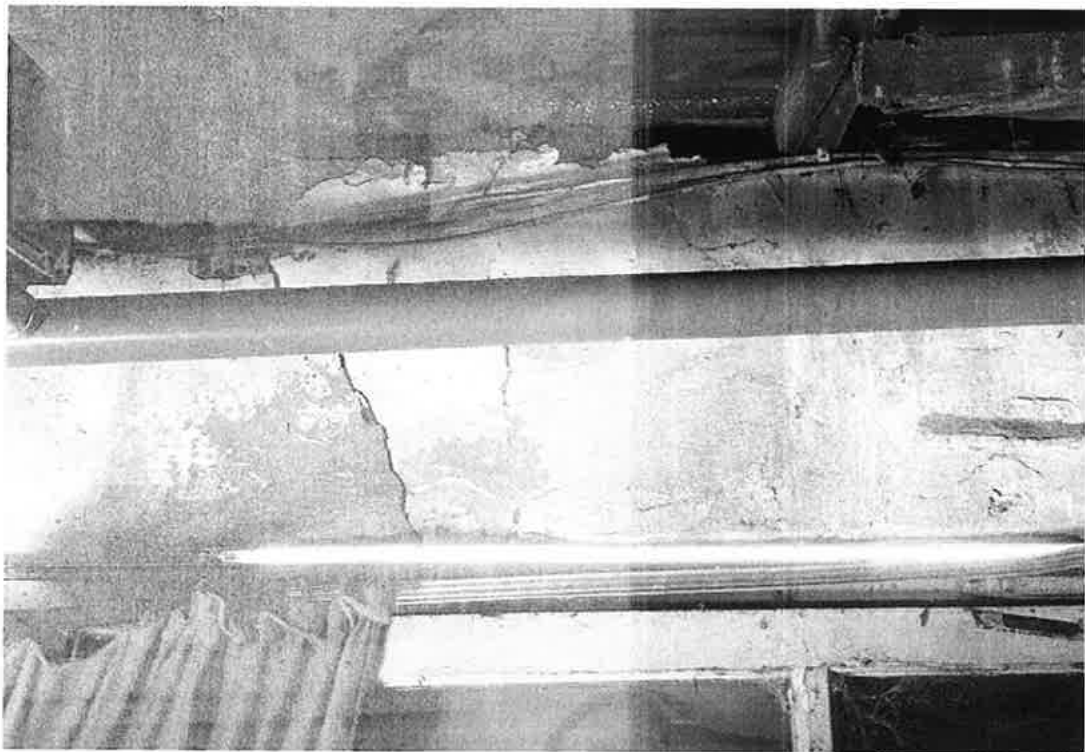
15- Garage roof frame and "cracking" at lintol

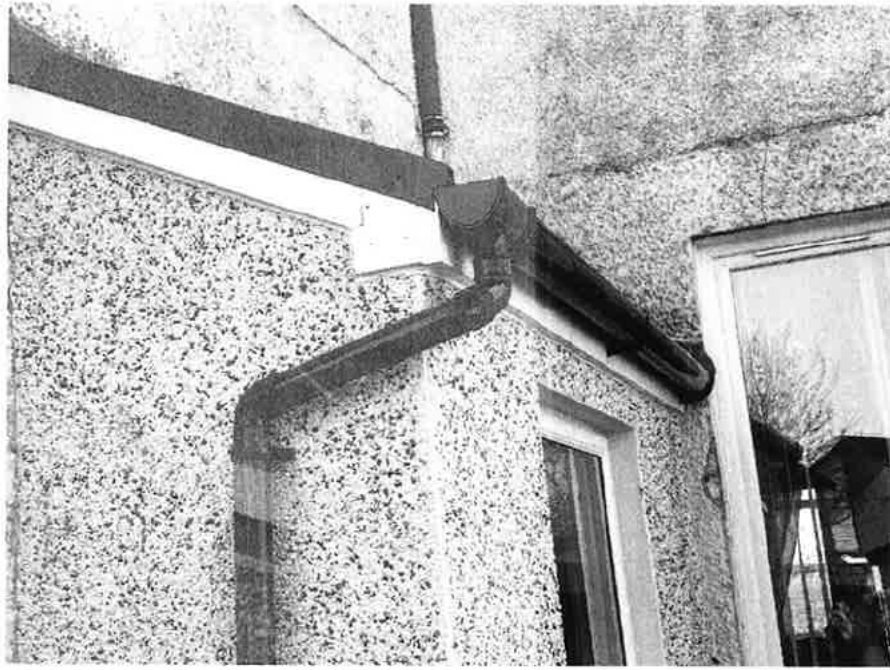
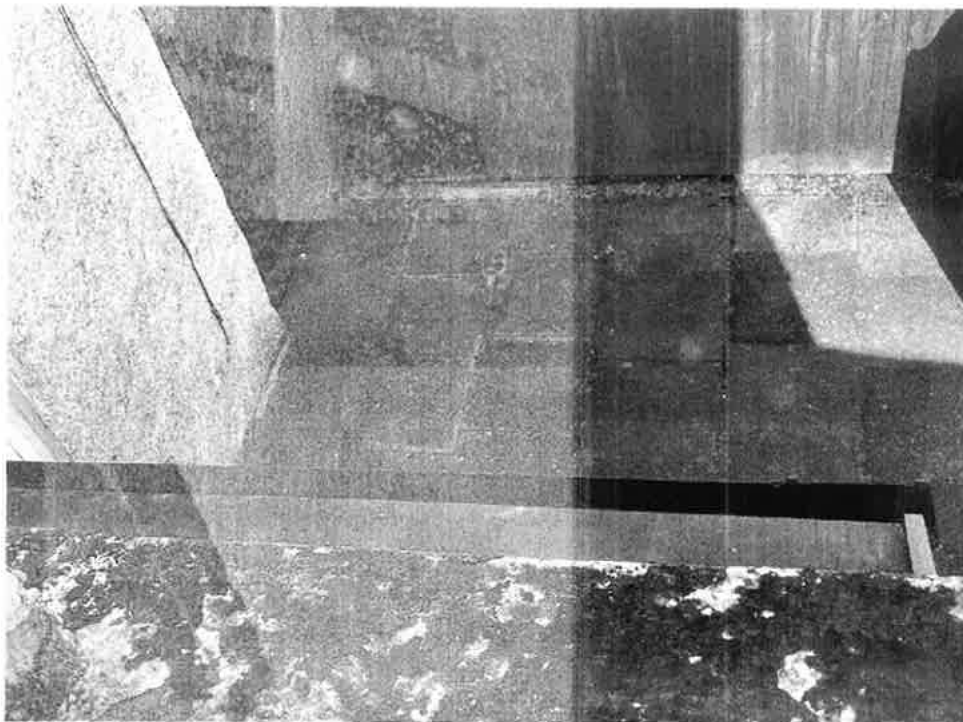
The single storey rear projection under the mono pitched, felt clad roof had recently been fitted with modern PVC gutters and a downpipe. Viewed from above the guttering was noted to be entirely free from moss and debris which, if present, may restrict water flow. The Tribunal were informed that the guttering had recently been cleared. There was no evidence around the external rendering below to suggest that the rainwater goods are defective.

6.2.7 The guttering to the roof of the kitchen extension was in a reasonable state of repair and proper working order.

The guttering to the kitchen extension was in a reasonable state of repair.

16 – 17 View of rear guttering from ground level and from first floor rear bedroom

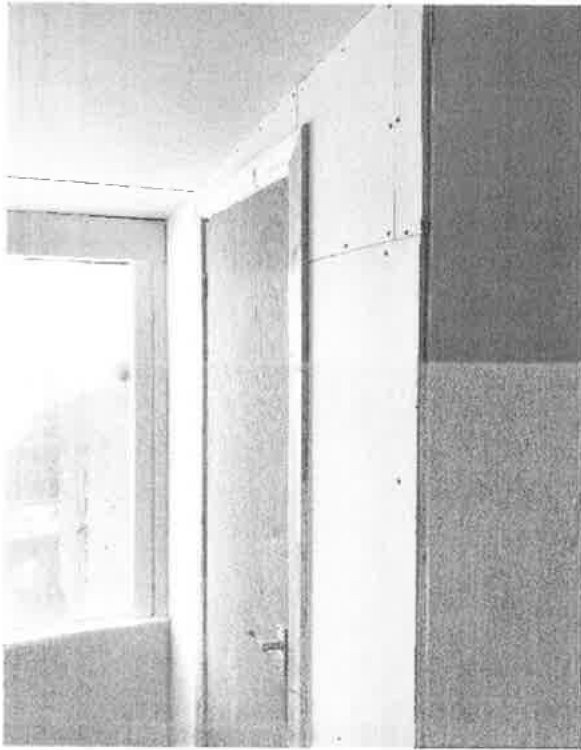
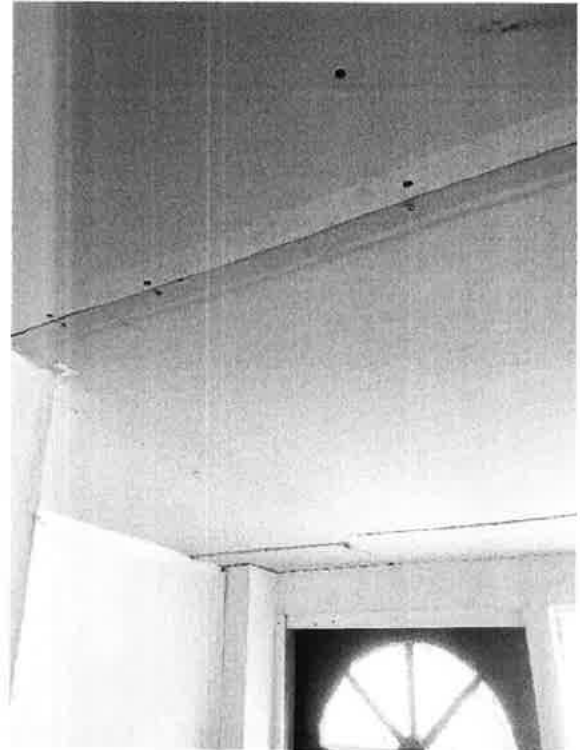
The walls and ceiling at the utility area projection had been lined in plasterboard. The joints between the plasterboard paneling have not been taped and no skim of plaster has been applied.

6.2.8 A number of the internal walls of the utility room had been lined with plaster board and the plaster board had not been skimmed or decorated and they were in a reasonable state of repair.

The fact that the utility room walls had not been skimmed or decorated was not a breach of the repairing standard.

18-19- Unskimmed plasterboard lining in utility area.

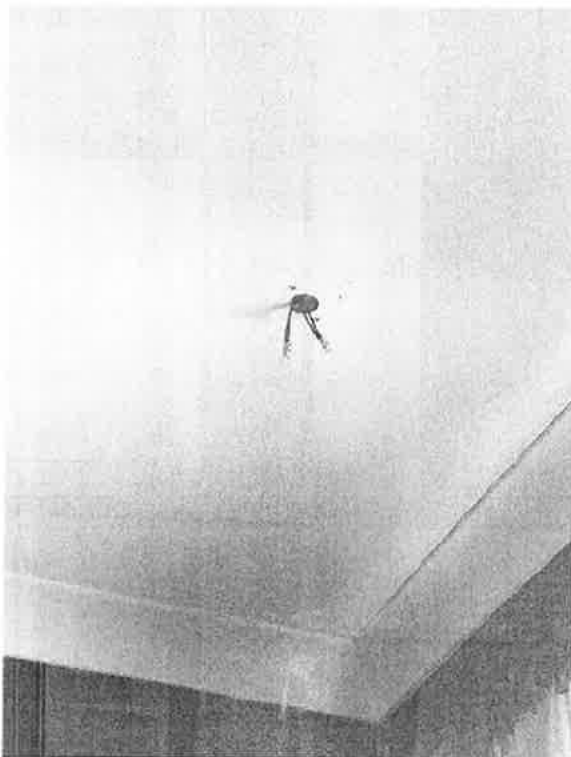
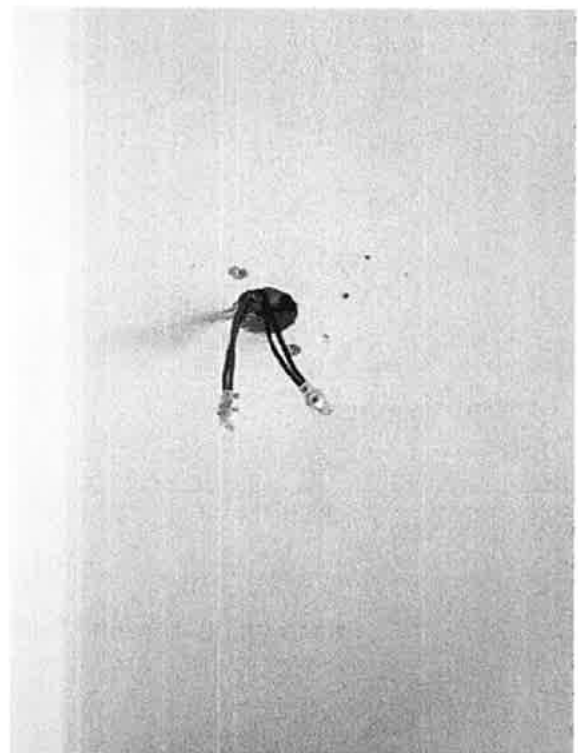
There were hanging/projecting electrical wires from the dining room ceiling. The ends of the wires had been secured into PVC connectors as a means of protection. Areas of ceiling plaster surrounding the main hole were also in need of infilling/repair.

6.2.9 Electrical wires protruded from a hole in the dining room ceiling.

The wires hanging down from the living room ceiling are not in a reasonable state of repair and proper working order.

20-21 – Diningroom ceiling and "hanging wires"

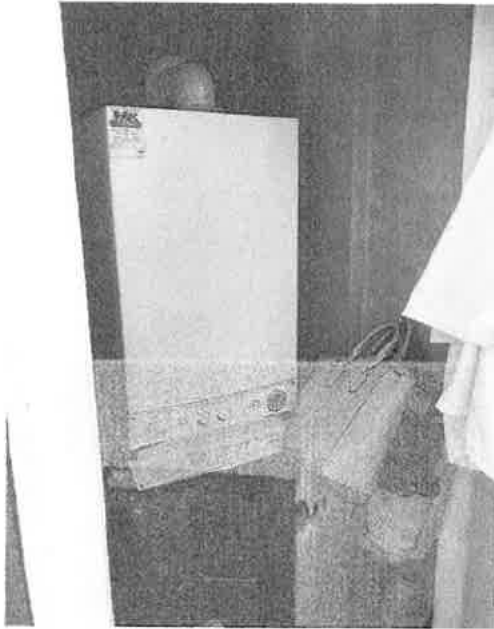
There was no functioning carbon monoxide detector around or in the vicinity of the gas fired central heating boiler located in the rear living room.

6.2.10 There was no carbon monoxide alarm in the Property.

The Property does not comply with the Tolerable Standard as it does not satisfy provision for giving warning if carbon monoxide is present in a concentration that is hazardous to health.

22. Gas wall hung boiler in diningroom

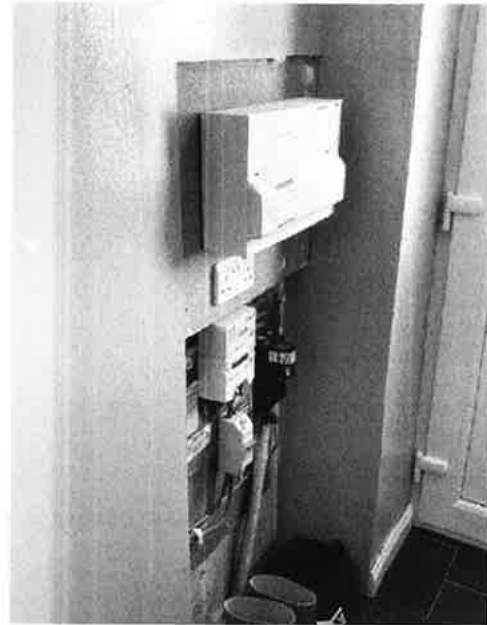
There was no cover or additional protection around the electrical consumer unit.

6.2.11 The electric meters were not covered.

The absence of a cover over the electric meters was not a breach of the Repairing Standard.

23. Electric consumer unit front entrance

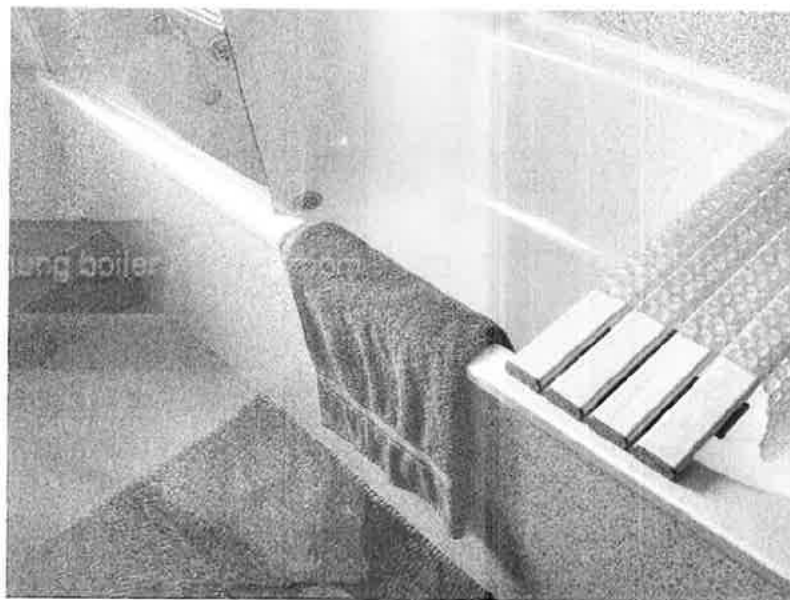
There were functioning panels on the side of the bath.

24. Bath side panel – same material and design as wet wall lining.
