Statement of Decision of the Housing and Property Chamber of the First-tier Tribunal for Scotland under Section 26 (1) of the Housing (Scotland) Act 2006

Chamber Ref: FTS/HPC/RT/0942

Property: 50 (2F1) Northfield Broadway, Edinburgh EH8 7PH (“the property/house”)

SCHEDULE OF PHOTOGRAPHS

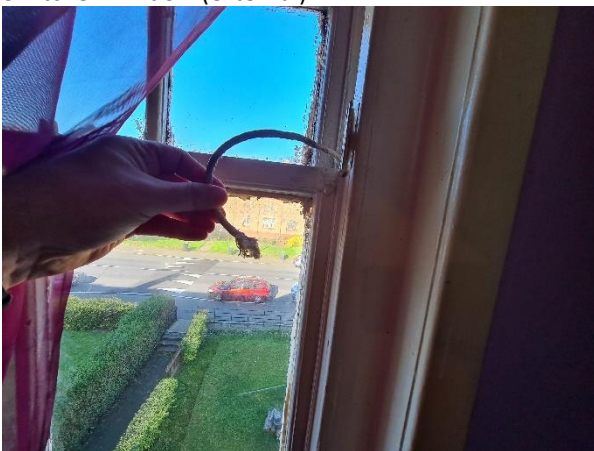
1. The bottom glazed panel of the left-hand window (looking outwards) in the lounge is cracked. Both sash cords are snapped and the sashes are impaired.
2. A new UPVC window has been installed to replace the previous broken window in the rear left bedroom.
3. There is no evidence of broken glass in the front garden.

5 Snapped sash cord to Lounge window.

Item	Issues Noted	Suggestion
1	<p>2 No. broken windows in Lounge</p> <p>Notes:</p> <ul style="list-style-type: none"> • Lounge, left hand window (looking out) bottom glazed pane cracked. • Both sash cords snapped and sashes impaired. • Glazing putties, perimeter sealants, decoration in poor condition – covered within Item 4. 	To replace all cracked glazing, re-balance sashes, replace snapped sash cords and broken sash fasteners, overhaul and adjusting the sashes to leave fully operational and free from impairment.
2	<p>1 No. broken window in a bedroom.</p> <p>Tenant progressed works – UPVC window now installed.</p>	N/A
3	<p>Broken glass in front garden.</p> <p>Tenant progressed works.</p>	N/A
4	<p>All window frames in poor condition.</p> <p>Notes:</p> <ul style="list-style-type: none"> • New windows installed in rear left bedroom and bathroom (UPVC). • Timber bipartite sash and casements serving i) Lounge and ii) Rear Right Bedroom are in poor condition. • Glazing putties, perimeter sealants and decoration in poor condition. Isolated areas of minor timber decay noted. • Various internal sash fasteners defective. 	To cut out and repair all localised timber decay to the timber sash and casement window units and sills, raking out and replacing all cracked and defective glazing putties (around perimeters of glazing) and perimeter sealant (at perimeter of timber frame to external wall junctions) and redecorate externally all timberwork to windows.

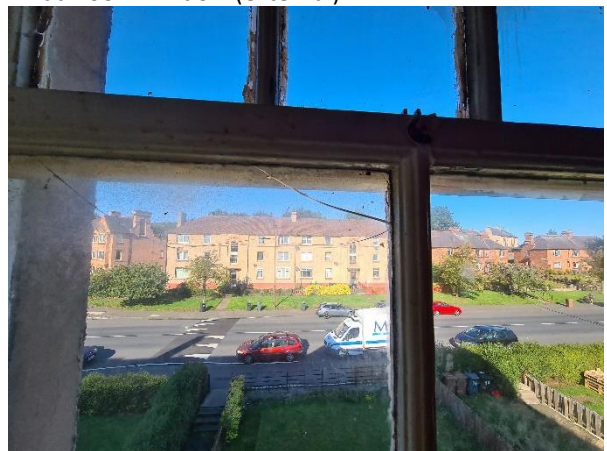
6 Cracked glass to Lounge window.

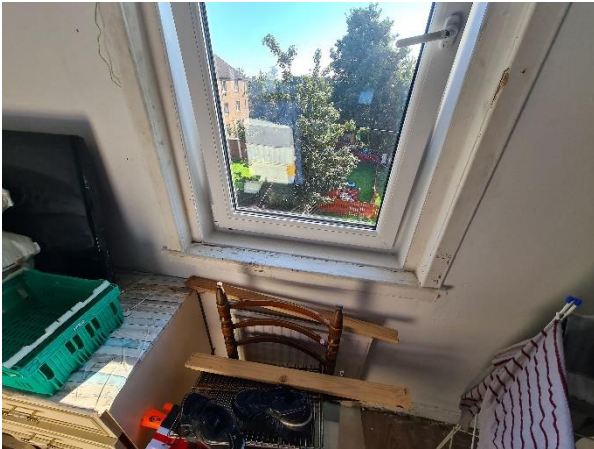
7 Replacement UPVC window to Bedroom.

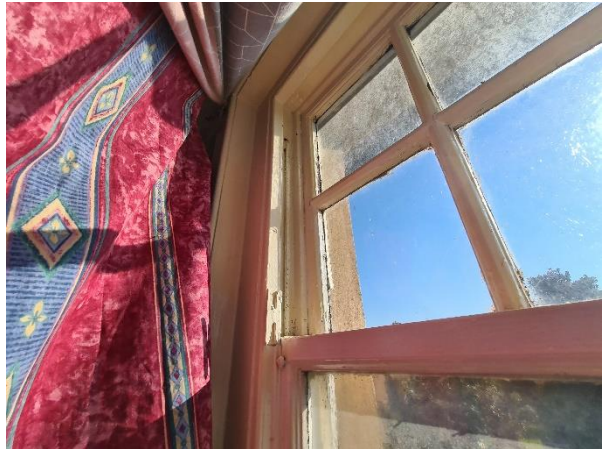
4. New UPVC windows have been installed in the rear left bedroom and bathroom. The timber bipartite sash and casements serving the lounge and rear right bedroom are in poor condition, as are glazing putties and perimeter sealants. Isolated areas of minor timber decay were also noted. Various internal sash fasteners are defective.

8 Defective sash cords to Bedroom sash and casement window.

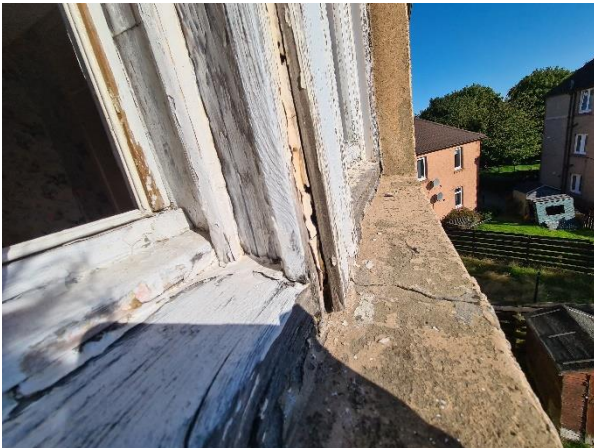
9 Poor condition of external timberwork at Bedroom window.

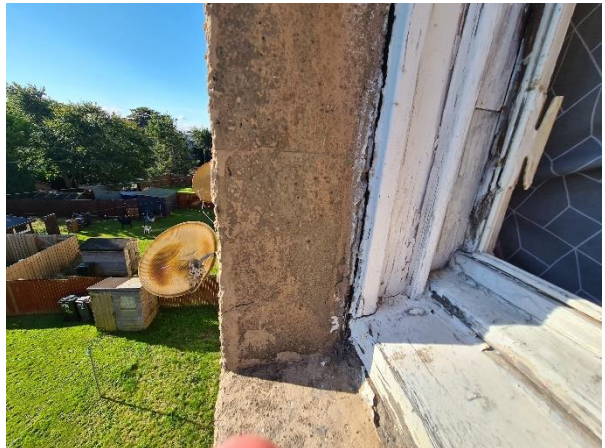
10 Defective perimeter seals to sash and casement window.

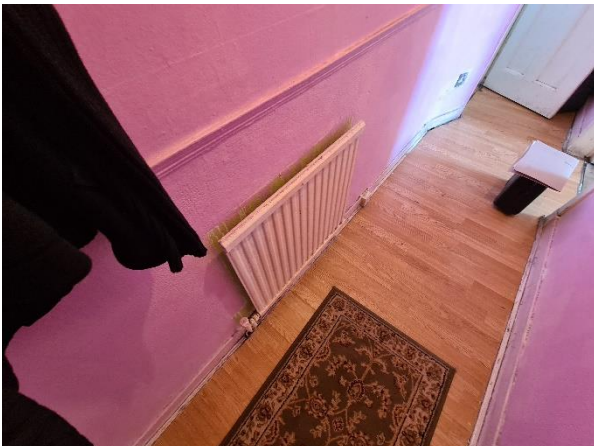
6. There are redundant metal pressed panel radiators throughout the Property. There is an electric fire in the lounge.
7. Testing at the Inspection established that hot water was present at the taps in both the kitchen and bathroom.

11 Redundant pressed panel radiator.

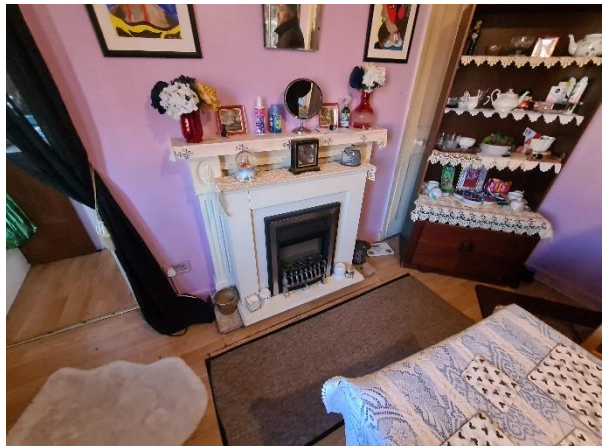
12 Fire within lounge.

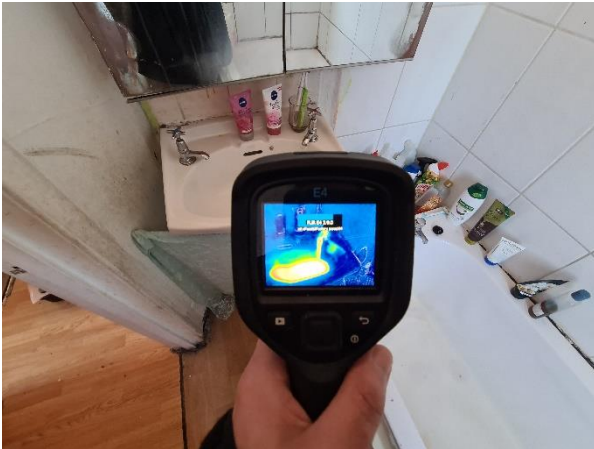
13 Hot water to wash basin.

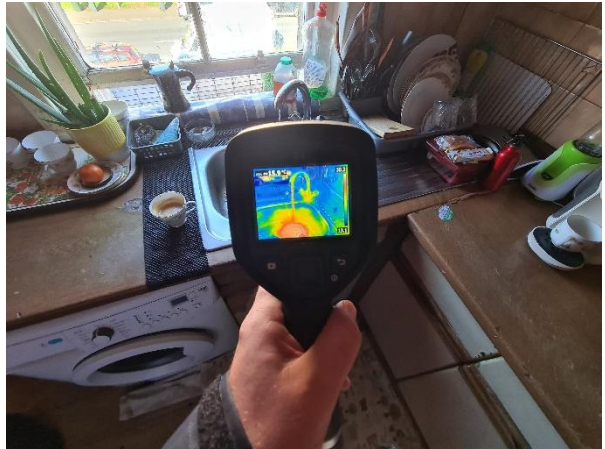
14 Hot water to kitchen sink.

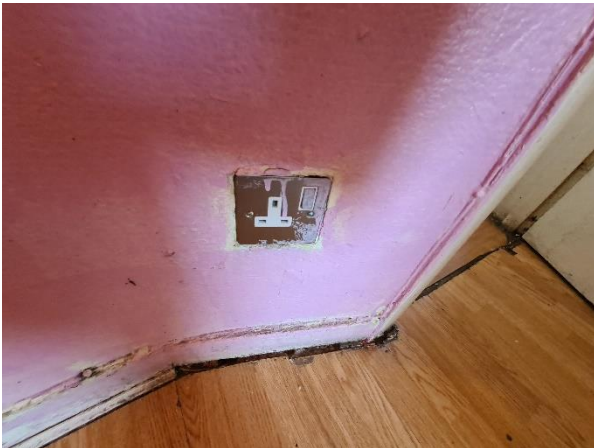
8. There is no evidence from visual inspection that the electrical socket in the hallway is damaged.
9. A new pendant light fitting has been fitted in the kitchen, but a gap was noted around the pendant cover rose to the ceiling.

15 Socket to hall.

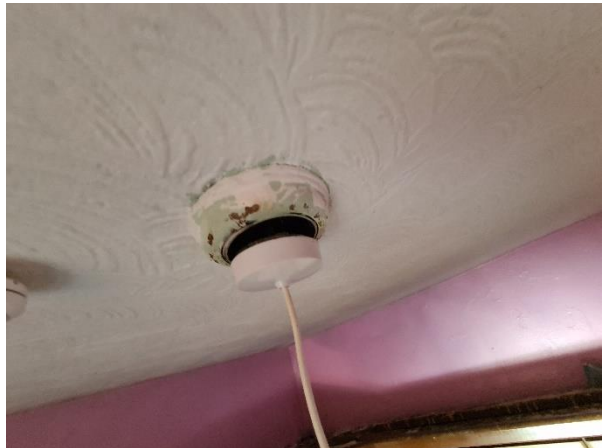
16 Pendant light fitting to Kitchen.

5	<p>No interlinked smoke/heat detection.</p> <p>Detectors noted within the Property (1 in Lounge, 1 Hall, 1 Kitchen), however not interlinked during testing.</p>	To install interlinked smoke detectors within the Lounge and Hallway, in addition to a interlinked heat detector within the Kitchen; all ceiling mounted.
6	<p>No fixed heating.</p> <p>Redundant metal pressed panel radiators throughout. Fire in Lounge.</p>	N/A Not considered a breach.
7	<p>Concern that no hot water.</p> <p>Testing undertaken on-site – hot water present in Bathroom and Kitchen at taps.</p>	N/A
8	<p>Damaged electrical socket in Hallway.</p> <p>Tenant progressed works.</p>	N/A
9	<p>Missing light fitting in kitchen.</p> <p>New pendant light fitting provided by Landlord however, gap noted around pendant cover rose to</p>	To adjust the pendant rose installation, installing a cover plate if required to ensure that

ceiling. Concern over IP rating and exposure to live cables.	no gap is present leading into the ceiling rose or ceiling.
10	<p>No evidence that electrical safety certificates have been carried out (EICR/PAT).</p> <p>Tenant to provide.</p>	<p>To provide to the Tribunal an up-to-date Electrical Installation Condition Report (EICR) pertaining to the fixed wiring of the Property. In addition to provide Portable Appliance Testing (PAT) certificate for all appliances provided by the Landlord under the Tenancy. All dated within the last 12 months.</p> <p>Any C1 or C2 items evidenced within EICR to be attended to.</p>
11	<p>Bathroom in very poor condition, damaged seals, broken shower and cistern is constantly running.</p> <p>Notes: Cracked wall tile noted within shower area. High moisture readings obtained to shower wall where moisture is penetrating behind tiles. Heavy mould to grouting and seals. Tape provided to shower head rail. Shower screen removed. Loose bath panel. Missing plug and chain to wash basin.</p>	<p>To replace any cracked wall tiles, rake out and re-seal bath and wash basin, rake out and replace grout where cracked and resulting in water ingress to shower wall, clean mould and discolouration from grout, and repair or replace shower head support bar fixture.</p>

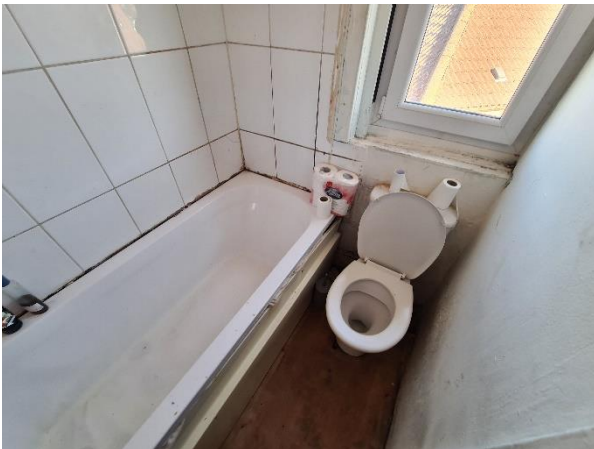
10. No evidence has been provided that up-to-date electrical certificates (EICR/PAT) have been obtained.
11. A cracked tile within the shower area was noted. High moisture readings were obtained to the shower wall where moisture is penetrating behind the tiles. There is heavy mould to the grouting and seals. Tape has been provided to the shower head rail and the shower screen has been removed. The bath panel is loose and the plug and chain to the wash hand basin are missing.

17 General view of Bathroom.

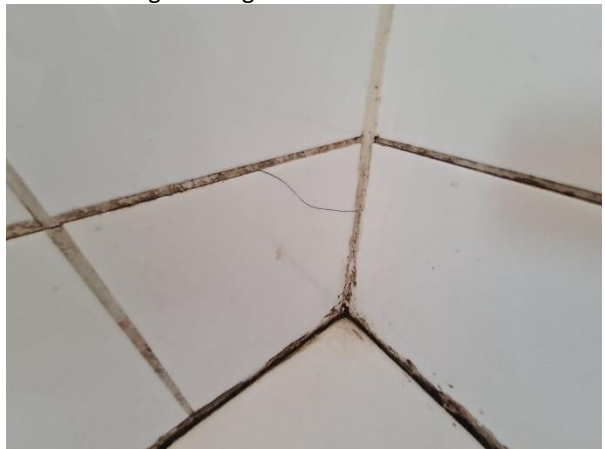
18 Cracked tile.

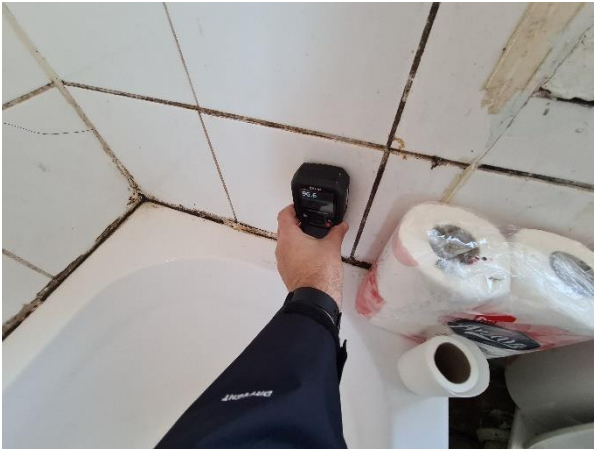
19 High moisture meter readings within Bathroom.

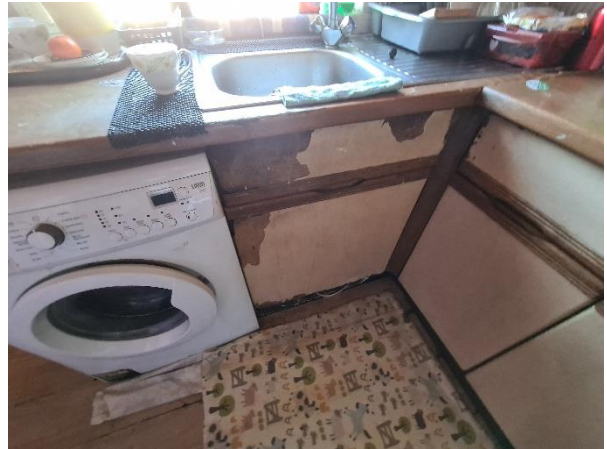
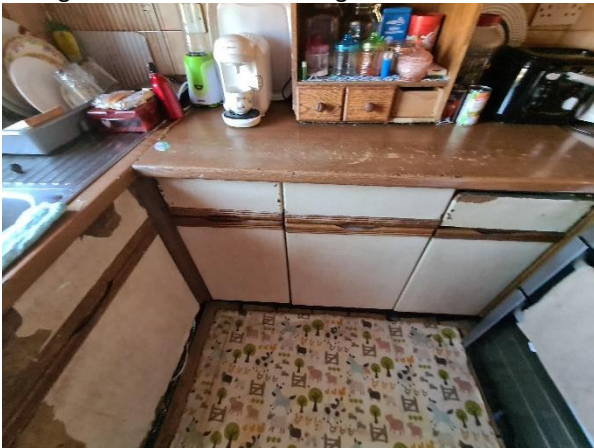
13. Localised timber decay was noted below the kitchen sink and to the kickplates. The veneer on the door fronts and carcasses is damaged and there is general deterioration to the exposed timber below the veneer.

20 Damaged kitchen components.

21 Damaged kitchen components.

12	<p>Kitchen floor in poor condition.</p> <p>Notes: Laminate floor covering water damaged and in poor condition. Underlying timber floor affected by water leak from washing machine area. High moisture meter readings recorded.</p>	<p>To appoint a recognised damp contractor or consultant to uplift the laminate floor covering, and expose the underlying substrate, including cutting open an area of flooring around the washing machine area to investigate the floor void below, providing a report with their recommendations for attending to any water damage and thereafter progress with all stated recommended remedial works, including replacement of the laminate floor covering.</p>
13	<p>Kitchen units in poor condition.</p> <p>Notes:</p>	<p>To remove and replace kitchen unit carcasses, door fronts, haffits, kickplates and worktop</p>

<p>Localised timber decay noted below sink and to kickplates. Veneer damaged to door fronts, carcasses etc. General deterioration to timber below veneer where exposed.</p>	<p>to leave all fixtures, fittings and appliances in reasonable and good working order.</p>
14	<p>Washing machine broken and disconnected.</p> <p>Notes: Washing machine not plugged in during inspection. Tenant confirmed washing machine was operational. Water saturation noted directly in front of washing machine.</p>	N/A
15	<p>Evidence of water leak on kitchen floor, resulting in damage to neighbours below.</p> <p>Notes: Linked to item 11. Agreed – evidence of water damage evident to floor. High moisture meter readings evident.</p>	N/A (covered under item 11)
16	<p>Property insurance details to be provided to neighbour.</p> <p>Not considered to be a Tribunal matter.</p>	N/A
17	<p>Evidence of water leak to Lounge ceiling.</p> <p>Notes: No evidence of any abnormal thermal image when using thermography. Moisture meter did not record any elevated readings to adjoining high level wall. Appears historic in nature.</p>	N/A

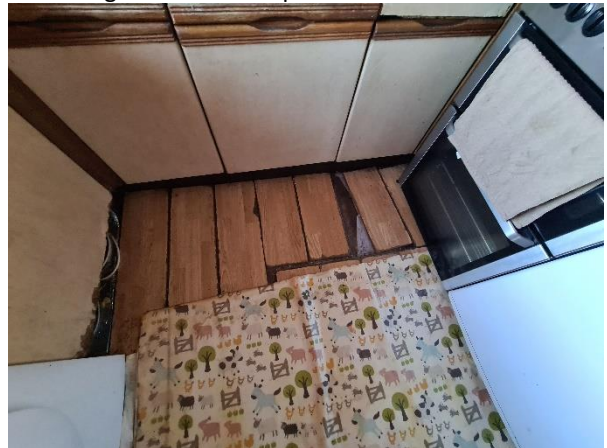
12. The laminate floor covering in the kitchen is water damaged and in poor condition. The underlying timber floor has been affected by a water leak from the area of the washing machine. High moisture readings were recorded in the flooring.

22 Water damaged laminate floor covering in Kitchen.

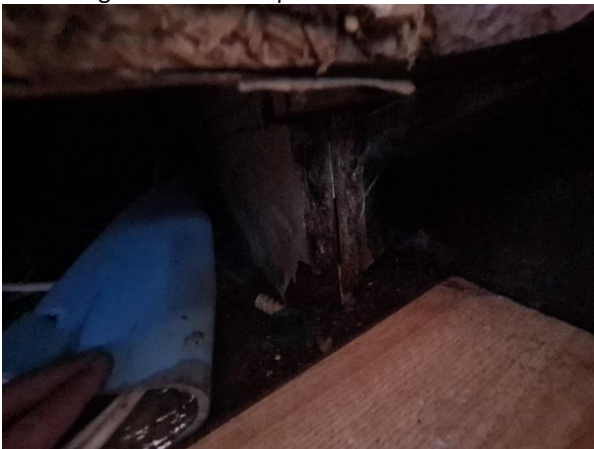
23 Area of timber decay below sink.

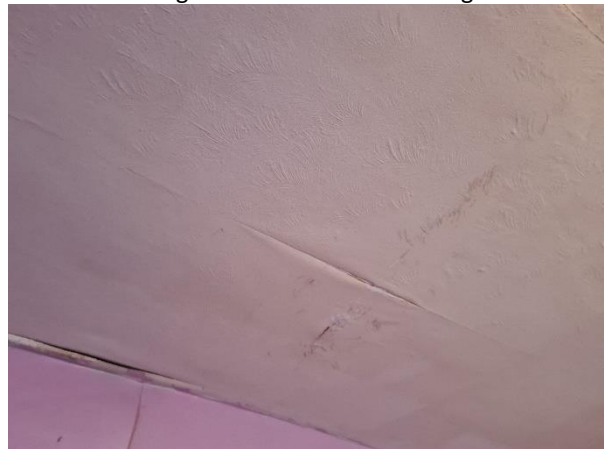
17. The use by the Tribunal of thermography did not produce evidence of any abnormal thermal image of the lounge ceiling and a moisture meter did not record any elevated readings to the adjoining wall at high level.

24 Loose ceiling paper and minor water staining to ceiling of Lounge.

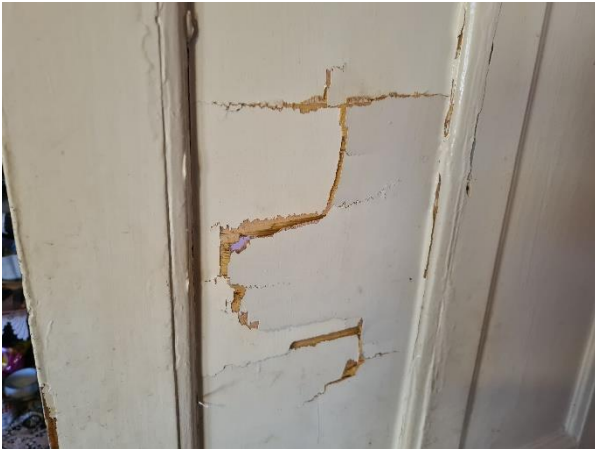
18. A panel within the lounge door is split and damaged.

25 Lounge – damage to door.

18	<p>Damaged Lounge door.</p> <p>Agreed. Panel within door split and damaged.</p>	To replace the damaged panels set within the Lounge door.
20	<p>Damaged bedroom door handle.</p> <p>Agreed – knob handle loose.</p>	To secure or replace the door knob ironmongery to leave this fully operational.
21	<p>Damaged front door handle</p> <p>Notes: Knob handle to external face, lever to internal face. Door operational and secure. Cylinder lock has been partly removed (secondary lock). Mortice lock remains.</p>	N/A
22	<p>Gas supply etc.</p>	N/A

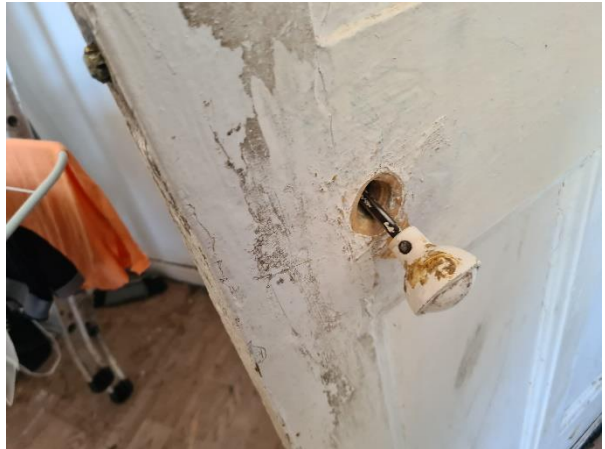
19. The bedroom door knob handle is loose.
20. There is a door knob handle to the external face and a lever to the internal face of the front door. The door is operational and secure. The mortice lock remains, but the cylinder lock (a secondary lock) has been partly removed.
21. There appears to be no gas supply to the Property.
22. The complaint relates to the previous letting or sub-letting issue and the present occupancy level as advised by the new tenant is suitable.

16 Loose door handle to Bedroom.

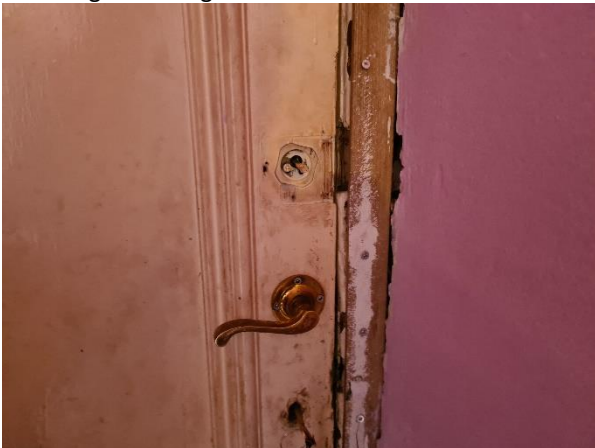
27 Entrance door – internal face.

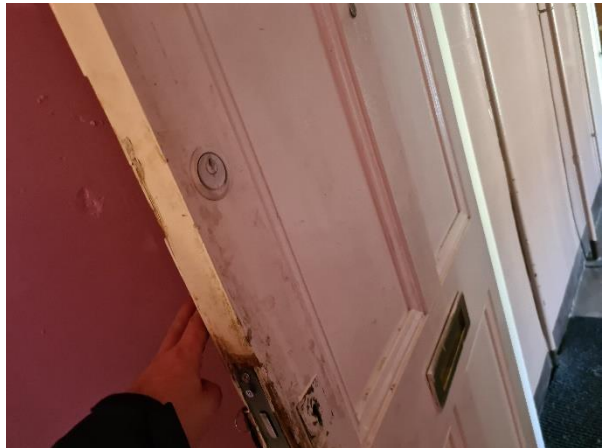
28 Entrance door – external face.
