STATEMENT OF DECISION OF THE TRIBUNAL UNDER SECTION 24(1) OF THE
HOUSING (SCOTLAND) ACT 2006

Chamber Ref: FTS/HPC/RP/23/0558

Re: Flat 2/2, 190 Main Street, Cambuslang, Glasgow, G727EN, being the subjects
registered in the Land Register of Scotland under Title Number LAN21107 ("The Property")

Schedule of photographs taken during the inspection on 08/08/23

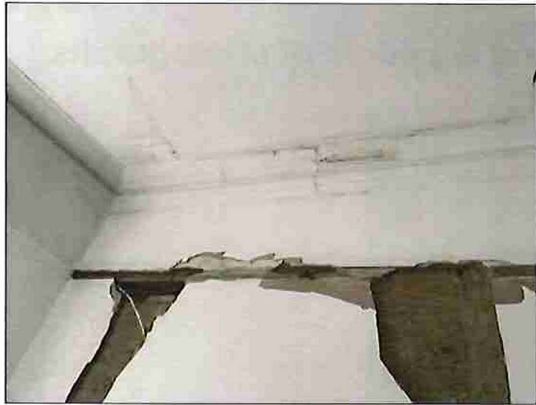
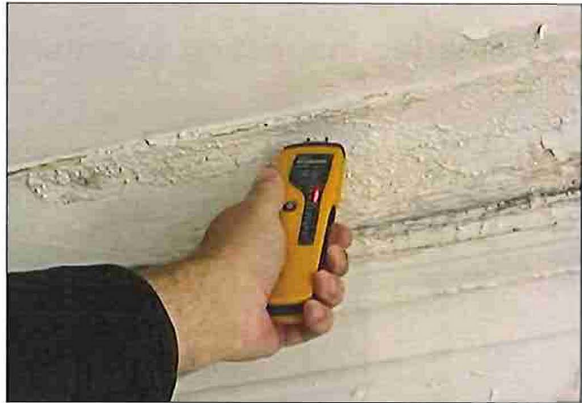
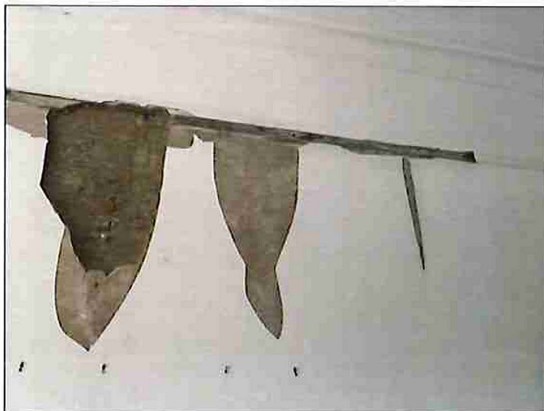
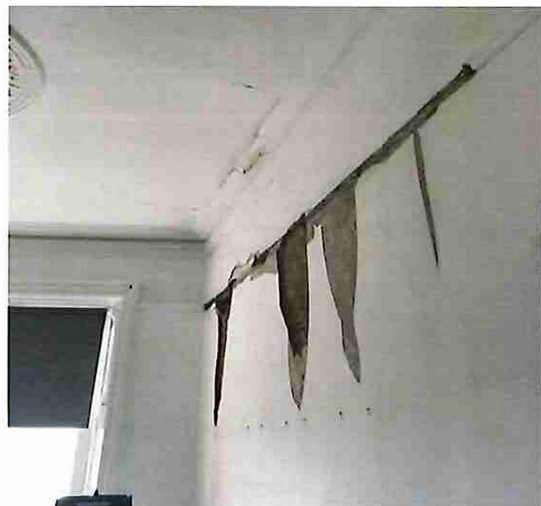
LOUNGE

The Tribunal had noted evidence of previous water ingress at the ceiling level of the Lounge. That water ingress had caused damage to the ceiling and the wall of the Lounge. There were large areas of plasterwork missing from the wall.

Using a damp meter, the Tribunal had noted that there were high levels of dampness recorded at ceiling level (at the site where there had been previous water ingress)

Large sections of plaster have been removed by contractors along the lounge wall and cracks are visible at the kitchen area.
Water staining and damage to the ceiling was visible.
High moisture readings were noted along the cornice and ceiling.

- (a) Carry out investigations to establish the cause of continuing high dampness readings at ceiling level in the lounge of the Property and to carry out any such works as may be necessary to ensure that there is no continuing water ingress at that area so that it is in a reasonable state of repair and in proper working order and

- (b) Repair the damaged plaster on the Lounge wall and ceiling so that it is in a reasonable state of repair and in proper working order
21. The Tribunal order that the works specified in the RSEO must be carried out and completed within the period of 6 weeks from the date of service of this Notice.

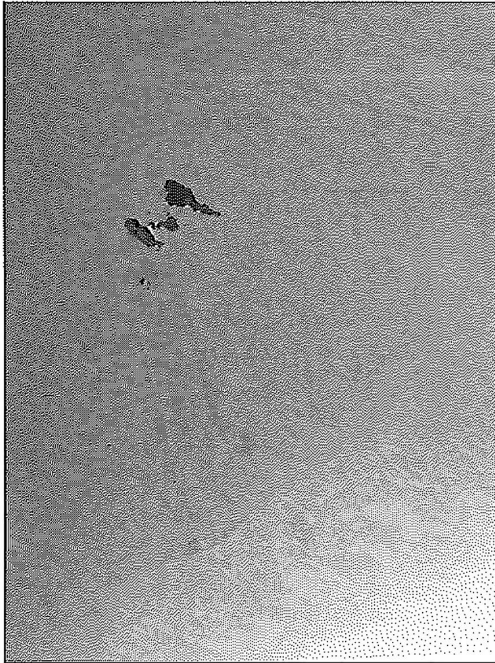
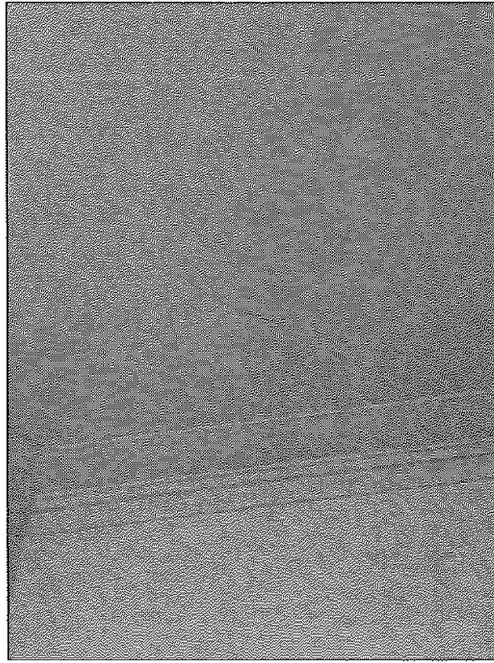
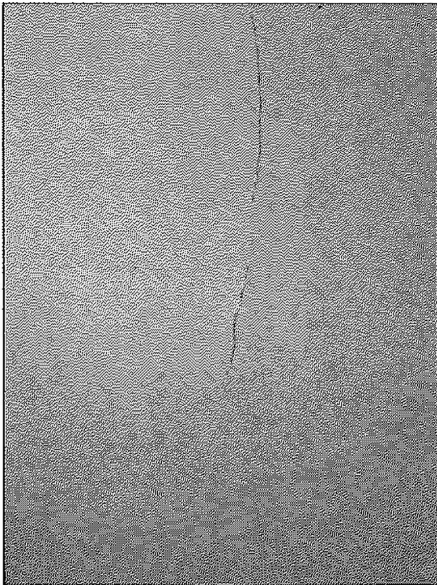
Front facing bedroom

The Tribunal had noted minor hair line cracking on the plaster walls of the Bedroom at various locations.

Using a damp meter, the Tribunal had noted that there was no evidence of dampness within the front bedroom.

Areas of cracking are visible on the walls and ceiling this appears to be superficial.
