# Housing and Property Chamber

**STATEMENT OF DECISION: Housing (Scotland) Act 2006, Section 24(1)**

Chamber Ref: FTS/HPC/RT/17/0339

**19 King Street, Stranraer, DG9 7JU**  
("The property")

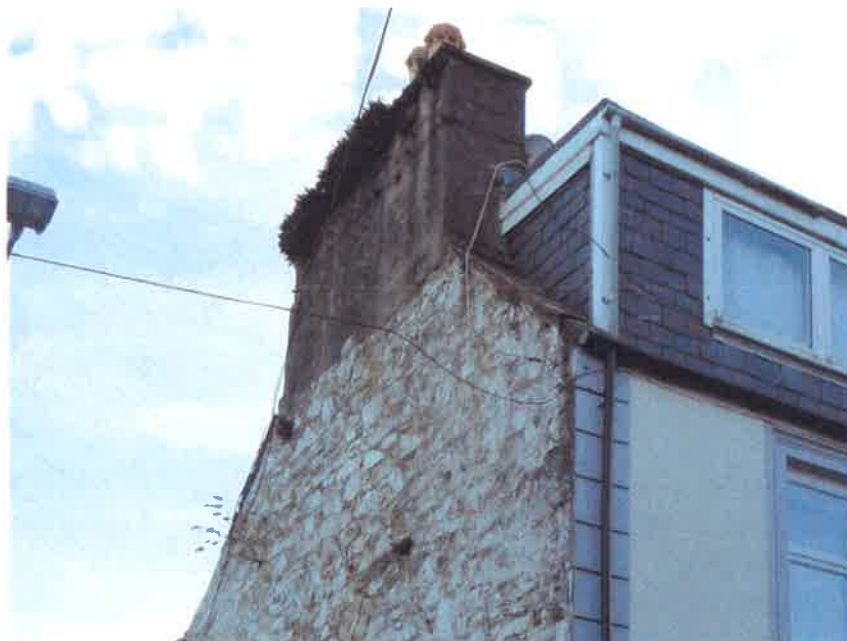
**Photograph 2:- Gable Wall & Chimney**

- xviii. There is significant vegetation affecting the gable chimney head and exposed gable wall. Localised repairs to the stonework in both the chimney head and gable wall are necessary.

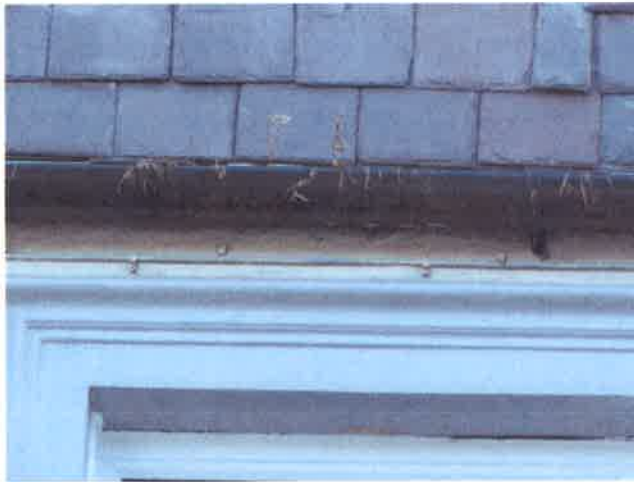
9. The tribunal also notes that early in the application process, a question arose as to whether the last of the above points ("Rainwater goods are choked with grass") had been notified to the landlord, as is required by section 22(3) of the Act. That does not appear to have been the case. Therefore, point (g) it does not form part of this application. The tribunal would not, in any event, have been persuaded to make a repairing standard enforcement order (RSEO) in respect of the rainwater goods. At the time of the inspection, there were no significant signs of vegetation, although the remains of localised, now apparently dead weeds, were noted. There was no evidence in the form of staining to the external wall rendering to suggest that the rainwater goods were not functioning satisfactorily.

**Photograph 3:-** Dead Vegetation in PVC guttering

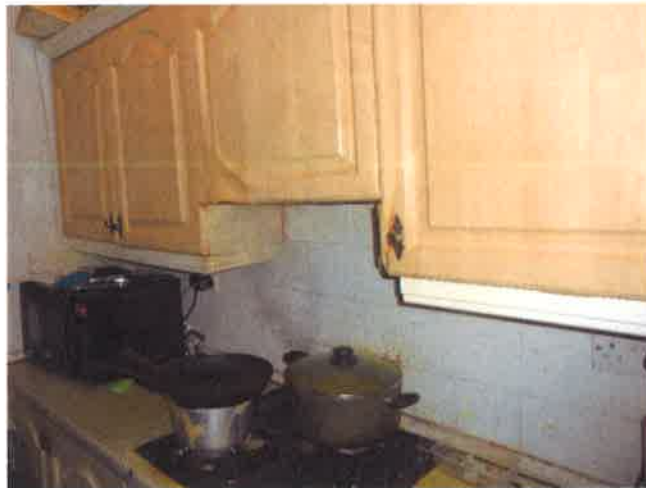
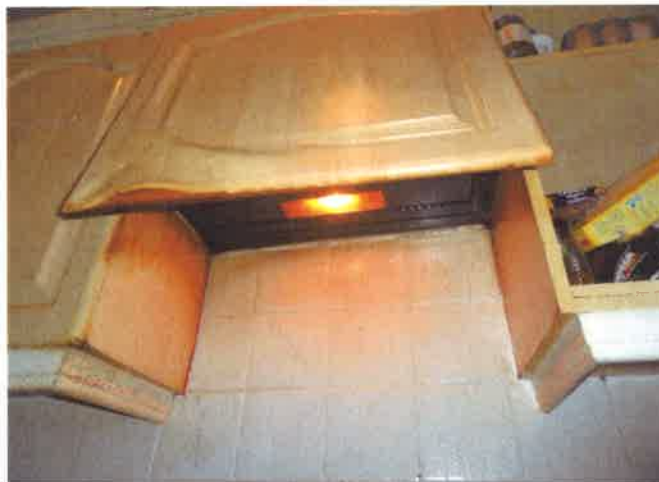
- vi. No gas safety certificate has been produced by the landlord to the third party applicant, or to the tribunal.
  - vii. The kitchen cabinets and fittings above and around the gas hob area are in a poor condition. In particular, there is a top hung protective covering in front of a non-functioning flueless ventilation device. This has become badly damaged and warped. This is due to its type of construction and positioning immediately above the gas hob. The adjoining wall cupboards display evidence of similar heat distortion.

- viii. The present positioning, condition and construction of the kitchen cabinets and fittings above and around the gas hob area represents a significant fire risk.

**Photograph 4:-** Warped kitchen fittings

**Photograph 5:-** Warped kitchen fittings

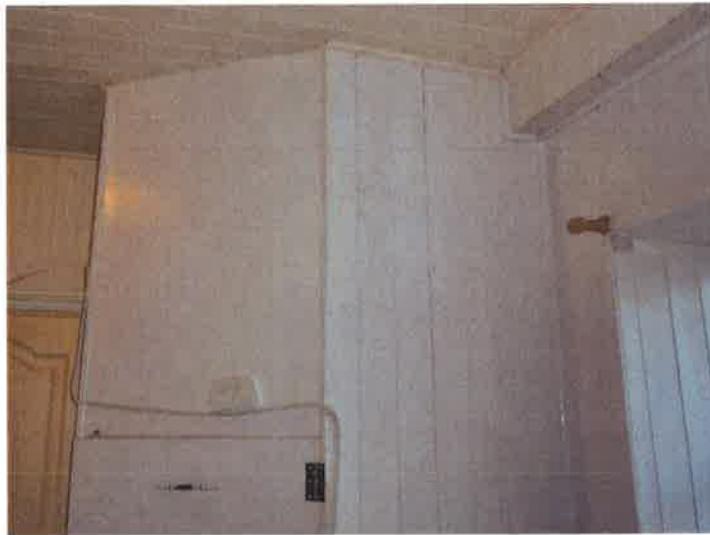
- v. Since the application was made, a carbon monoxide detector has been fitted in the kitchen. It is located approximately 600 mm below ceiling level and below the height of both the door and window.

14. As regards point (a), a carbon monoxide detector has been fitted in the kitchen. However, it is not positioned in accordance with the Scottish Government Statutory Guidance for the provision of Carbon Monoxide alarms in private rented housing. This states that, unless otherwise indicated by the manufacturer, such alarm should either be ceiling mounted and positioned at least 300mm from any wall, or wall mounted and positioned at least 150 mm below the ceiling and higher than any door or window in the room. That is not the case here.

**Photograph 6:-** CO detector

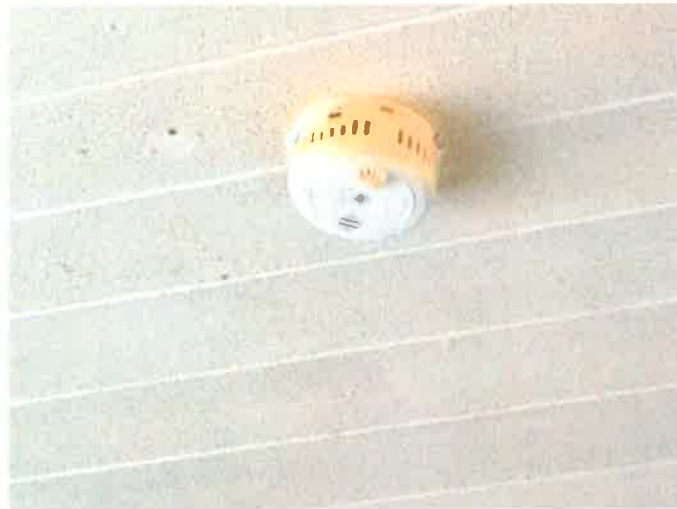
- ix. The air ventilation system above the hob is not functioning.
  - x. There is a ceiling mounted heat detector in the kitchen and a separate ceiling mounted smoke detector at the first floor landing. At the ground floor entrance hall there is, attached to the ceiling, what appears to be the remains of a former battery operated smoke detector fixing.

- xi. The aforementioned smoke and heat detectors are not mains powered, or interlinked.
  - xii. No Electrical Inspection Condition Report (EICR) has been produced by the landlord to the third party applicant, or to the tribunal.

15. As regards point (d), there was no evidence, in the form of wiring or otherwise, that the smoke and heat detectors were mains powered or interlinked. The requirements regarding smoke and heat detectors as outlined in the revised Domestic Technical Handbook regarding private rented property states there should be at least: one functioning smoke alarm in the room which is frequently used by occupants for general daytime living purposes; one functioning smoke alarm in every circulation space, such as hallways and landings; one heat alarm in every kitchen, that all alarms should be interlinked, and that the alarms should be mains powered. The tribunal accordingly concluded that these requirements were not met.

**Photograph 7 :-** Heat detector - kitchen

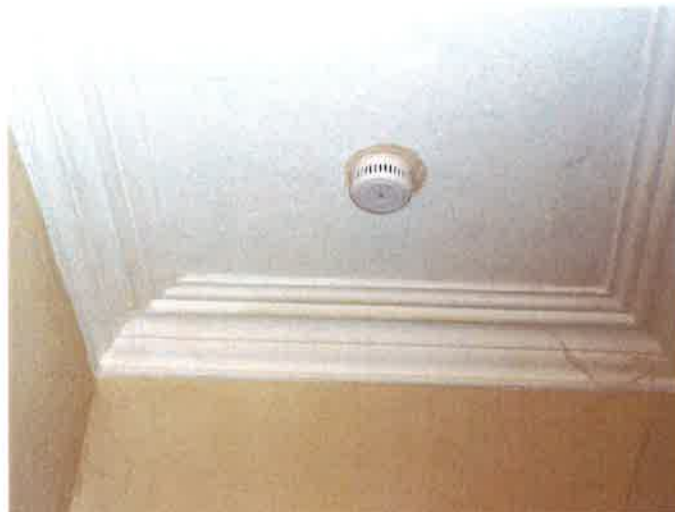
**Photograph 8:-** Landing smoke detector

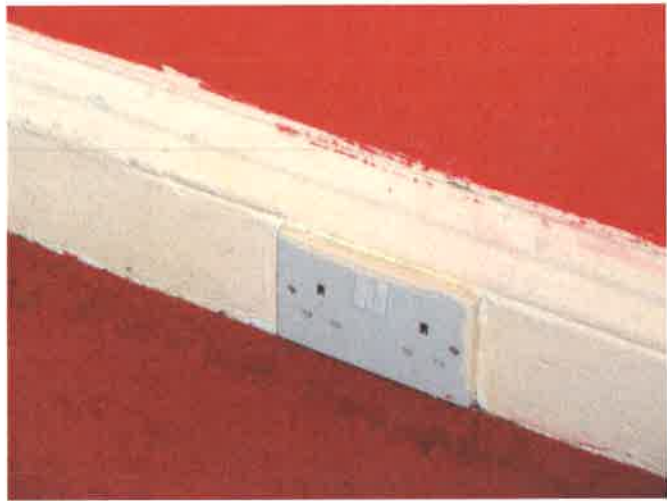
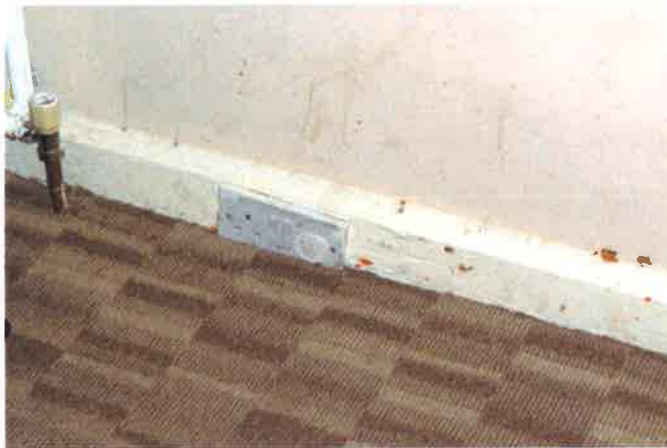
- xiii. The electrical power points are set into the walls at a level well below the minimum height requirement.
  - xiv. Since the date of application, the landlord has replaced several of the windows, at first floor level.

**Photographs 7 & 8:-** Low mounted power points

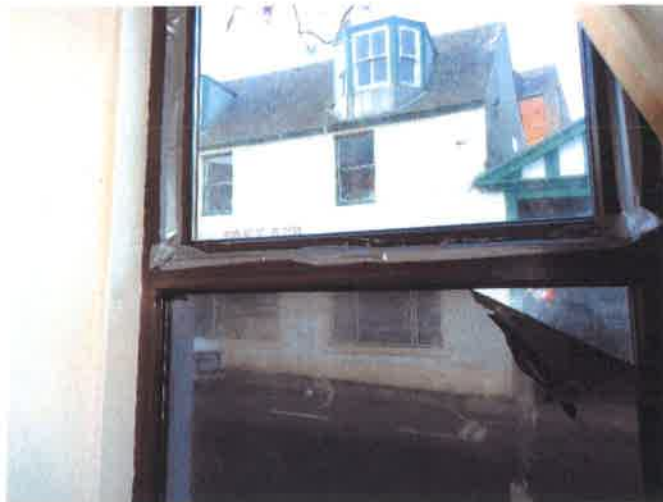
- xv. The ground floor living room window is an old double glazed fitting. Duct tape or equivalent has been fitted around the window to mitigate against draughts. The window comprises a deadlight lower panel with top hung upper panel and at the time of inspection was incapable of being opened.

**Photograph 9:-** Living room window
