**First-tier Tribunal for Scotland (Housing and Property Chamber)**

**Statement of Decision of the First-tier Tribunal for Scotland  
(Housing and Property Chamber) under section 60(5) of the  
Housing (Scotland) Act 2006**

**Chamber Ref: FTS/HPC/RP/22/4369**

**33 Bon Accord Crescent, Shotts, ML7 4EA being the subjects registered  
in the Land Register of Scotland under Title Number LAN140092 ("the  
Property")**

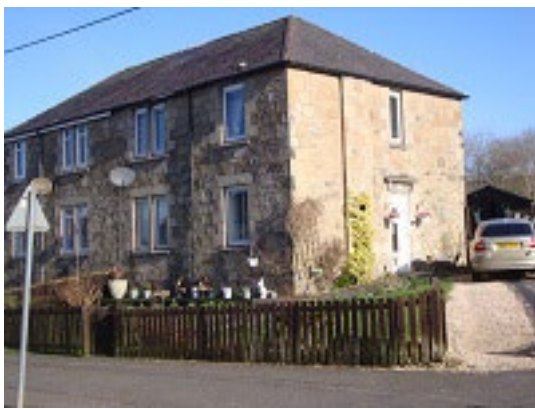
1.

FRONT ELEVATION

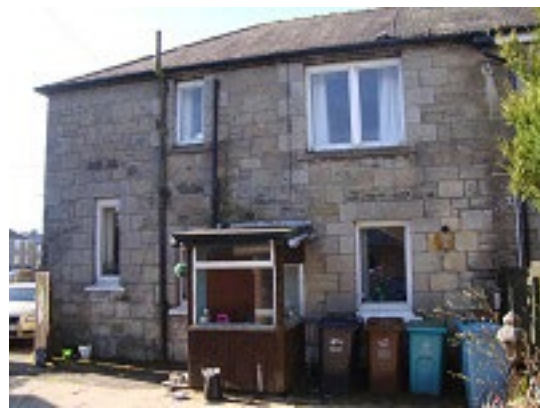
2.

The guttering at the rear of the Property does not connect to the downpipe. There is green mould on the rear wall of the Property. There is mould on the bathroom ceiling. The area where the mould is situated was tested with a damp meter and was found to be dry.

7.1.4 There is green mould on the rear wall of the Property.

REAR ELEVATION

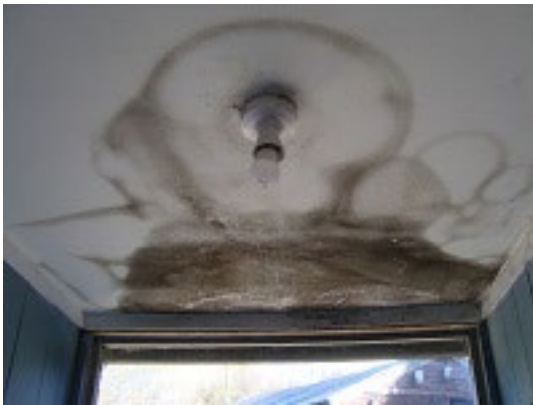
3.

The porch has a lean to roof with a felt covering. There is flashing between the porch roof surface and the rear wall of the Property. The flashing has a hole in it which is causing water to seep into the ceiling of the porch. On the internal surface of the porch ceiling there is black mould. The area where the mould is situated was tested with a damp meter and was found to be dry.

7.1.8 There is black mould on the porch ceiling.

PORCH CEILING

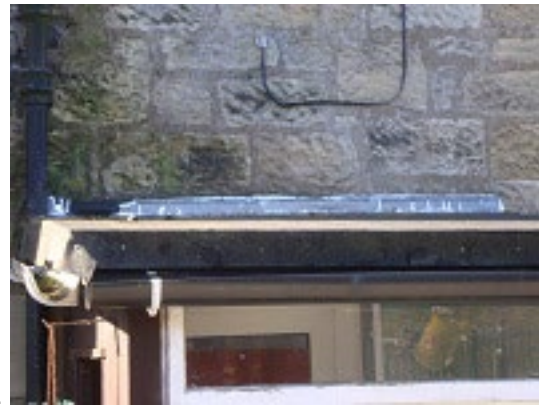
4.

The guttering to the rear porch is not complete. There are no corner junctions and the guttering is not connected to a downpipe.

PORCH ROOF FLASHING/GUTTERS

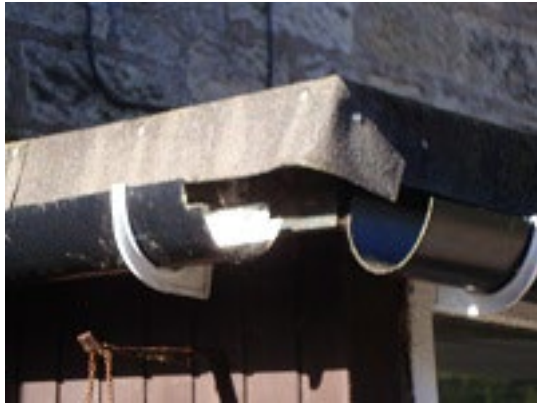
7.1.10 The guttering around the porch is not complete. There are no corner junctions and the guttering is not connected to a downpipe.

5. PORCH GUTTER

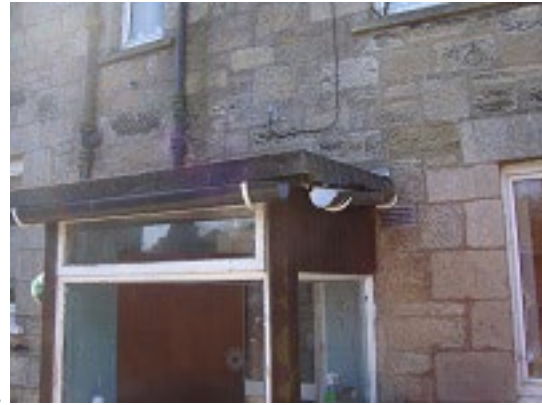
6. PORCH GUTTER

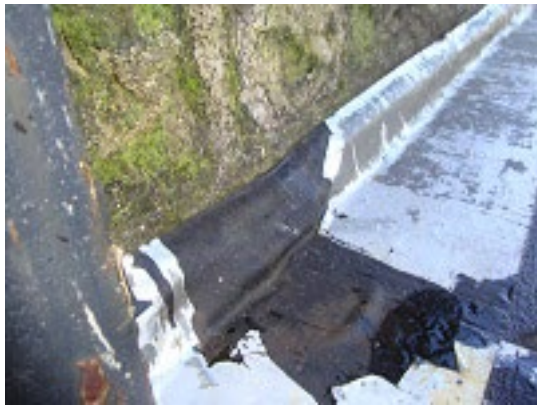
7.1.7 The porch has a lean to roof with a felt covering and flashing between the roof surface of the porch and the rear wall of the Property. The flashing has a hole in it.

7. FLASHING AT PORCH ROOF

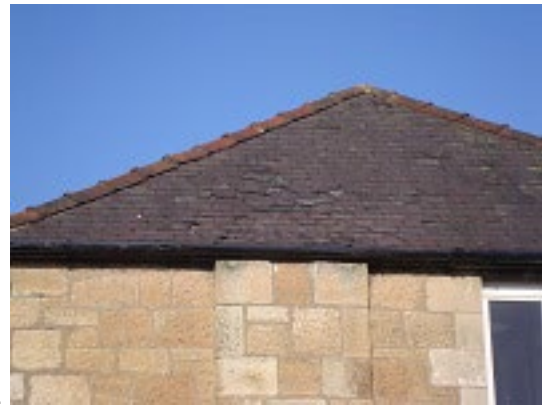
A number of slates on the side slope of the roof have slipped and one of the ridge tiles is missing. Mr Links carried out a head and shoulders inspection of the roof space and could see daylight through the roof in the area where the tiles have slipped.

7.1.1 A number of the slates on the section of the roof at the side of the Property have slipped and daylight can be seen through the section of the roof where the slates are missing.

8. HIP SLOPE ON ROOF

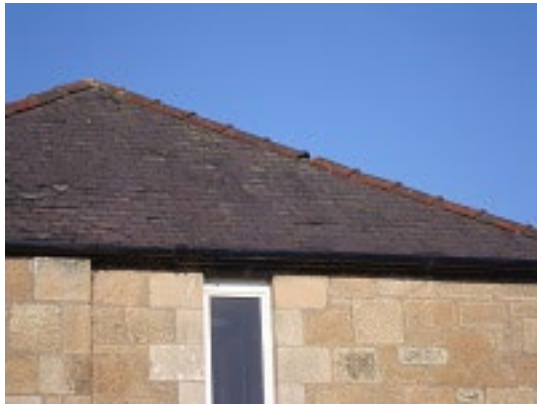
9. BROKEN/MISSING RIDGE TILE

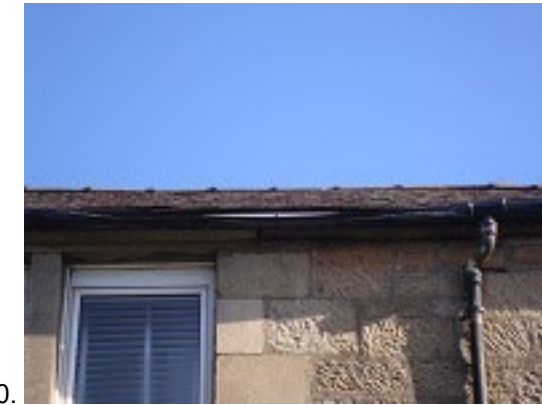
The plastic guttering to the front of the Property is twisted and is incapable of allowing the discharge of rainwater to the downpipes.

7.1.2 The guttering to the front of the Property is twisted.

10. GUTTER AT FRONT ELEVATION

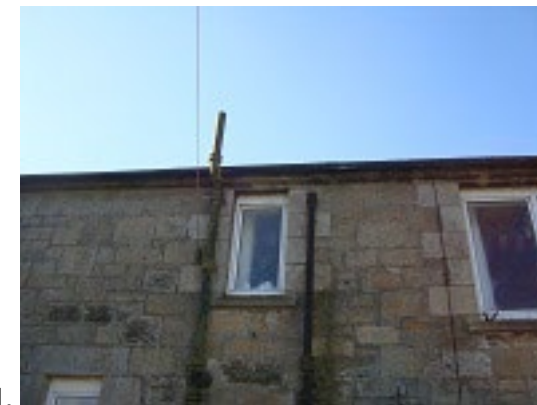
7.1.3 The guttering at the back of the Property does not connect to the downpipe that is situated in the middle of the rear wall of the Property.

11. REAR GUTTER AT REDUNDANT DOWNPIPE

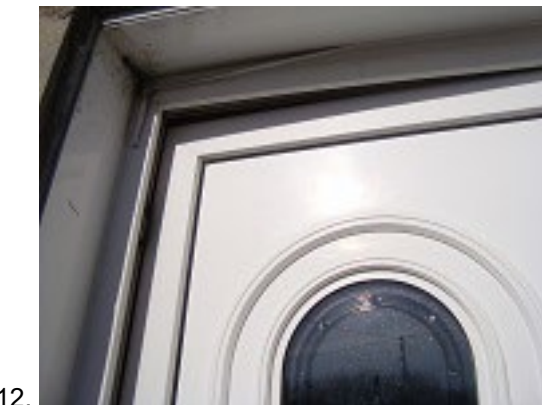
The front door is ill fitting and catching on the door frame when it is operated. There is also a gap between the kick plate and the door frame.

7.1.11 The front door has slipped on the hinge and there is also a gap between the kick plate and the door frame.

12. ENTRANCE DOOR

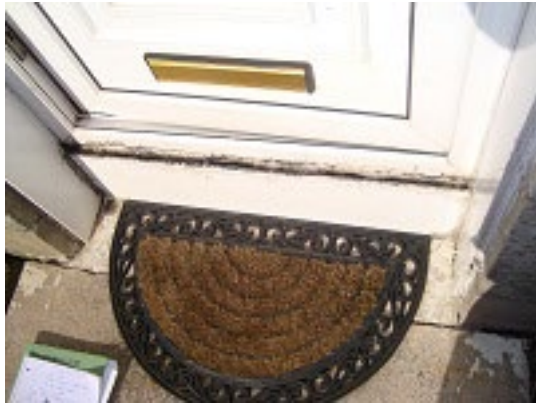
13. BASE OF ENTRANCE DOOR

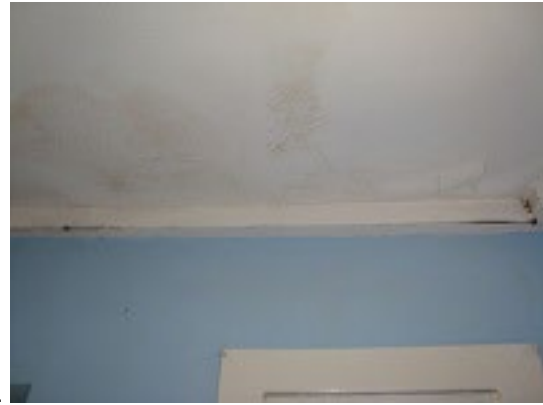
Lisa Craig advised that there had been a leak of sewerage from the upstairs toilet through the kitchen ceiling. She had notified the landlord of the leak but he had not arranged the repair. Due to the urgency of the situation she had arranged the repair herself.

14. KITCHEN CEILING

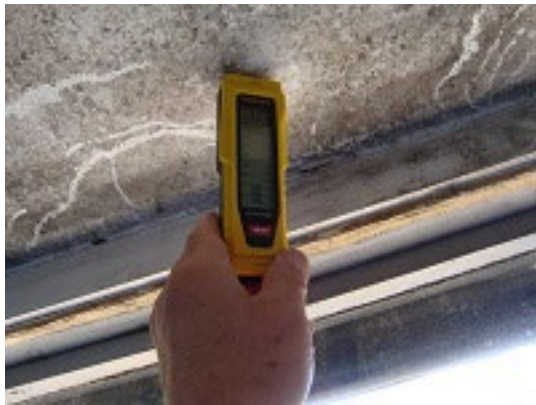
7.1.9 The porch ceiling is not damp.

15. DAMP METER READING – PORCH CEIL.

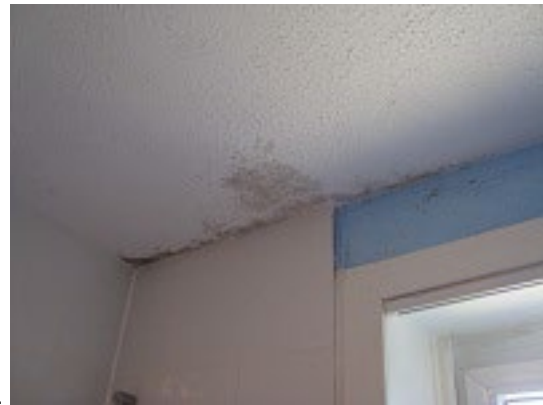
7.1.5 There is black mould on the bathroom ceiling.

7.1.6 The bathroom ceiling is not damp.

16. BATHROOM CEILING

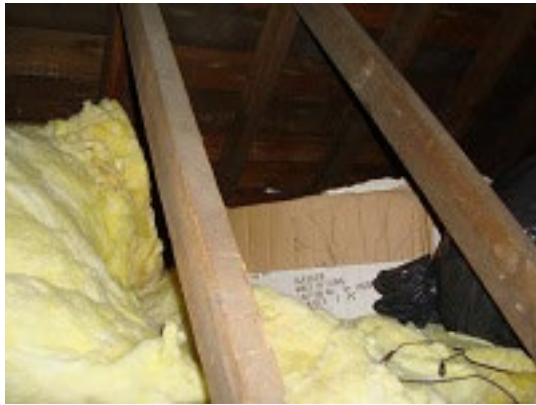
17. ATTIC
