First-tier Tribunal for Scotland (Housing and Property Chamber)

Statement of Reasons: Housing (Scotland) Act 2006 Section 24

Chamber Ref: FTS/HPC/RT/23/0847

Property: 21b Kirk Brae, Fraserburgh AB43 9BY('The House')

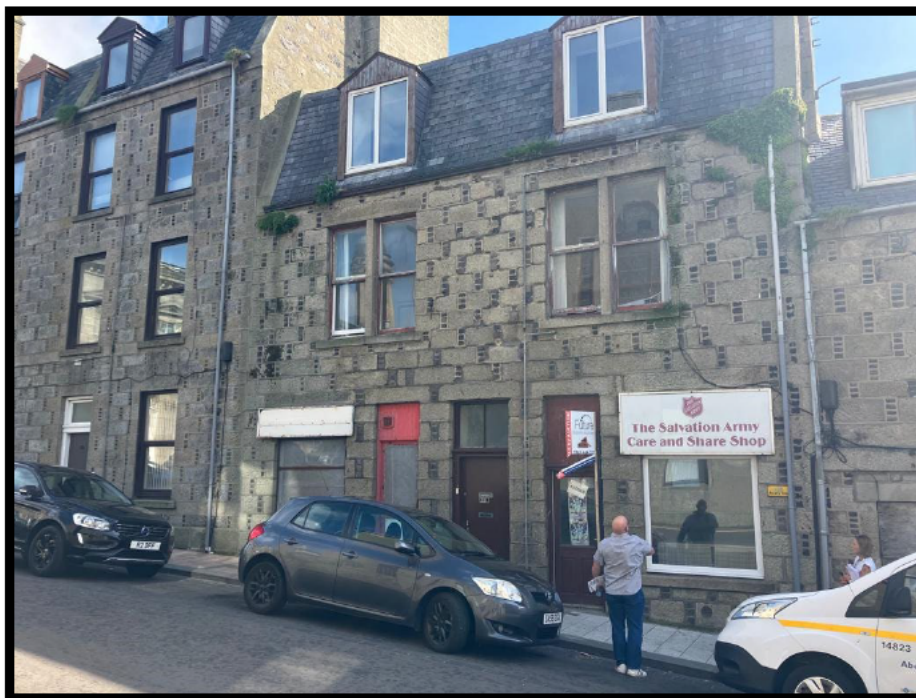
12. Gutters: The front cast iron gutter was choked with vegetation and heavily corroded. There was green staining to the right of the lounge window, indicative of previous or current leakage from the gutter. There was significant vegetation growth below the gutter at the left side of the building and around the head of the downpipe at the right side of the building. At the rear of the building, the middle section of the gutter was missing, with short lengths remaining at each end of the eaves. The sections that remained were choked with vegetation.

Photograph 1 Front (Western elevation): Communal entrance, first floor lounge and Bathroom windows, vegetation in rainwater goods.

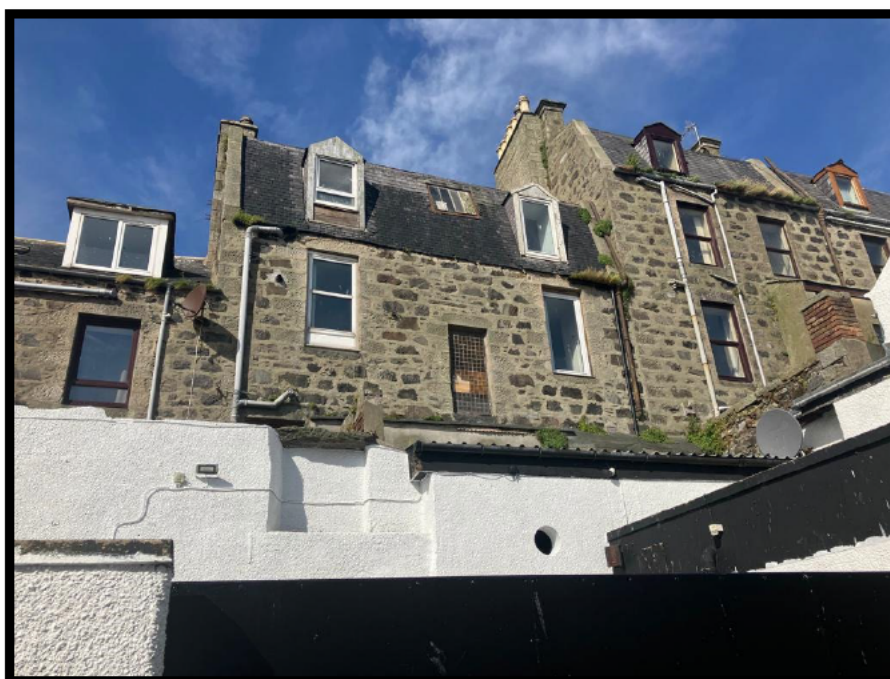
- e. The gutter to the rear of the house is missing the middle section. The remaining sections are choked with vegetation. It does not adequately drain rainwater from the house.

- f. A number of slates were missing from the roof of the house below the dormer window exposing the roof timbers.
- g. The flashing at the change in roof pitch and the skylight over the staircase were in a poor state of repair. The rear window of the attic flat, above the kitchen of the subject flat, was in poor condition with decay to timbers and the lower panel was missing.

Photograph 2 Rear Elevation: First floor Kitchen and Bedroom windows, defective rainwater goods, missing slates.

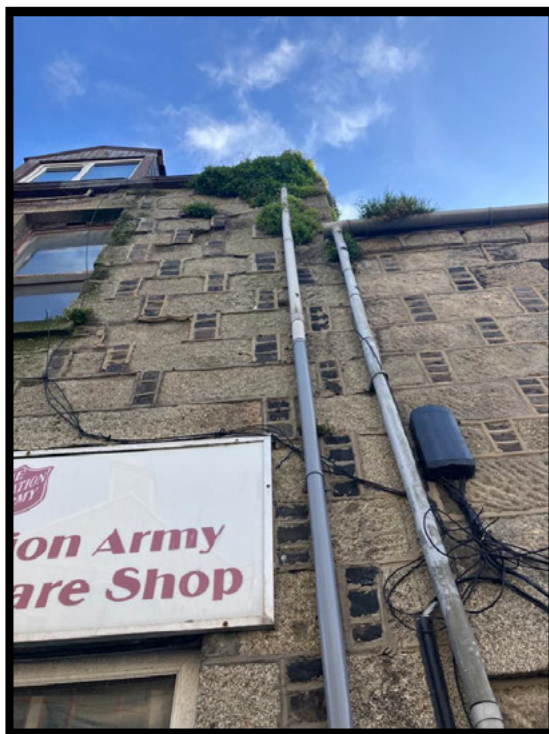
- d. The gutter to the front of the house is in a state of disrepair. It is corroded, choked with vegetation and does not adequately drain away water from the roof of the house.

Photograph 3 Front elevation: Vegetation to rainwater goods and masonry.

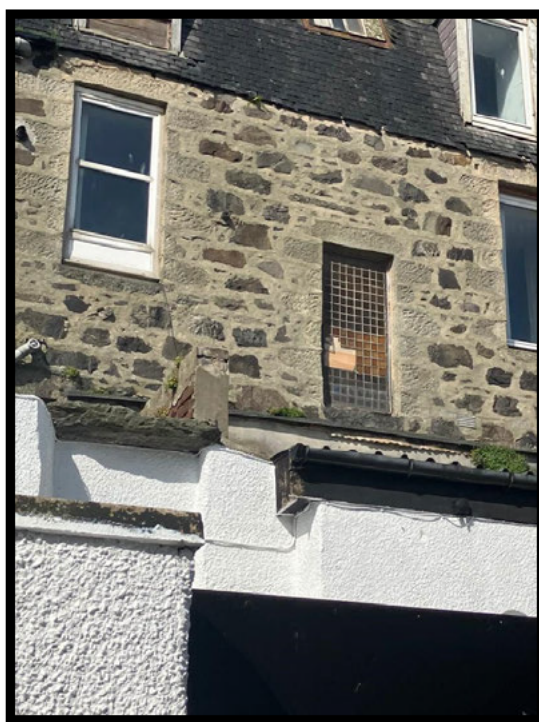
Photograph 4 Rear elevation: Damage to stairwell window, missing slates adjacent to top floor dormer.

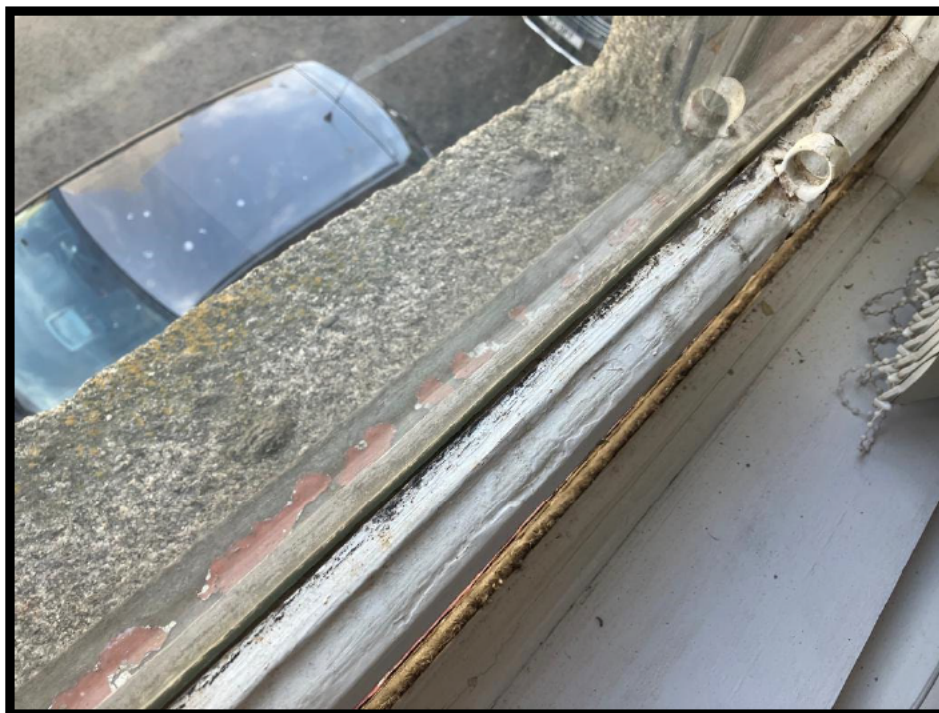
10. The Tribunal inspected each of the items specified in the application.
11. Windows: There was some decay and softening of timbers to both front windows. There was a broken sash cord to one of the sashes in the lounge. The putty was cracked and missing in places. Some of the sashes were painted shut and could not be opened. The front windows have relatively low internal sill heights. There was no way of restricting the opening of these windows to prevent accidental falls by children. The rear bedroom window had been replaced recently with a new, PVC framed, double glazed unit. The kitchen window was an older, PVC framed double glazed unit. Both upper and lower double glazed units panes had a degree of moisture between the panes of glass.

Photograph 6 Lounge window: Decay to timbers, weathered décor, perished putty.

- 29. The Tribunal accepted that the landlord had instructed new windows to be fitted to the front of the property however at the date of the inspection and hearing the windows had not yet been repaired.

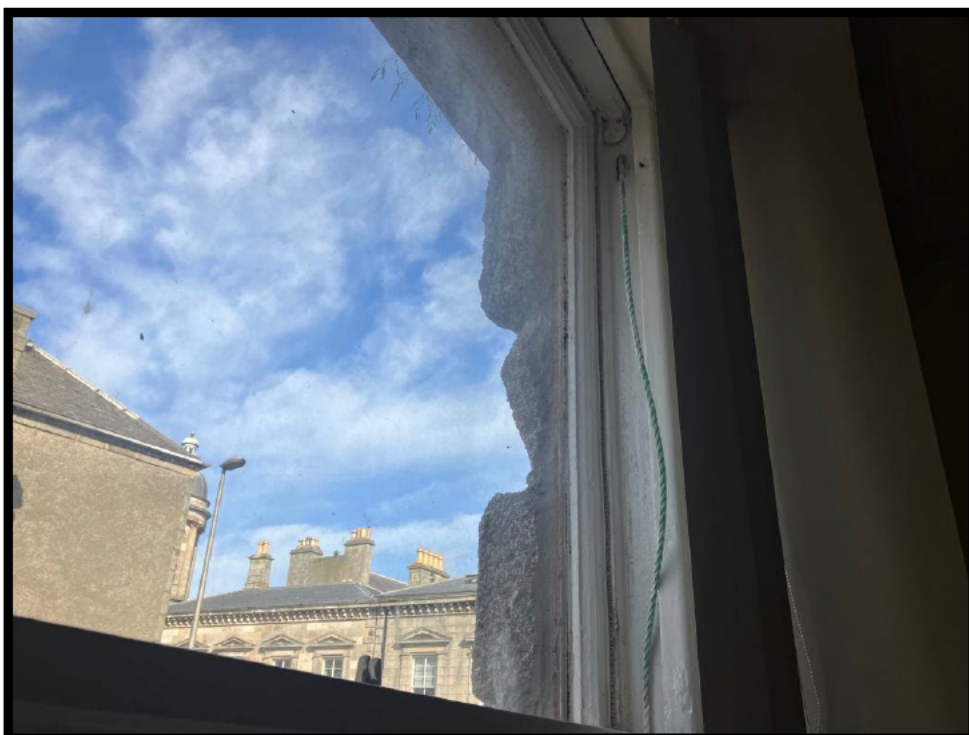
Photograph 7 Lounge window: Broken sash cord.

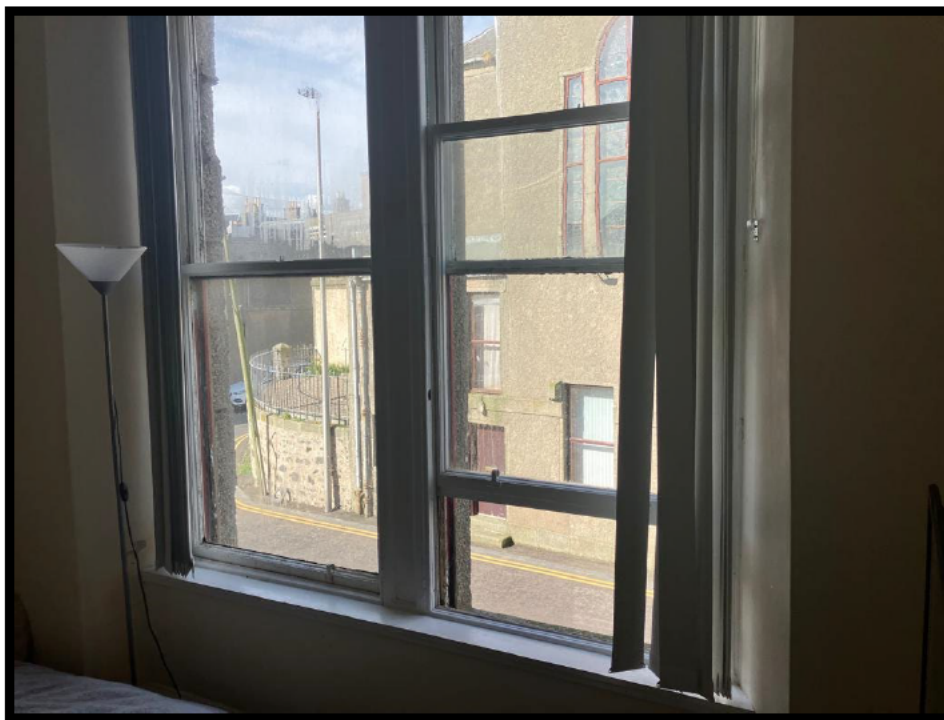
- c. The two windows at the front of the house are in a state of disrepair and represent a risk to the tenants as the opening mechanism is not child safe and some windows have been painted shut.

Photograph 8 Bedroom window: Overview, no method of restricting opening, low sill height

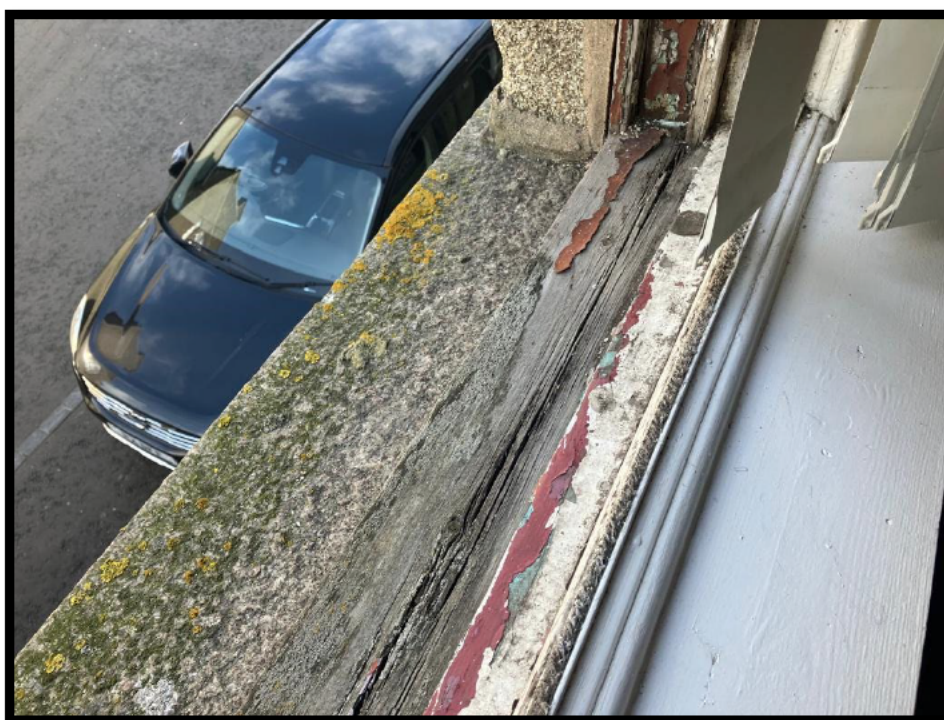
Photograph 9 Bedroom window: Rot to sill, weathered décor.

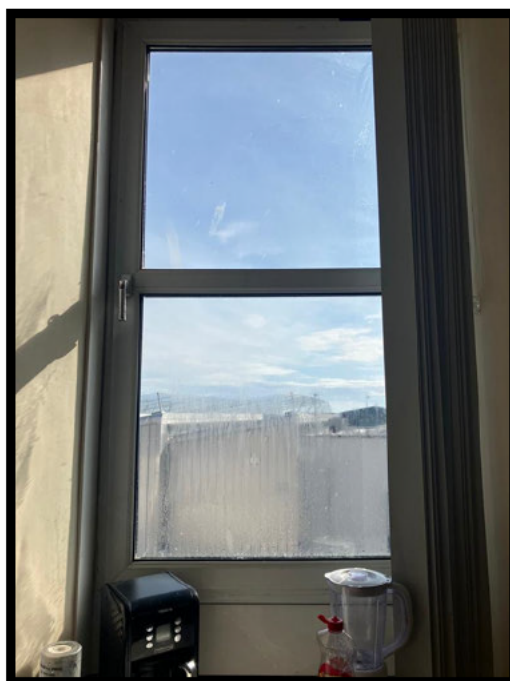
Photograph 11 Kitchen: Window: misted panes.

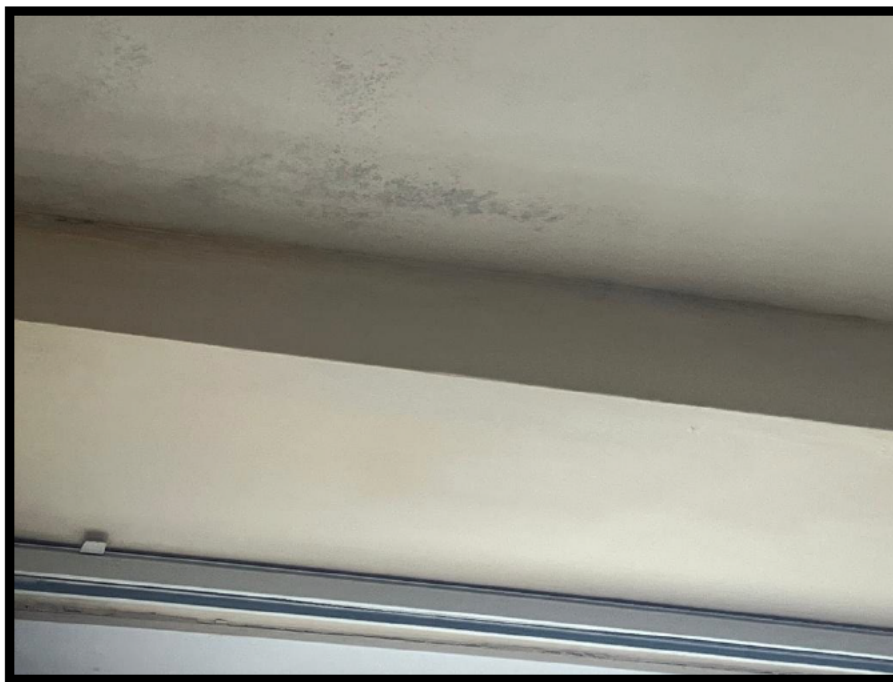
- h. Water ingress has taken place in the ceiling above the kitchen window.

Photograph 12 Kitchen: Staining above window from previous damp ingress.

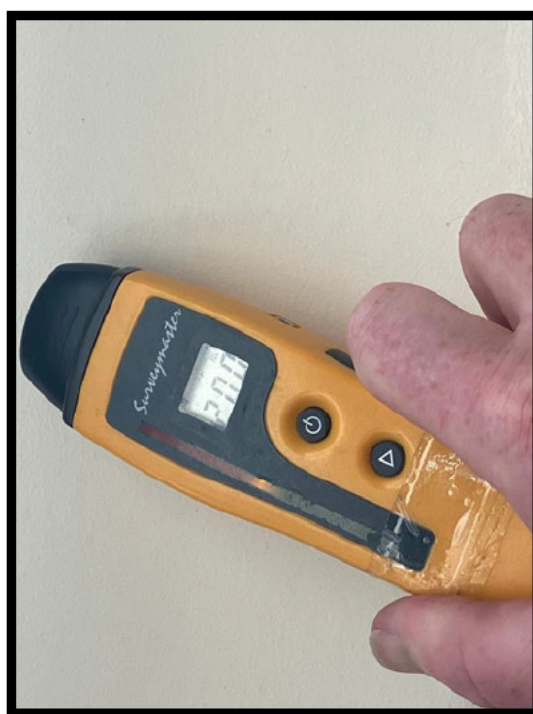
15. It was noted that there was some dampness caused by water ingress to the ceiling above the kitchen window with elevated damp meter readings around the window.
16. The landlord indicated at the conclusion of the inspection that he would not be in attendance at the hearing. He advised that he had instructed new windows to be fitted at the front of the property. He also provided an EICR to the third party.

Photograph 13 Kitchen window frame: Moisture reading 20%.

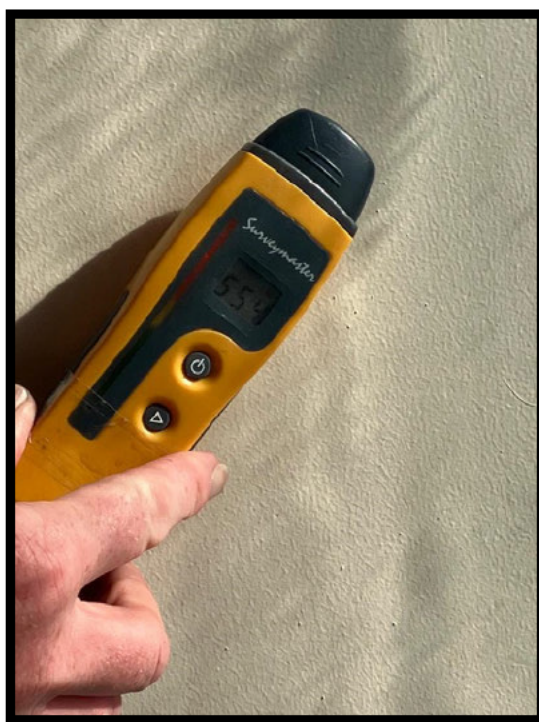
Photograph 14 Kitchen window ingo: Moisture reading 55%.
