**Housing and Property Chamber**  
First-tier Tribunal for Scotland

**Decision with Statement of Reasons of the First-tier Tribunal for Scotland (Housing and Property Chamber) under Section 24(1) of the Housing (Scotland) Act 2006**

**Chamber Ref: FTS/HPC/RP/0473**

**Re: Property at 2 Kirkton, Appin, PA38 4DL ("the Property")**

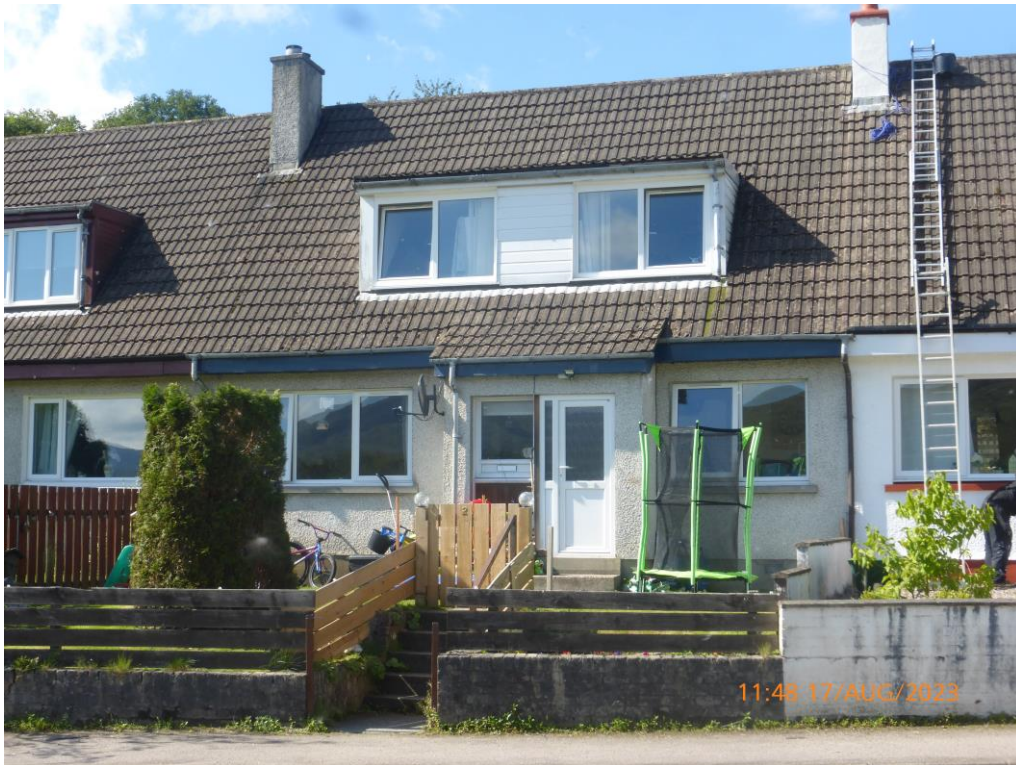
Front

- 15 The Tribunal inspected the gutters and noted those to the rear of the property were full of vegetation. There was some rot to the facings at the front of the property and to the rear at the lower level.

- 28 There is rot in the facings to the front of the property. The window sills and facing require painting.
- 29 There is vegetation in gutters to the rear of the property and moss in the gutters to the front of the property.

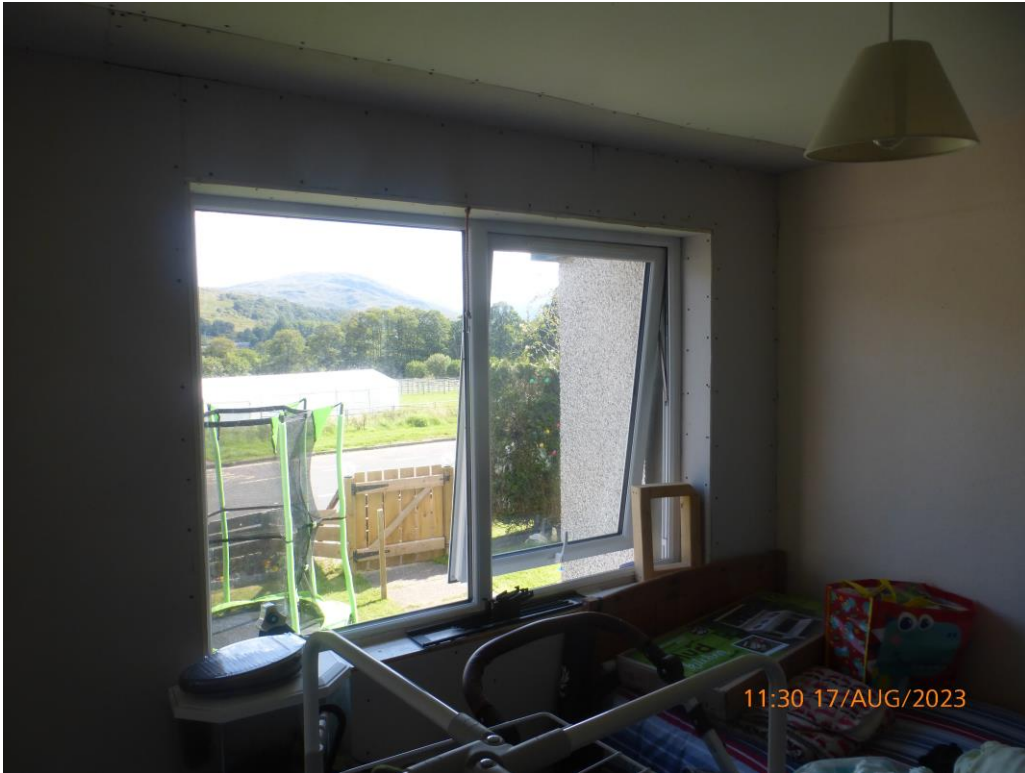
Replaced plasterboard

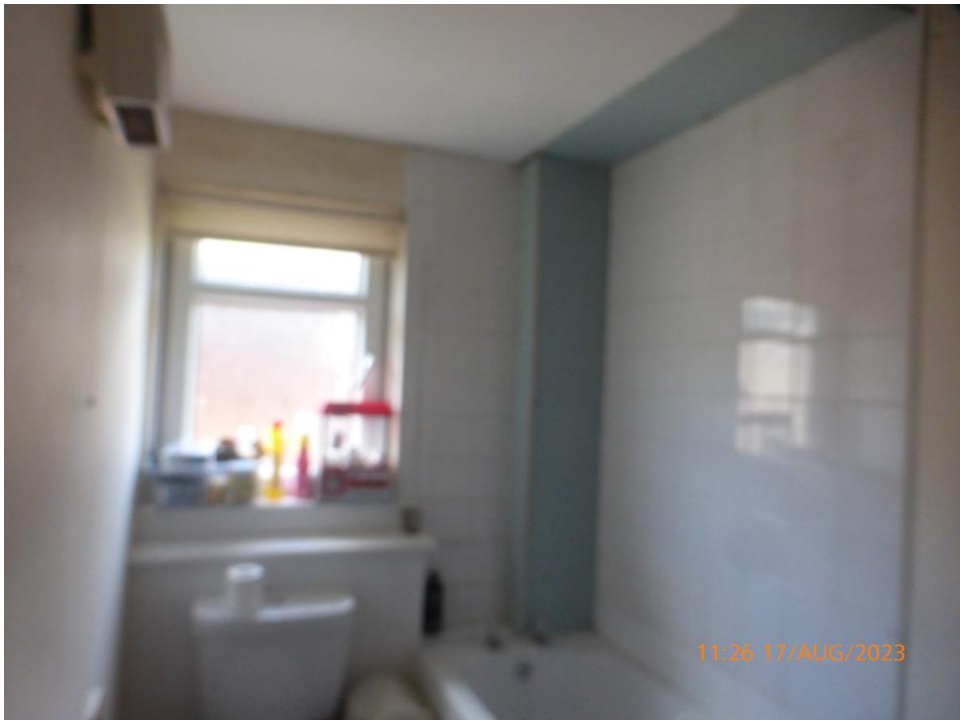
Bathroom

- 10 The Tribunal inspected the bathroom. Plasterboard had been applied to the wall around the bath but had not been decorated. Damp meter readings showed some residual dampness and there was evidence of water staining. There was a small hole in the ceiling. The Tribunal found a similar hole in the ceiling of the downstairs hall.

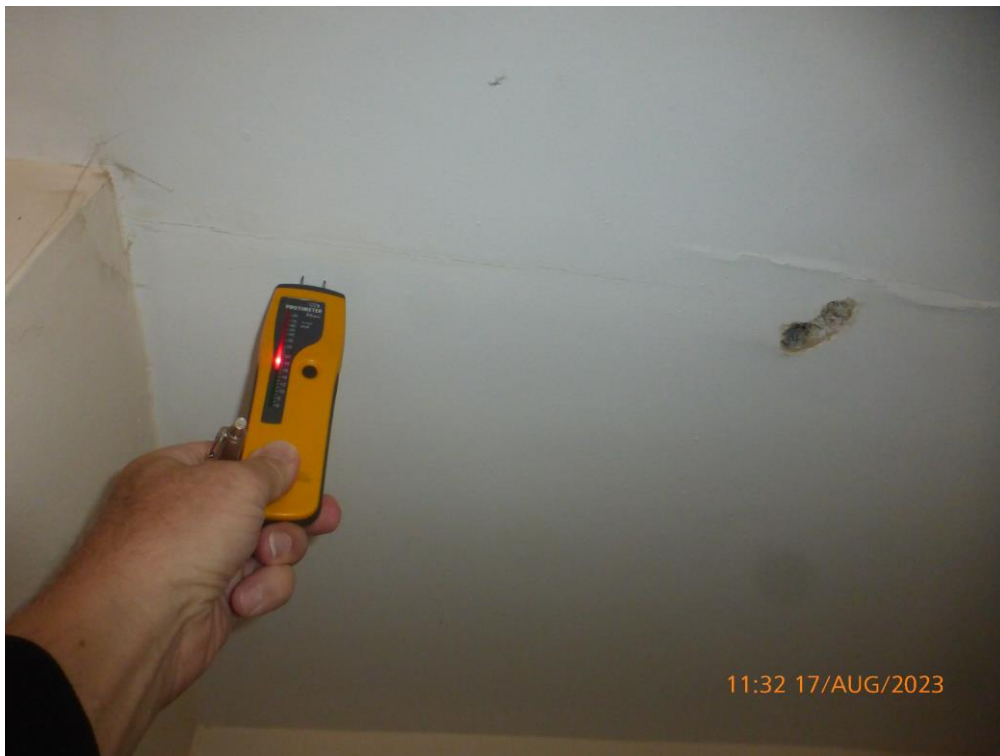
- 26 The radiator in the upstairs bedroom is not fixed to the wall and an electricity socket in the room has no cap leaving bare wiring.
- 27 There are holes in the ceiling in the downstairs hall and the bathroom.

Damp stain and hole in the ceiling

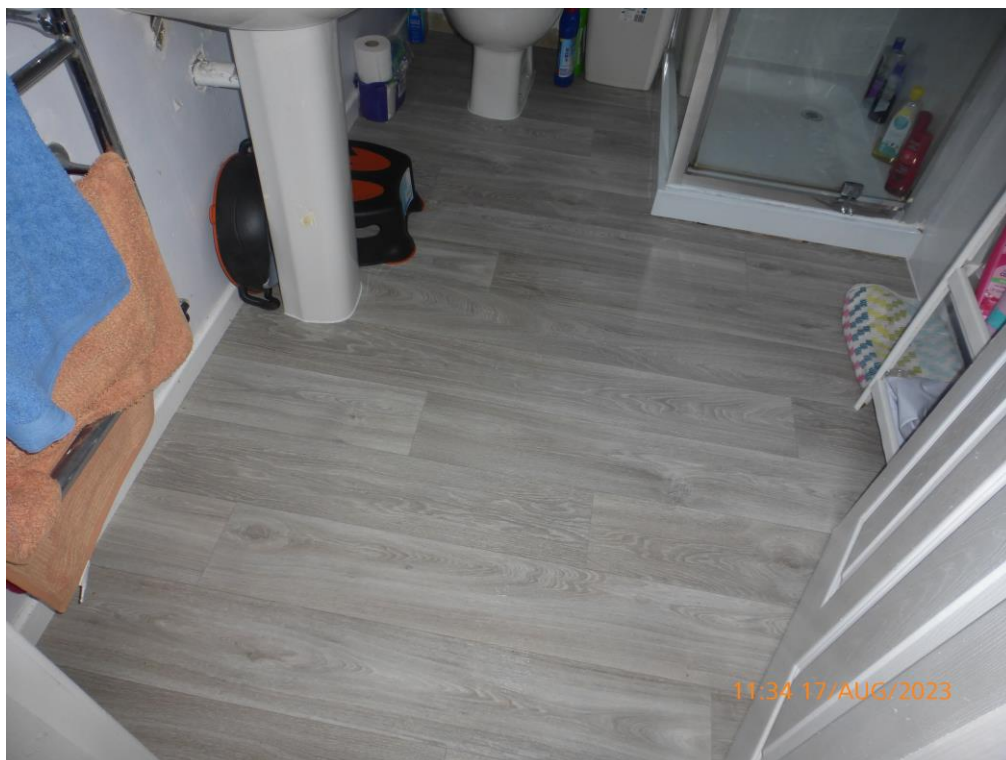
- 12 In the shower room upstairs the wall had been plastered but decoration remained outstanding. The floor covering had been replaced.
- 13 The Tribunal inspected one of the upstairs bedrooms, currently occupied by the Tenant's teenage son. Plasterboard had been replaced on the walls but remained undecorated. The radiator had been taken off the wall but not re-fixed. There was a plug socket that had been left with no facing and exposed wiring.

New floor covering in the shower-room

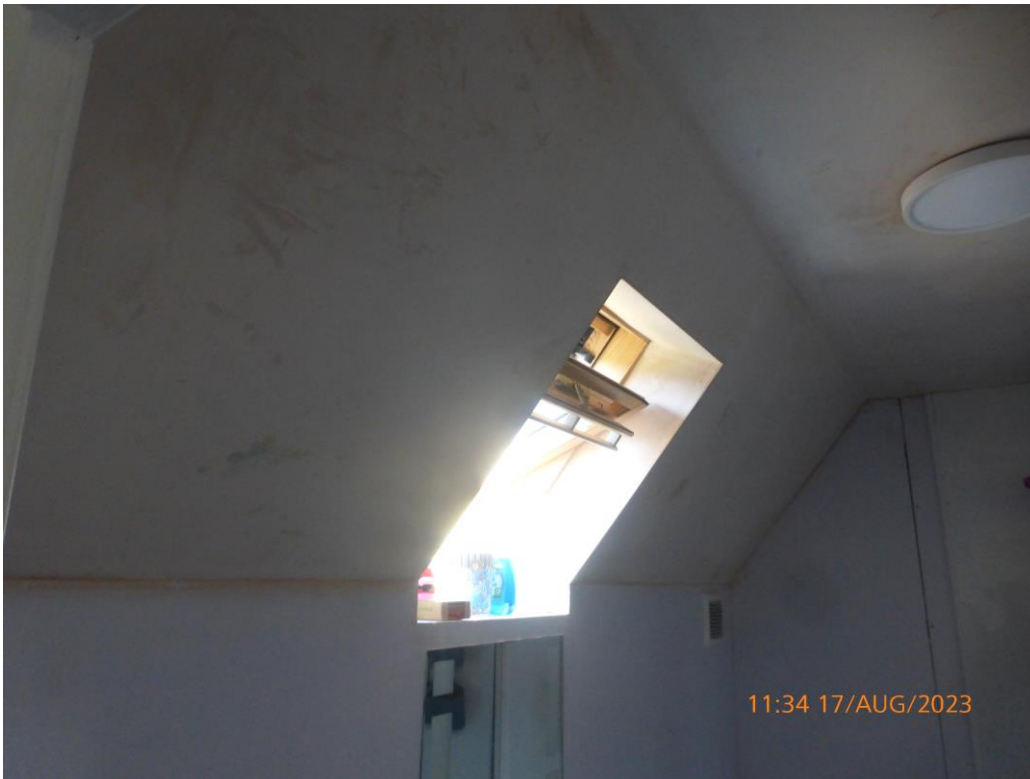
New plasterboard in the shower-room

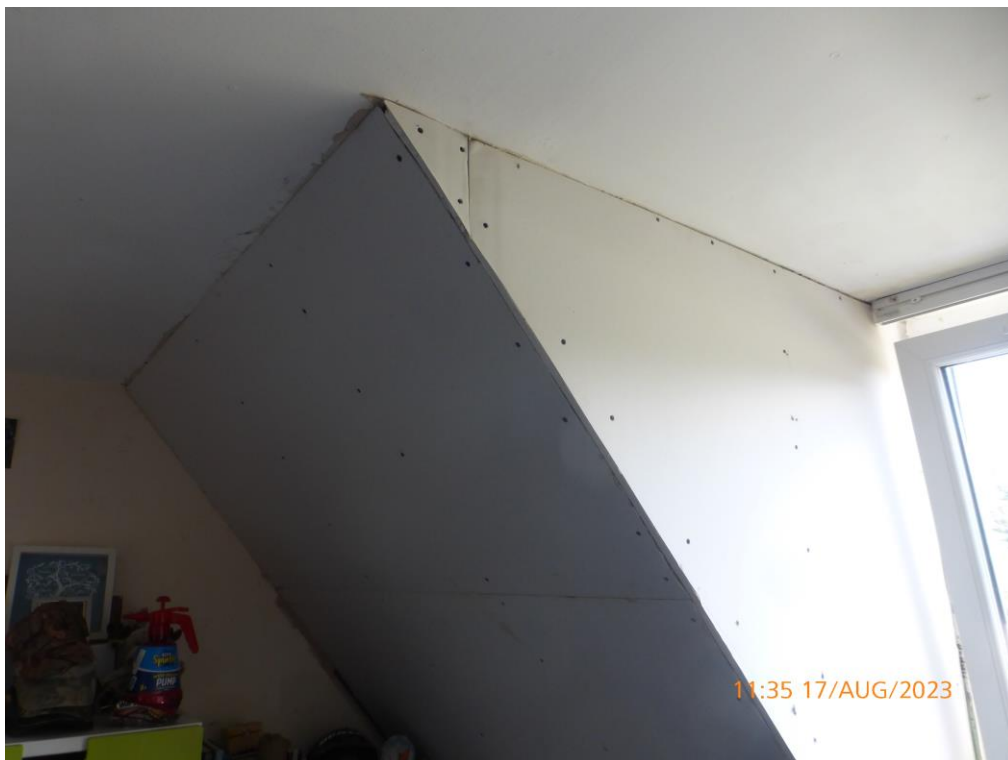
- 11 In the downstairs bedroom new plasterboard had been applied to the front wall and part of the ceiling. Decoration remained outstanding. Damp meter readings in the cupboard showed some residual dampness.

New plasterboard in the bedroom

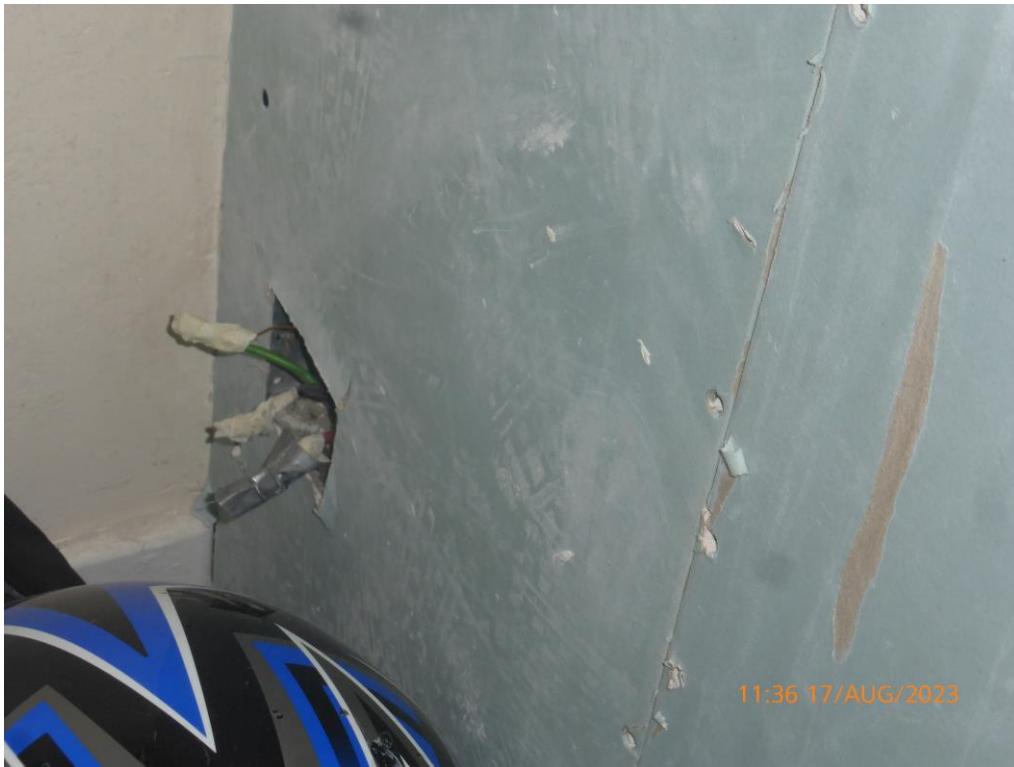
Exposed electrical wiring in the bedroom

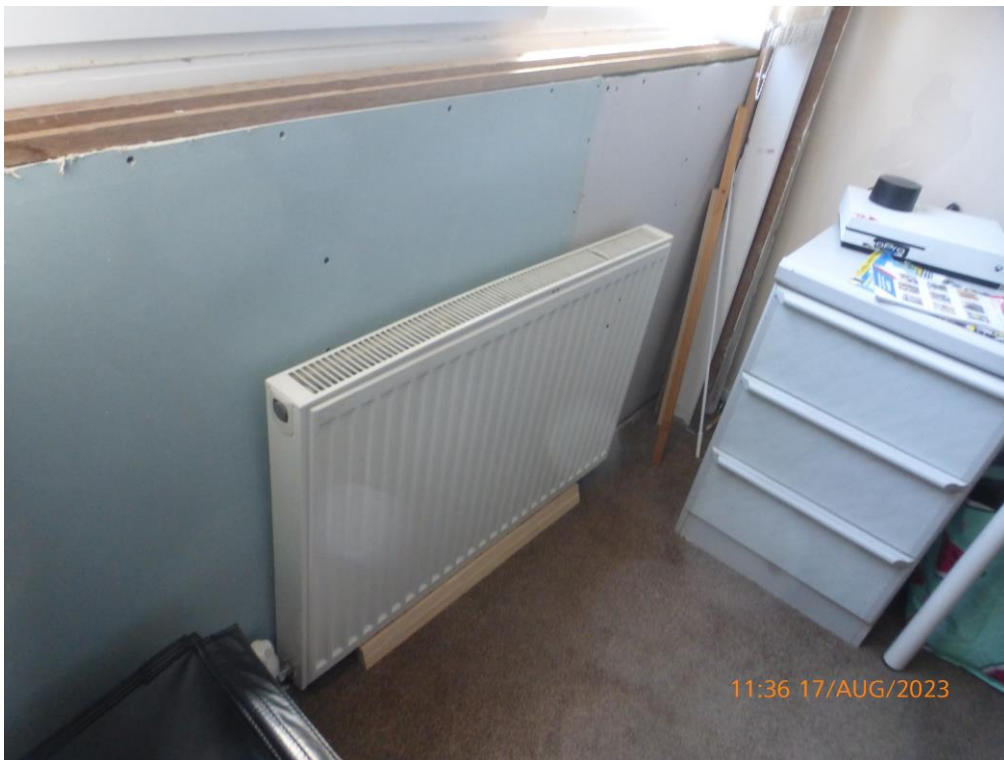
Unsecured radiator

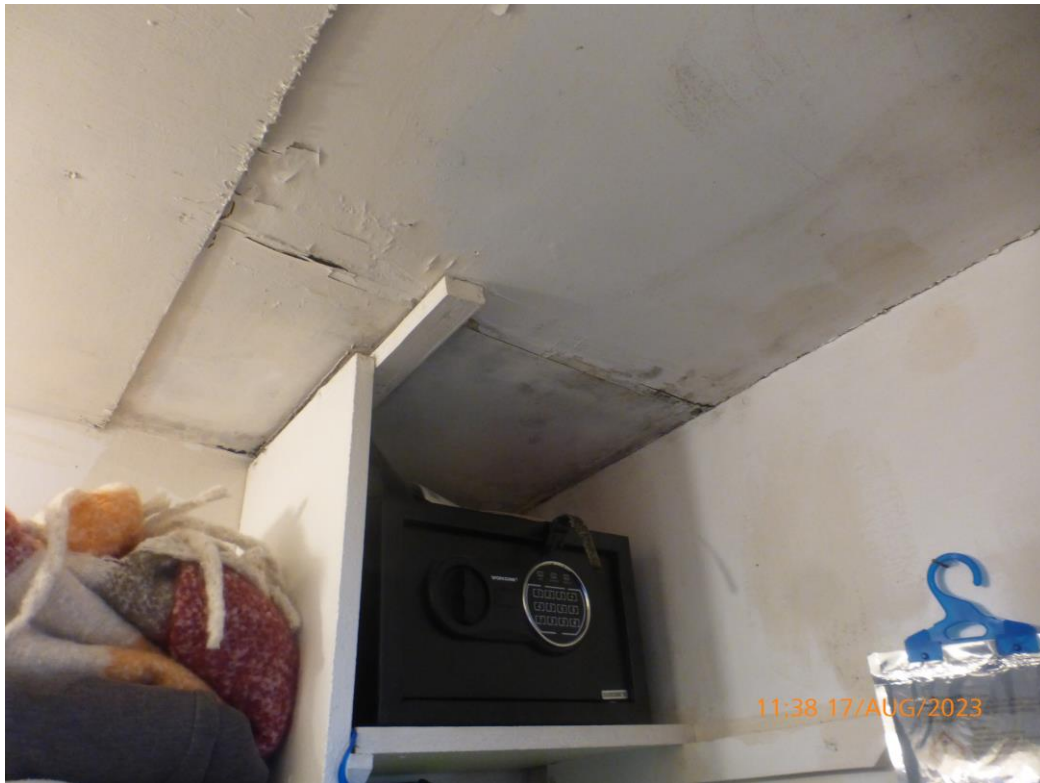
- 14 The Tribunal inspected the second bedroom, currently occupied by the Tenant. Plasterboard had been applied to the wall but remained unfinished. The cupboard had dehumidifier pouches which were noted to be filled with water.

Past staining in the wardrobe

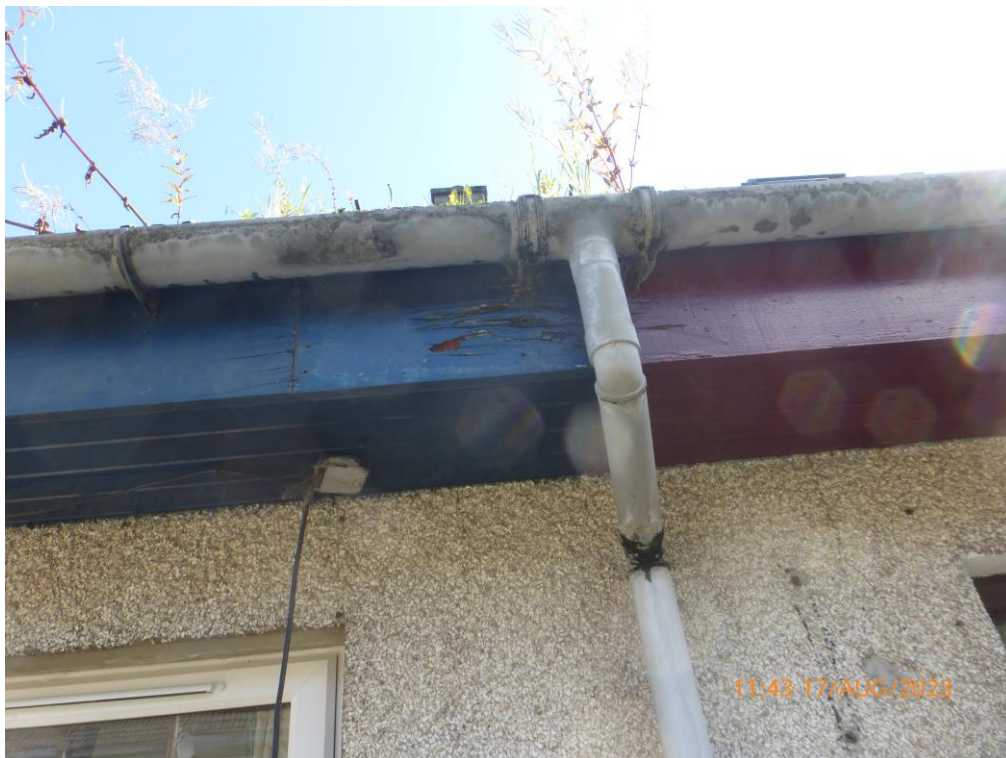
Rotten woodwork below choked rainwater fitting

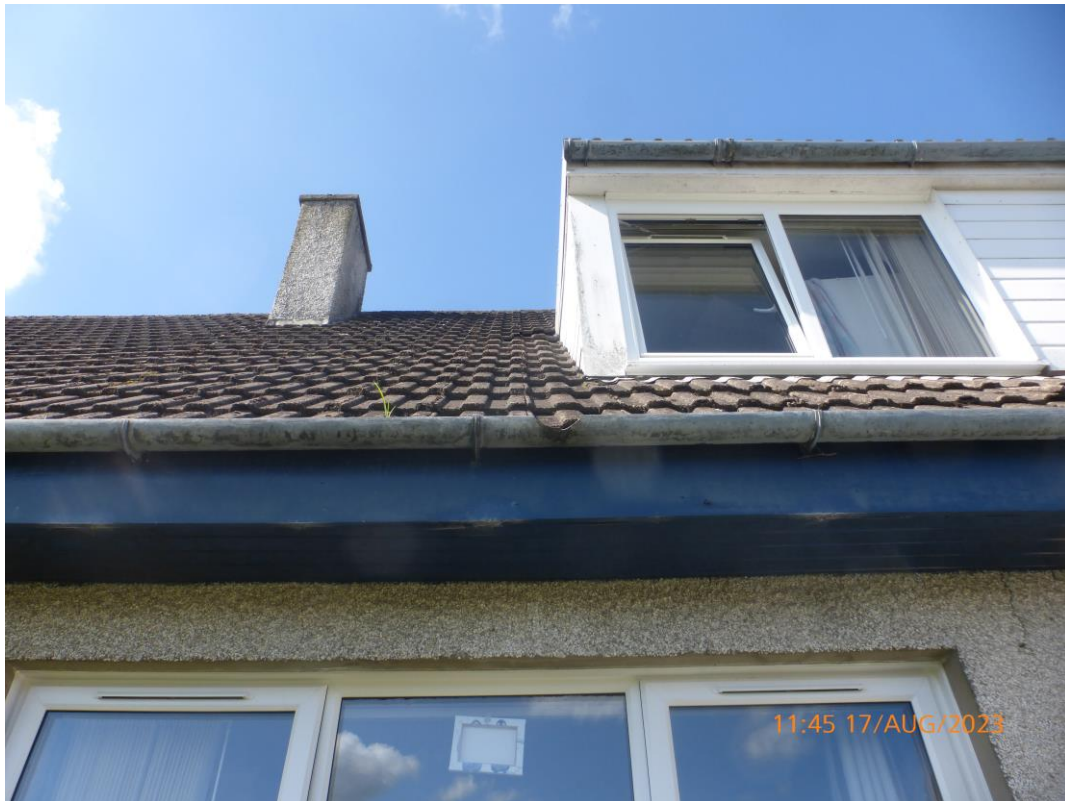
Broken front guttering
