STATEMENT OF DECISION: in terms of Section 24 (1) of the Housing (Scotland) Act 2006 (“the Act”) in respect of an application under Section 22 of the Act

Chamber Ref: FTS/HPC/RP/21/2723

Re: Property at 5 Gigha Place, Broomlands, Irvine, Ayrshire, KA11 1DS registered in the Registers of Scotland under Title Number AYR79476 (“the Property”)

Pre-hearing inspection summary and schedule of photographs

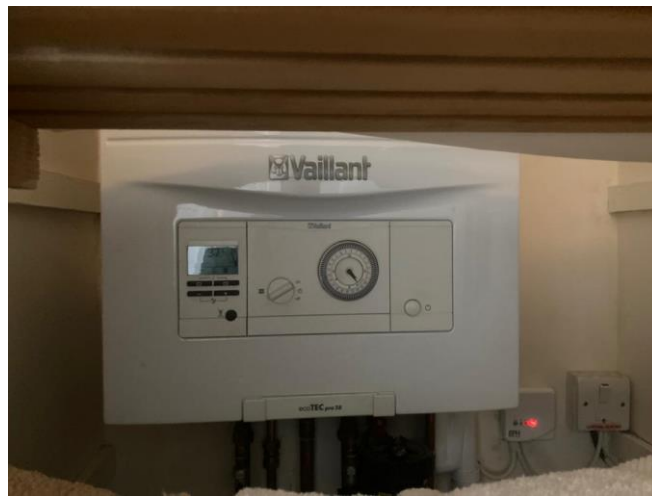
2.

The original application to the Tribunal included an alleged leak within the central heating system which is provided by a wall mounted "Vaillant" boiler. This has since been repaired to the satisfaction of the applicant and no longer forms part of the Repairing Standard application.

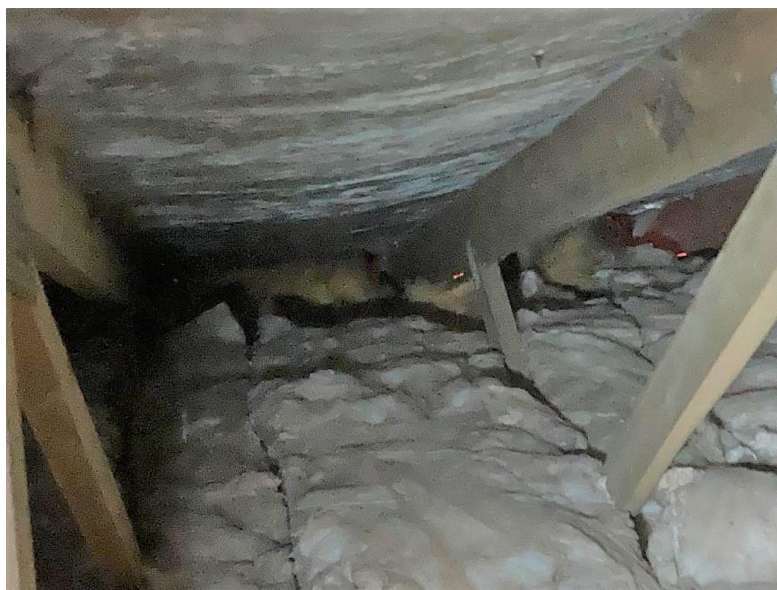
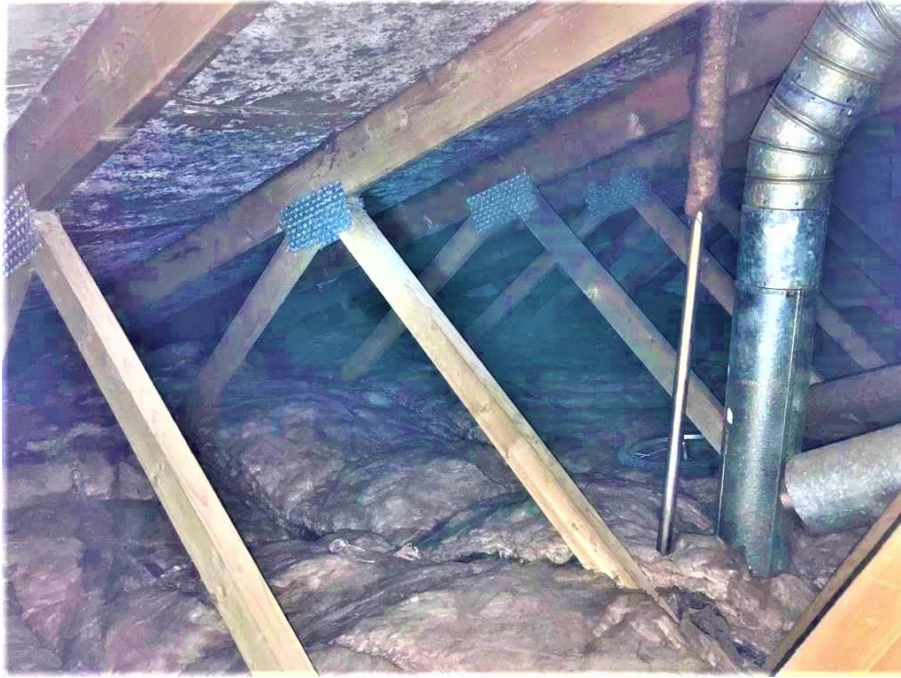
7. The Inspection Report notes the following in respect of each of the heads of complaint listed in the Application:
 - i) Replace roof: Photographs 18 and 19 show the pitch of the roof. Photographs 3 and 4 show the roof space and the rafters. Due to the shallow angle of pitch, when viewed externally from ground level it was difficult to determine the condition of the roof tiles. However, the rafter timbers appeared to be relatively dry. The insulation in the roof space is significant and is restricting ventilation within the roof void, specifically at the eaves and at the front of the Property where the angle of the roof is shallow.

Photographs 3 and 4 detail damp staining and mould growth on the plaster board panel sarking within the roof void. The significant (approx 300mm) insulation is restricting ventilation

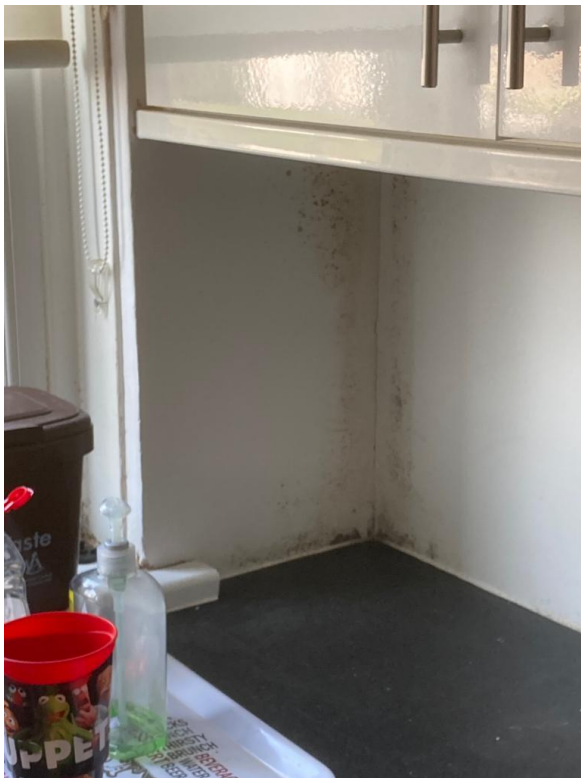
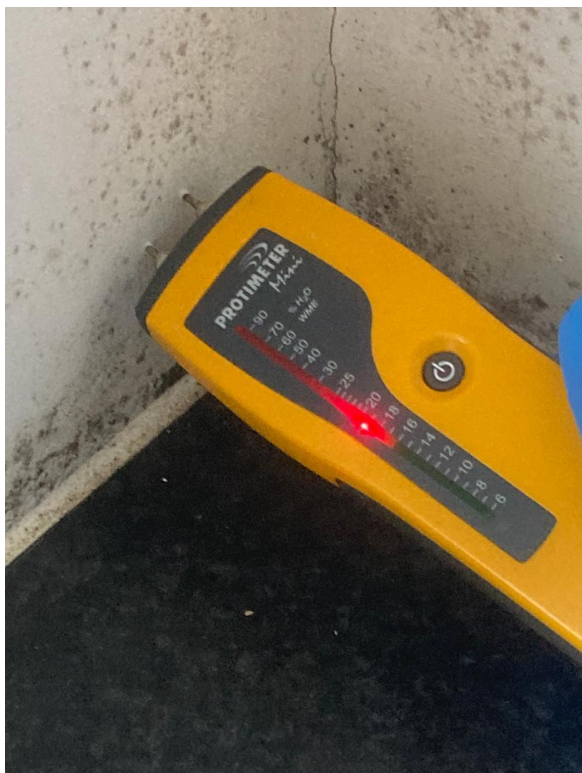
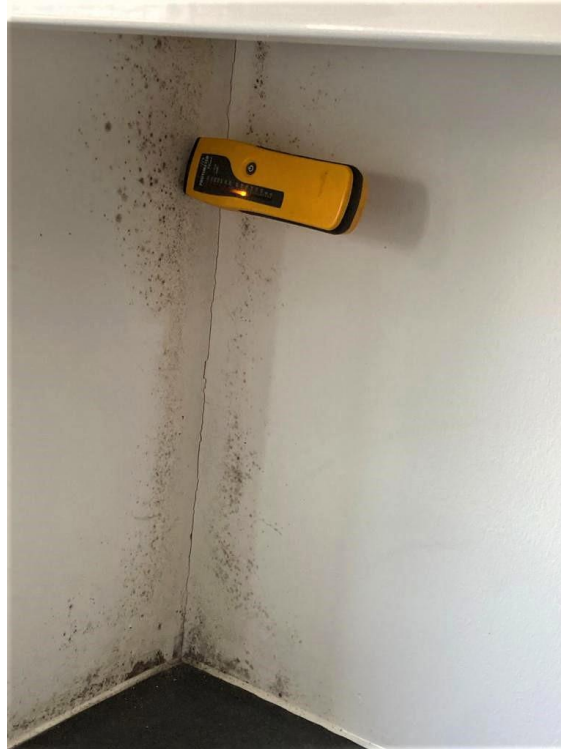
Photographs 5-7 identify damp staining and mould growth within the kitchen at a level likely to cause further deterioration to the property if left unchecked.

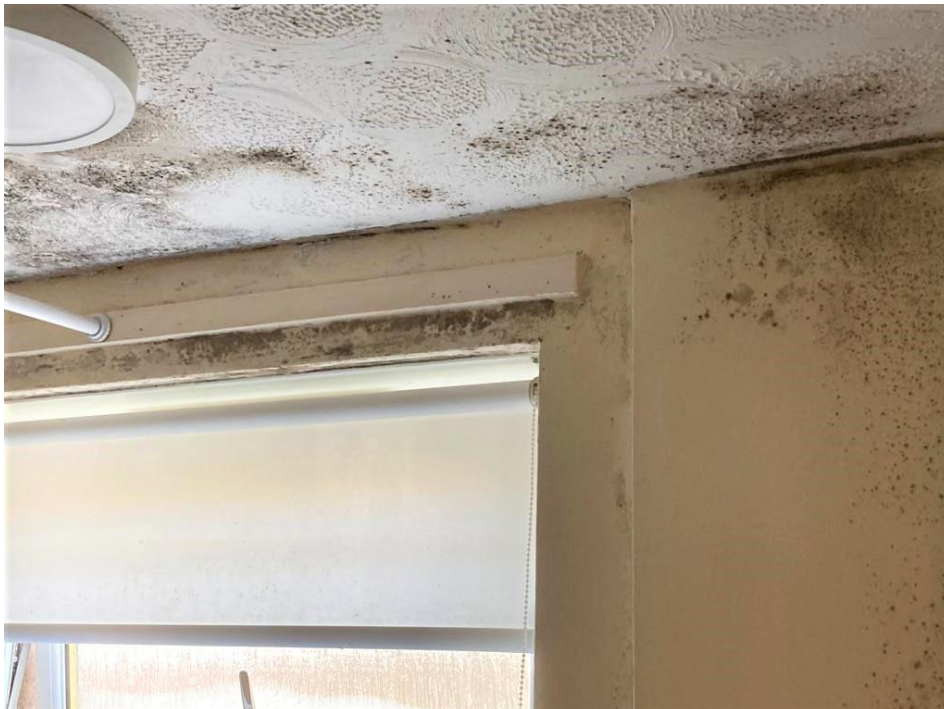
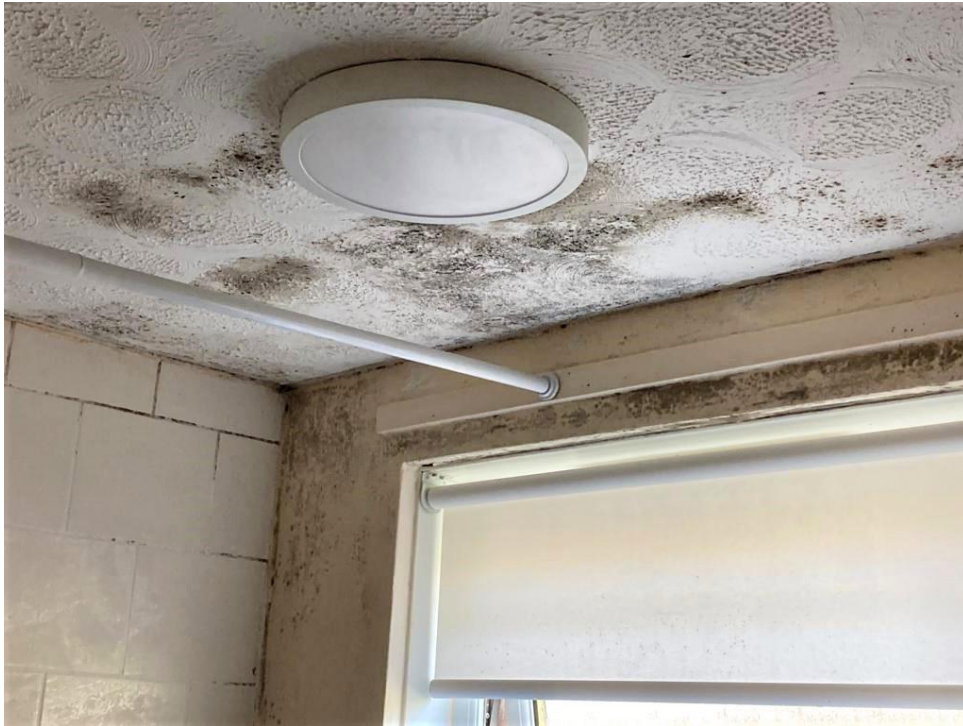
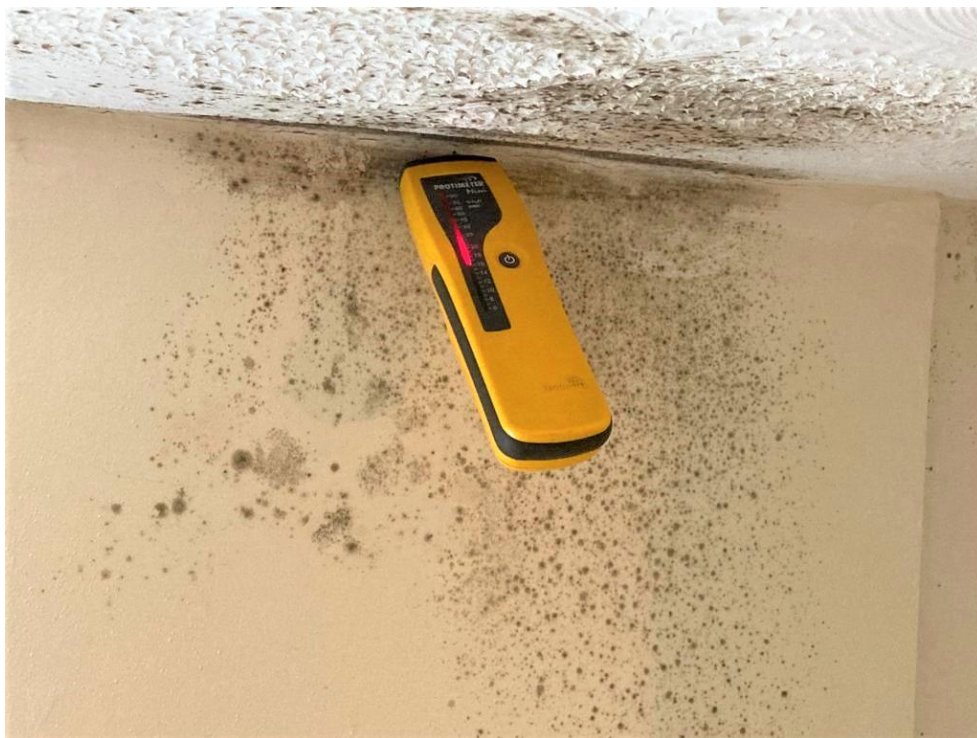
Photographs 8 – 10 identify significant damp staining and mould growth within the bathroom at a level likely to cause further deterioration to the property if left unchecked.

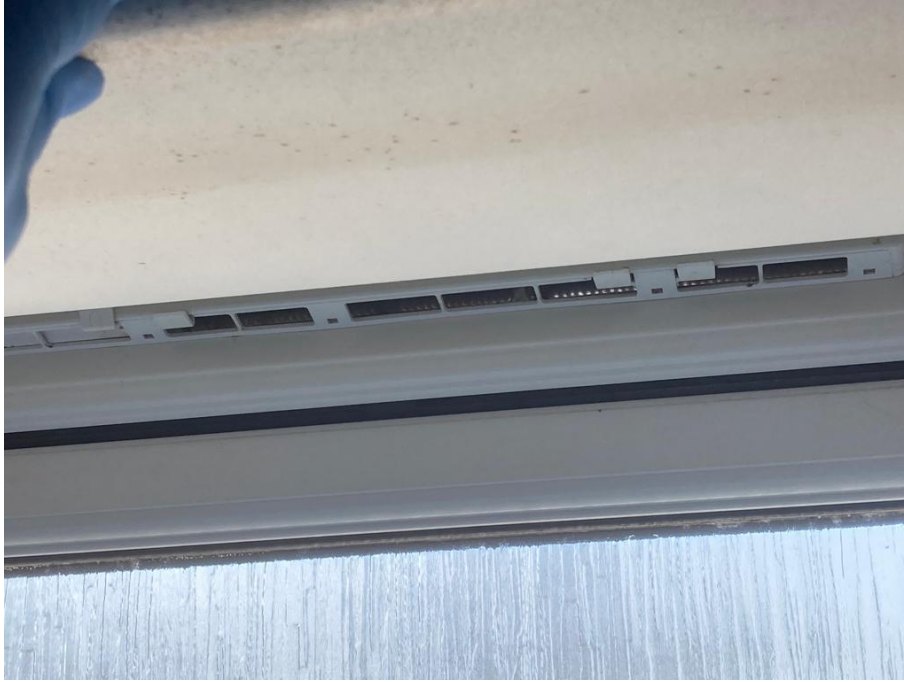
11.

Open ventilator at the bathroom window.

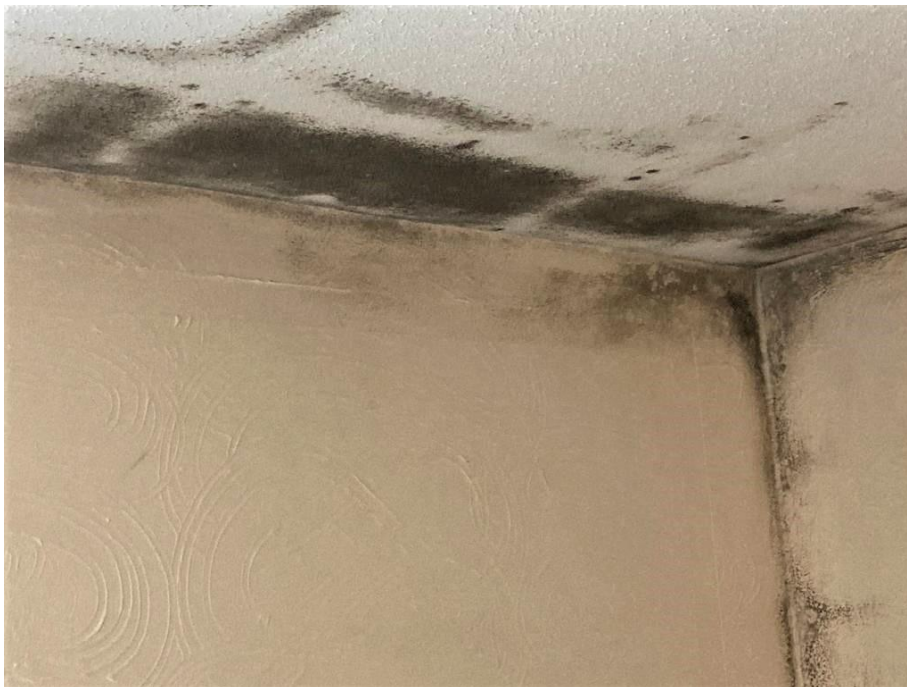
12

Damp staining and mould growth affecting the ceiling and internal walls of the front bedroom.

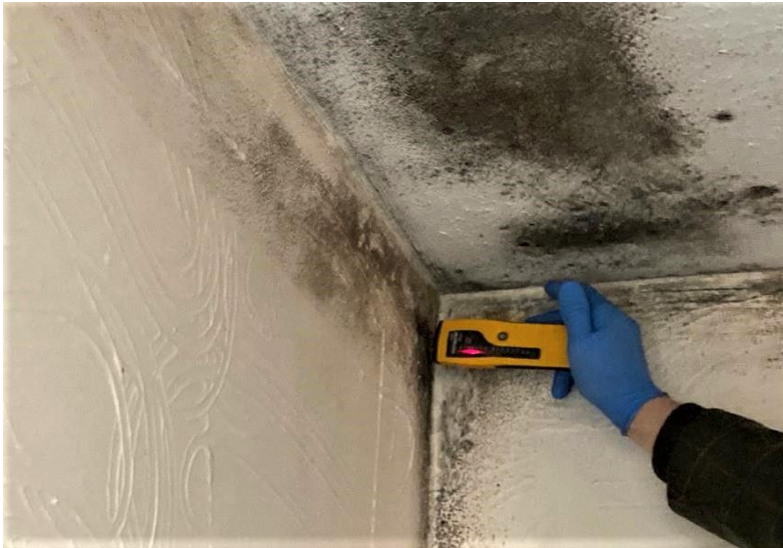
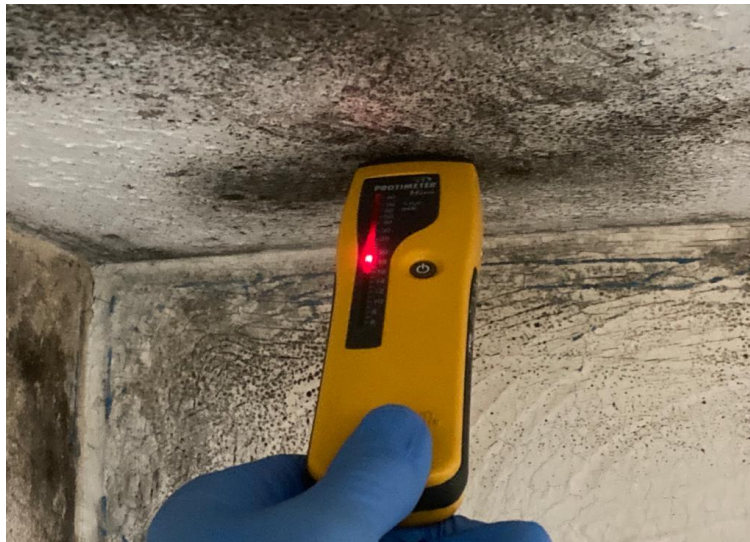
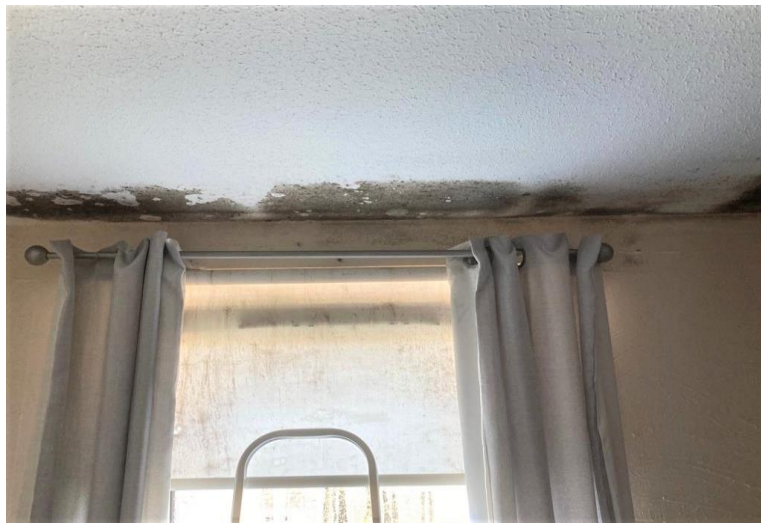
Photographs 13 – 15 illustrate damp staining and mould growth affecting the ceiling and internal walls of the front bedroom at a level likely to cause further deterioration to the property if left unchecked.

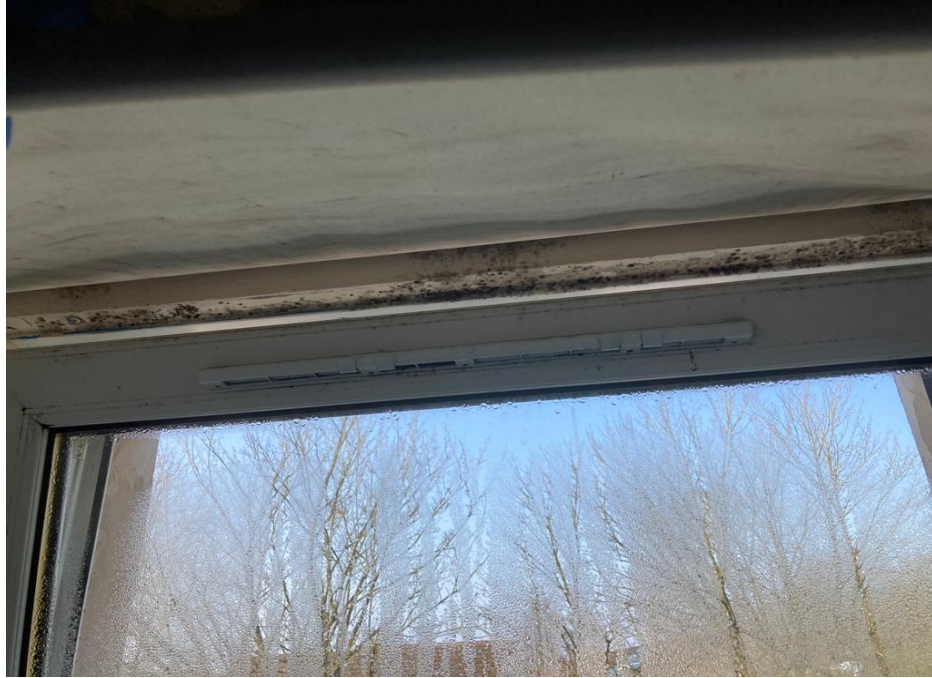
16.

Open ventilator at the front bedroom window.

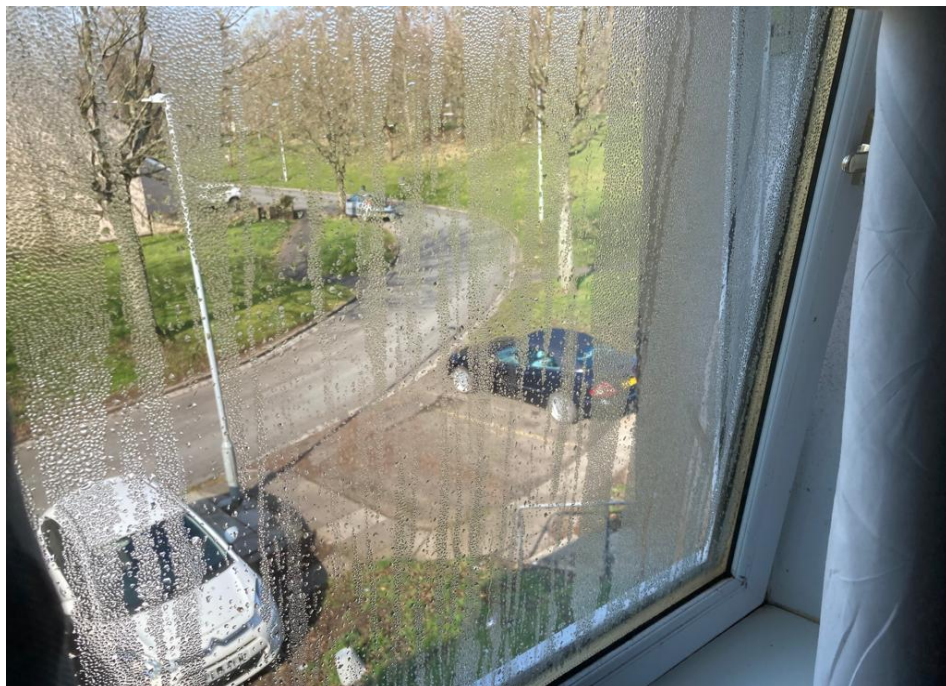
17

Condensation on the internal face of the front bedroom window.

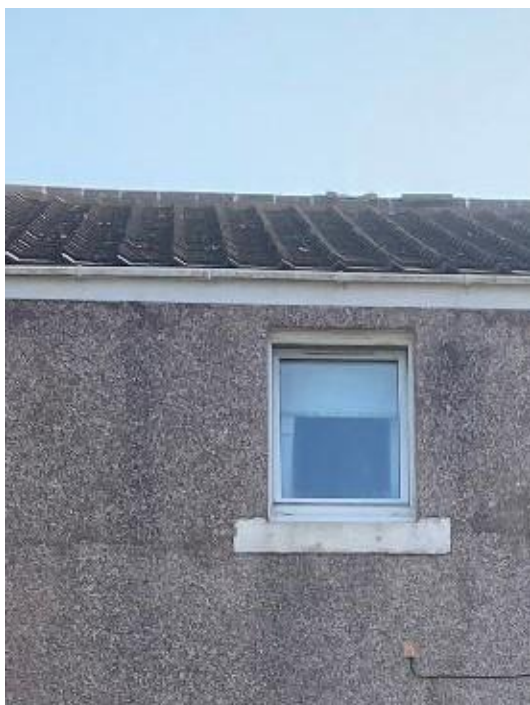
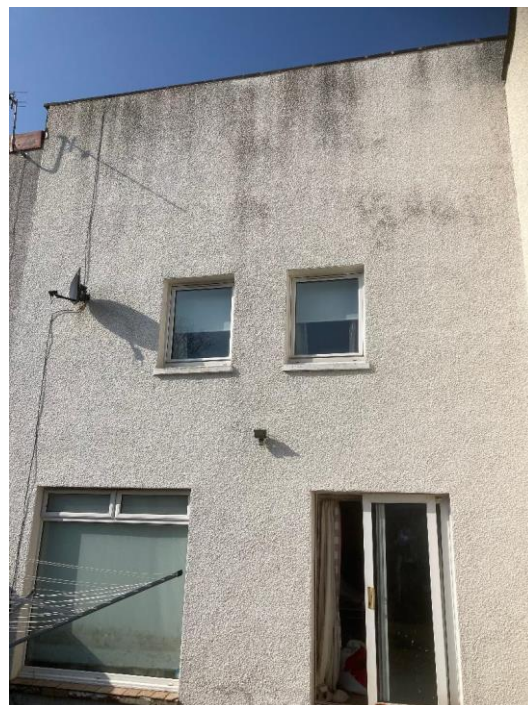
The roof is of a relatively shallow mono pitch design rather than a more traditional dual pitch with a central ridge. It slopes up from the front elevation to the rear wall head. The angle of pitch is shallower than in a more traditional dual pitched roof. The type of tiles used, as detailed in photograph 18, are of a design suited to a shallow roof pitch. Due to the shallow angle of pitch, when viewed externally from ground level it is very difficult to determine the condition of the roof tiles.

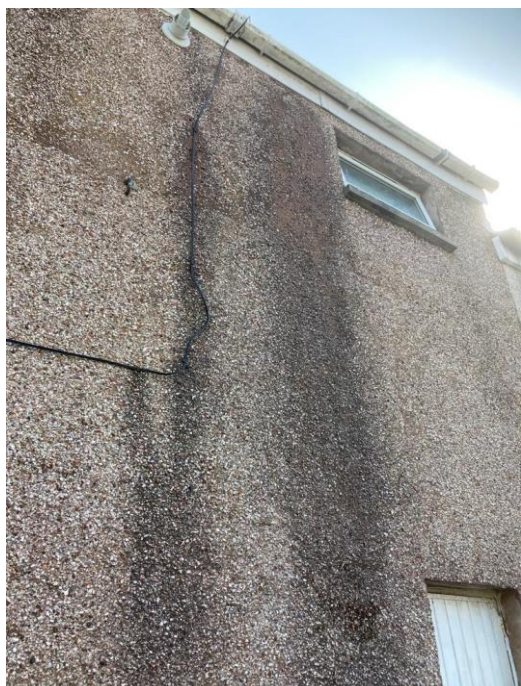
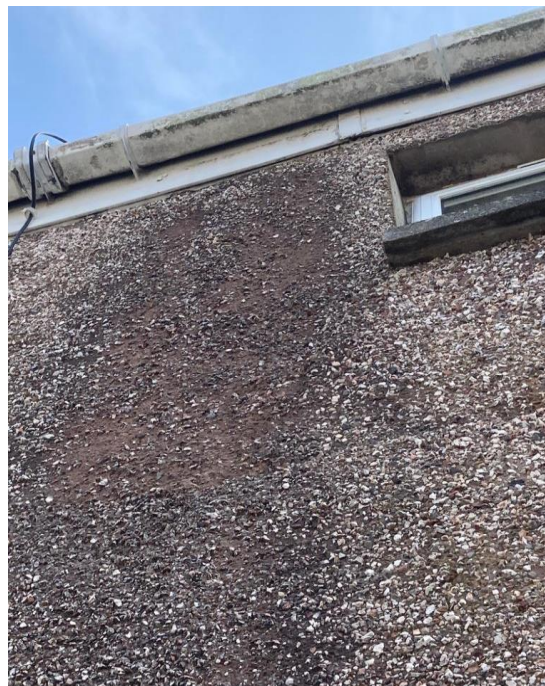
Photographs 20 and 21 illustrate a large area of the wall between the eaves, passing the bathroom window and extending towards the ground floor where the dry dash rendering appears to have been worn or washed away. There are random areas of cracked and bossed rendering.

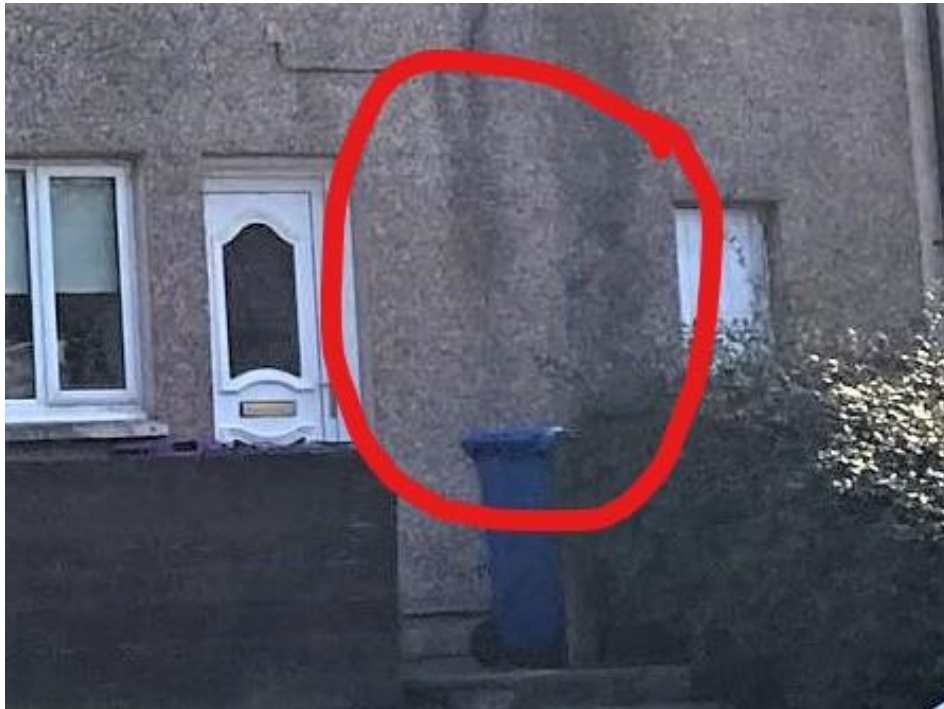
22.

At the area circled in red (photograph 22) the rough cast rendering is entirely “bossed” with little or no adhesion to the brickwork.

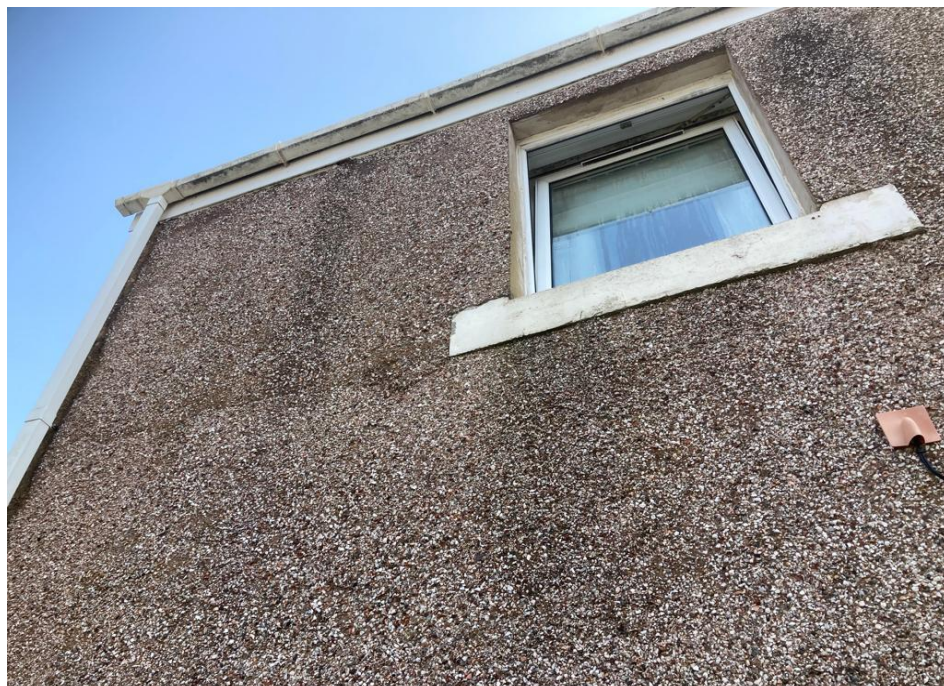
22.

Photograph 22 illustrates further cracked and bossed rendering on the front elevation towards the gable wall.

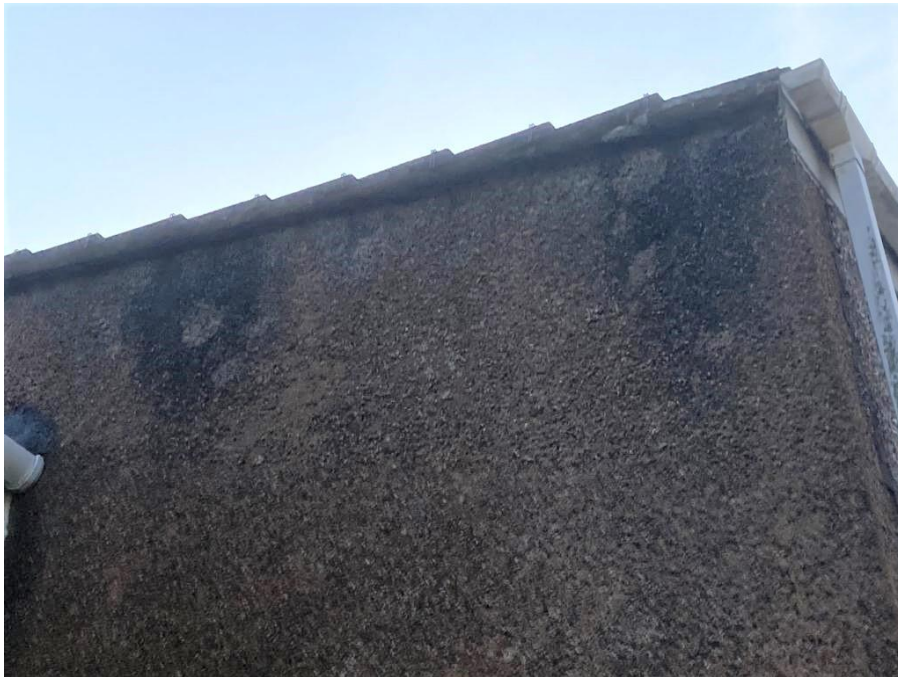
23.

Bossed and cracked rendering at the “gable wall”.
