**STATEMENT OF DECISION: Housing (Scotland) Act 2006 Section 24 (1)**

**Chamber Ref: FTS/HPC/RP/17/0417**

**Property at 11C Laird Place, Glasgow, G40 1JS**

Schedule of photographs taken at the inspection on 18<sup>th</sup> January 2018.

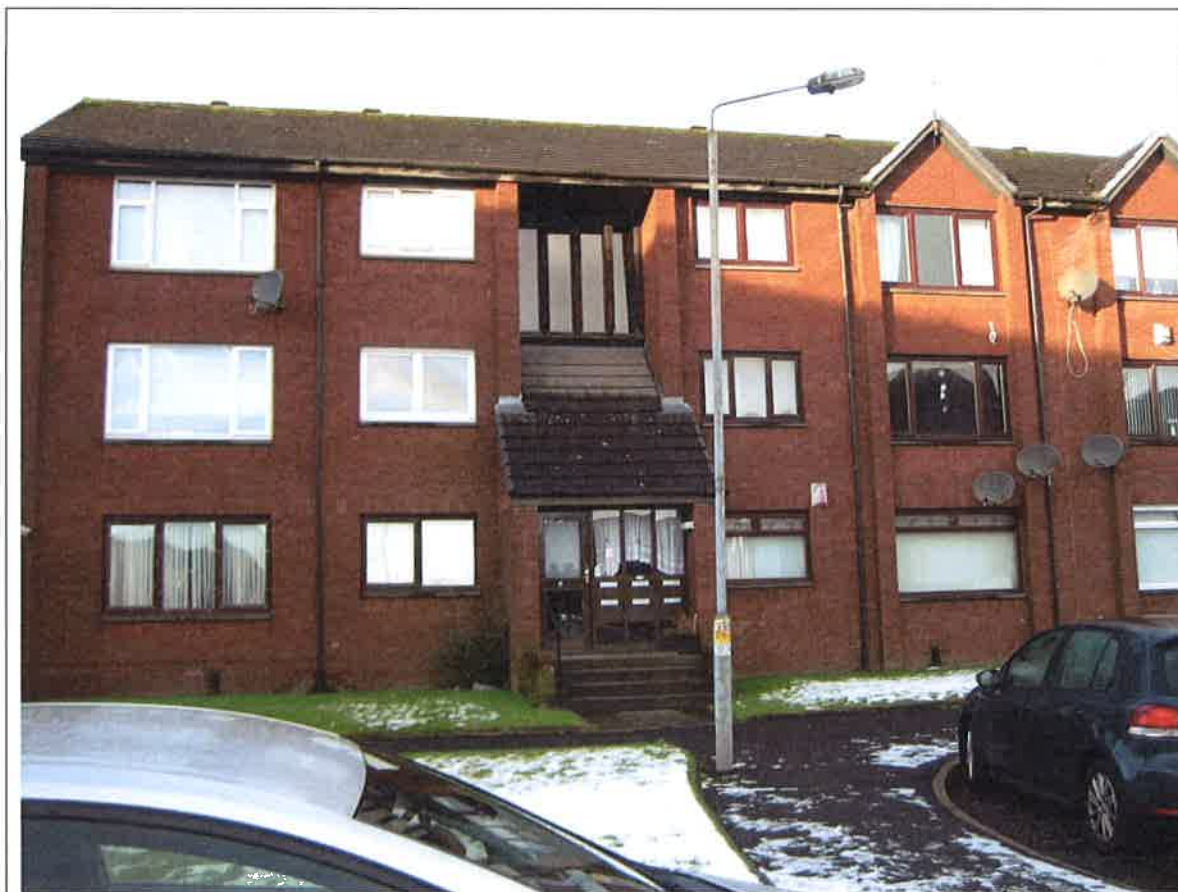
Photo 1 – Exterior of property front

Exterior of property front

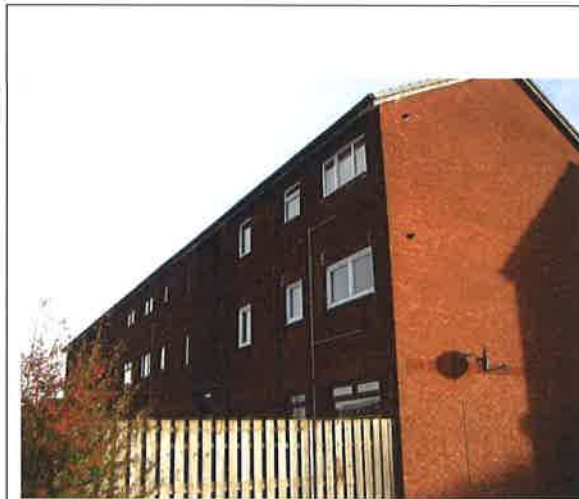
Photo 2 – Exterior of property rear

**Exterior of property rear**

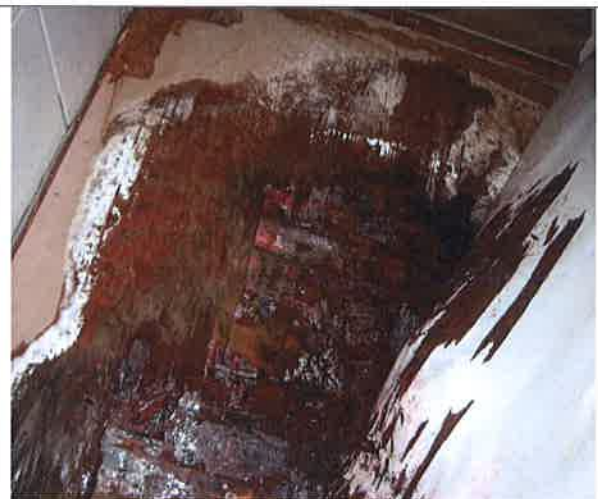
- a) that part of the floor next to the bath in the bathroom has suffered significant water damage. It was spongy underfoot. When the Ordinary Member of the tribunal lifted the vinyl floor covering there was a large area where the chipboard flooring had disintegrated and was visibly very wet.

- j) The flooring next to the bath was very spongy and underneath the vinyl floor covering the floor was still very wet. The chipboard flooring was damaged and had disintegrated in parts.

- a) It was patently obvious that the flooring in the bathroom has suffered significant water damage. The bathroom floor is uneven and spongy under foot. Upon lifting the vinyl floor covering the floor was obviously wet and there was an area where the chipboard flooring was significantly damaged.

Photo 3 – Bathroom floor wet rot

**Bathroom floor wet rot**

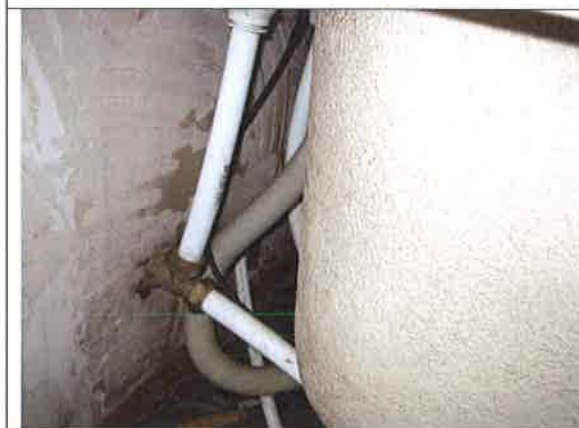
Photo 4 – Pipes to rear of bath

**Pipes to rear of bath**

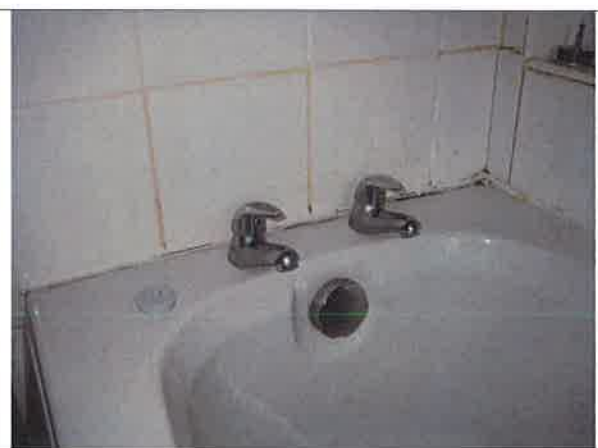
- b) there was an electric shower over the bath, but the seals between the surface of the bath and the walls surrounding same are perished and are no longer water tight.

- e) It was evident upon inspection that the seals round the bath had perished and failed and the grouting to the tiled walls around the bath was broken and damaged with multiple holes visible in same.

Photo 5 – Poor seal below shower

**Bathroom seal poor**

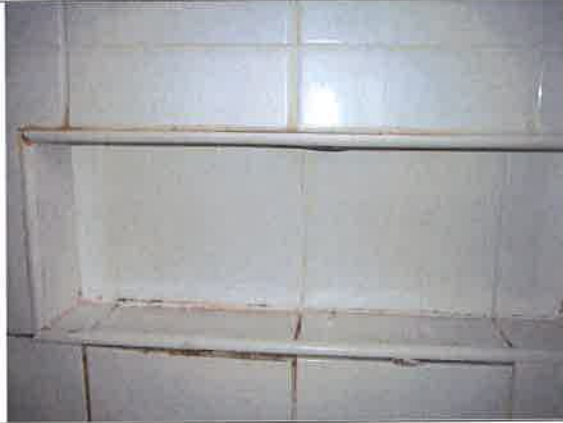
- c) that the grouting in the tiled walls adjacent to the bath and underneath the shower unit was cracked and damaged in multiple areas and is therefore not watertight.

- k) That the seals around the bath were perished and the grouting to the tiles on the walls next to the bath and shower was broken and there were multiple gaps evident in same.

Photo 6 – Poor grout to tiling

**Poor grout to tiling**

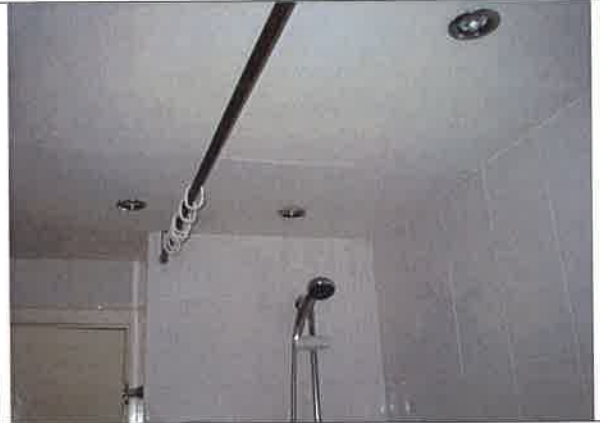
- f) whilst it was noted that there was a shower rail, but no shower curtain, there was no suggestion by the Landlord at the inspection that a shower curtain had not been in use.

Photo 7 – No shower curtain

**No shower curtain**

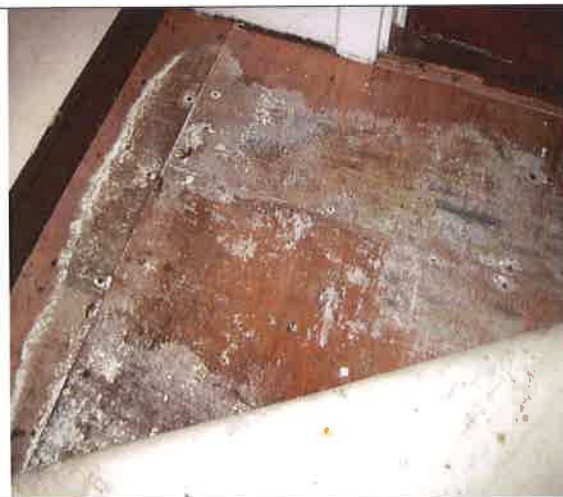
- l) That in the cupboard off the lounge between the bathroom and the kitchen there was evidence of dampness at floor level.
- m) That the floor in the kitchen was also affected by damp, was water stained and uneven in places as a result.

- b) In the cupboard between the bathroom and the kitchen, there was evidence of significant dampness at floor level.
  - c) In the kitchen the floor was damaged and uneven and upon lifting the vinyl floor covering, evidence of dampness was plain to see.

Photo 8 – Water damage – kitchen floor

**Kitchen floor damp**

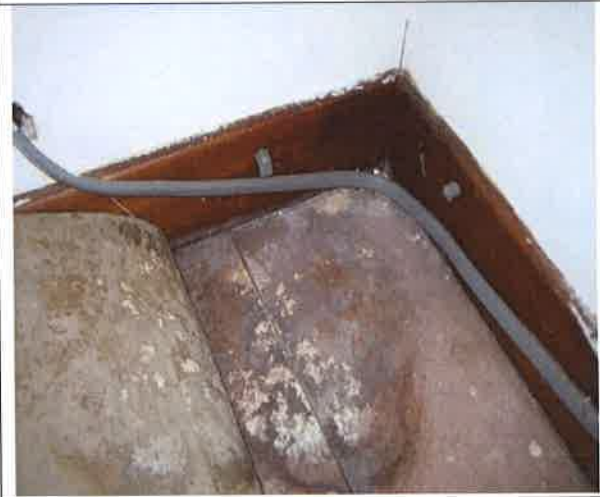
- d) that on opening the cupboard between the bathroom and the kitchen, the floor was damp and wet to touch.
  - e) that the floor in the Kitchen (nearest the bathroom) had also suffered water damage and was uneven. Upon lifting the floor covering the floor was damp and there was evidence of extensive water staining.

Photo 9 – Water damage – Lounge cupboard floor

**Lounge cupboard floor damp**
