**First-tier Tribunal for Scotland (Housing and Property Chamber)**

**STATEMENT OF DECISION: Housing (Scotland) Act 2006 section 24(1)**

**Chamber Ref: FTS/HPC/RP/17/0009**

**House address:** Clisham, Ardvar, Drumbeg, Lairg, Sutherland, IV27 4NJ ('the House')

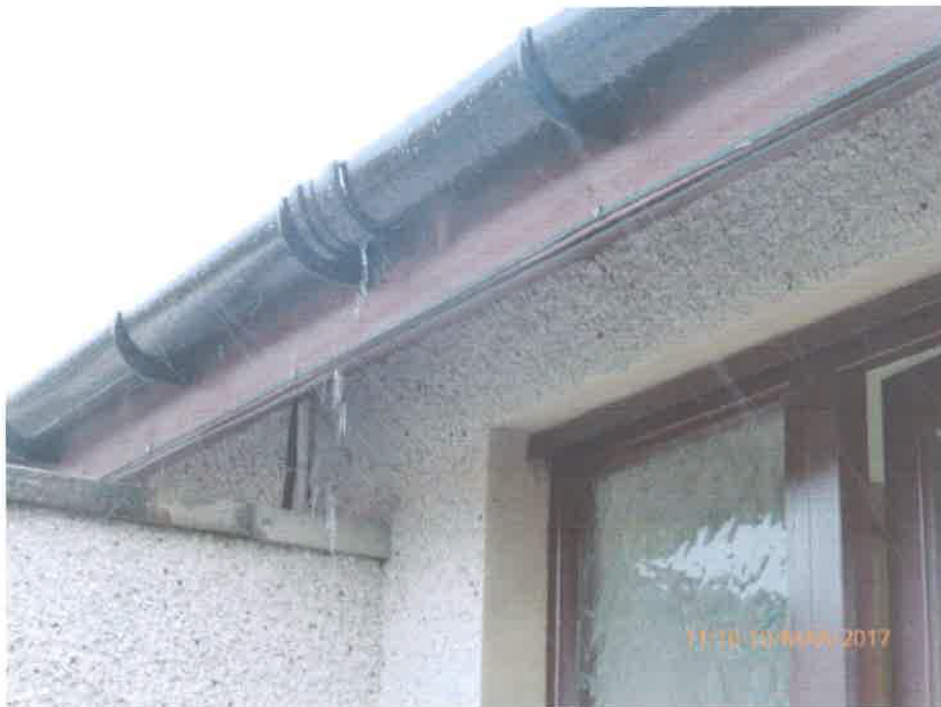
The Applicant said that he has jet-washed the step twice since he moved in, as it was covered in green vegetation due to the leak from the gutter. The disconnected section to the other side of the property would also run with water, in the same way as the section above the front door. In icy conditions, the water freezes and the step becomes 'a death trap'.

The guttering is defective to the front and the rear of the property, and is not in a reasonable state of repair and in proper working order. It could be anticipated that this could present a considerable safety risk due to ice hazard.

Leaking gutter

1. Repair or replace the patio door and associated glazing to ensure that the door is wind and water tight, and in a reasonable state of repair and in proper working order;
2. Install satisfactory thermal insulation in the loft of the House to meet current standards;
3. Repair or replace the guttering to ensure that it is in a reasonable state of repair and in proper working order.

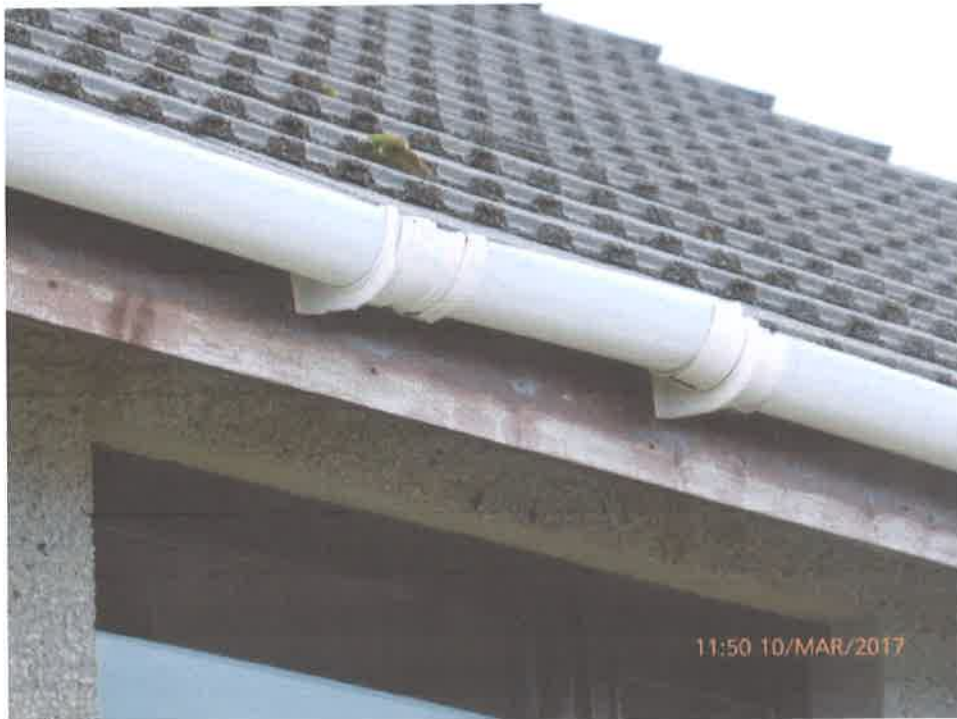
**Defective guttering**

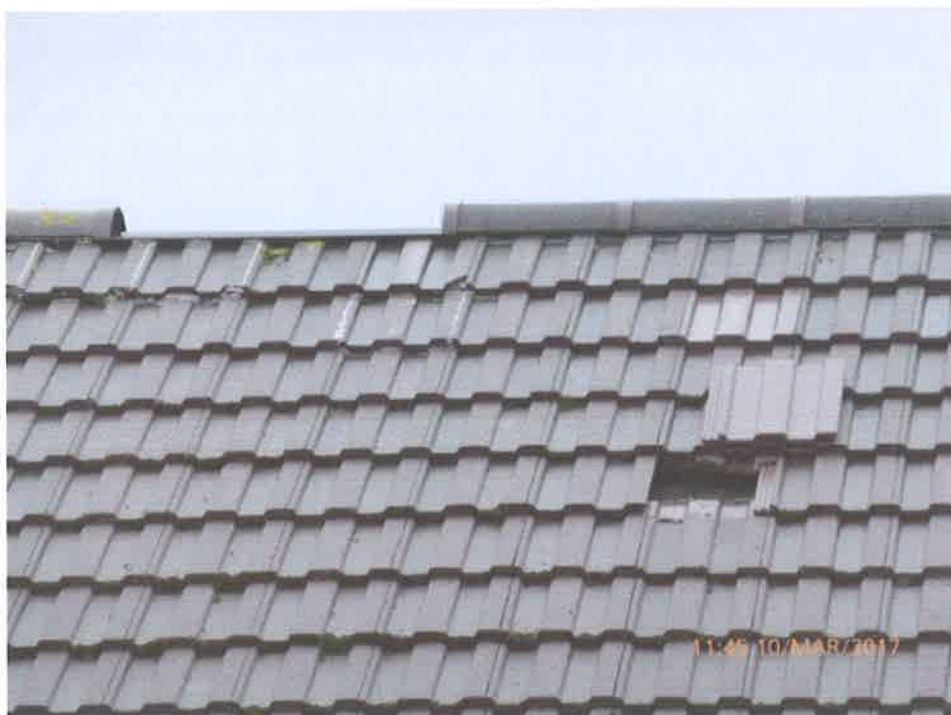
It was observed that there were 3 areas of considerable size where the roof tiles were missing. This issue had not been included in the application, but the Landlords were aware of it, and their representative had attended to repair the roof, but the work was not done due to a disagreement between the parties.

The Tribunal made an observation that the roof tiles require to be replaced, given the significant defects within the roof.

**Missing/dangerous roof tiles**

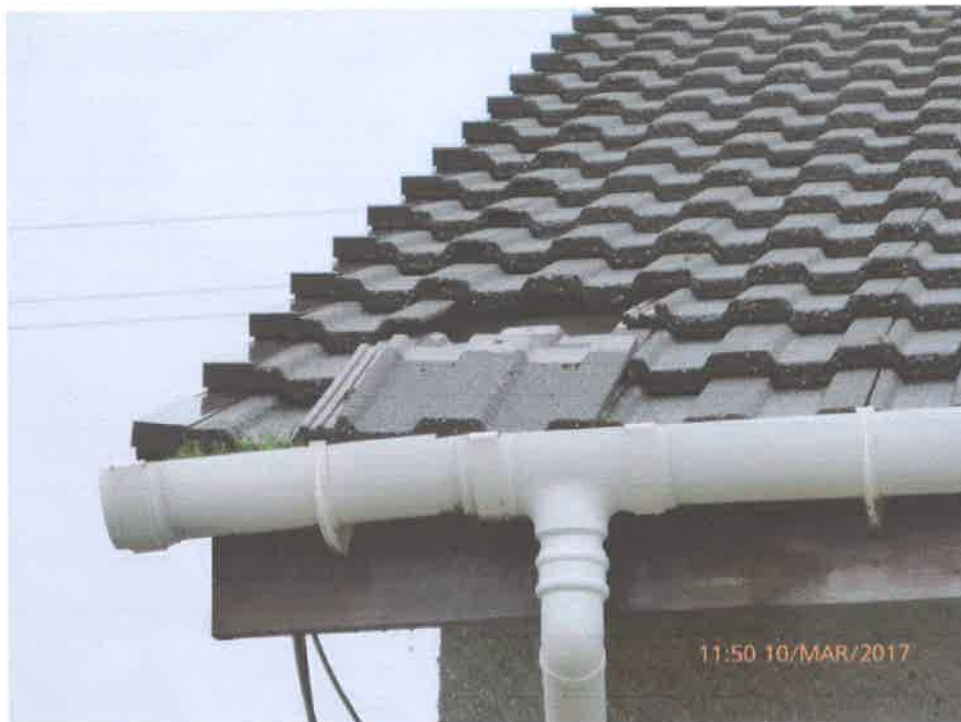
Slipped tile

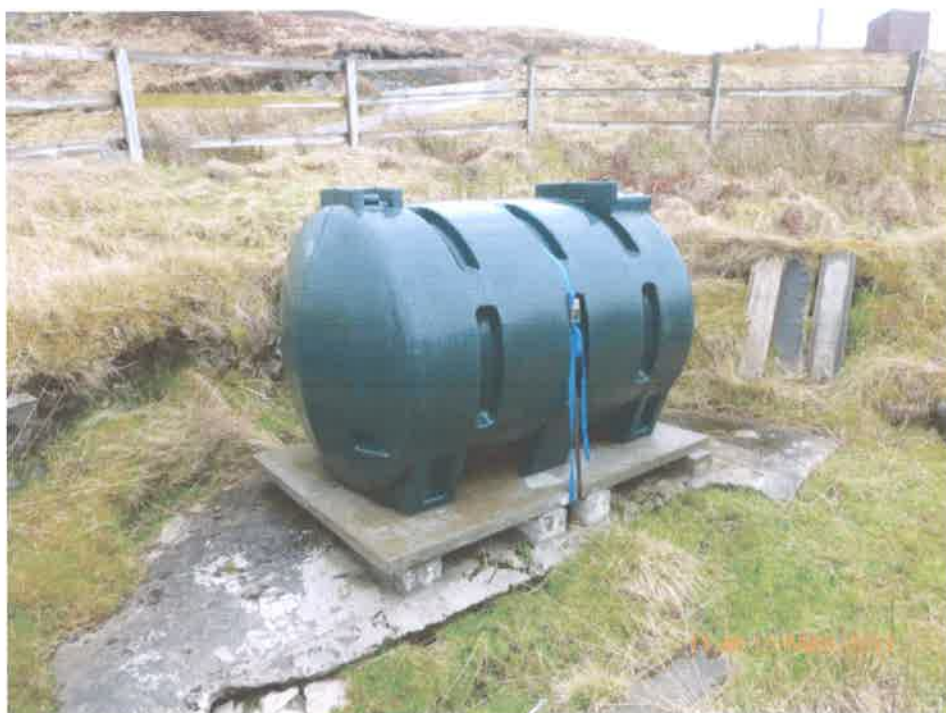
The tank capacity was 1350 litres. It was observed to be empty. There was no evidence of a leak from the tank.

Oil storage tank

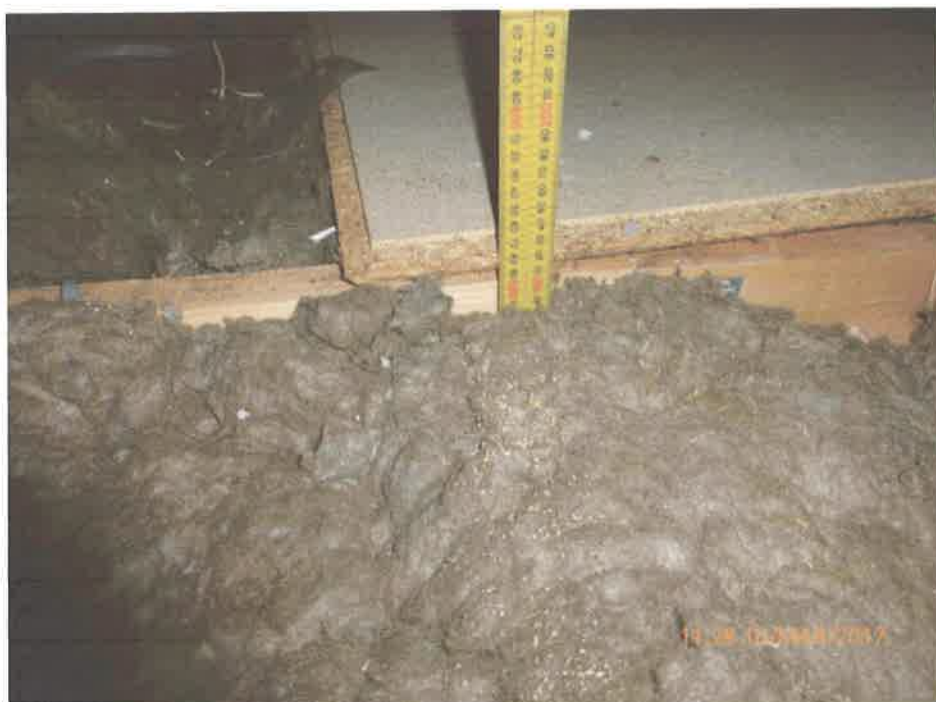
The House is not reasonably fit for human habitation give the depth of insulation in the loft, which falls well below the current recommended standard of at least 270mm. As this thickness is not usually available, the normal depth of modern insulation installed is usually at least 300mm, and in recent times, it has been available free from various sources. The lack of insulation will have contributed to heat loss within the House. The existing insulation is of an older expanded fibreglass type, which loses its properties over time.

Loft insulation

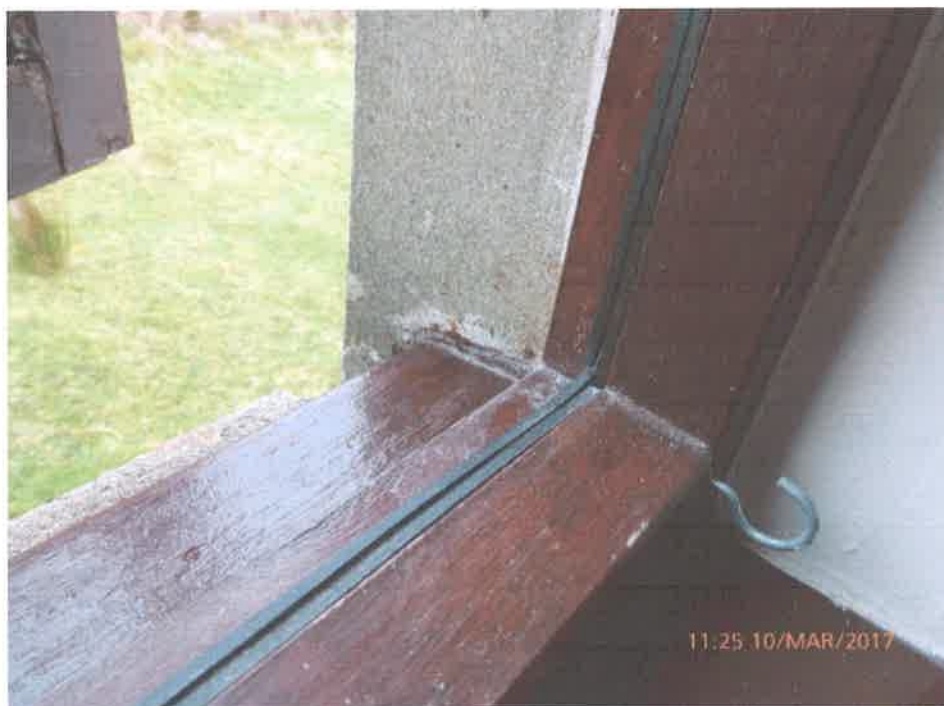
The windows in the living room, dining area, bedrooms 2 and 3, and the en-suite in bedroom 3 appeared to open and close properly. There was evidence of previous application of draught-proofing strips on the opening windows. There was no apparent draught and no evidence of failure of the double-glazing units.

Multiple draught proof strips

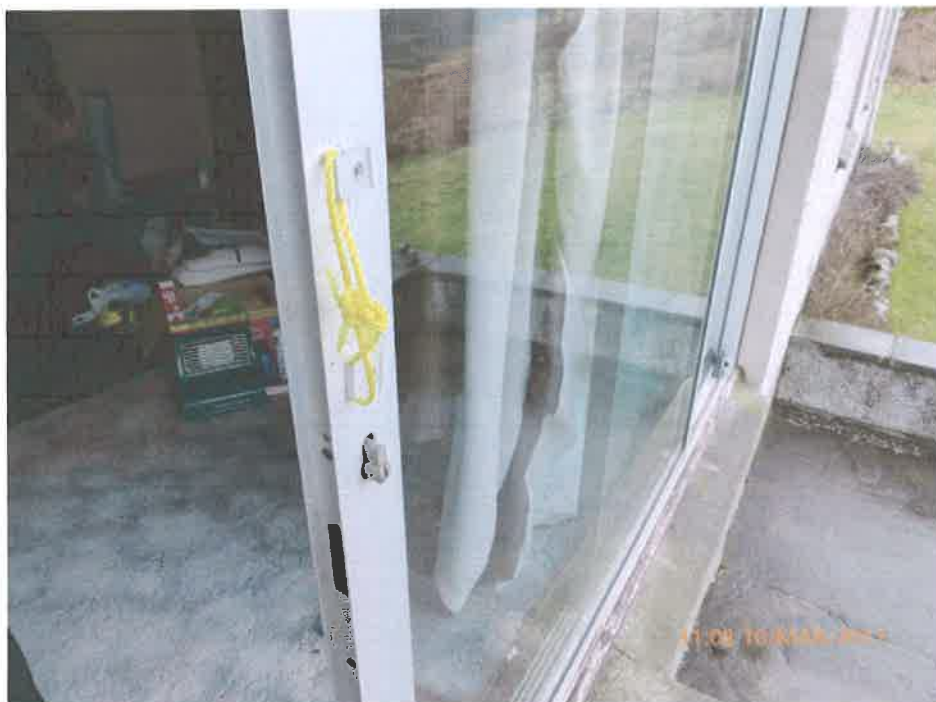
The structure and exterior of the House is not in a reasonable state of repair and in proper working order. The patio door is not functioning as it should. It is very difficult to open the door, and the internal handle is loose as a result of having to apply considerable pressure in order to open the door; the outside handle is missing; and the double glazing units have failed.

Missing door handle on patio door

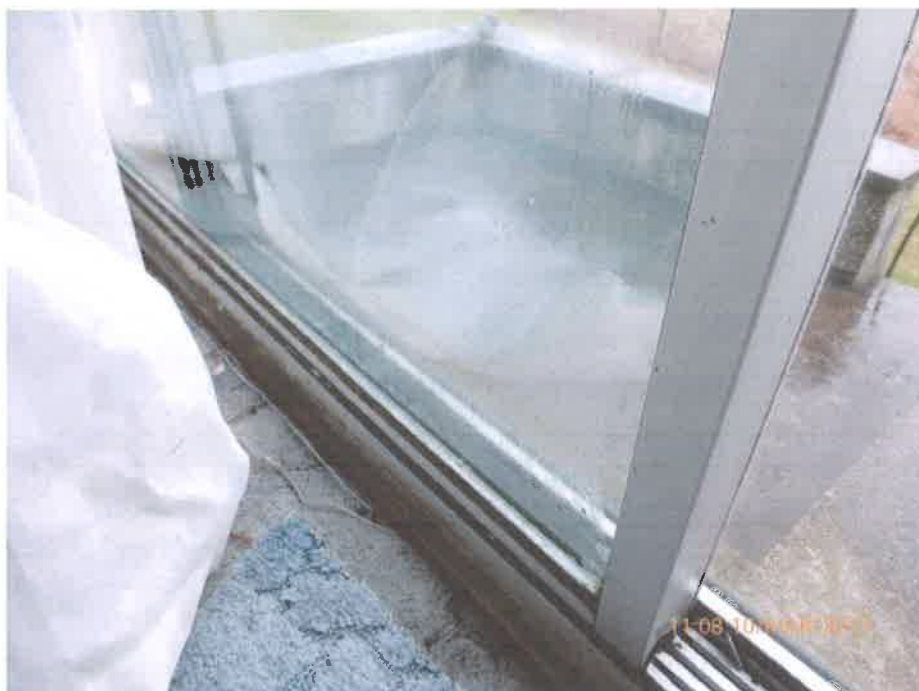
Misted double glazing

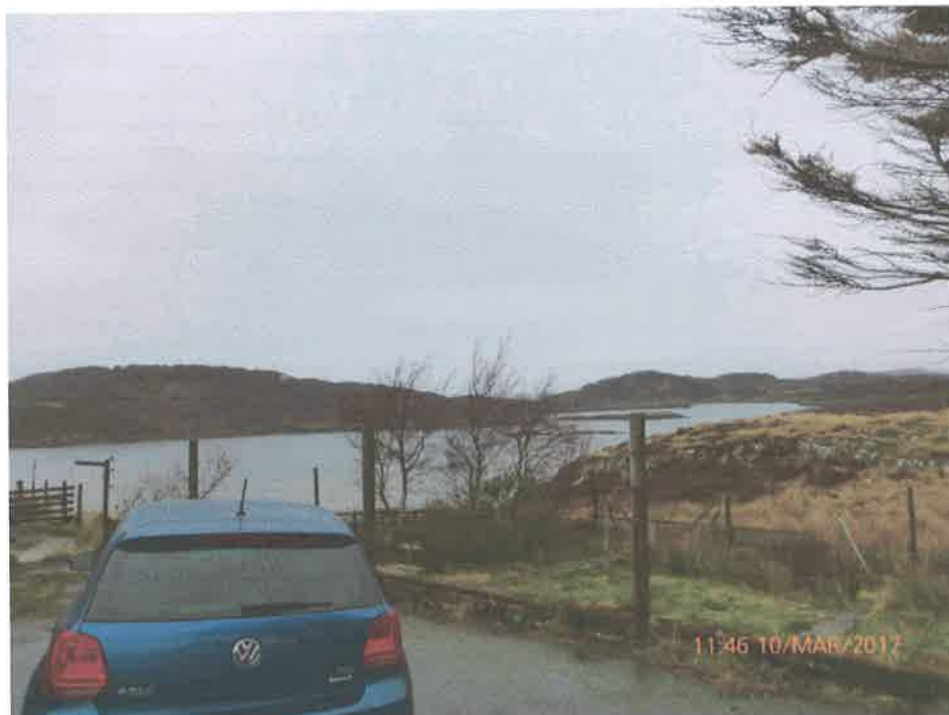
The windows are in proper working order, and, with the exception of the glazing in the patio door, there was no sign that the double glazing units had failed. It was observed by the Tribunal that, given the exposed location of the House, a higher standard of windows might be expected.

Exposed location
