**Private Rented Housing Panel (PRHP)
Reinspection report**

Date of Reinspection: 14 March 2016 at 3pm

Reference Number: RP/15/0202

Property: 1 Kirkstone, Kirkvale Court, Newton Mearns G77 5HG

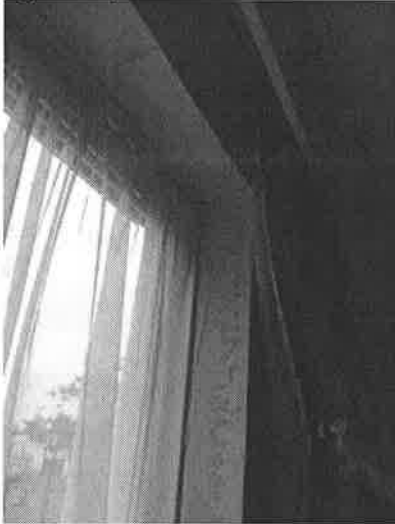
**2 October 2015
Bedroom window**

Shown signs of water ingress on underside of lintel and on wall to side of window. Decoration had been damaged by dampness

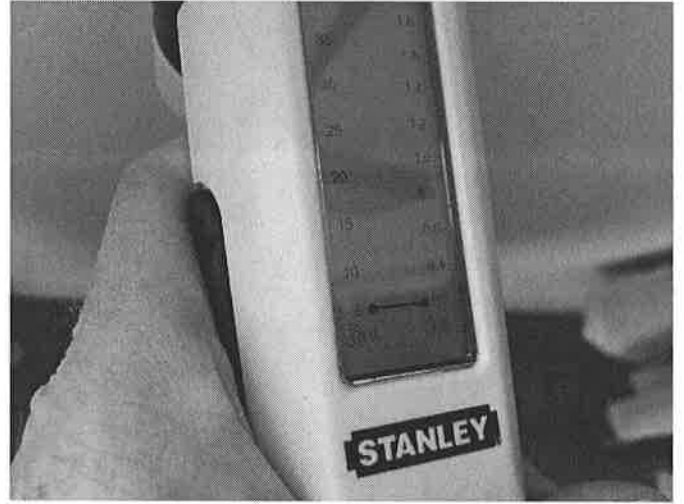
14 March 2016

- 4.1 Work has been carried out to the external wall and seal above the bedroom window on the external elevation. This has assisted in stopping the water ingress which appear to result at times of wet and windy weather. The tenant was reasonably satisfied with the repair, and the internal walls around the window had dried considerably. However the tenant did advise that there had still been some water ingress, and it is recommended that this area be monitored to ensure that the repair is sufficient.

Internal walls now dry, although still stained.

- a) monitor the repair above the bedroom window to ensure that it is sufficient.
- b) obtain a registered electrician's Electrical Installation Condition Report. On receipt of a satisfactory report I would recommend discharge of the RSEO.
- c) if the landlord decides to relet rather than sell the flat then he should update the smoke detection system.

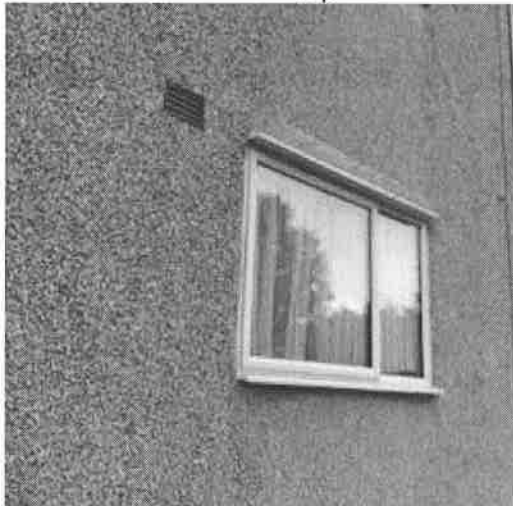
Bedroom window externally – this showed previous repairs to render above window. A projecting 'tray' had been installed above the window – this detail did not occur on any other windows in the development.

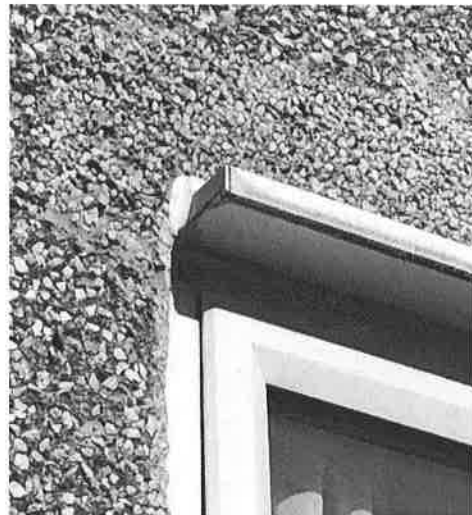
The joint above between the tray and wall above the bedroom window has been sealed.

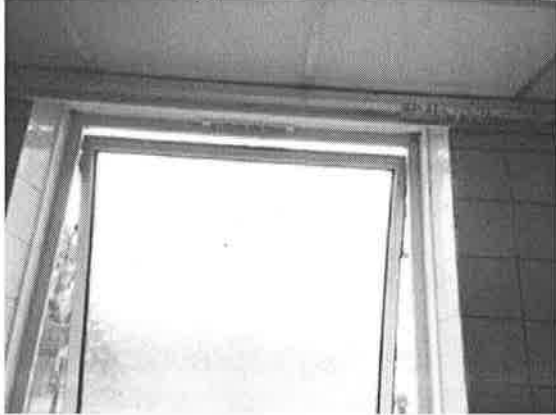
Bathroom walls

Bathroom window was only means of ventilation, but cannot be secured in open position. Mould evident on bathroom tile grout.

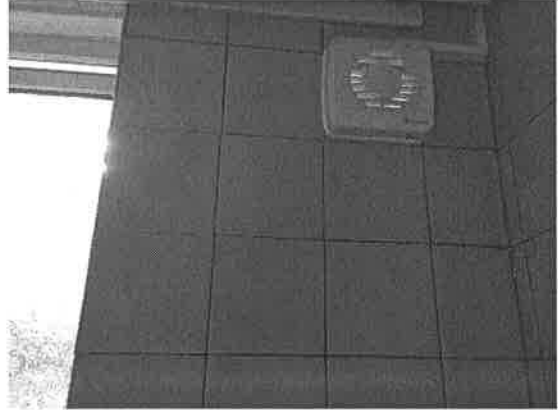
- 4.2 A mechanical extract ventilation fan has been installed on the external wall of the bathroom adjacent to the window. There was no sign of any dampness or mould in the bathroom, and therefore this problem appears to have been resolved. The tenant confirmed that she was satisfied with the ventilation, and had removed most of the mould. She would continue to clean the grout and bath sealant.

Mechanical ventilation fan has now been installed. No mould evident.

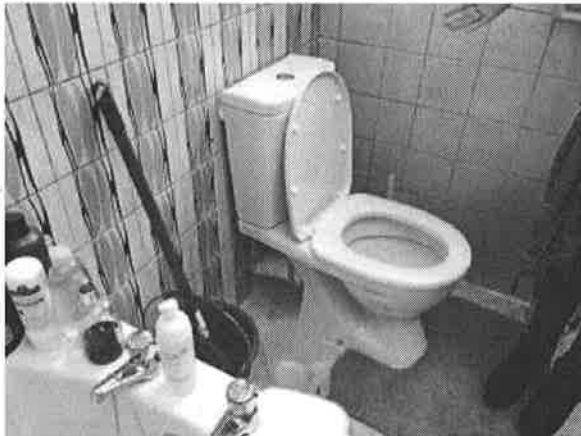
Toilet/WC

Modern close coupled WC system.

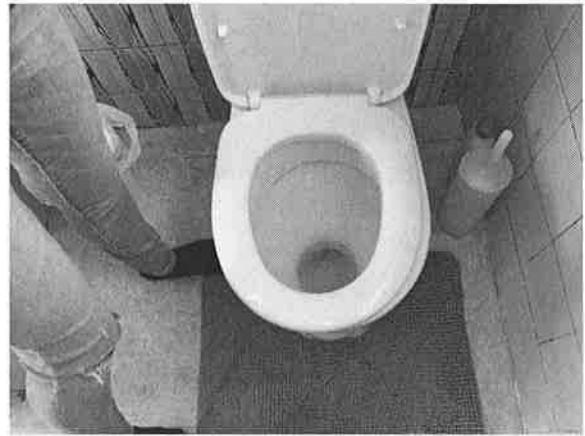
- 4.3 The WC had been repaired and it was observed that it was now flushing correctly. The tenant was satisfied with the repair.
- 4.4 A new boiler had been installed and all radiators had been fitted with thermostatic radiator valves. The tenant confirmed that the heating system was working satisfactorily and that there was no noise from the system. She also advised that she no longer needed any additional portable heaters in the flat. A Carbon Monoxide detector had been installed.

WC now flushing correctly

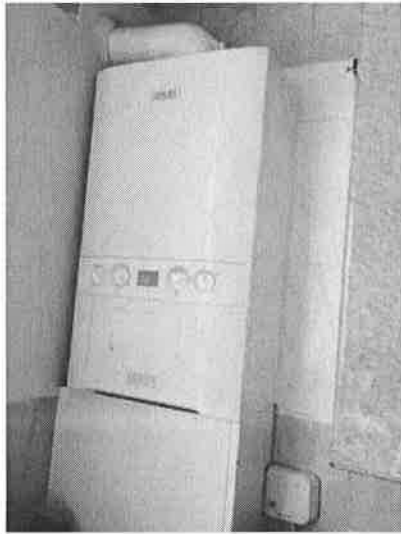
Boiler and heating system

New boiler fitted.

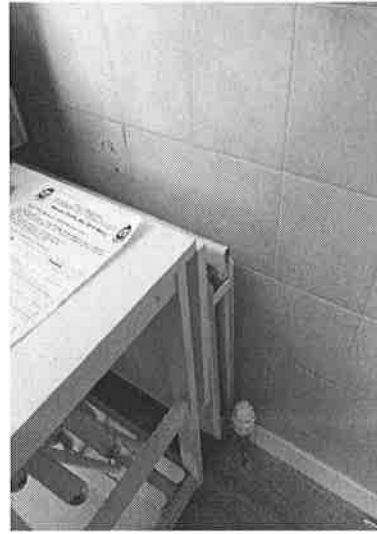
New boiler fitted, Thermostatic Radiator valves & CO Detector

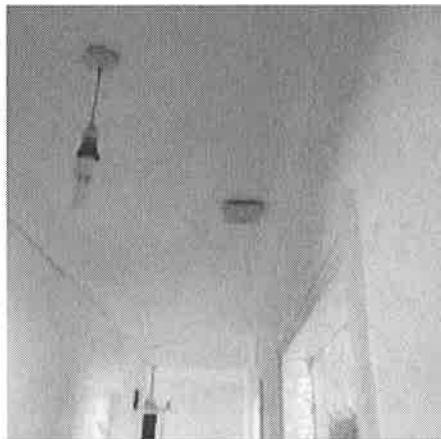
Smoke & heat detection sensors

Photographs showed battery operated smoke detectors fitted.

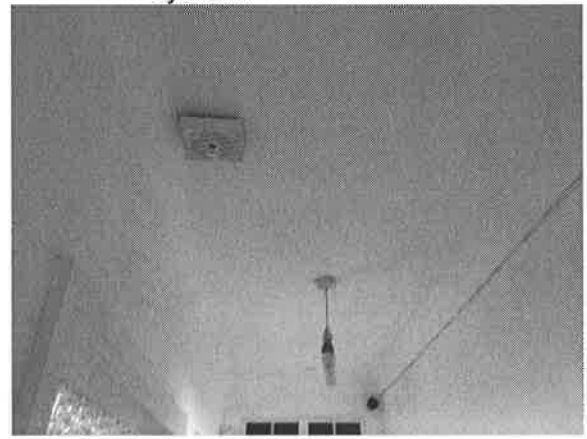
It was noted that the smoke detector system has not been updated and therefore does not comply with current guidance. We understand that the Landlord plans to sell the property, but if he were to decide to relet the flat then the smoke detection system should be updated to current standards.

No work has been carried out to smoke detection system
