### **First-tier Tribunal for Scotland (Housing and Property Chamber) (“the tribunal”)**

Certificate of completion of work under section 60 of the Housing (Scotland) Act 2006 (“the Act”) of the Private Rented Housing Committee issued under the First-tier Tribunal for Scotland Housing and Property Chamber (Procedure) Regulations 2016

**Chamber Ref:** PRHP/RP/16/0088

**Property:** 38A Woodside Road, Raploch, Stirling FK8 1PS (“the property”)

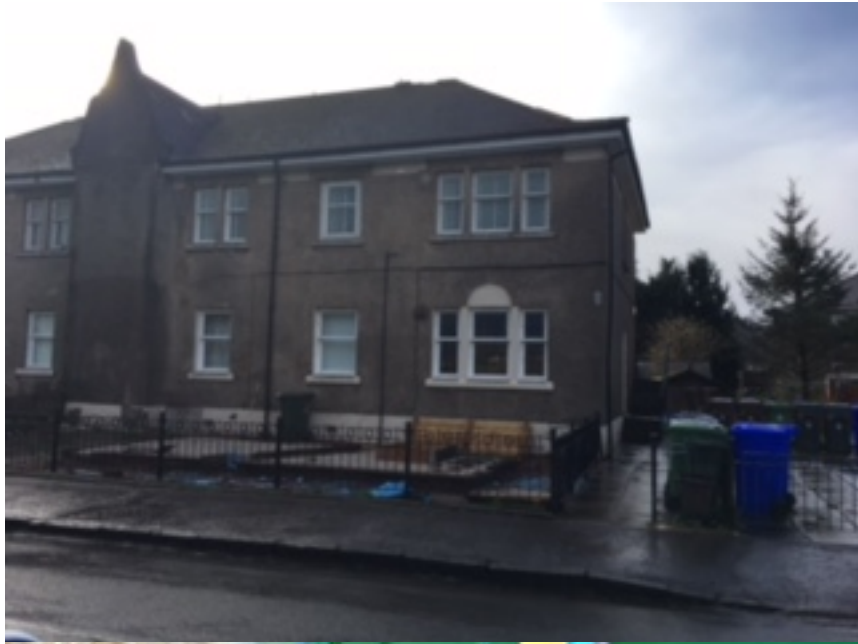
The front door was examined and it was apparent that weather strips had been fitted around the door externally and it appeared to be weathertight.

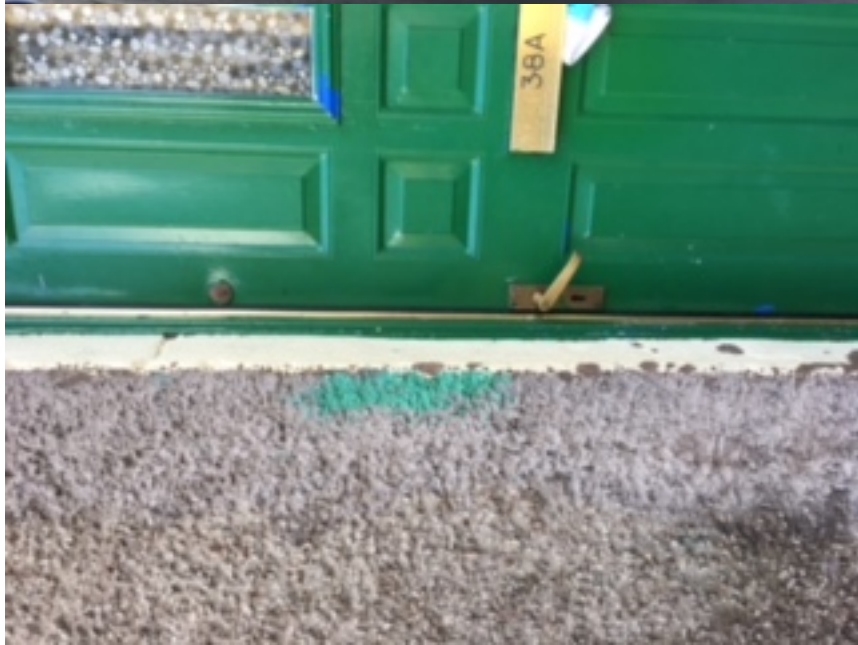
The back door, previously replaced had been painted.
