STATEMENT OF DECISION: Housing (Scotland) Act 2006 section 24(1)

Chamber Ref: PRHP/RT/16/0372

Property address: 5 Thomson Terrace, Stonehaven, AB39 2LX ('the Property')

Schedule of Photographs

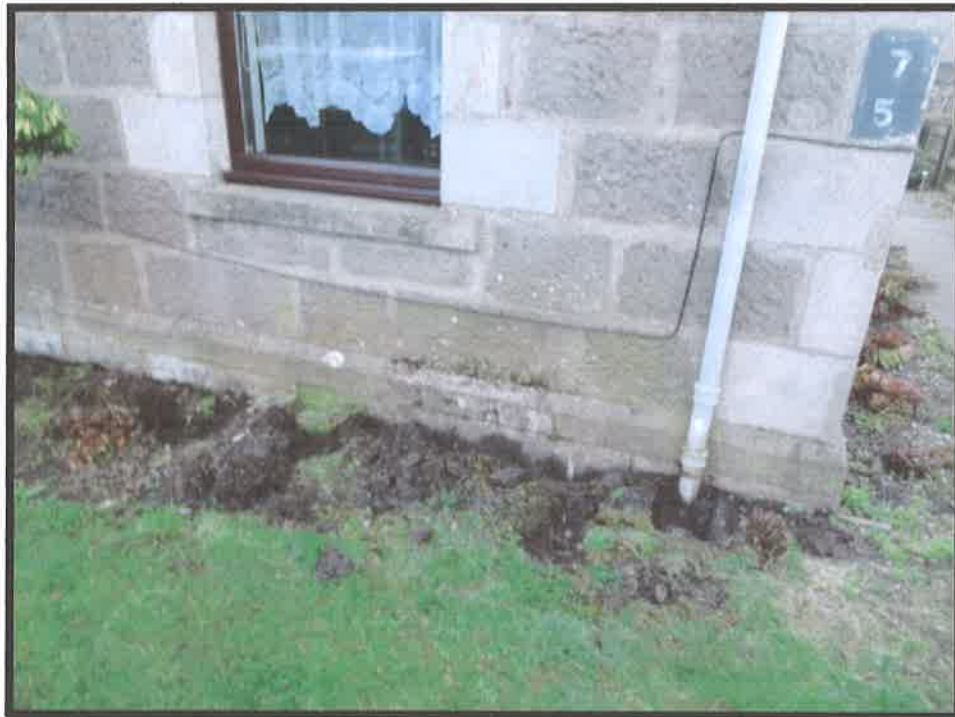
11.5 Externally, the front elevation was inspected. The rainwater goods appeared to be whole, but their function could not be assessed as it was not raining. There was some corrosion to the gutter joints. There was some slight green staining and moss growth to the base course of stonework below the right hand side of the bedroom window. It could not be established if this was historic or current. Some earth had been dug out recently along the front wall, adjacent to the bedroom. The lower section of the downpipe had been exposed and it could be seen that the downpipe discharged into a gully.

Figure 2 Front Elevation, bedroom window and downpipe

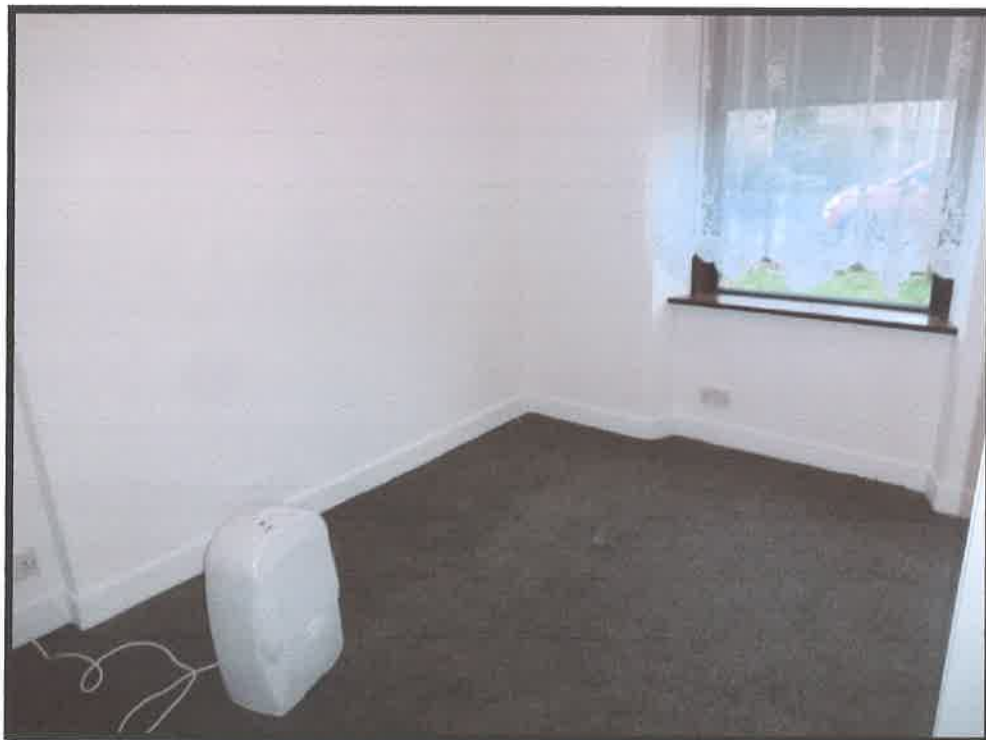
- 11.1 The bedroom was inspected first. A de-humidifier was present, although not operating at the time. Moisture meter readings were taken to the outer wall surfaces at various heights and locations. Generally, the readings were consistently around 18%. The carpet was pulled back at the front corner of the room, moisture readings taken at the floor surface were also around 18%. There were traces of mould residue to the skirting board inside the built-in wardrobe. There were no obvious water marks or other visible indications of water ingress. A fireplace had once been present; the opening had been boarded over and an air vent was present.

Figure 3 Bedroom, view towards window and front elevation

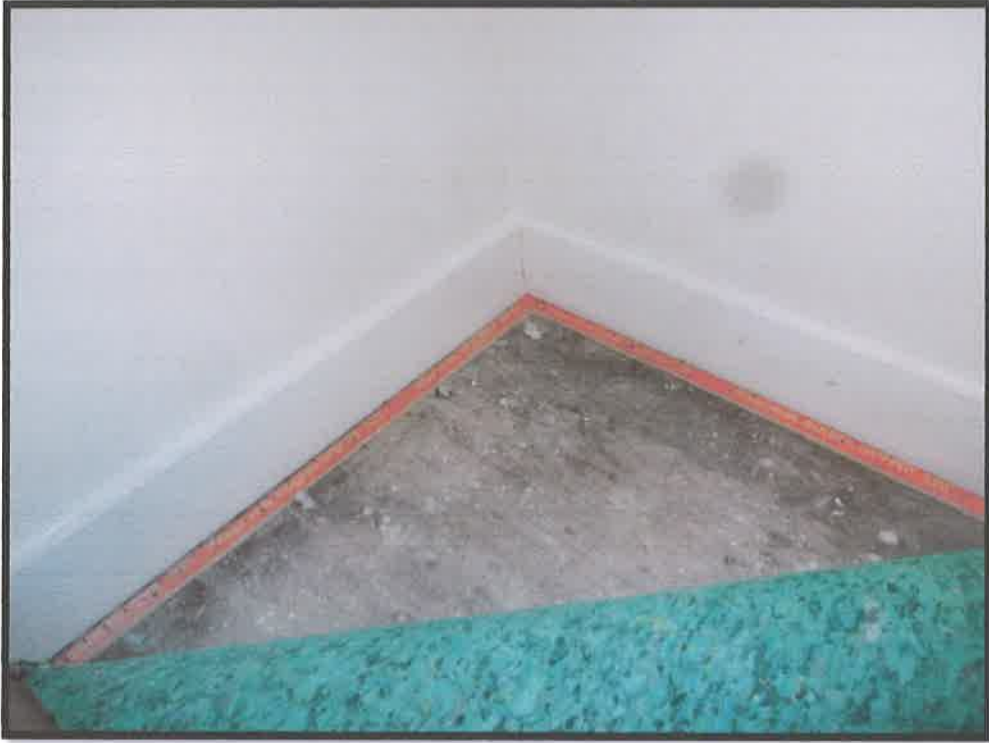
Figure 4 Bedroom - surface of flooring in front corner of room

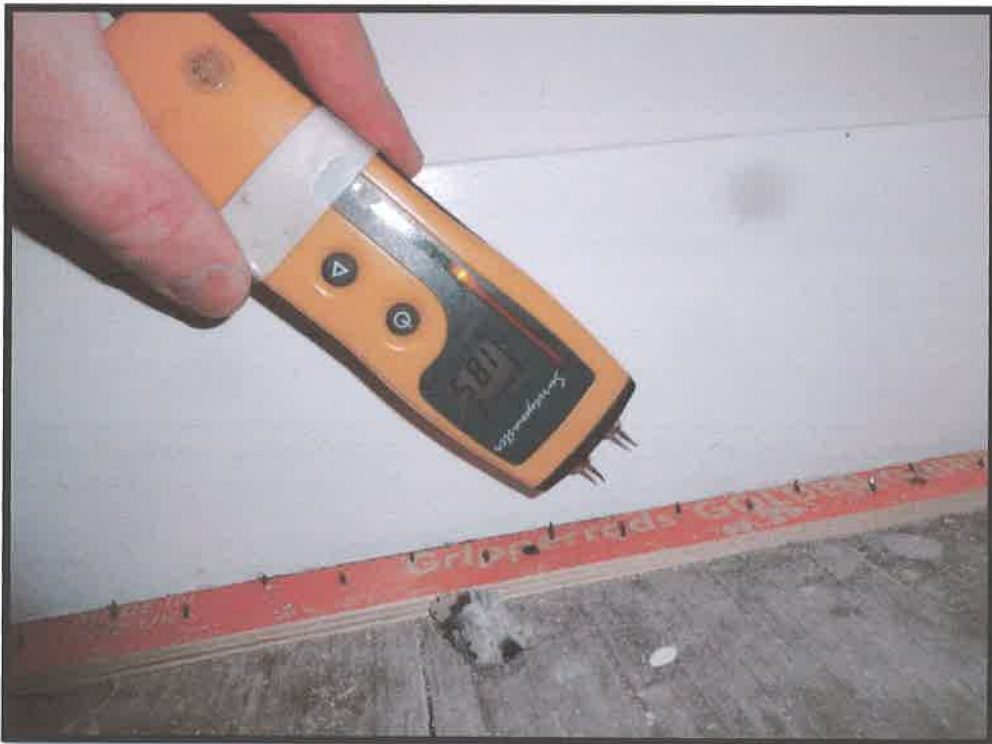
Figure 5 Bedroom - Meter reading (18%) at skirting board.

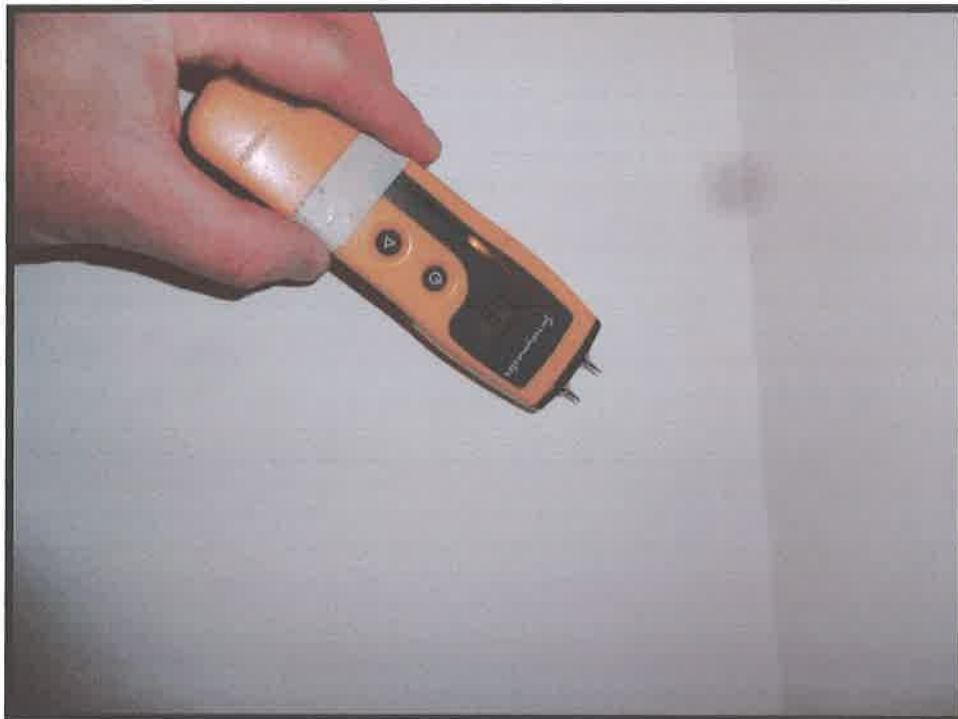
Figure 6 Bedroom - Meter reading (18%) front corner wall, mid height.

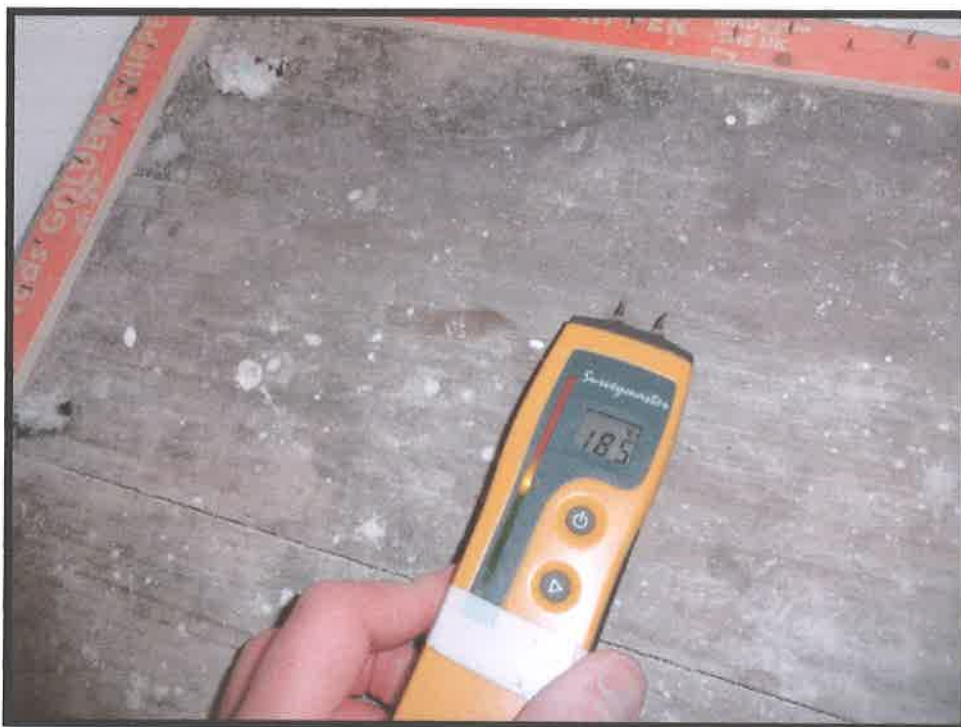
Figure 7 Bedroom - Meter reading (18%) at top surface of flooring.

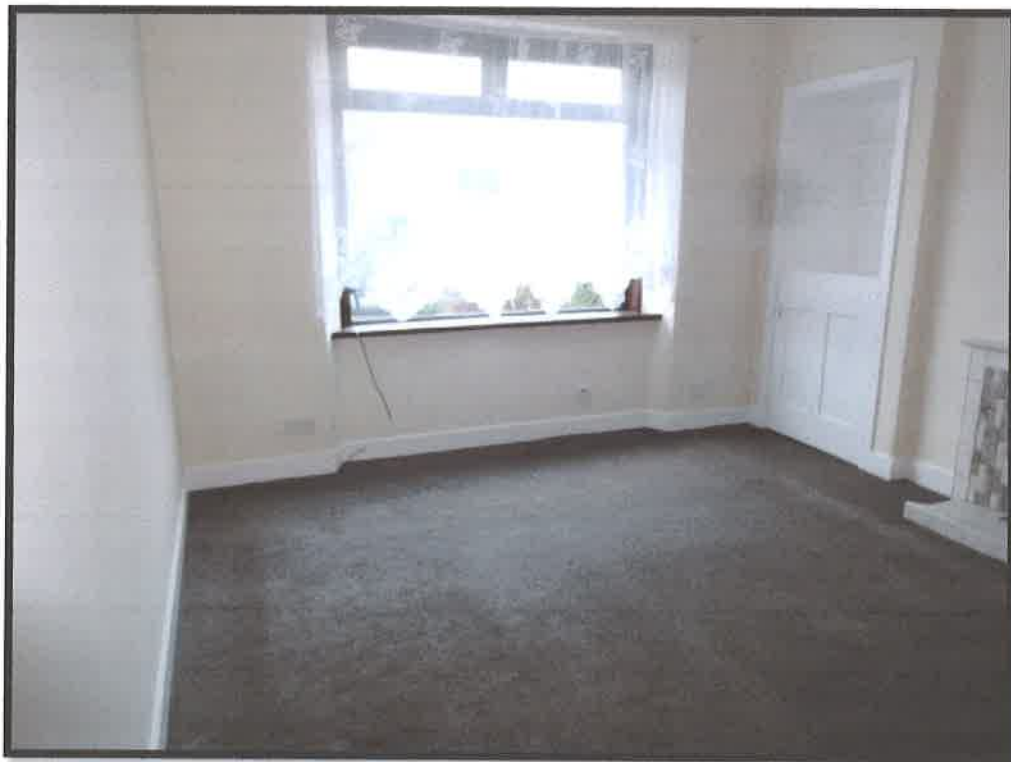
- 11.2 The lounge was inspected. Again, moisture meter readings were taken to the outer wall surfaces at various heights and locations. Generally, the readings were consistently around 18%. There were traces of mould residue to the plaster finish beneath the front window, just above the skirting board. There were no obvious water marks or other visible indications of water ingress. The fireplace remains in position, but the throat of the fire had been sealed with scrunched up newspaper.

Figure 9- Lounge - view towards front wall and window.

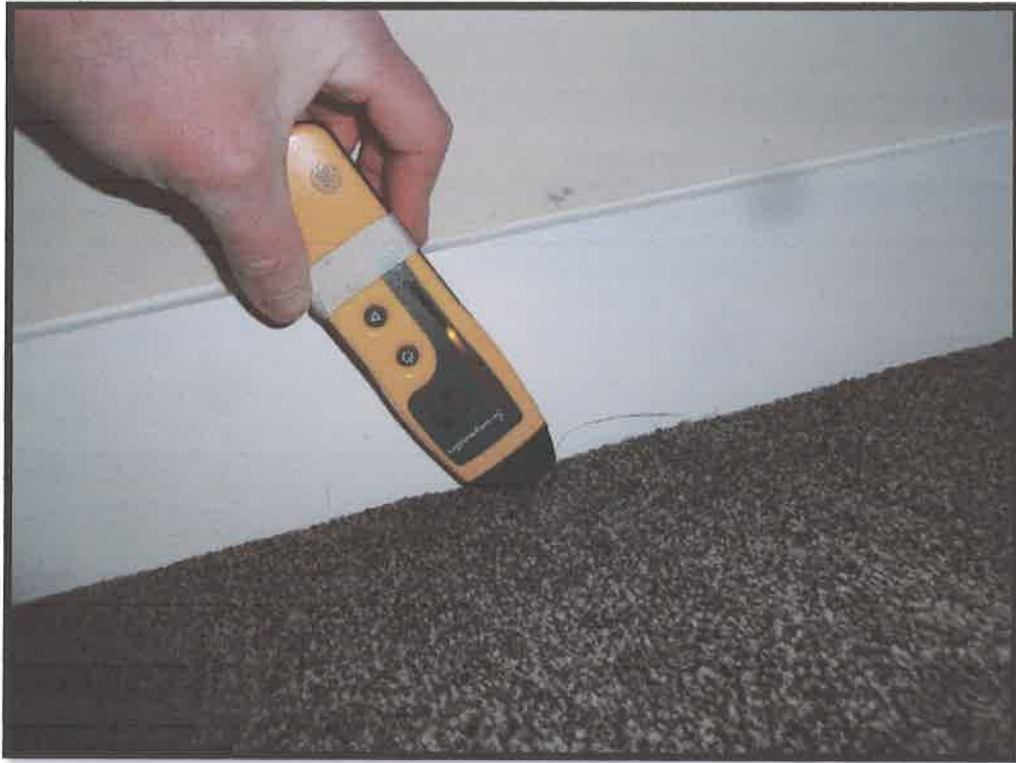
Figure 10 Lounge - Meter reading (18%) skirting below front window, mould residue above skirting

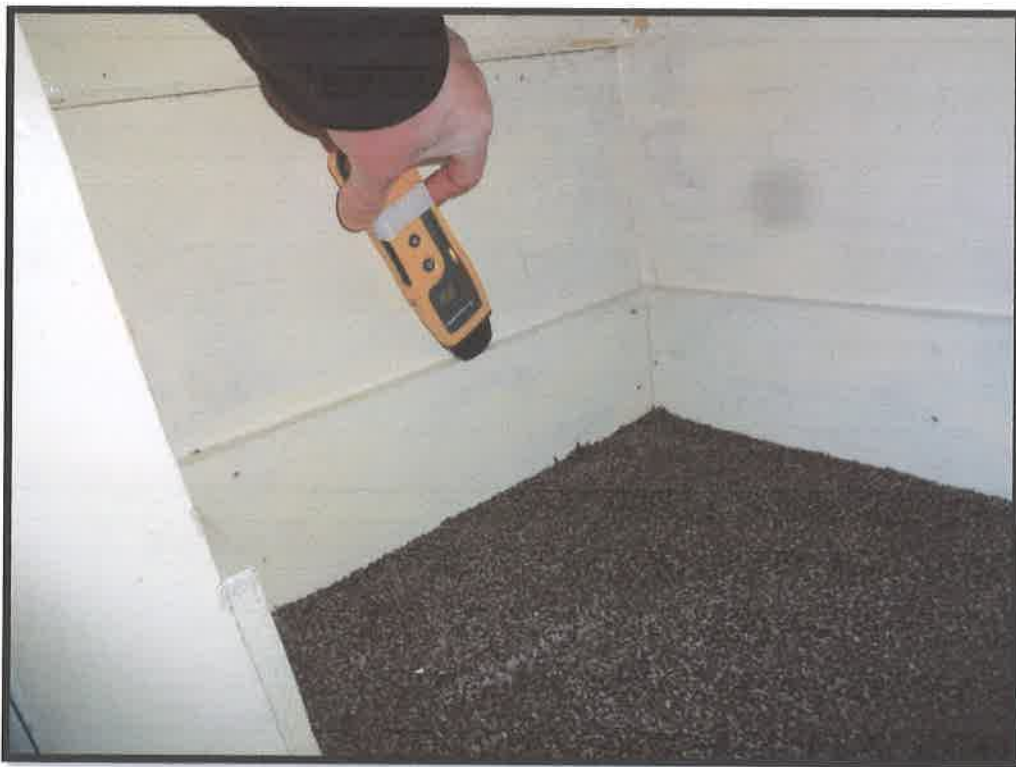
Figure 11 Lounge - Meter reading (18%) inside alcove cupboard at outer wall surface, above skirting

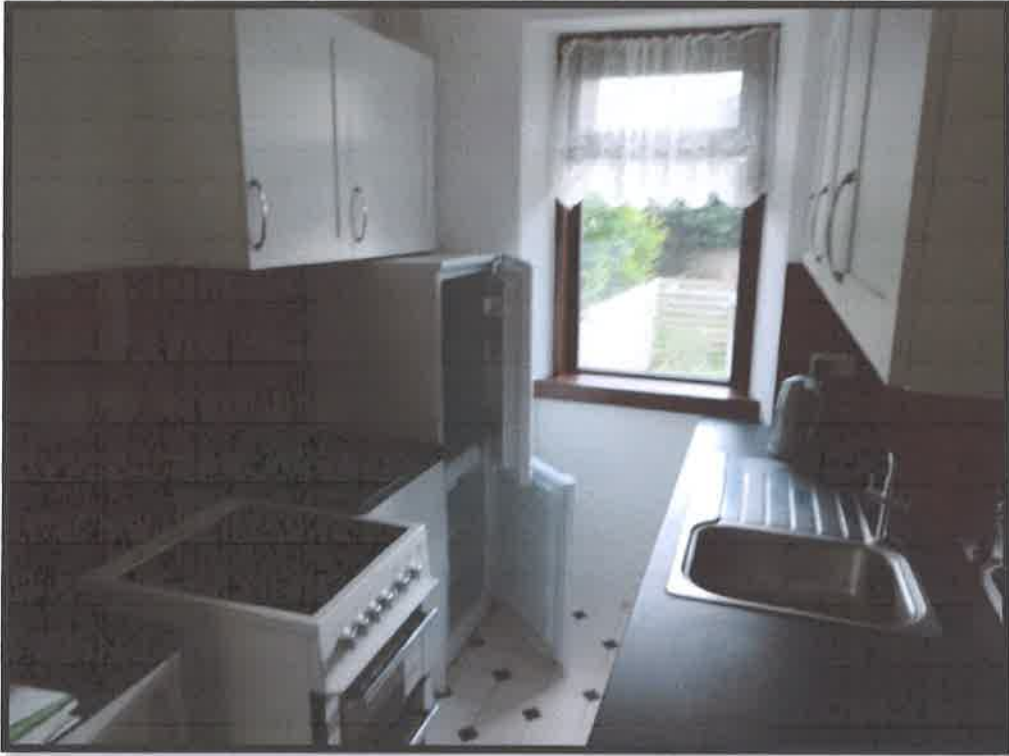
- 11.3 The kitchen and shower room were inspected. No evidence of significant mould or other forms of water ingress or damp were observed. The windows were found to be relatively new PVC framed double glazed type and the opening lights were found to operate properly.

Figure 7 Kitchen - view towards window and rear elevation

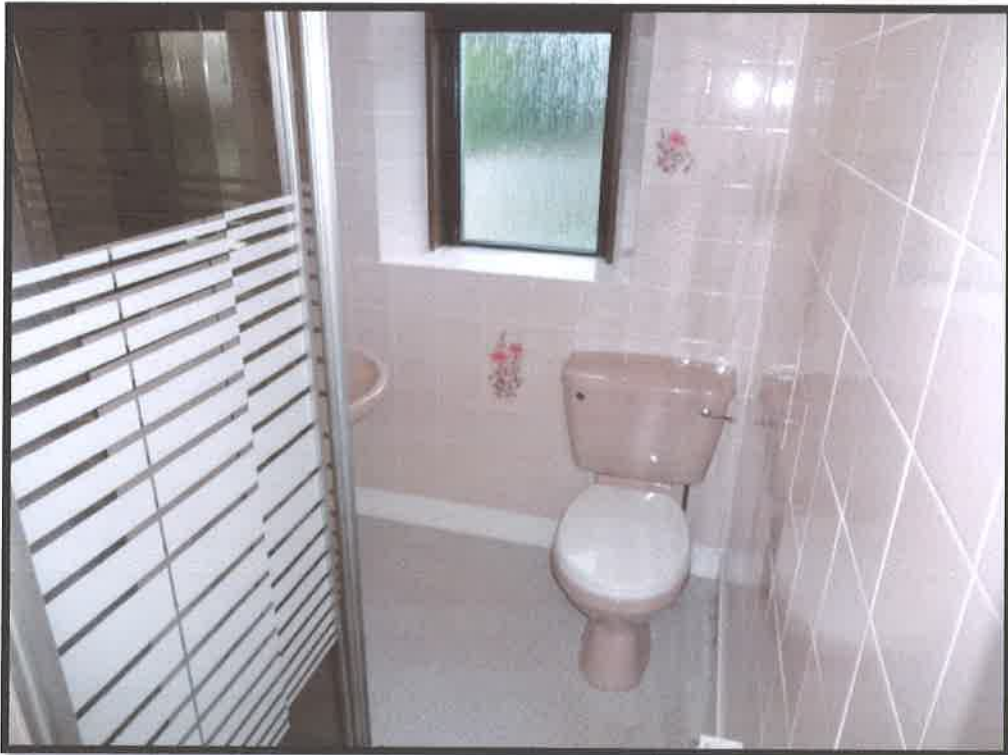
Figure 8 Shower room - view towards window and rear elevation
