Repairing Standard Enforcement Order

PRHP Ref: PRHP/RP/15/0072

Property at: 32 Auchmill Road, Aberdeen, AB21 9LD ("the property")

Schedule of Photographs
32 Auchmill Road, Aberdeen AB21 9LD
Case Reference Number PRHP/RP/15/0072
Date: 09/07/2015

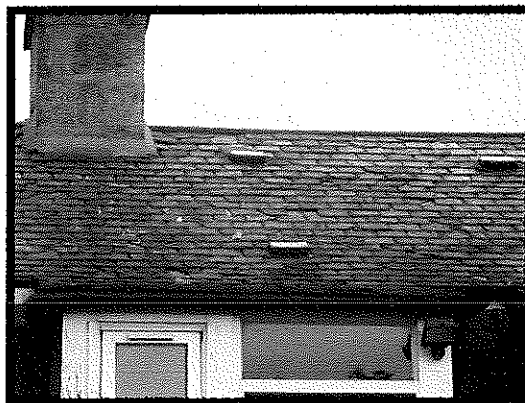
Figure 2 Rear Roof Slope

(k) The property has a slated pitched roof. Some of the slates are chipped and broken. Some slates have slipped. There is evidence of water ingress in one small area of the bedroom ceiling. It is likely that water has leaked through the compromised areas of slating.

(d) Inspect, overhaul and repair as necessary, the roof of the property;

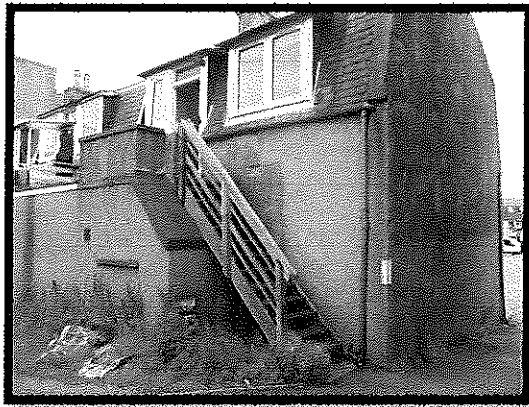
Figure 4 Rear Stair Overview

(e) On the date of inspection, the steps did not have any anti-slip protection on the treads. The fifth step from the ground is broken. The wooden stringers are rotten.

(m) Externally, the original wooden staircase was inspected. The original wooden treads had been overlaid with new timbers similar to those used for external decking and a new handrail had been fixed on to the original. Decay was evident to the stringer, adjacent to the rear wall of the building. The leading edge of one tread was broken. Other than the "deck board style" grooves on the tread surface, there was no anti-slip coating. The flight had a relatively steep angle, to fit the confines of the space available. It did not appear that the angle of the stairs had been altered in recent times, if ever.

(b) Replace the broken and rotten sections of wood on the external stair to the property and to fit an anti-slip surface on each of the step treads on that stair;

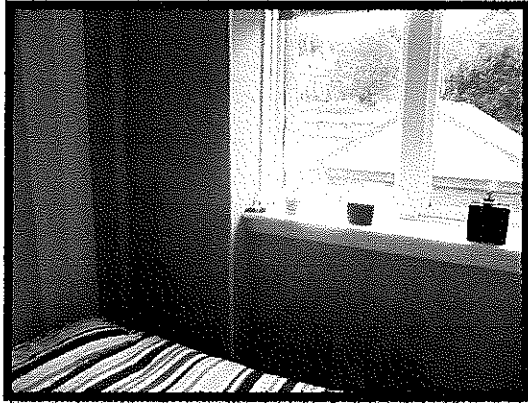
Figure 7 Bedroom

(b) On entry to the property, Committee members could see signs of condensation dampness. Higher than average meter readings were taken in each of the rooms. Staining was obvious on the interior walls in each of the rooms, and the wallpaper in the bedroom was peeling away from the wall. The damp in the property is neither rising nor penetrating damp. It is condensation dampness. Condensation is found in properties which are not adequately heated or ventilated. It is common ground that the only source of heat in this property is two electric heaters belonging to the tenant. It is also common ground that the property was let unfurnished.

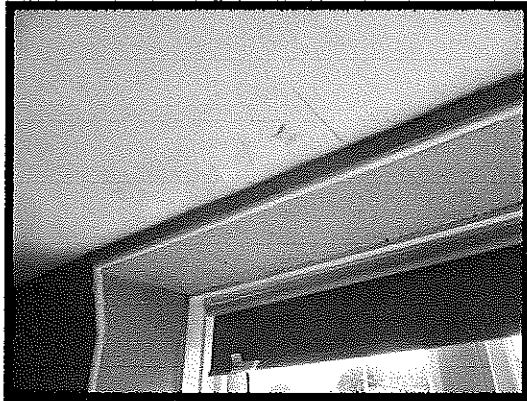
Figure 8 Rear Bedroom Ceiling

(l) The internal soffit of the lintel over the main entrance door was stained and appeared slightly bowed. When tested, no significant damp was detected. An area of staining on the ceiling adjacent to the bedroom window was tested with the damp meter; this area was found to have high levels of damp. There had been rainfall during the 24 hours preceding the inspection. Externally, the rear roof slope was inspected from the garden area. It could be seen that there were several missing and broken slates. The absence and presence of dampness in the respective locations indicated there was no longer a leak at the entrance door, but the area adjacent to the bedroom window was still affected by penetrating damp.

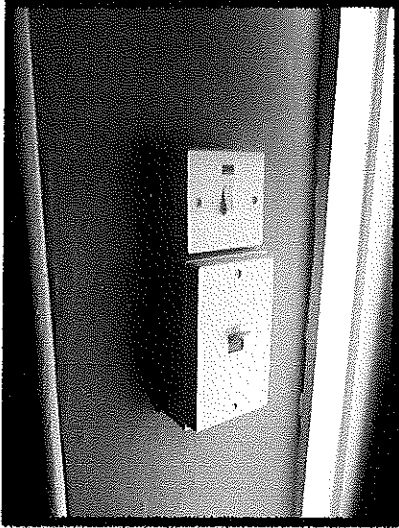
(g) There have been no electrical safety inspections since the tenant moved into the property. In the livingroom/kitchen an electrical wall socket has a loose facing, which makes the socket difficult to use. In the kitchen there are three electrical switches which should control, *inter alia*, the extractor fan and the immersion heater. Each of those power supply switches are painted over so that they cannot be used.

(d) During the inspection, the tenant complained that there was no hot water in the property. Both the tenant and the landlord agreed that there is an immersion heater in the property, activated by an electrical switch on the wall of the kitchen. The tenant demonstrated that the immersion switch is locked in the off position. Committee members could see that there were three similar switches at about shoulder height in the kitchen. One was to operate the immersion heater, another to operate an extractor fan fitted into the window above the kitchen sink. It was not clear whether or not the remaining electrical switch is still in use but each of the electrical switches had been painted over so that they could not be used and each switch was locked into the "off" position.

Figure 10 Painted Switches - kitchen/Lounge

(a) To instruct an appropriately qualified contractor to carry out a standard electrical installation condition report on the property and to carry out any works which are shown to be necessary in terms of said report to bring the electrical installations and wiring throughout the property into a proper state of repair and to proper working order, with particular attention to the immersion heater, kitchen water heater, kitchen/living room extractor fan and loose socket. Thereafter to produce an electrical installation condition report dated after today's date;

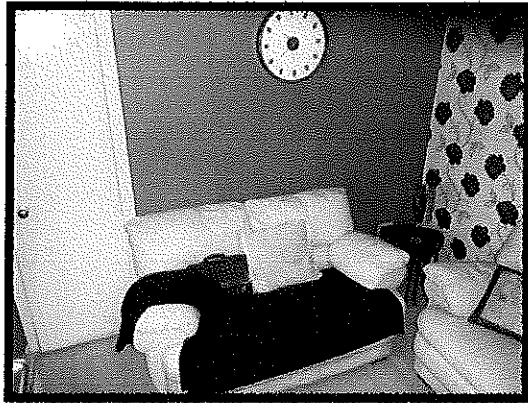
Figure 11 Kitchen/Lounge Overview

(j) During the inspection, mould growth was evident to the surface of the outer walls within the Kitchen/Living Room, particularly behind and on the furniture, from skirting height up to around 80cm. The wallpaper was beginning to lift in some areas. Damp meter tests revealed slightly above average readings on the whole outer wall surface, with no significant difference between mouldy areas and areas unaffected, which were generally higher up the walls. Further mould growth was evident within the Bedroom, again on the surface of the outer walls from skirting height up to around 80cm and again wallpaper was lifting in places. Damp meter tests again revealed slightly above average readings on the whole outer wall surface, with no significant difference between mouldy areas and areas unaffected. The mould growth and level and the pattern of damp readings are consistent with condensation.

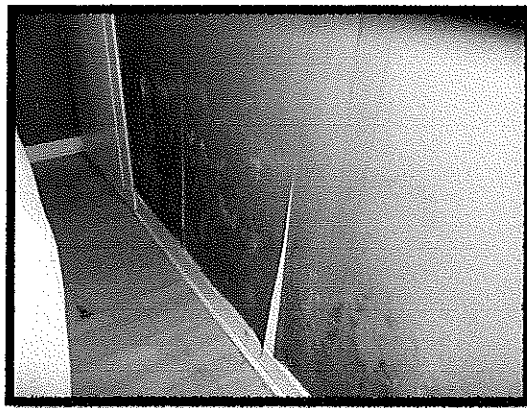
Figure 12 Mould Behind Sofa

(c) The remedy for condensation is in the tenant's own hands. Condensation exists in the property because of the interaction between warm air and cold air circulating within the property. If the tenant moves the furniture away from the walls and heats and ventilates the property so that there is an adequate circulation of warm air, the condensation problem will be resolved.
