Repairing Standard Enforcement Order

Reference Number:- PRHP/RP/16/0011

Re: Property at Flat 4, 14 Main Street, Milngavie, G62 6BL all as more particularly described in and registered in Land Certificate DMB52210 (hereinafter referred to as “the property”).

Schedule of photographs taken during the inspection of Flat 4, 14 Main Street, Milngavie
G62 6BL
by the Private Rented Housing Committee on the 29 March 2016.

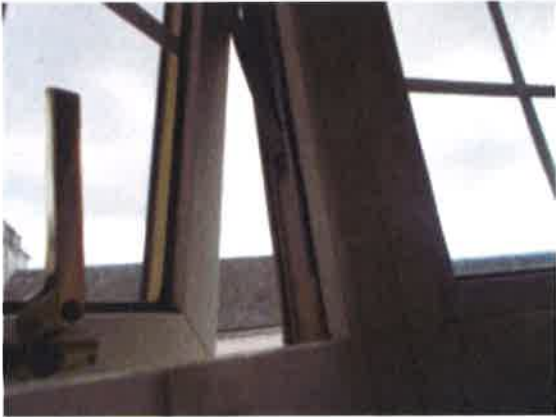
- (c) The larger bedroom has a large bay window consisting of three window units and the top right of the window unit located at the left most side when viewed internally within the property was not flush with the frame. There was a gap between this upper part of the window and the frame where an additional strip of foam seal had been added but the gap remained. The Tenant advised that this had been his first bedroom when he moved into the property in October 2015 but that he could not continue to use this room due to the draughts caused by the faulty window units and the fireplace/chimney, especially during periods of high winds. According to the Tenant the electric storage heater located in this room was not functioning properly. Damp meter

Front large bedroom window - left top light

- (a) To repair or replace all of the windows in the property to ensure that they are wind and watertight and in proper working order.
- (b) To repair or replace the front door and the surrounding frame of the front door to ensure that it is wind and watertight and in proper working order.

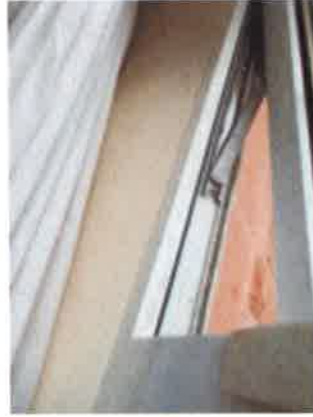
Front large bedroom window - left - lower section

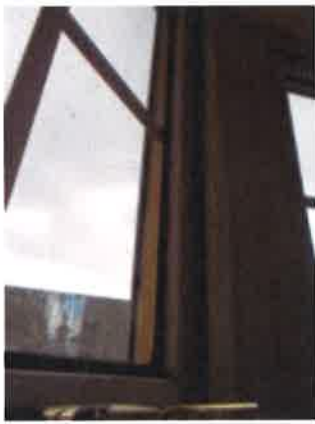
Front large bedroom window - left - lower section

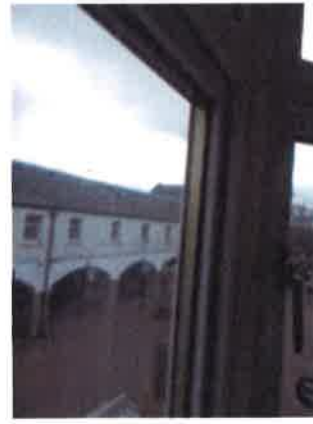
Front large bedroom window - middle section

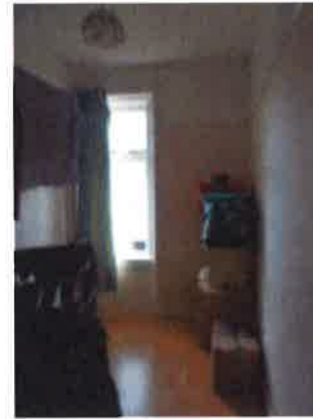
Front small bedroom

- (d) In the smaller bedroom, the window also appeared to be draughty. The Tenant advised that he had moved into this room and attempted to use this as his bedroom when he moved out of the larger bedroom but that he could not remain in this bedroom either due to the draughts emanating from the window causing the bedroom to be too cold whether or not the heating in the bedroom was switched on. The electric storage heater in this room was functioning.

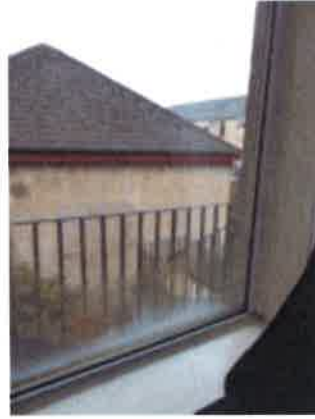
- (i) The living room was now being used by the Tenant as his bedroom and living room area combined. The kitchen is located off this room but the Tenant kept the door to the kitchen closed and placed blankets around this door to prevent draughts and the cold which emanated from the kitchen into the living room. The Tenant advised that this was the only way he could keep the room warm enough for him to sleep there. The Tenant had also blocked off the fireplace in this room to prevent draughts emanating from it. The control button for the boost heat function of the electric storage heater in the living room was broken. In order to make this heater work, the Tenant required to use a screwdriver to change the control of the heater. The Tenant complained that the window in this room was also draughty.

Living Room - window

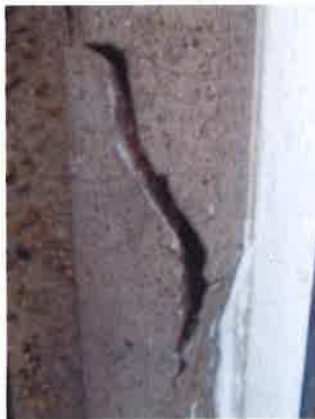
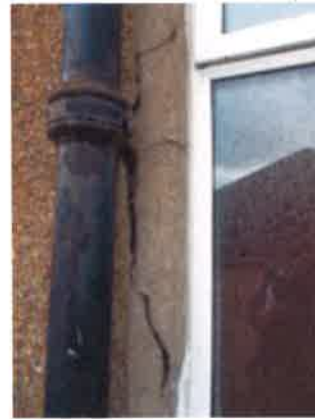
- (e) There was some black spot mould located on the internal bathroom wall above the skirting board and above the window to the rear elevation and the external masonry surrounding the bathroom window was badly cracked. The Tenant complained that the bathroom was too cold to use in cold weather due to the draughts in the bathroom.

The Landlord accepted that the masonry surrounding the bathroom window was badly cracked but he confirmed to the Committee that he did not intend effecting any repairs to this until the better weather came in as there was no point in fixing these cracks while the risk of frost remained.

Crack to side of bathroom window to rear elevation

- (c) To repair the cracked masonry surrounding the bathroom window and reseal the window to ensure that the structure and exterior of the house are in a reasonable state of repair and in proper working order.

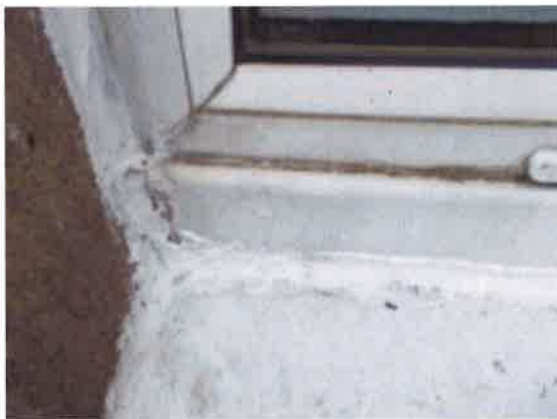
The Tenant advised that due to the cracks in the masonry surrounding the bathroom window the bathroom was often too cold to use. The Tenant advised that the Landlord had attempted to use bathroom sealant along the bottom edge of the bathroom window where there was a gap but that this had not improved matters much.

Sealant at Bathroom window - external

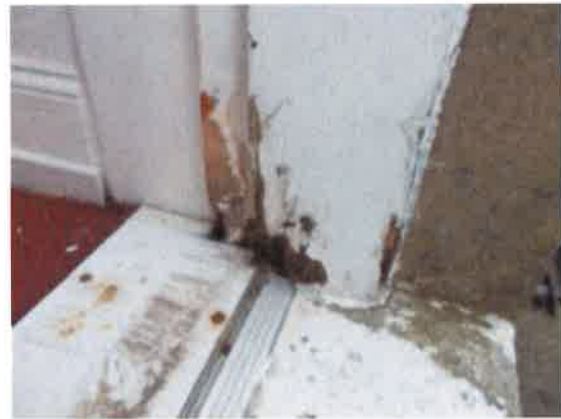
- (g) The front door of the property was badly swollen, cracked and rotten at the base. There was a large clear gap between the front door and the door frame where daylight freely filtered through. The door frame was also rotten. A new lock had been fitted to the front door but the Tenant complained that water ingress still occurred via the front door into the vestibule of the property during periods of heavy rain and wind. The Tenant also complained that the front door would swell up in heavy rain making it difficult for him to exit the property which concerned him if there were to be an emergency and he required to leave the property quickly.

Rot to External door frame

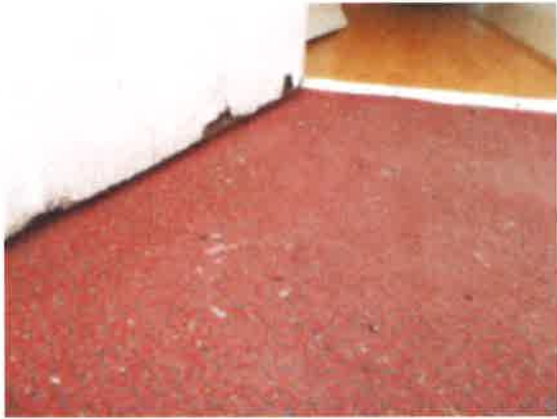
Rot to base of External door

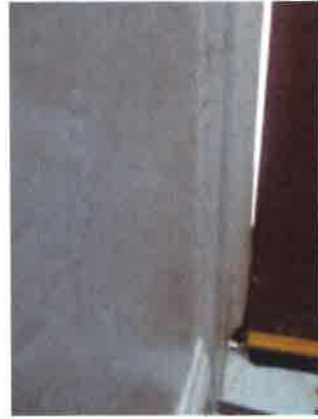
The Tenant confirmed that there was still water ingress from the front door of the property when it was wet and windy due to the large gap between the front door and the door frame.

Gap at side of External door - view from entrance vestibule

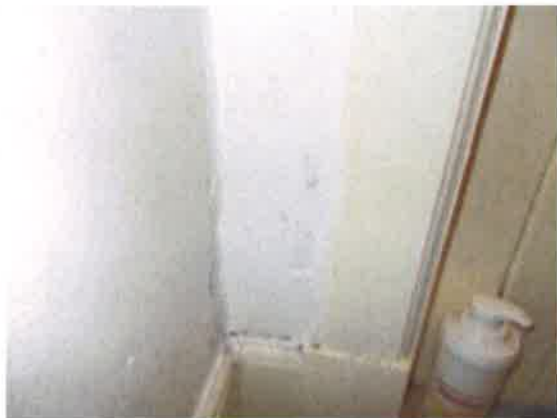
- (f) There was a high reading for dampness located in the bottom left hand corner of the bathroom, on the same wall where the window was located and adjoining the vestibule.

Bathroom - base of external wall

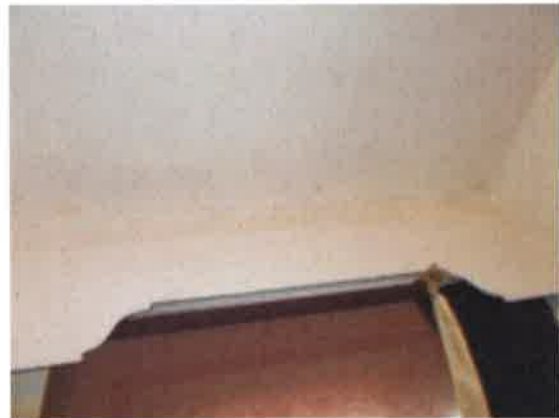
Bathroom - above window

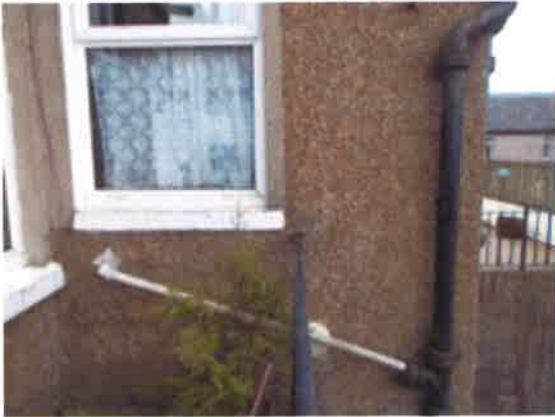
- (j) There was a high reading of dampness within the kitchen on the wall located behind the tumble dryer. On the outside of this wall, there was a large crack in the rendering. The Tenant advised that he did not use the kitchen as the cooker was dangerous to use due to its location, there was a draft which emanated from a wooden panel covering a vent and located on the back wall of the kitchen, the tumble dryer did not work and the toaster shorted. The Tenant complained that the electrics were not safe and the sockets in the kitchen kept tripping so he cooked using his own microwave oven which was located in the living room. The Tenant confirmed that some of the appliances, in particular the tumble dryer, had failed a recent Portable Appliance Test (PAT). The Tenant confirmed that he kept the door to the kitchen closed to try and keep the living room warm. The Landlord advised that this was the wrong thing to do as it would be better to keep this door open to allow the air to circulate in the property and for the kitchen to receive heat from the living room.

External projection - Kitchen

- (d) To repair the crack on the rendering located on the external wall outside the kitchen to ensure that the structure and exterior of the house are in a reasonable state of repair and in proper working order.

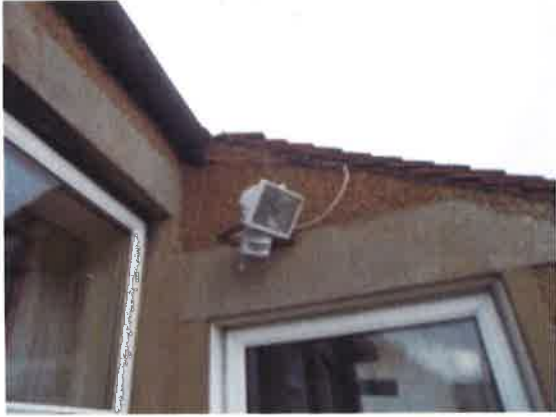
- (l) There was an external light outside the front door of the property and located above the kitchen window. The Tenant confirmed that this light worked but that he was concerned about it as its function was intermittent and that this was another example of problematic electrics within the property.

External security light

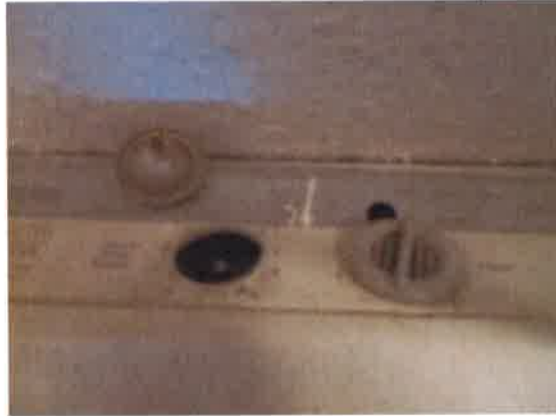
The Tenant complained that the electric storage heater located in the larger bedroom had only worked intermittently since he moved into the property. He advised that the Landlord had instructed contractors to effect repairs on this heater but that it still did not work properly.

Defective control knob to electric heater in Living Room

- (f) To repair or replace as required all of the electric storage heaters located within the property.
- (g) To produce a Portable Appliance Test (PAT) on all portable electrical appliances and equipment supplied by the Landlord and located within the property.

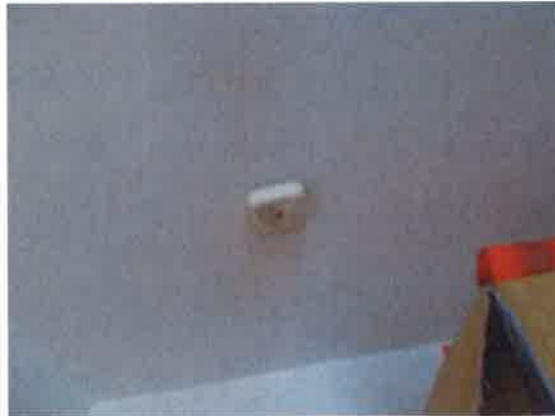
Smoke alarm in small front bedroom

- (k) There were two battery operated smoke detection devices in the property, one located within the hallway of the property and the other located within the smaller bedroom.
