**REPAIRING STANDARD ENFORCEMENT ORDER
Ordered by the Private Rented Housing Committee**

RE: Property at 69 Avonbank Crescent, Hamilton ML3 7PB more particularly described in Land Certificate Title number LAN62076 (hereinafter referred to as “the House”)

**STATEMENT OF DECISION OF THE PRIVATE RENTED HOUSING COMMITTEE
UNDER SECTION 24(1)
OF THE HOUSING (SCOTLAND) ACT 2006**

**Property at 69 Avonbank Crescent, Hamilton ML3 7PB (hereinafter referred to
as “the House”)**

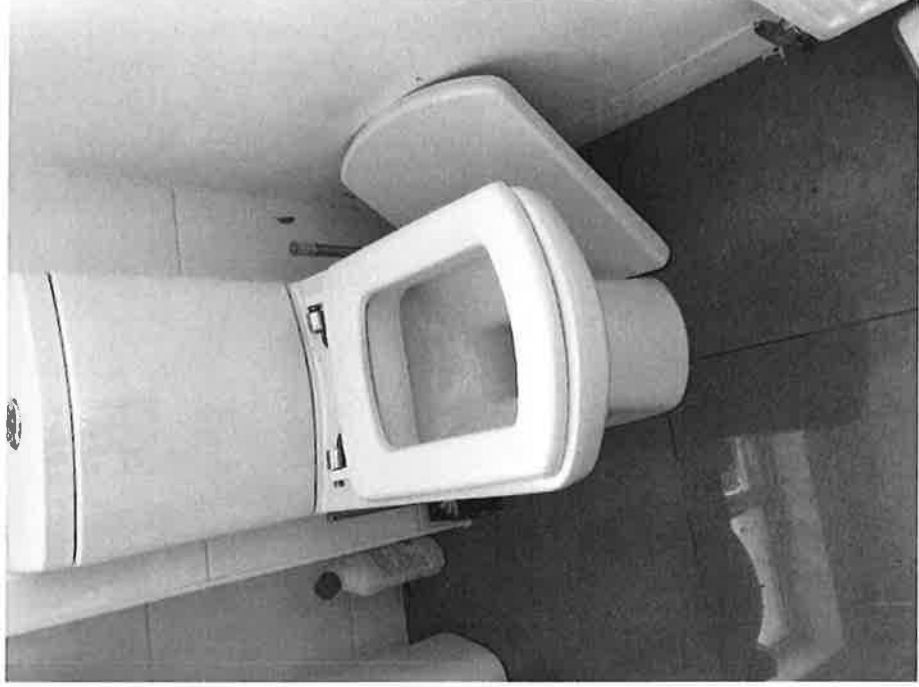
The toilet seat was ill fitting and had fallen off. The Tenant advised that a previous repair had not been successful. Mr Stretton accepted that the matter required to be addressed. He had been unaware that the earlier repair had failed.

The toilet seat lid has fallen off.

The toilet seat was ill fitting and had fallen off. A previous repair had not been successful. We consider this item to constitute a breach of the repairing standard.

WC with Seat Cover at Side

- 1 To repair the shelf in the upstairs hall cupboard such that it fits properly and is able to be used as intended.
- 2 To repair or replace the toilet seat such that it is secured and functions as intended.

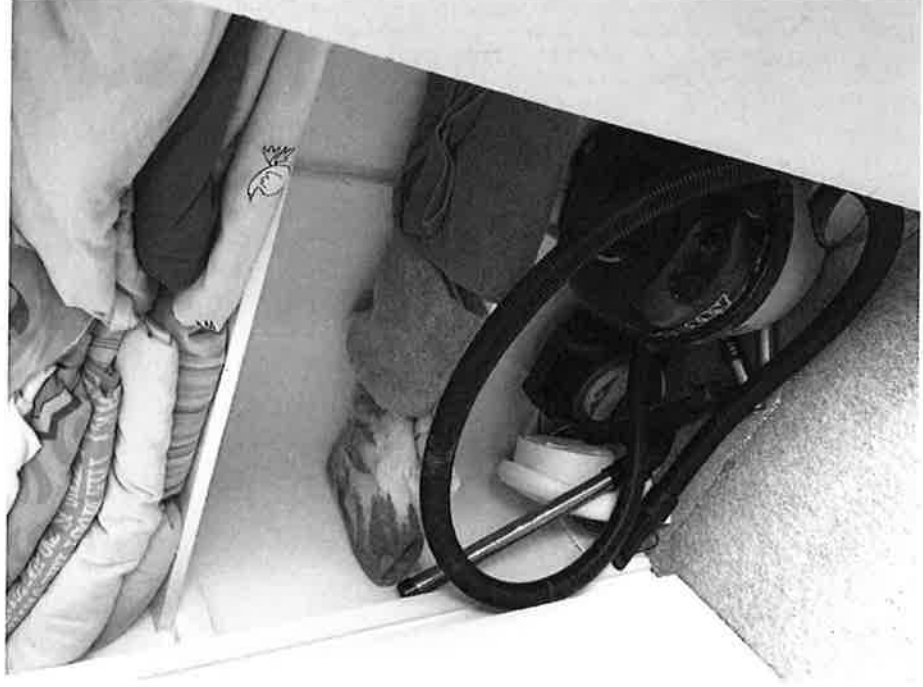
There was a space where a shelf was absent. The Tenant advised that that shelf had never been in place during the tenancy. A second shelf was present but was ill fitting. Mr Stretton indicated that the Landlord would be prepared to repair/replace the ill fitting shelf and would consider replacing the “missing” shelf.

In the upstairs cupboard, one shelf is missing and a second is ill fitting.

There was a space where a shelf was absent in the cupboard. The shelf had never been in place during the tenancy. A second shelf was in use but was ill fitting. As the “missing” shelf had never been present during the tenancy, we identify no breach of the repairing standard. We do, however, consider the condition of the ill fitting shelf to be a breach of the repairing standard.

Hall Press with Missing Shelf

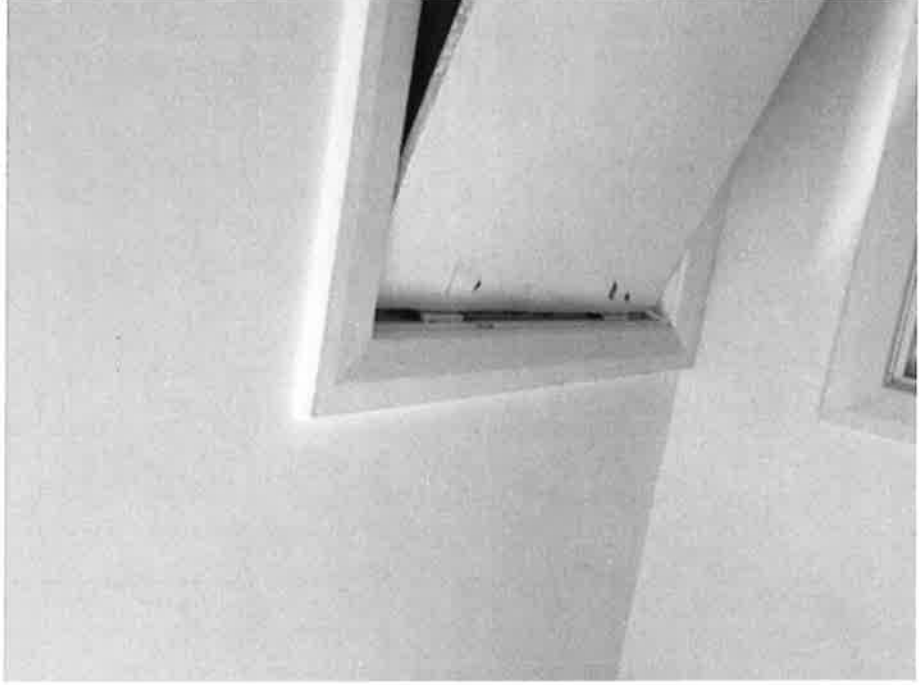
The Tenant reported that the loft hatch had previously fallen open and the ladder had hit her son on the head. A repair had been carried out but the loft hatch was still prone to falling open and, as a result, she now keeps it permanently open. Mr Stretton advised that he had been unaware that the repair was unsuccessful but acknowledged that the issue should be addressed.

The loft hatch was found in an open position. It was able to be closed and secured by its latch.

The loft hatch appears to continue to present a risk of opening unintentionally to the potential injury of those below. The catch appears old and unreliable. We consider this to constitute a breach of the repairing standard.

Loft Hatch Door

- 9 To repair or replace the loft hatch such that it may be secured without risk of opening unexpectedly.
- 10 To make the loose driveway slab reasonably secure such that it does not move excessively when weight is applied to it.

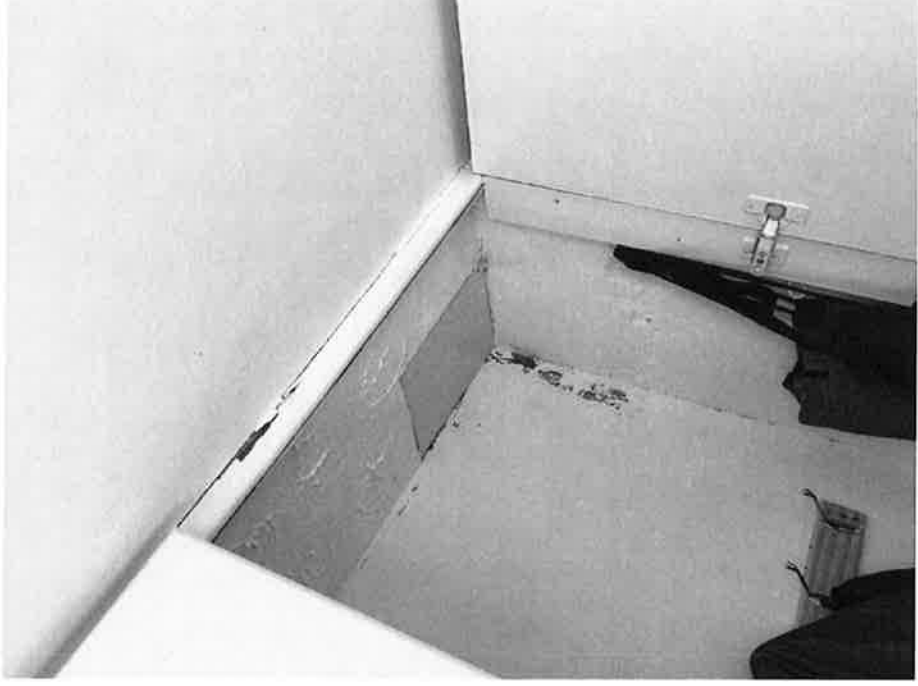
The Tenant had complained about a loose wire and sparking sockets. She reported that a repair had been carried out by persons accompanying the Landlord's maintenance man who she had presumed to be electricians. The repairs had removed the loose wire although the Tenant was unhappy with the finish of the repair which was unsightly. The repair had involved power being disconnected from the adjacent sockets. Mr Stretton agreed that the necessary decorative finishing works would be undertaken. He was unaware as to whether the property had a current Electrical Installation Condition Report (EICR).

In the entrance hall cupboard, no wires are evident. A repair has been carried out but the surfaces are rough and unfinished/undecorated.

The repair carried out to deal with the tenant’s complaint of a loose wire have left the walls unfinished and in unsightly condition. The nearby sockets now do not work. There is a legitimate concern as to matters of electrical safety in these circumstances and we find there to be a breach of the repairing standard in these respects.

Ceiling of Hall Cupboard showing Repair

- 3 To produce an Electrical Installation Condition Report prepared by a qualified electrician who is, or whose employer is, registered with NICEIC, SELECT or NAPIT, which confirms that the electrical installations within the House are in safe, working order. The Report should, in particular, address the sockets adjacent to the entrance hall cupboard.

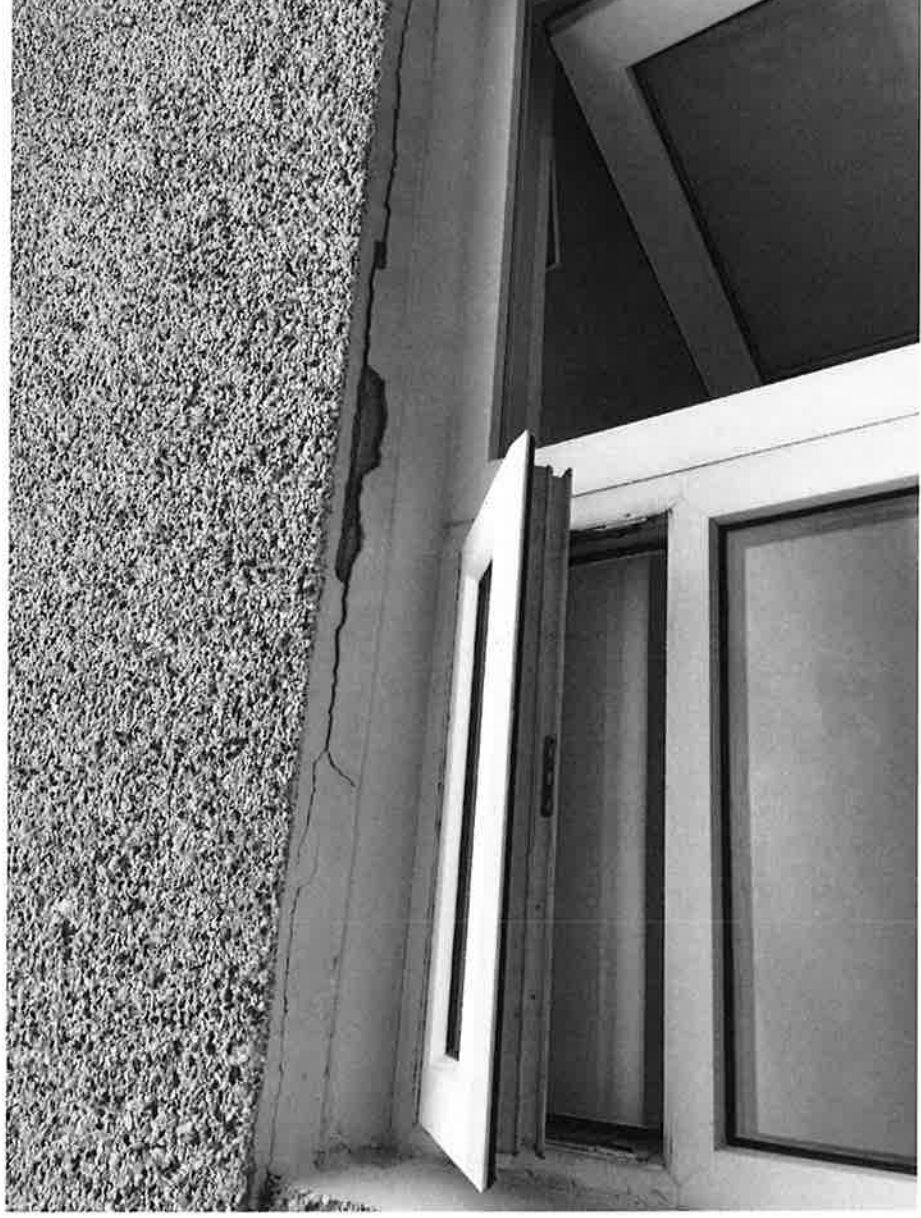
The plaster is cracked and flaking and in need of repair. Mr Stretton accepted this.

Plasterwork to the lintel above the back door is cracked and flaking.

The plaster is cracked and flaking and in need of repair and is likely to fall onto those passing under it. We consider this to constitute a breach of the repairing standard.

Roughcast falling away from Rear Door Lintel

- 4 To repair/replace the outside tap such that it is secured to the building and can be operated by hand.
- 5 To put the plaster above the back door into reasonable condition such that it is not cracked or flaking.

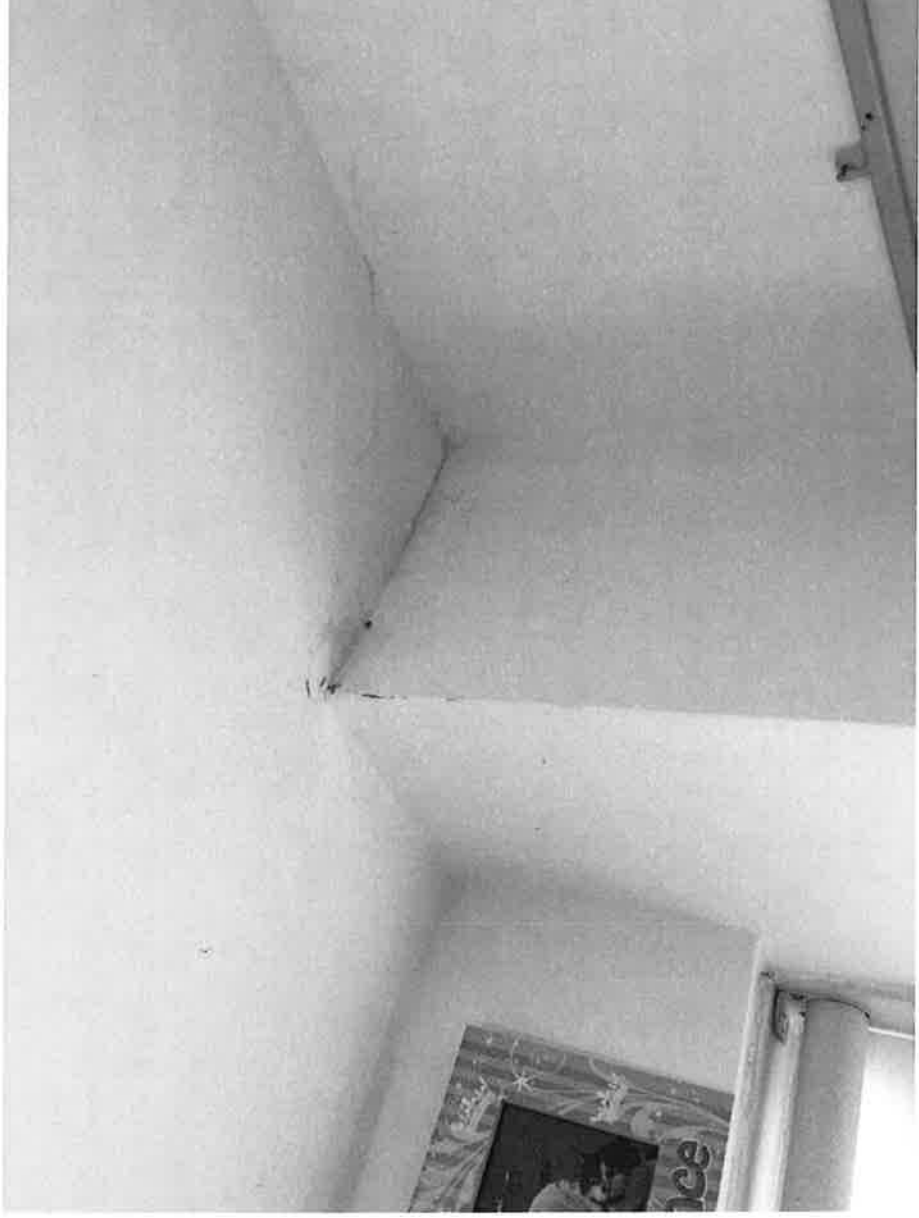
Staining/mould was observed in a top corner of the exterior internal wall of the kitchen. The damp meter indicated high moisture readings in this area. The parties agreed that a few months ago plumbers had investigated the cause of the dampness, it having been suspected that there may be a leak from the bathroom plumbing. No leak was identified and the area was repainted. Mould and staining has reappeared recently. The Tenant has not observed any water dripping but remains concerned that there may be a leak from the plumbing.

Staining/mould was observed in a top corner of the exterior internal wall of the kitchen. The damp meter indicated high moisture readings in this area.

We consider the staining/mould and damp areas to constitute breaches of the repairing standard.

Ceiling in corner of Kitchen where Damp

- 7 To fit an appropriate handle to the opening section of the kitchen window.
- 8 To investigate the causes of dampness within the kitchen wall and to carry out any repairs required to address water leaks and/or ingress such that the wall is reasonably free of damp and to redecorate same (such redecoration to include the removal of any mould or staining).

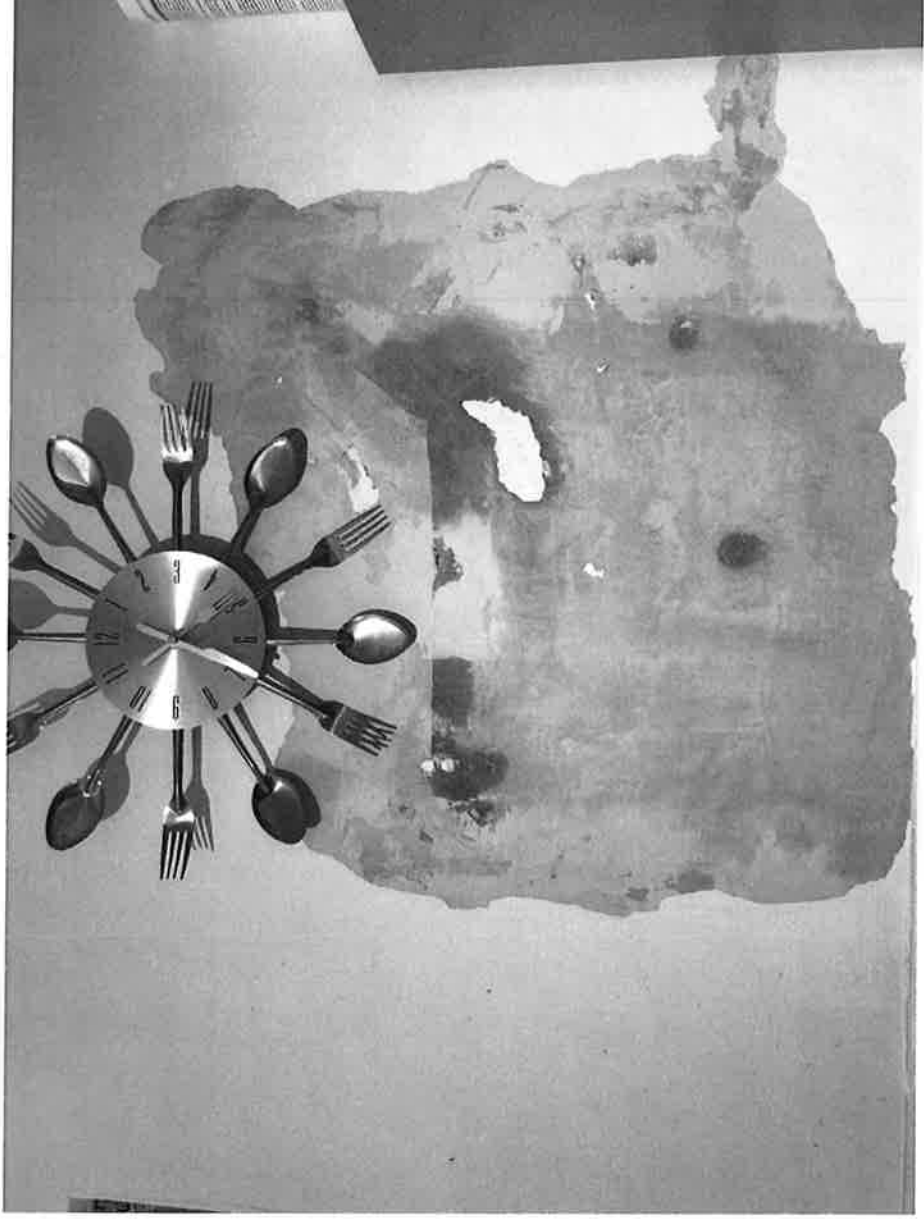
In the centre section of the side facing kitchen wall there was an exposed section where the parties reported that the paint had bubbled and peeled away. The

exposed section was generally dry on the damp meter but a small section showed high readings. The parties agreed that this area had been the location of the previous boiler and that the, now apparently redundant, flue remained in place in the area where the dampness was observed.

In the centre section of the same wall the exposed section was generally dry on the damp meter but a small section, which is believed to be the location of an old flue, showed high readings on the damp meter.

Kitchen wall – site of Old Boiler - damp

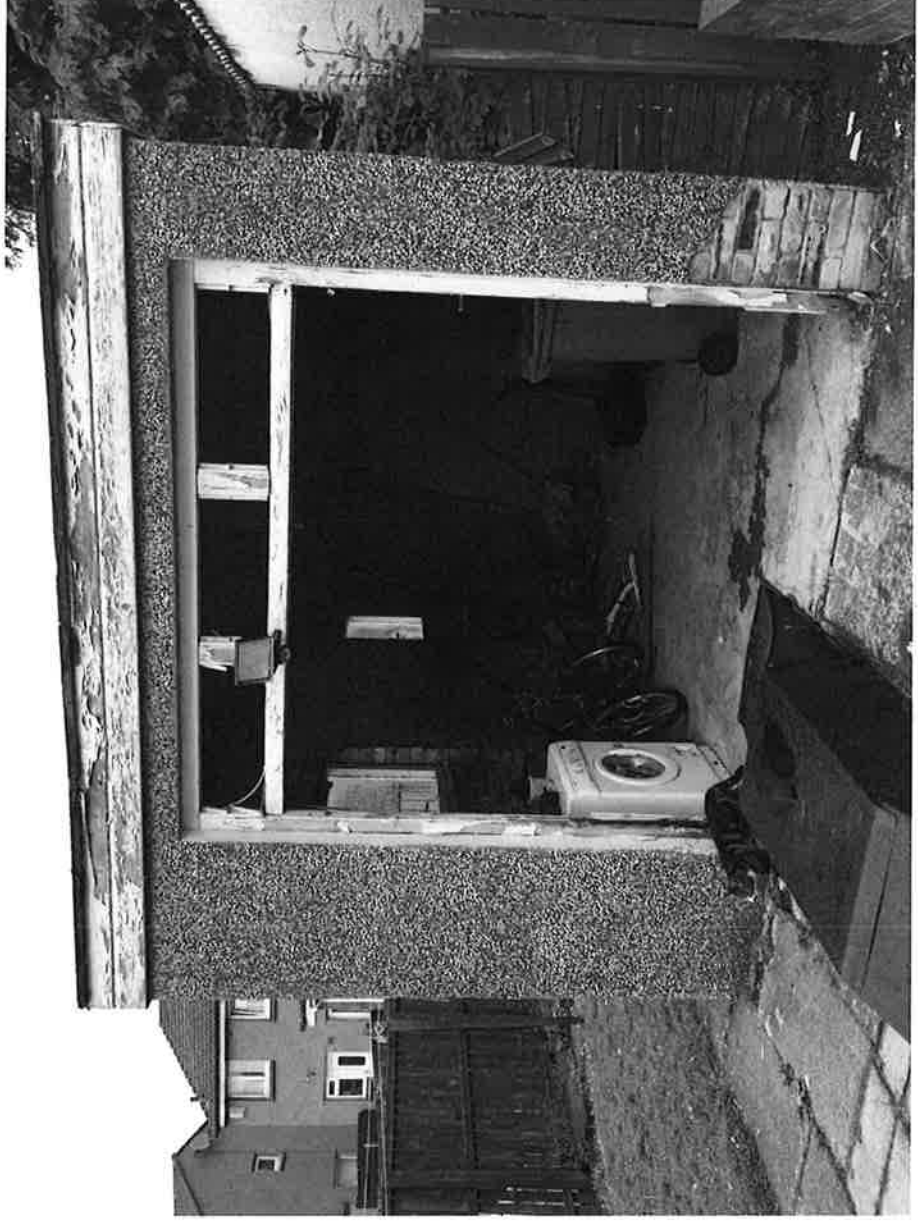
The garage door has been taken down and is on the floor of the garage. Its wooden frame remains in place but is in poor condition. The Tenant reports that the Landlord's maintenance man had taken it down and had intended to replace it but has not done so. Mr Stretton accepts that a new door is necessary and advised that the Landlord has obtained quotations for this. He was unaware of the Landlord having accepted any quotation.

The garage door has been taken down and is on the floor of the garage. Its wooden frame remains in place but is in poor condition.

The garage door has been taken down and is on the floor of the garage. Its wooden frame remains in place but is in poor condition. We consider these matters to constitute a breach of the repairing standard.

Front elevation of Garage – door off

- 6 To repair or replace the garage door and its surround such that there is a properly functioning garage door capable of being opened and closed and locked.

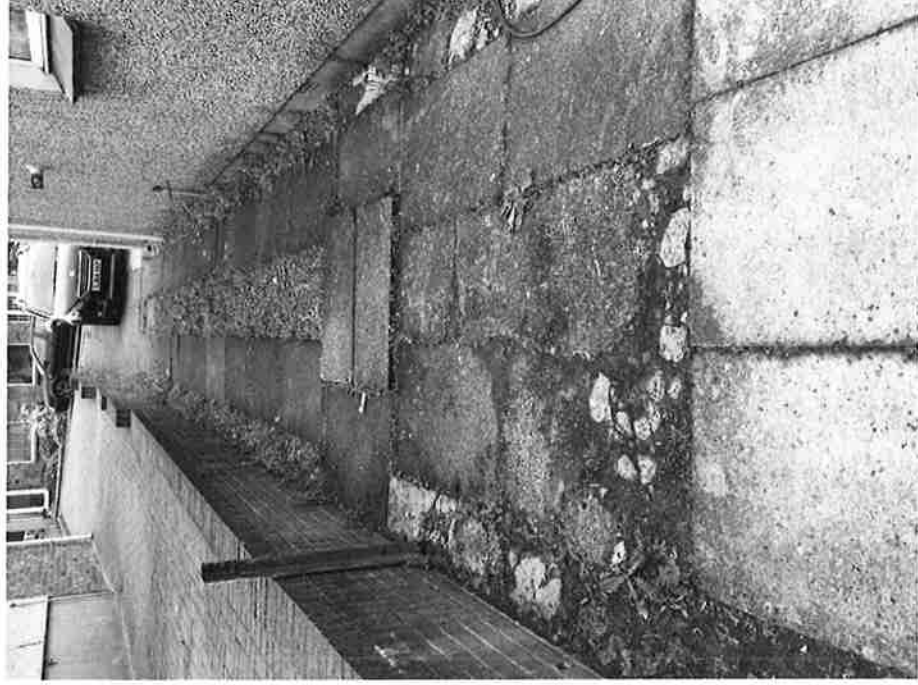
View along Driveway at side of House

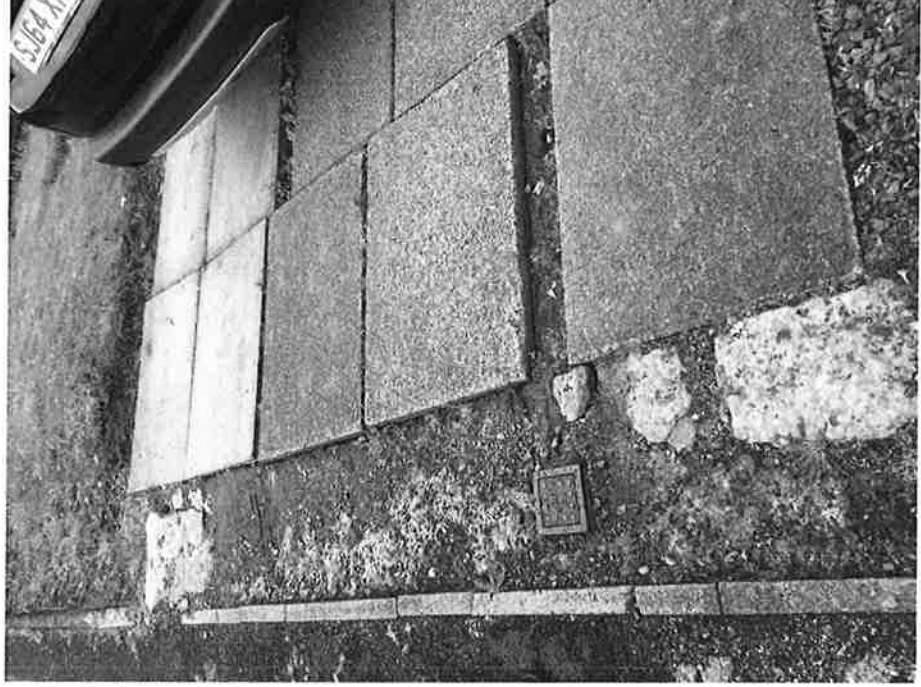
The Tenant was concerned about a particular slab at the top of the driveway where it meets the public pavement. It is loose and, she says, causes difficulty when driving her car in and out. Mr Stretton acknowledged this and advised that that the slab would be rebedded securely.

A slab at the top of the driveway adjacent to the public pavement moves excessively and is poorly bedded in.

The driveway is slabbed and the quality of the driveway is generally poor with large gaps between the slabs. The particular slab in which there is excessive movement is considered by us to represent a breach of the repairing standard.

Driveway at Public Footpath

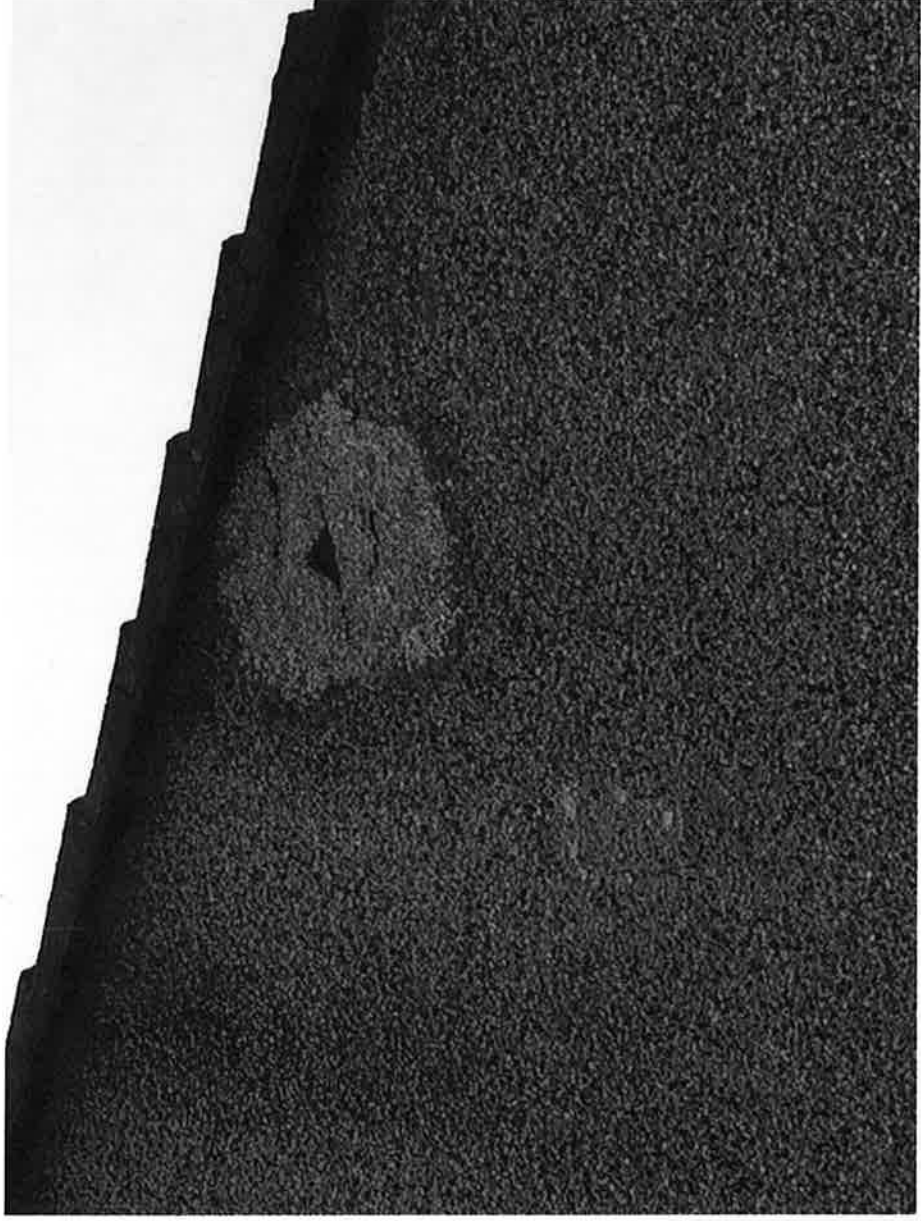
Roughcast Repair – Former Overflow?

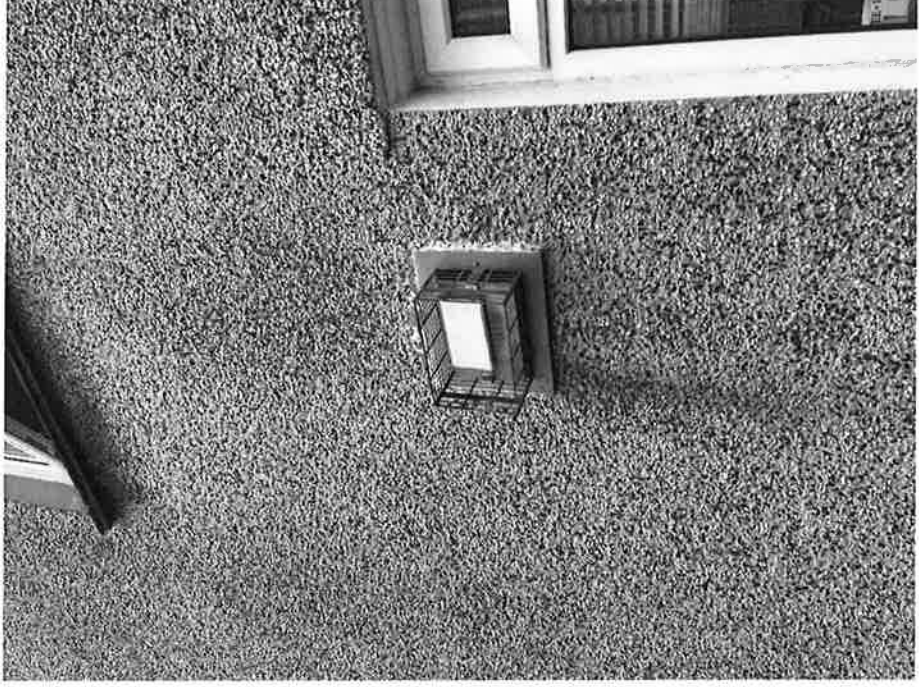
Redundant External Flue from Old Boiler
