**Statement of Decision of the First-tier Tribunal for Scotland (Housing and Property Chamber) under Section 24(1) of the Housing (Scotland) Act 2006**

**Chamber Ref: FTS/HPC/RP/17/0233**

**20 Citadel Place, Motherwell, ML1 3NT ("the House")**

Schedule of photographs taken during the inspection of 20 Citadel Place, Motherwell ML1  
3NT by the First-tier Tribunal for Scotland (Housing and Property Chamber)  
21 August 2017

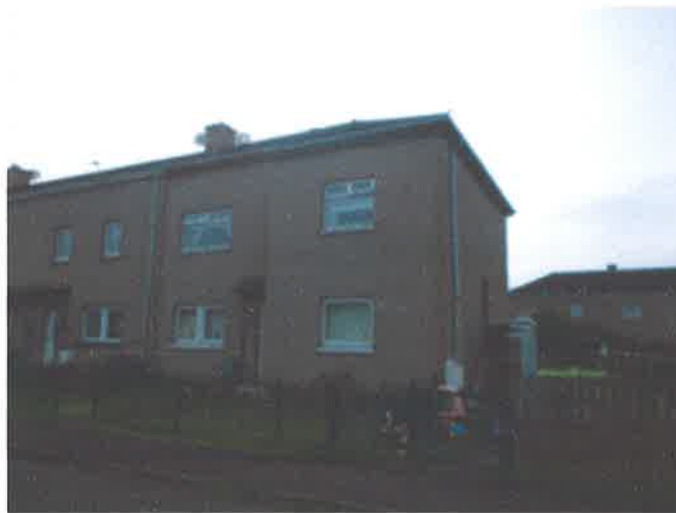
Front Elevation (Upper 4 in a block flat)

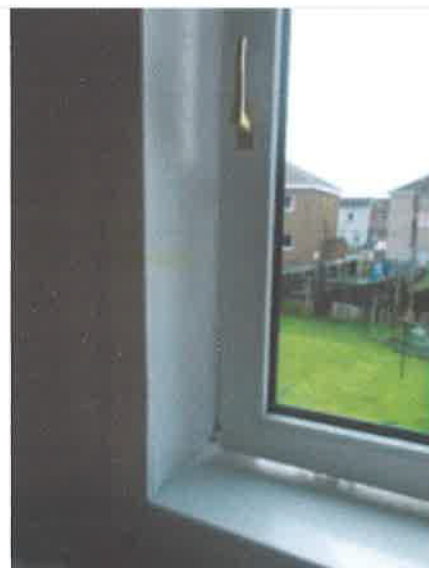
**24.** The back bedroom window is defective and does not open fully so as to allow proper safe cleaning and escape in the event of fire and it does not close properly. The House is accordingly not wind and watertight or reasonably fit for human habitation in terms of Section 13(1)(a) of the Act. The window requires to be repaired or replaced to ensure that the House meets the repairing standard.

Back Bedroom window - restricted opening/loose  
frame and defective opening mechanism

- (1) To repair, or, as necessary replace, the back bedroom window of the House to ensure that it can open and close properly and is fully operational such that the House is wind and watertight and in all other respects reasonably fit for human habitation.

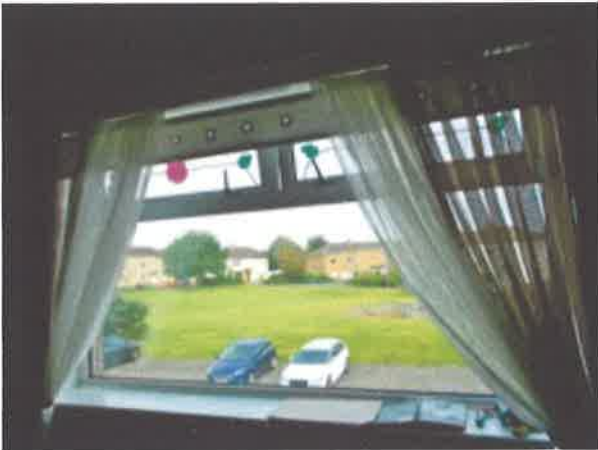
Living Room window

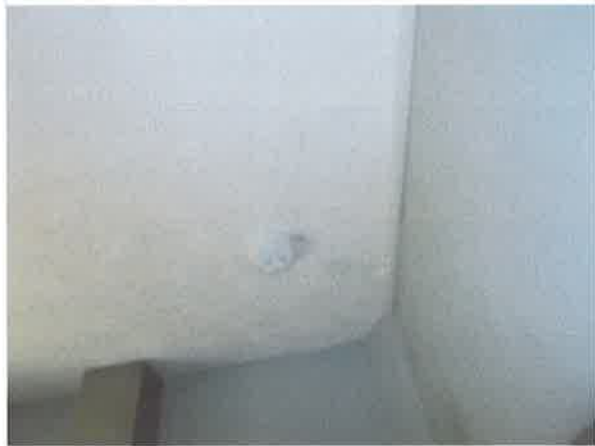
Ceiling mounted heat alarm - Kitchen

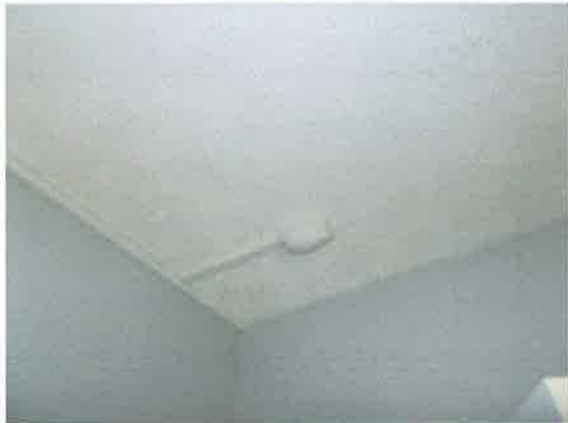
- (d) There was a ceiling-mounted carbon monoxide alarm in the kitchen, situated near the boiler cupboard. The Tenant indicated that this alarm had also been installed a few weeks before.

Ceiling mounted CO alarm - Kitchen

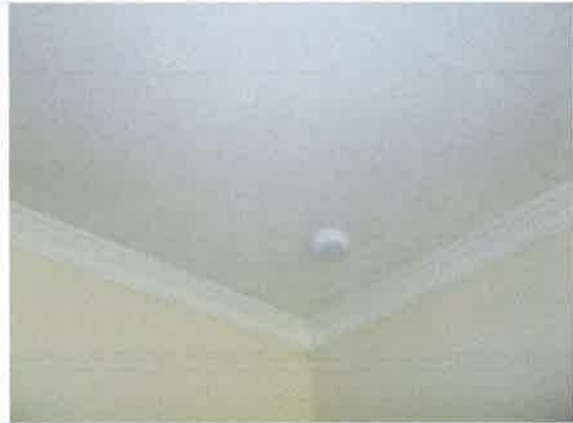
Ceiling mounted smoke alarm - Living Room

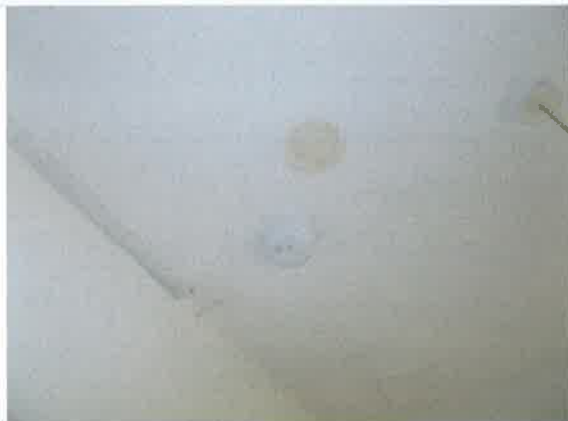
Ceiling mounted smoke alarm - Hall

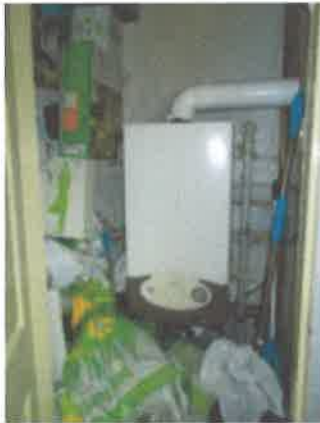
**Boiler - Kitchen cupboard**

**25.** The Gas Safety Record dated 3 August 2017 submitted by the Landlord was recent and in order. However, no evidence was produced to indicate that the boiler had been serviced. Given the Tenant's evidence about the repeat problems she had experienced throughout the tenancy and as recently as June 2017, with the boiler not working, the Tribunal was not satisfied that the installations in the House for the supply of gas, for space heating and heating water are in a reasonable state of repair and proper working order in terms of Section 13(1)(c) of the Act. A report from a Gas Safe registered engineer is required, confirming that the boiler has been serviced, when it was serviced and that any defects identified have been rectified to ensure that the House meets the repairing standard.

- (2) To submit to the Tribunal a report from a Gas Safe registered engineer confirming that the gas boiler has been serviced, when the service took place and that any defects identified have been rectified, to ensure that the gas boiler is in a reasonable state of repair and in proper working order.

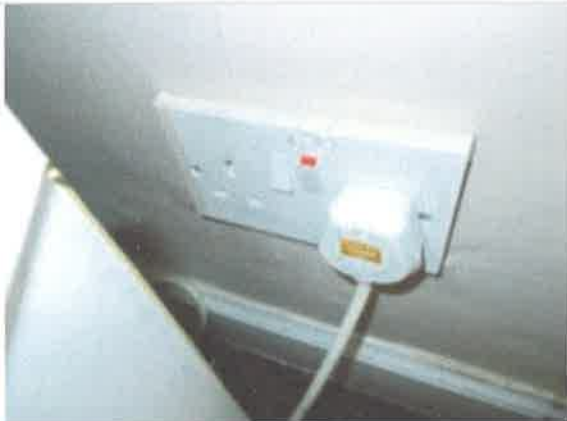
- (f) The electricity consumer unit was situated in a hall cupboard. The Tenant mentioned having experienced some electrical problems. One of the switches in a double socket in the living room was defective, in that it was jammed and could not be switched on/off. The light fitting attached to the ground floor entrance hall ceiling was cracked and the cable loose. There was no bulb in the fitting, the Tenant indicating that if she tries to switch this light on, the electricity "trips". The Tenant also mentioned an electric extractor fan which was not working.

**Double socket in Living Room - defective/jammed switch**

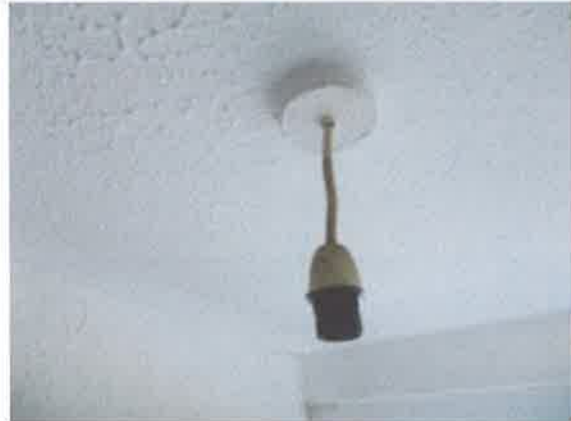
**Light Fitting - ground floor hall ceiling - cracked/ loose cable**

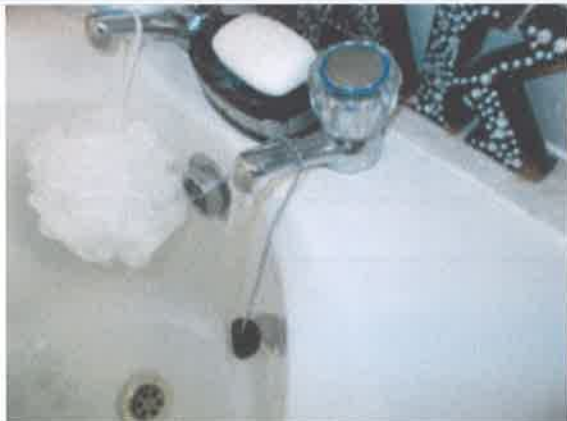
**Bathroom - cold tap operating properly**

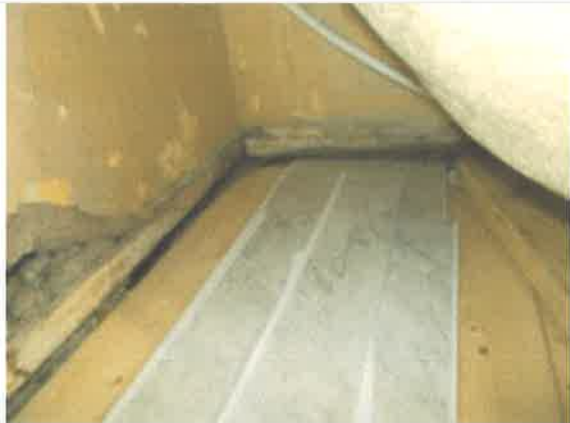
Bathroom - floor under bath - showing electric cable

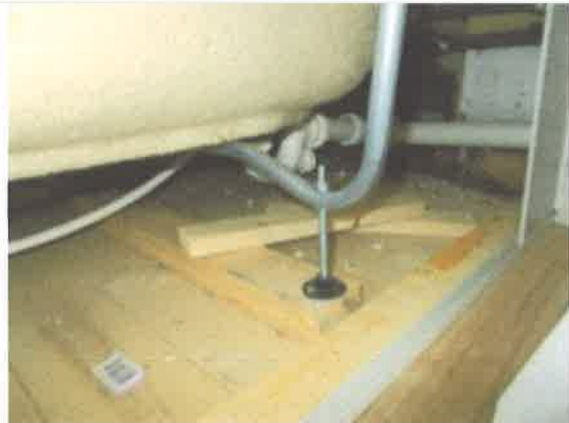
Bathroom - floor under bath and pipework

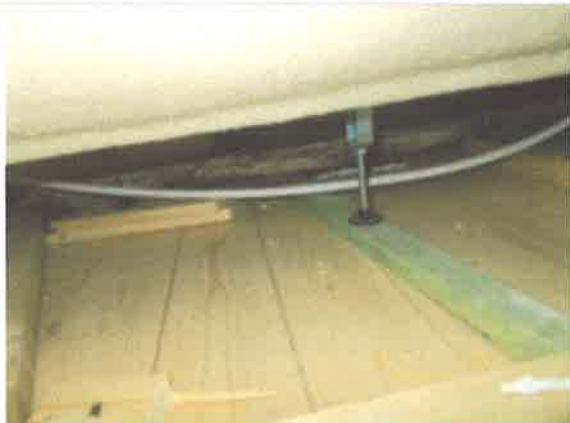
Bathroom - floor under bath

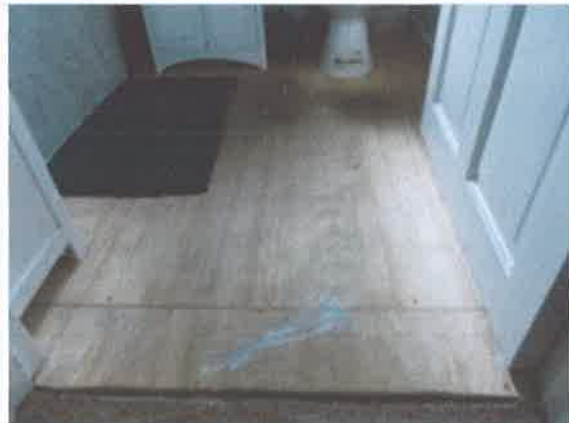
- (e) The bathroom appeared to be in a satisfactory state of repair, other than the flooring. The bath cold tap was operating properly. The bath panel was removed and the area under the bath looked dry. Most of the floorboards looked new and were dry. Some of the pipework behind the bath looked to have been recently replaced and to be in order. There was no visible evidence of an ongoing leak. There was an electric cable under the bath. The covering appeared to be in good condition with no wiring exposed. There was no satisfactory floor covering on the remainder of the bathroom floor. The flooring consisted of plywood, with exposed nails and screws showing.

**26.** Although works had been carried out to the bathroom including repair of the leak and replacing the bathroom floor, the flooring had not been made good in that a satisfactory floor covering had not been laid, leaving bare plywood, with exposed screws and nails showing. Fixtures and fittings provided by the Landlord are not therefore in a reasonable state of repair and in proper working order in terms of Section 13(1)(d) of the Act. Section 14(2) of the Act specifies that the Landlord's duty to ensure that the House meets the repairing standard includes a duty to make good any damage caused by the carrying out of any work to comply with the repairing standard. A suitable floor covering requires to be installed in the bathroom to ensure that the House meets the repairing standard.

Bathroom floor - exposed plywood - no floor covering

- (3) To make good the bathroom floor by installing a proper floor covering of a type suitable for use in a bathroom over the exposed plywood to ensure that the flooring is in a reasonable state of repair and in proper working order.
