**Notice of Variation of Repairing Standard Enforcement order:
Housing (Scotland) Act 2006 : Section 25(1)**

**2 Afton Place, Ardrossan, KA22 7JD
("The House")**

Statement of Decision : Housing (Scotland) Act 2006 : Section 24(1)

Schedule of photographs taken during the inspection of 2 Afton Place, Ardrossan KA22 7JD by the First-tier Tribunal for Scotland (Housing and Property Chamber) on 20 February 2017.

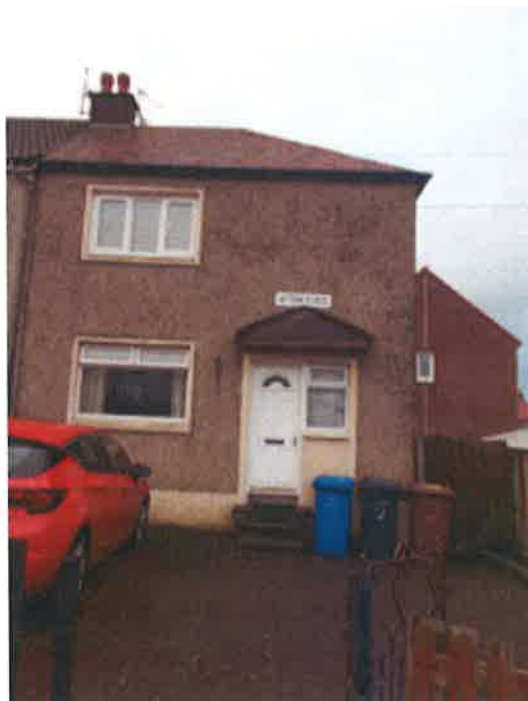
External view - Front elevation of property

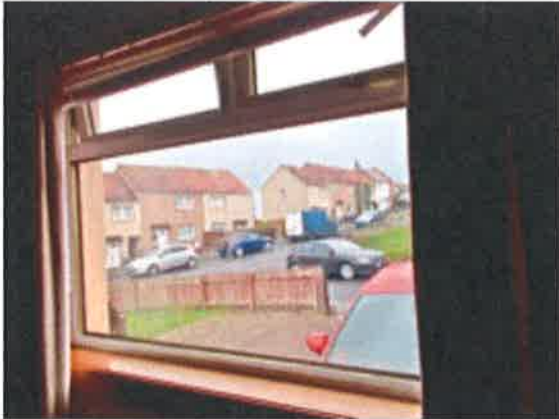
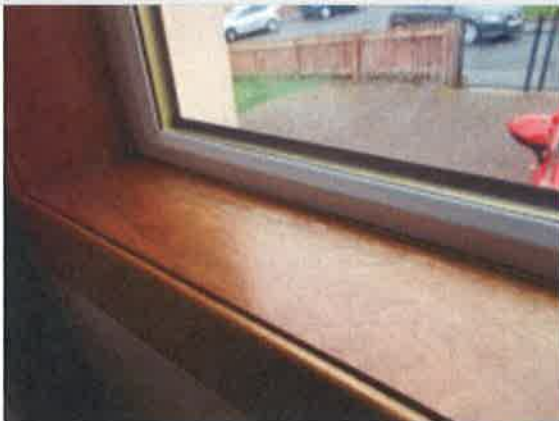
Living Room window - front

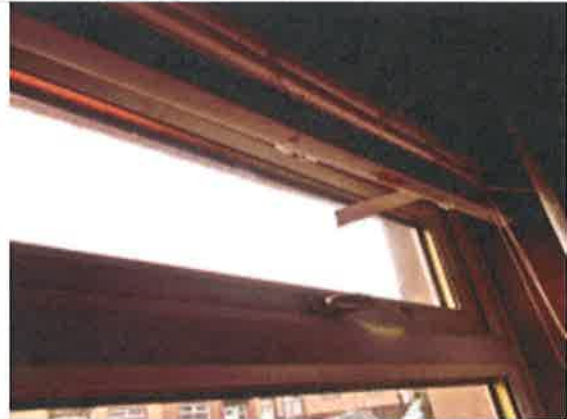
Living Room window - front - top light

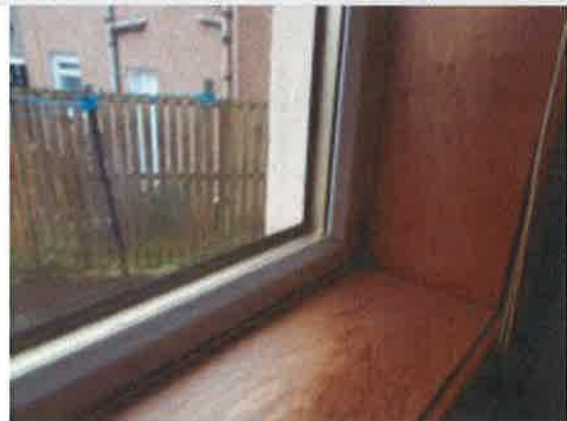
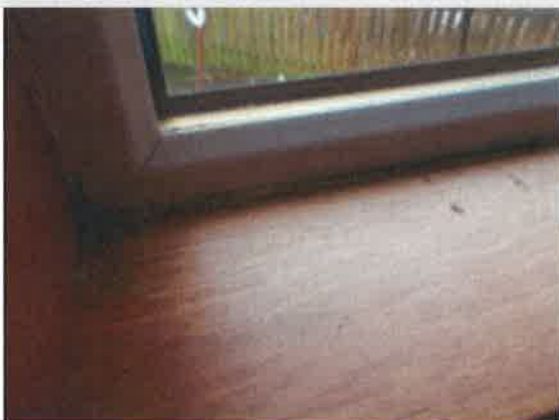
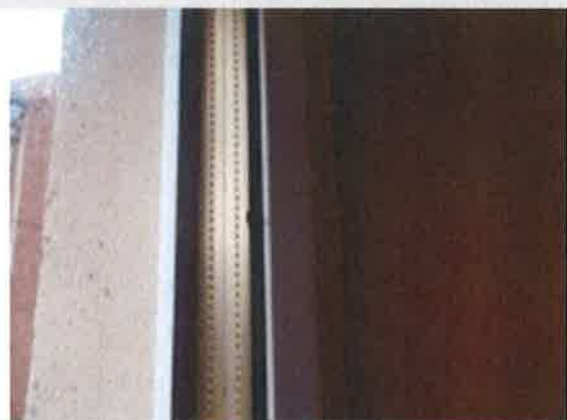
Living Room window - rear

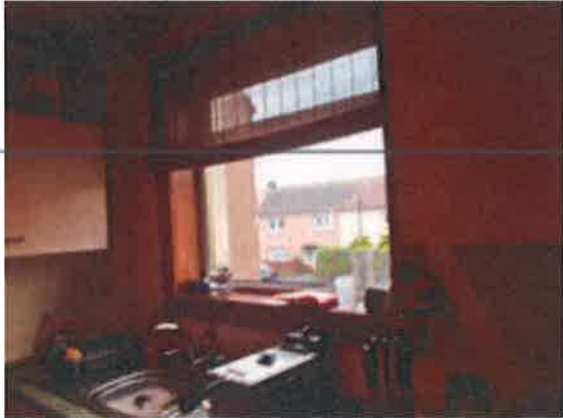
Kitchen window - internal

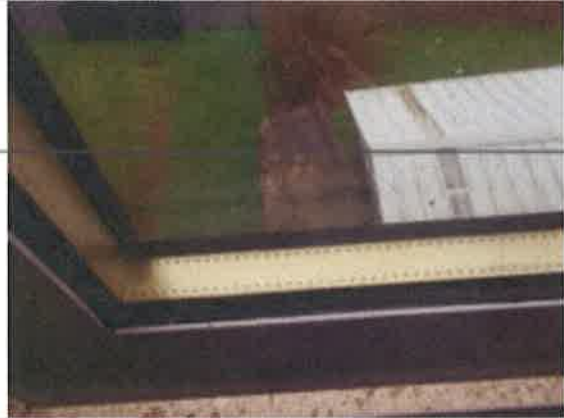
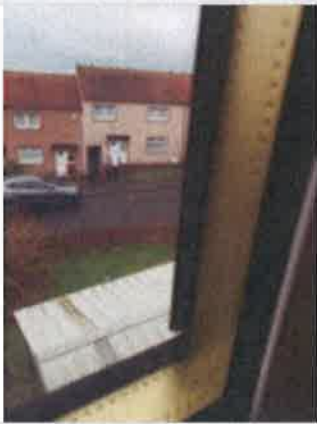
Landing window

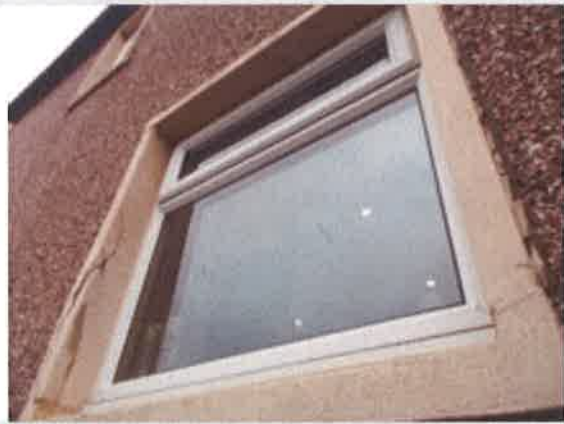
Kitchen window - external

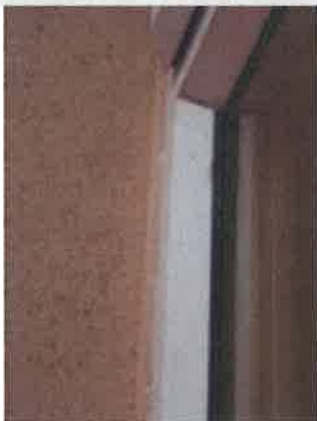
Living Room window - front - external

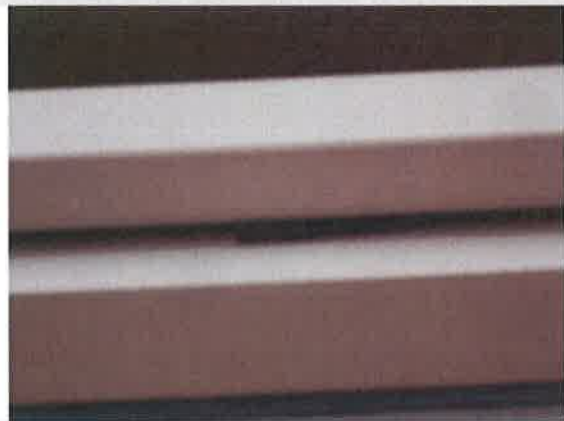
Living Room window - front - external view of left side top light

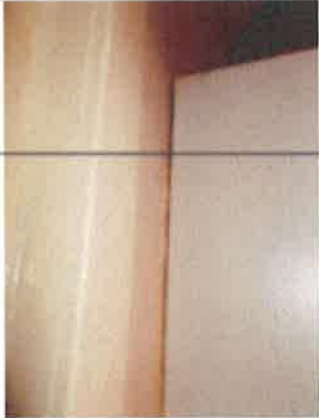
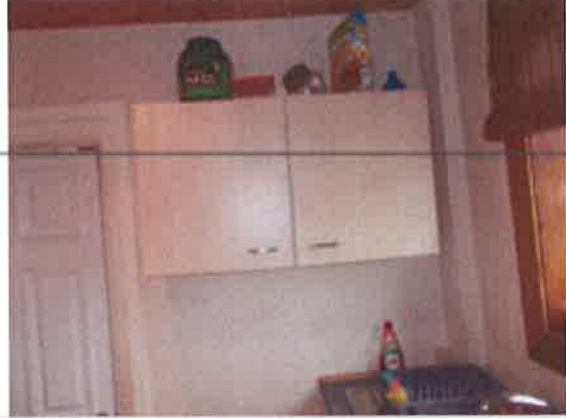
Kitchen - double wall mounted cabinet

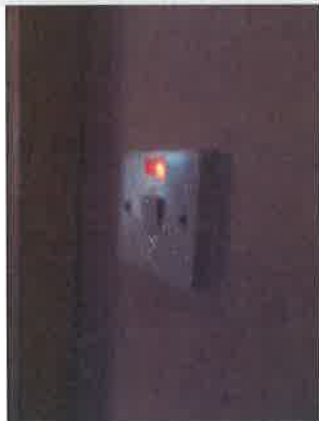
Hall - kitchen light switch

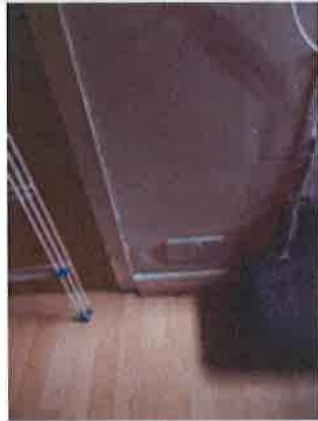
The tribunal noted the Tenant's evidence regarding the electrics in the House. It considered that the matter of the non functioning socket in the hall did not bring the house below the repairing standard. It had regard to the terms of the RSEO. The Landlord had produced an Electrical Installation Condition Report which states that the electrician's overall assessment of the installation is satisfactory. The Report raised no issue concerning the lights and the Tenant had stated that the lights are working. The tribunal considered that the Landlord had complied with the RSEO in this regard.

Hall - double socket - disconnected
