### Statement of Decision of the First-tier Tribunal for Scotland (Housing and Property Chamber) under section 25 of the Housing (Scotland) Act 2006

**Property Re-inspection Report**

**112 Queen Street, Dumfries, DG1 2JT**

**Case Reference:** PRHP/RT/16/0359

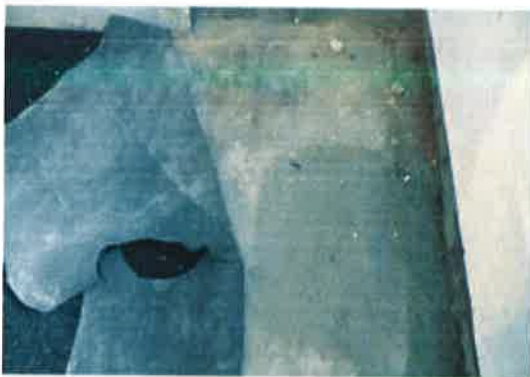
- **The Contractor advised that excavation works along the rear elevation had been undertaken by the landlord, the window assembly sealed, the drain hole in the floor, previously used to drain the waste water from the washing machine, sealed (See Photograph 1 below). It was observed that the door steps into the external kitchen door have been reset to ensure that rainwater flows away from the house and basement area (See Photograph 2 below). It was also noted that the window sill (See Photograph 3 below) had been cleared although it was not evident to the Surveyor Member, or the Contractor, where the rainwater would eventually drain away to.**

**Photo 1 – R/B former drain hole**

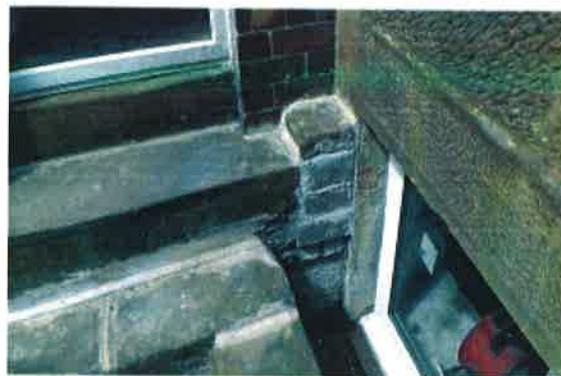
**Photo 2 – Re-aligned steps and sealed window**

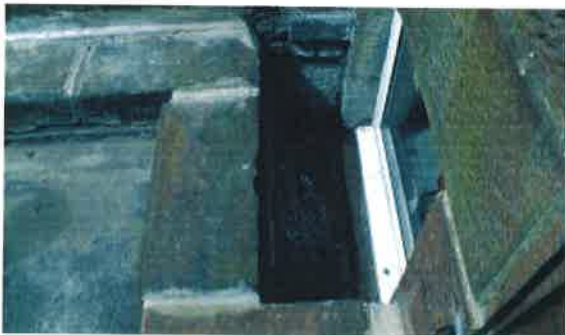
**Photo 3 – External sill and soakaway**

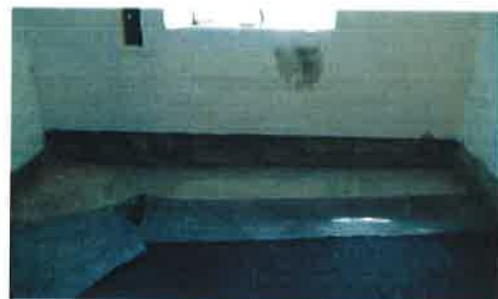
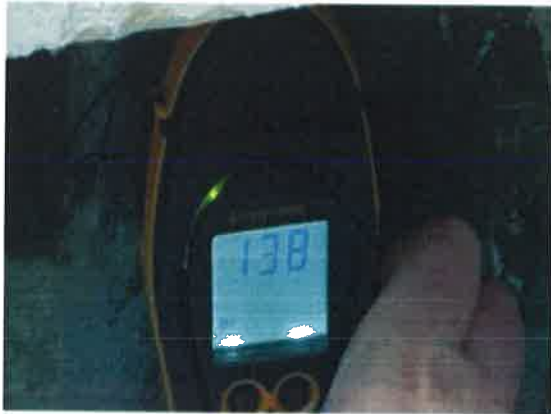
- **Improved dampness readings were obtained along the lower sections of the rear elevation using a dual function dampness meter capable of determining levels of moisture below the surface, and deeper within building materials. The readings recorded would suggest that the measures outlined above have been successful. (See Photographs 4 + 5 below)**

**Photo 4 – Rear wall inner face**

**Photo 5 – Rear wall reading**

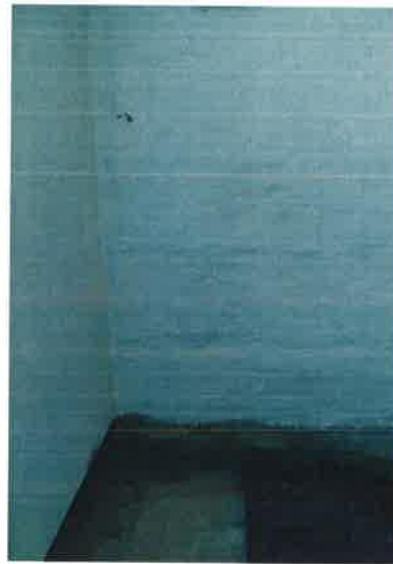
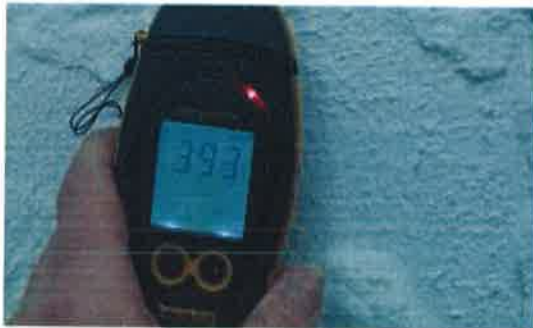
- **Meter readings were also obtained once again from the internal wall running perpendicular to the right of the window opening (See Photographs 6 + 7 below). These readings were higher than the ones obtained from the rear elevation and fell within the 22-40% range. They were also concentrated at a height of 4-5ft above the floor level in one small isolated section, and not in the vicinity of any timber. There was no obvious cause for this isolated section of dampness at this location suggesting that this section of wall may still be drying out. Rising damp can also be ruled out.**

**Photo 6 – Right hand wall**

**Photo 7 – Right hand wall reading**

**Recommendation:** Allow a further period of 1 month for remaining damp areas to hopefully dry out, and for the washing machine hoses to be fitted. Request a Gas Safety certificate. Re-inspect when appropriate.

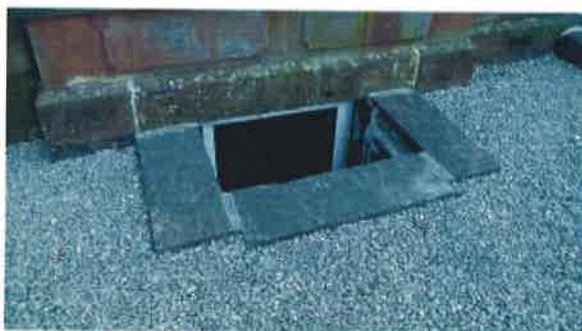
- The sodden earth in the front garden has been removed and replaced by stone chips (See Photograph 9 below);
- The Landlord and the Contractor have undertaken “tanking” work on the interior face of the front elevation and a section of the floor slab.

**Photo 9 – Re-surfaced front garden**

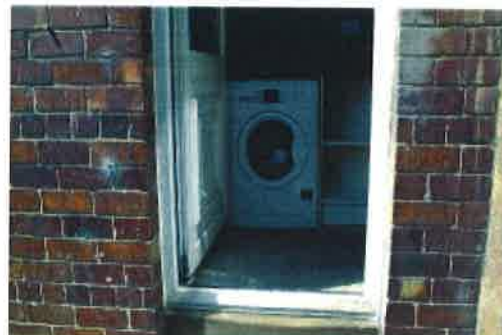
- Install the washing machine in the kitchen and properly connect the outflow pipe to the drains.
- It was noted that the washing machine had been relocated to the kitchen and the relevant pipework was in place to properly connect it to the water supply and drainage outlet (See Photograph 10 below). However, it was noted that the washing machine hoses were still to be fitted to the pipework. It was also noted that the washing machine could be powered up.

**Photo 10 – Re-located washing machine**

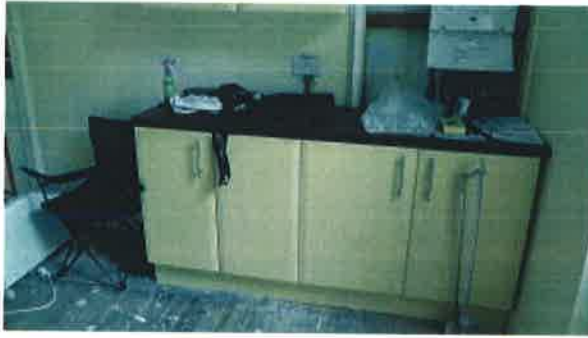
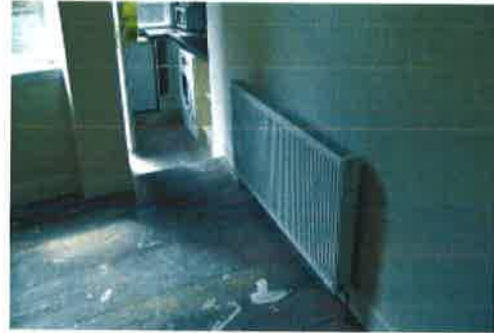
- The Property was installed with a gas central heating system on 26/04/17 by Harness Plumbing and Heating Ltd. Appropriate radiators have been fitted in all the main rooms, the hallway and basement area. There is no radiator in the bathroom, or the rear kitchen area (See Photographs 11 + 12 below). The contractor advised that it is intended to install fixed electric panel heaters in these areas. As the property is now vacant, the central heating system was not in use at the time of the inspection. The Contractor was unaware if a Gas Safety Certificate had been provided to the Landlord.

**Photo 11 – Installed gas boiler**

**Photo 12 – Recently installed radiator**
