**Housing and Property Chamber**  
First-tier Tribunal for Scotland

**First-tier Tribunal for Scotland Housing and Property Chamber) (“the Tribunal”)**

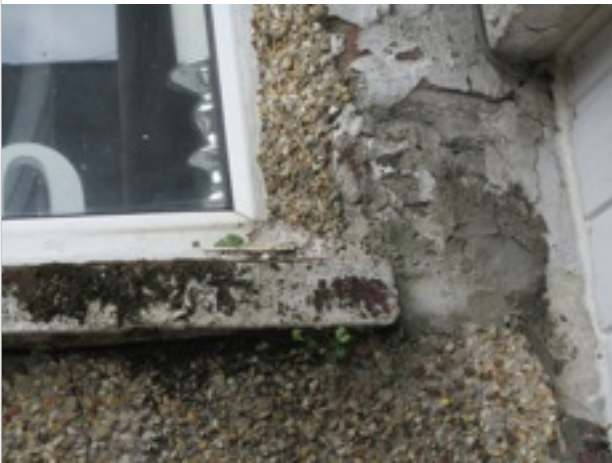
External view of Hall window showing extensive moss to concrete sill, vegetation growth and possible rot to timber above

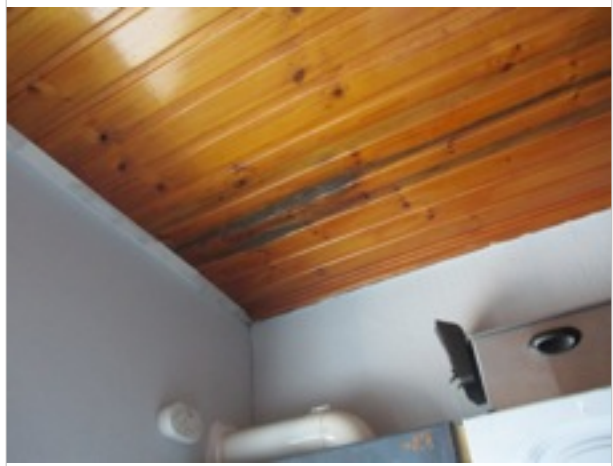
Kitchen - blackened section of timber clad ceiling/water damage

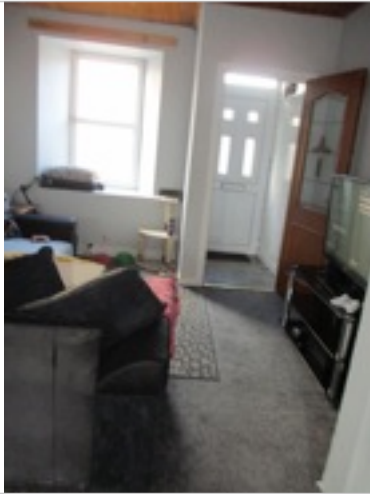
Living Room and front vestibule

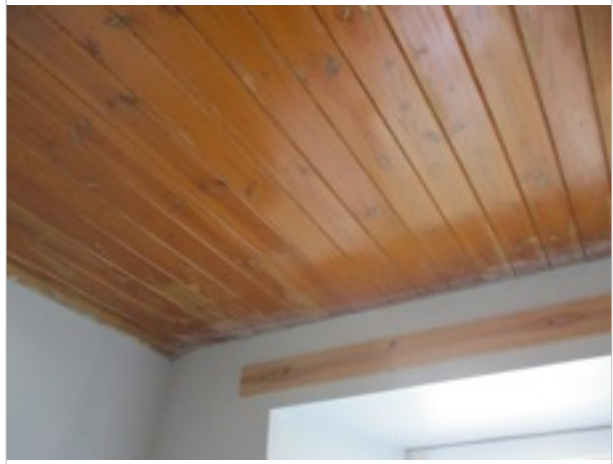
Living Room - some deterioration to varnish on timber clad ceiling

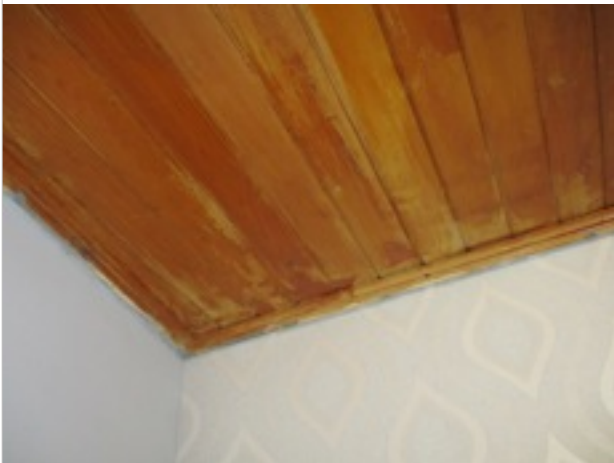
Living Room - deterioration/uneven application of varnish to timber clad ceiling

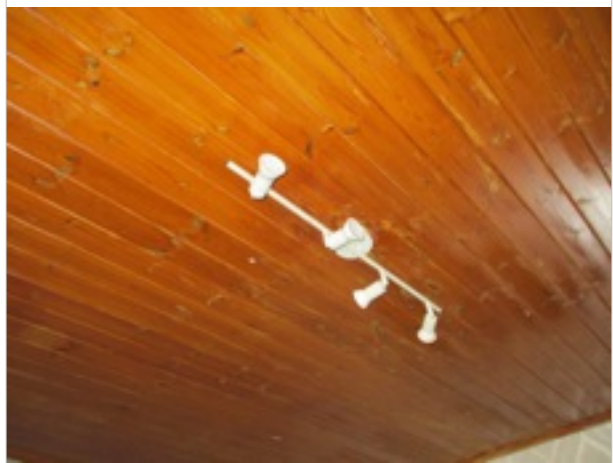
Living Room - some deterioration to varnish on timber clad ceiling (no smoke detector)

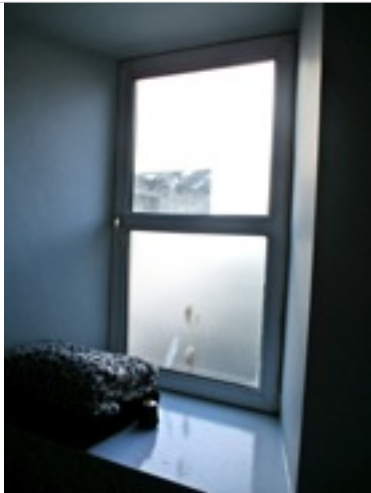
Living Room - uPVC double glazed window

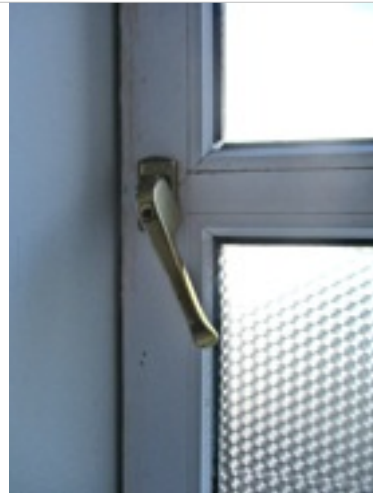
Living Room - window - not possible to open/  
missing key/loose/damaged handle

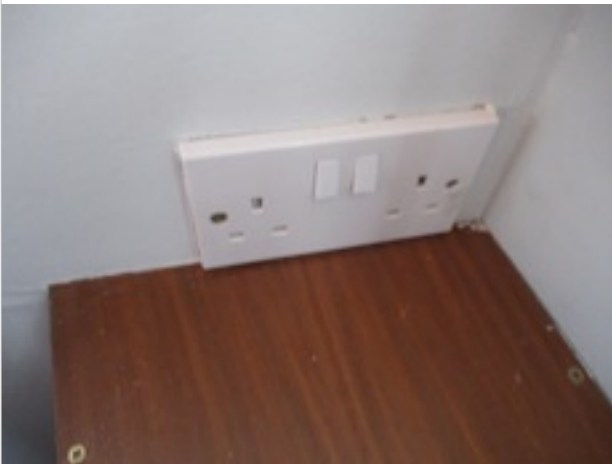
Living Room - double socket near window

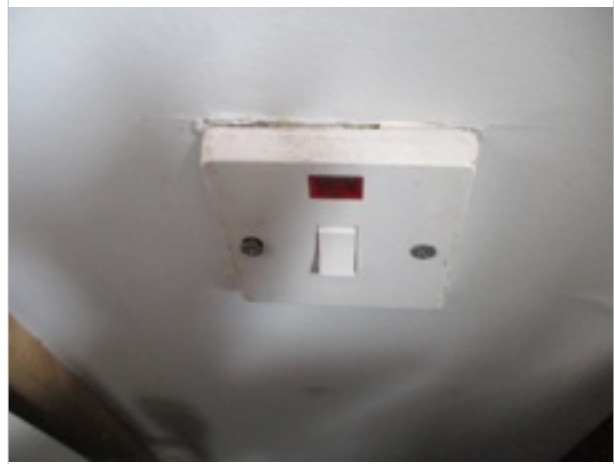
Living Room - switch for former electric storage  
heater - loose screws

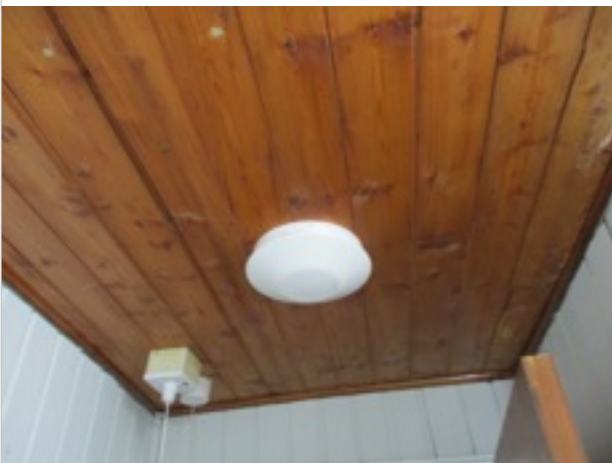
Bathroom - ceiling mounted extractor fan

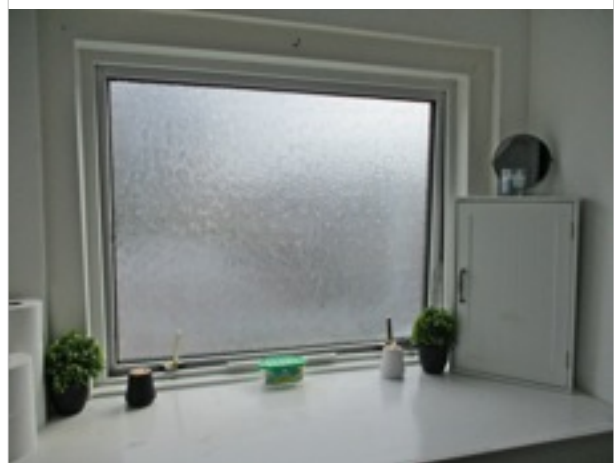
Bathroom - uPVC double glazed window - hard  
to close properly/possible defective hinges

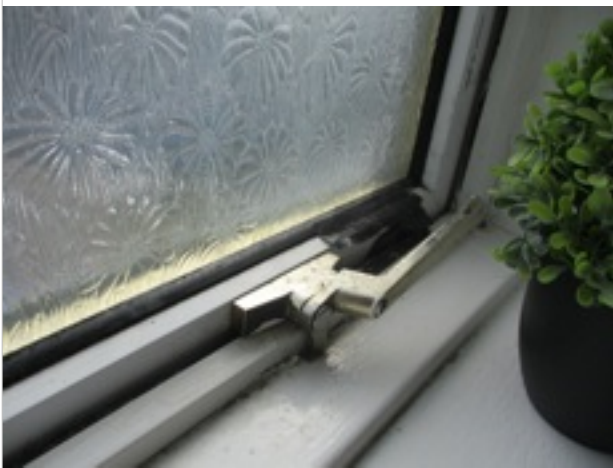
Bathroom - window - duct tape applied to base of frame

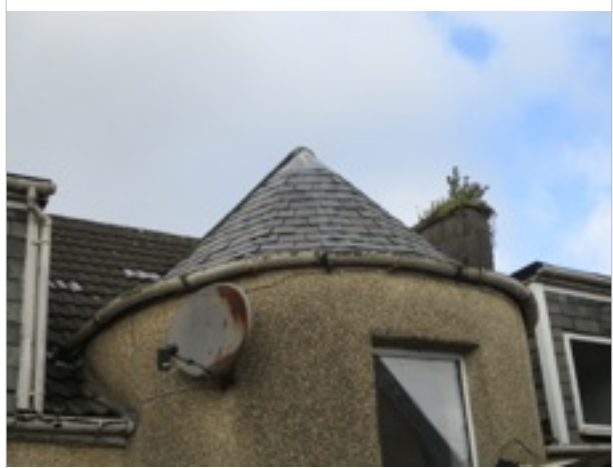
Rear Elevation - staircase projection - corrosion to cast iron gutters/uneven and loose/damaged fixings

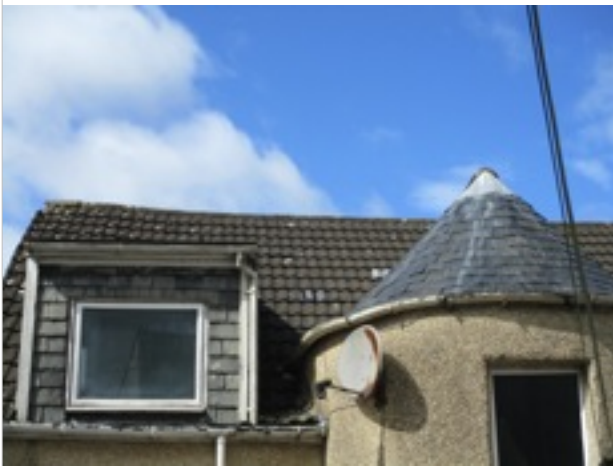
Rear Elevation - roof - sagging ridge line

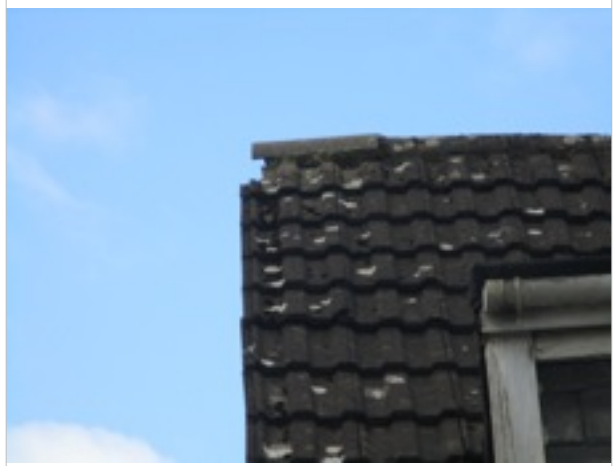
Rear Elevation - uneven tiles at roof verge and ridge/gap near ridge/broken tile

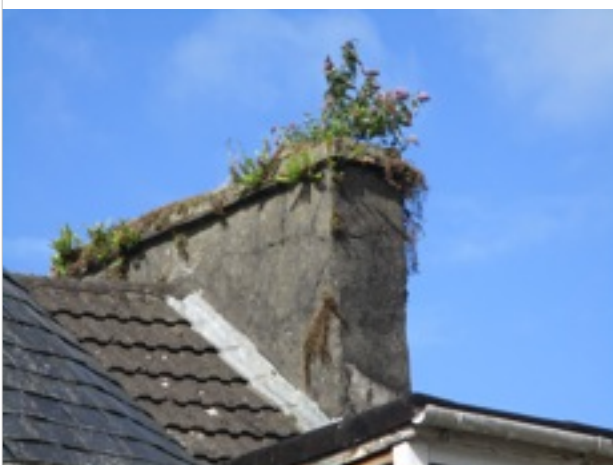
Rear Elevation - chimney - extensive vegetation growth
