Statement of Decision of the Housing and Property Chamber of the First-tier Tribunal for Scotland under Section 26 (1) of the Housing (Scotland) Act 2006

Chamber Reference number: FTS/HPC/RP/24/1363

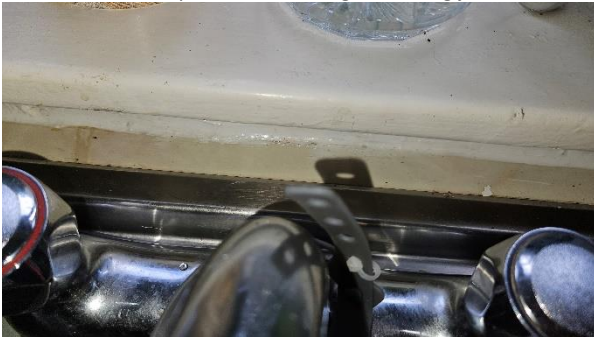
3 Silicon sealant in Kitchen recently replaced.

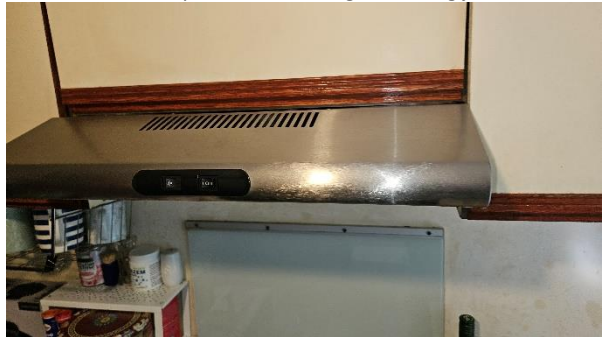
4 Cooker hood – recently replaced.

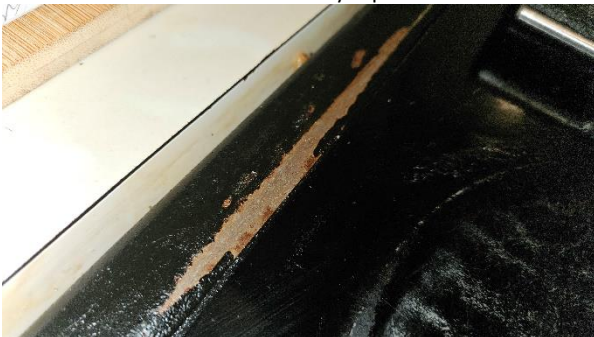
5 Example of localised area of defective coating to freestanding cooker.

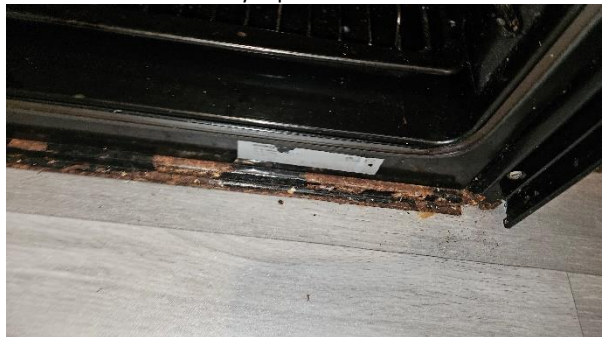
6. Further example of localised area of defective coating to freestanding cooker.

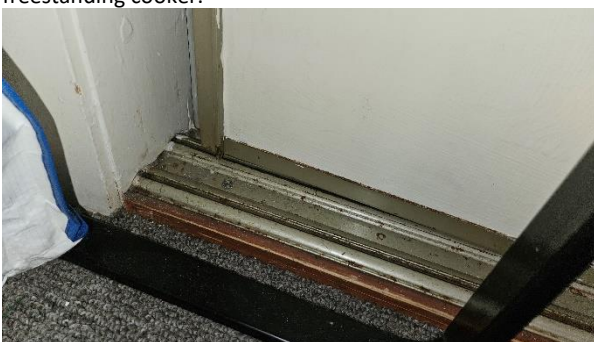
7 Bottom of door disengaged from sliding track (bedroom wardrobe).

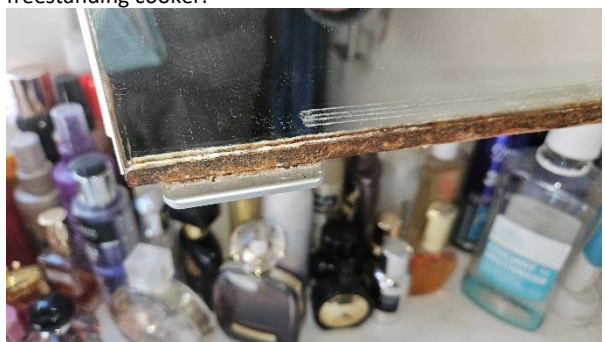
8 Bathroom cabinet – corrosion evident along metal retention trim.

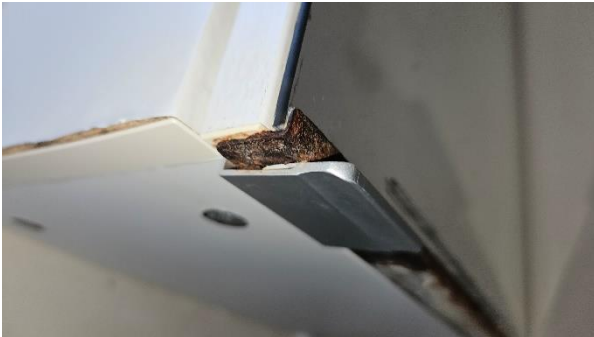
9 Bathroom cabinet - "L" shaped metal retention trim corroded.

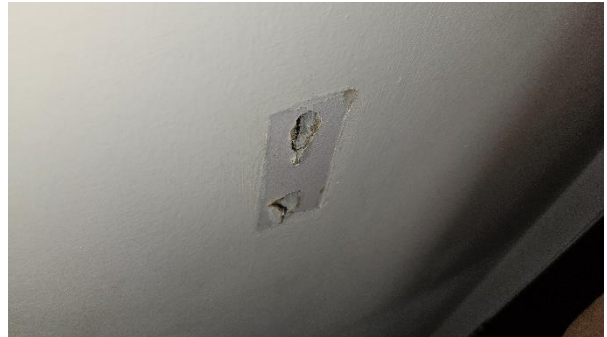
10 Bathroom walls – redundant fixing holes evident from previous fixtures/fixings.

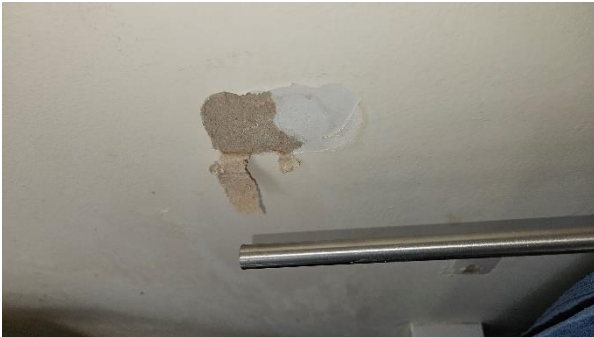
11 Towel rail support bracket secured by adhesive pad which has failed within Bathroom.

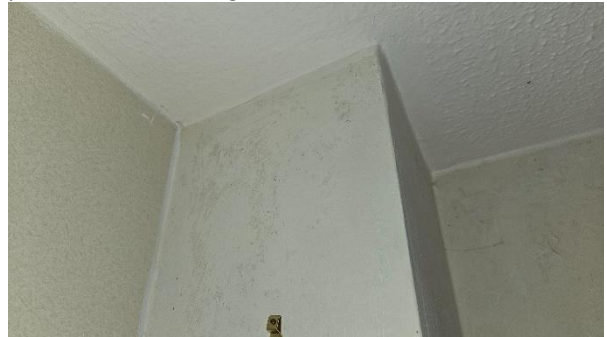
12 Bathroom walls – minor mould growth evident to external wall.
