# **Housing and Property Chamber**

## **First-tier Tribunal for Scotland**

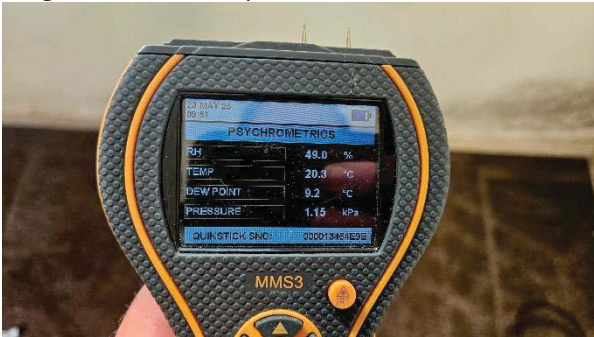
7 Psychrometric data within Eastmost Bedroom.

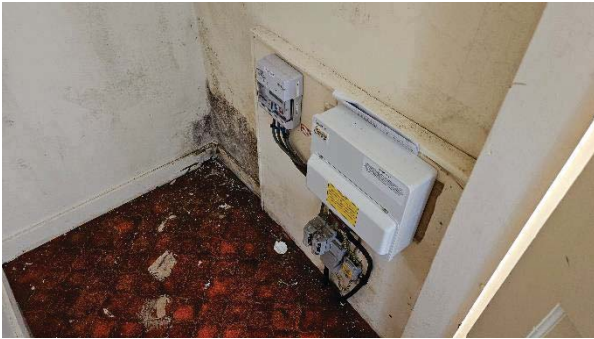
9 View within Hallway Cupboard.

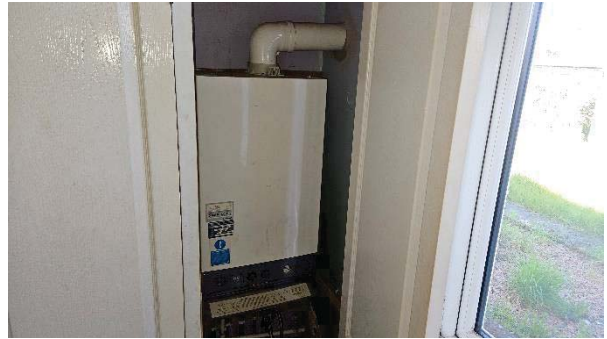
18 Gas fired boiler.

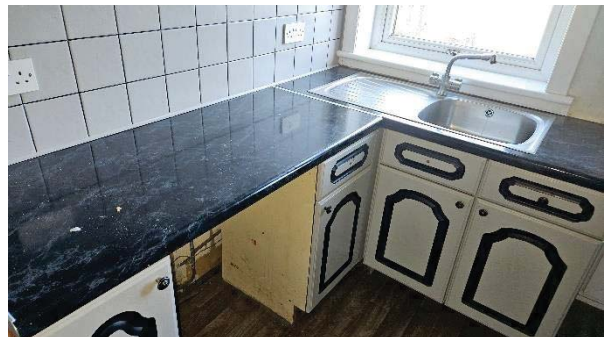
24 Missing handles to drawers.
