Determination of the First-tier Tribunal for Scotland (Housing and Property Chamber) under Section 26 of the Housing (Scotland) Act 2006

Reference number: FTS/HPC/RP/19/2530

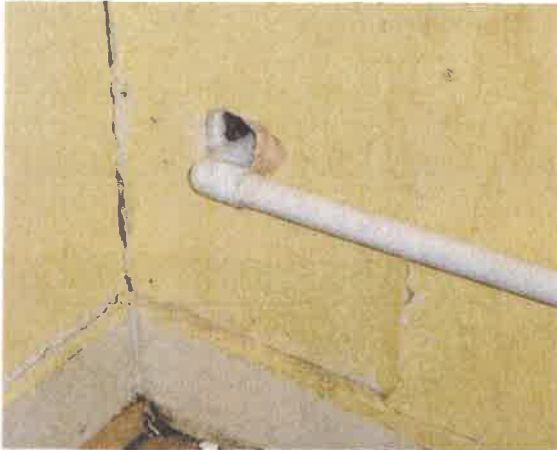
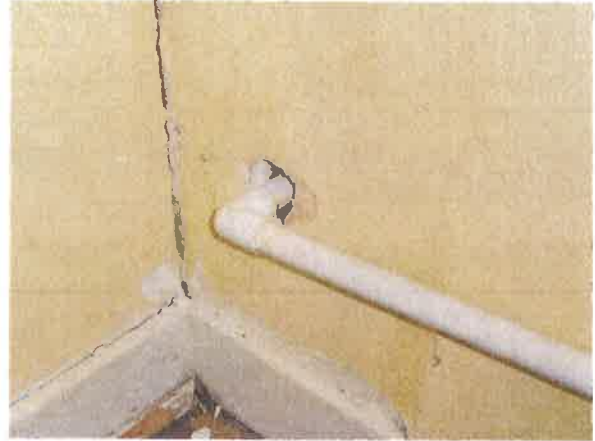
Hole in rear wall of bedroom **5 Nov 2019** Hole in rear wall of bedroom **13 Jan 2020**

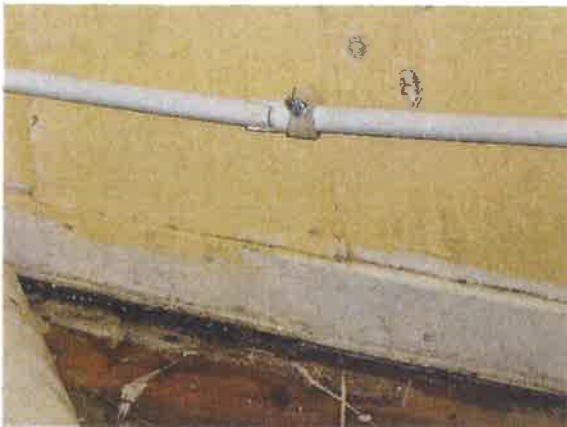
Sagging pipe **5 Nov 2019**

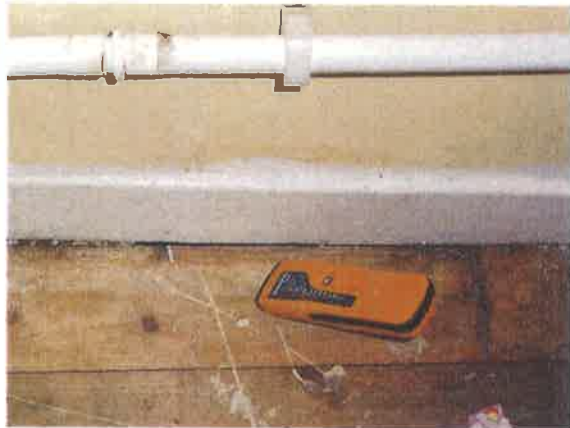
Repaired condensate pipe **13 Jan 2020**

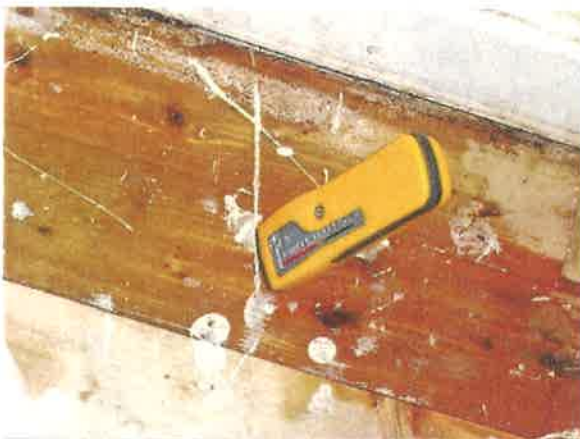
Saturated floor **5 Nov 2019**

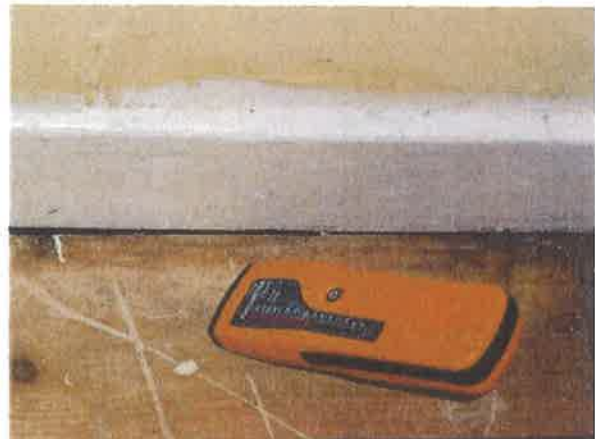
No discernable damp **13 January 2020**

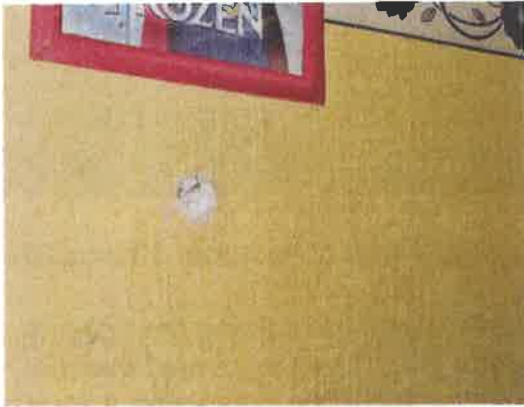
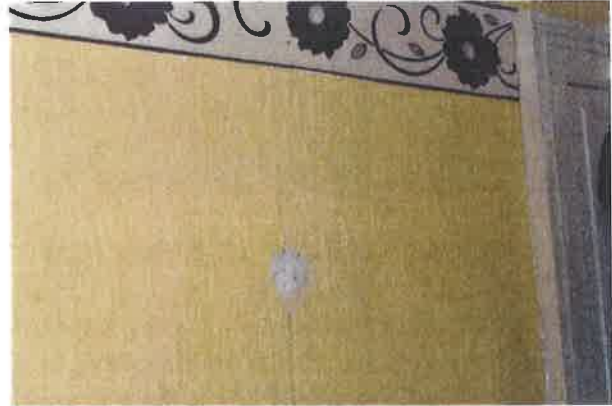
Damaged and poorly repaired wall plaster in living room **5 November 2019**

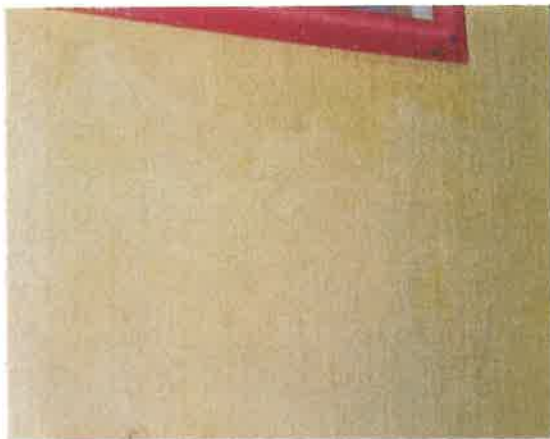
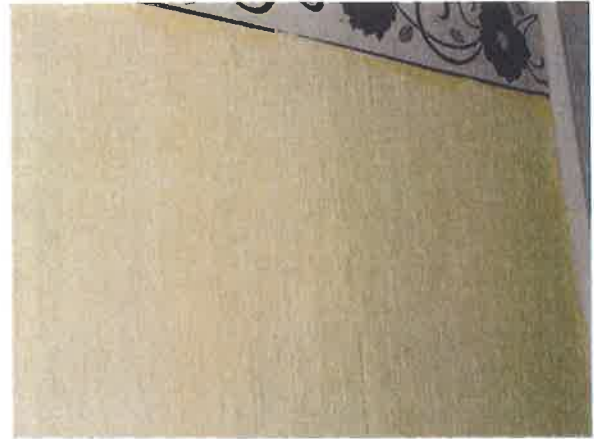
Living room wall plaster following redecoration **13 January 2020**

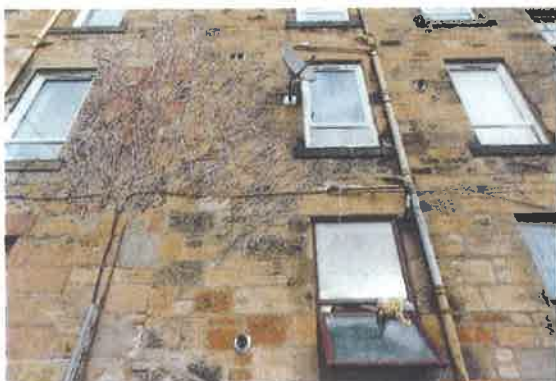
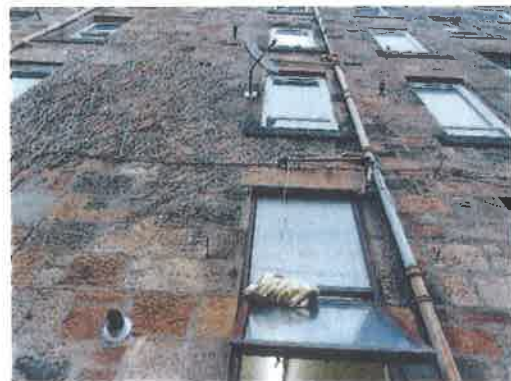
Lack of ventilation rear wall **5 Nov 2019** Lack of ventilation rear wall **13 Jan 2020**
