Housing and Property Chamber

First-tier Tribunal for Scotland

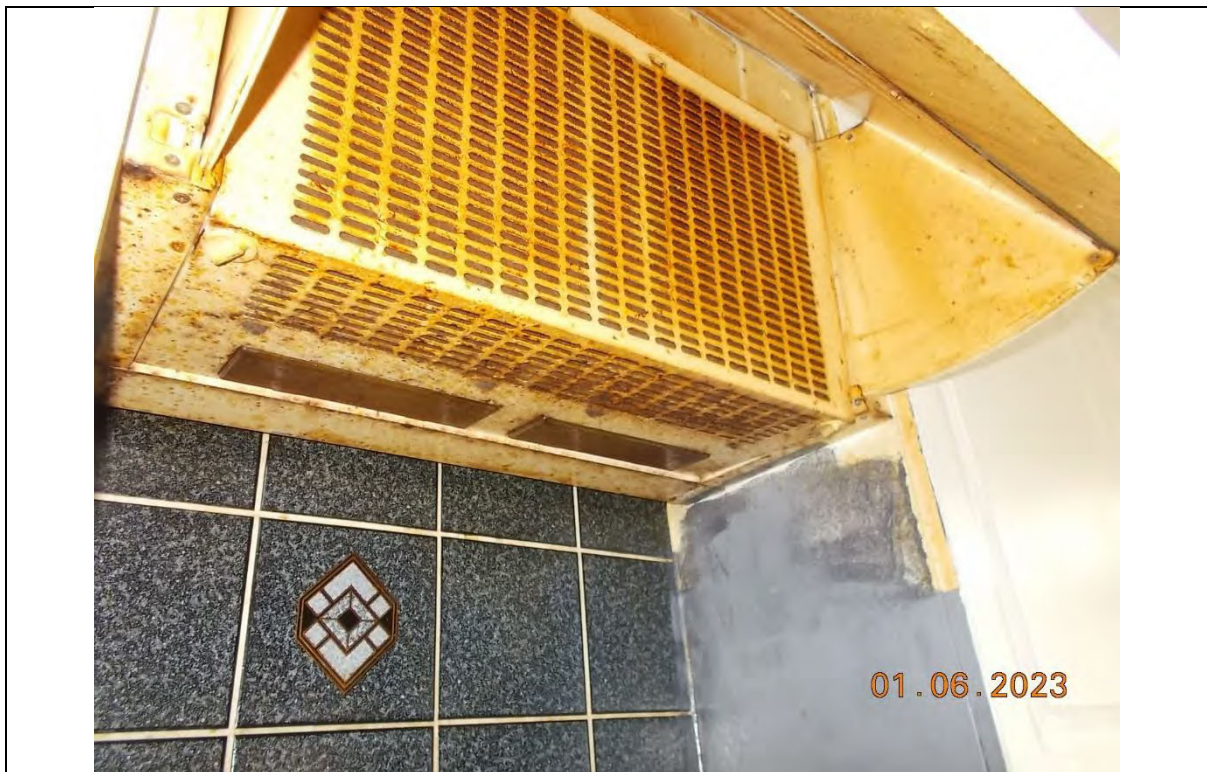
1. Fan above Cooker in Kitchen. Found not to be operational.

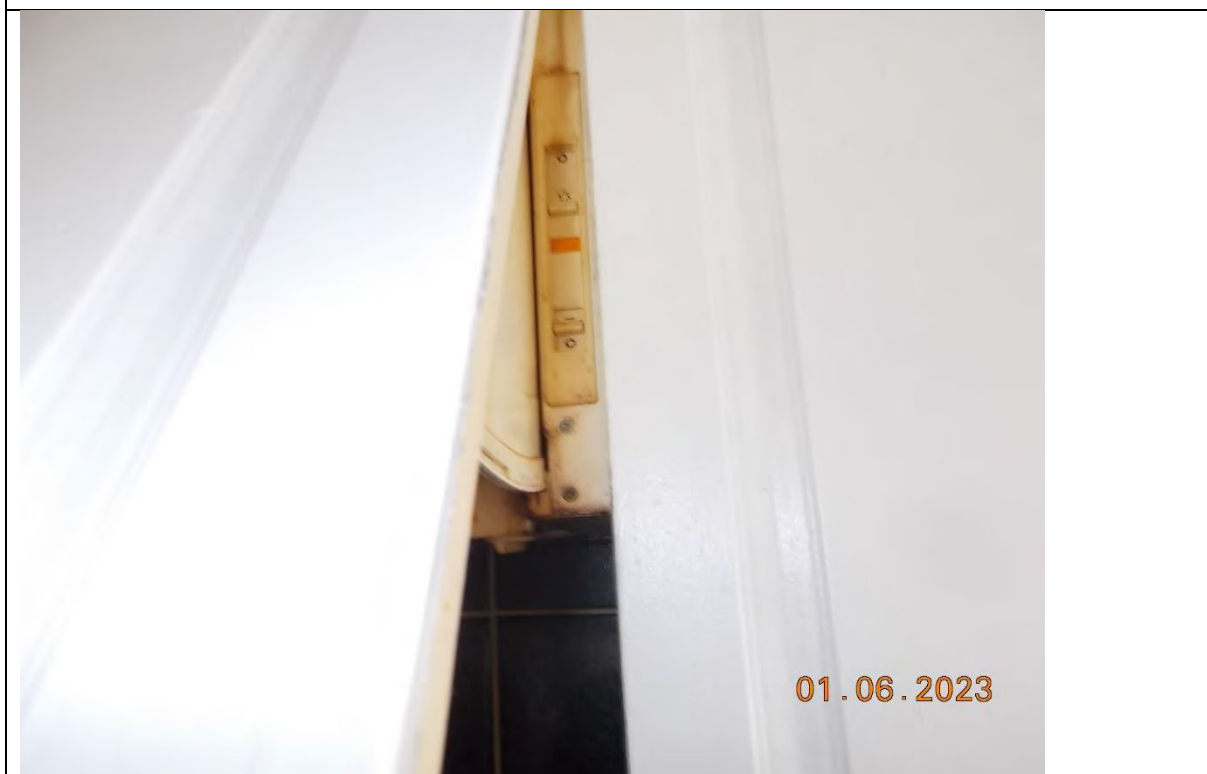
2. Controls for fan above Cooker in Kitchen. Found not to be operational.

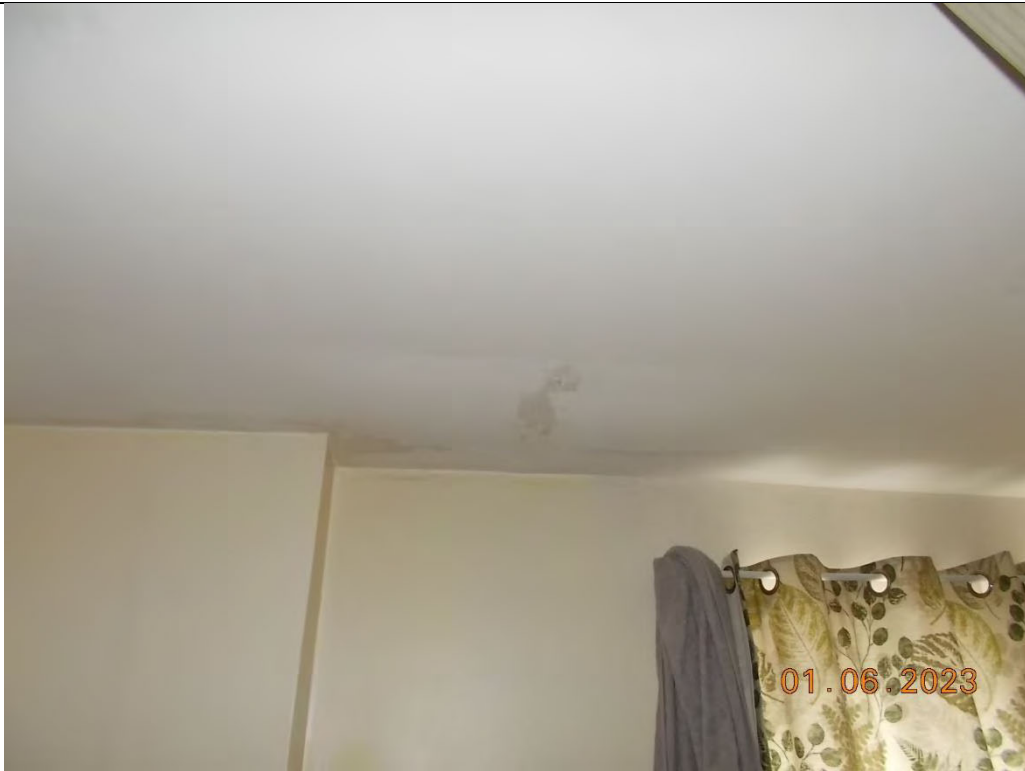
3. Damp stain on ceiling of “small” bedroom. Damp meter confirmed still damp.

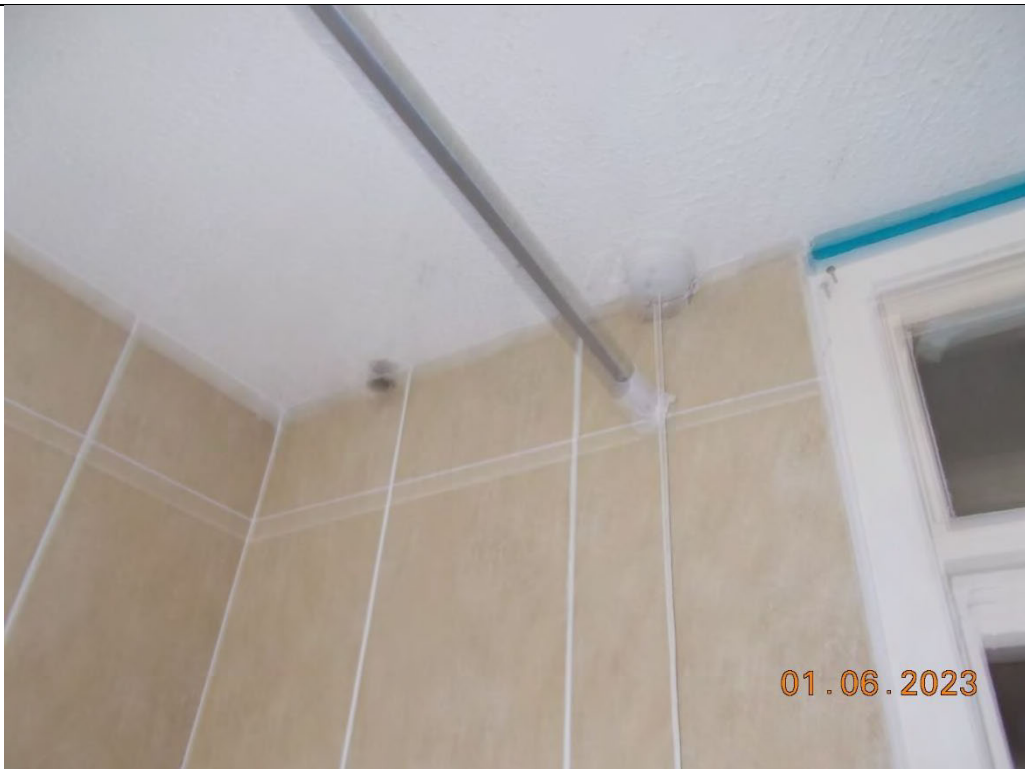
4. Hole on bathroom ceiling. Not possible to get meter readings. (poor photo)

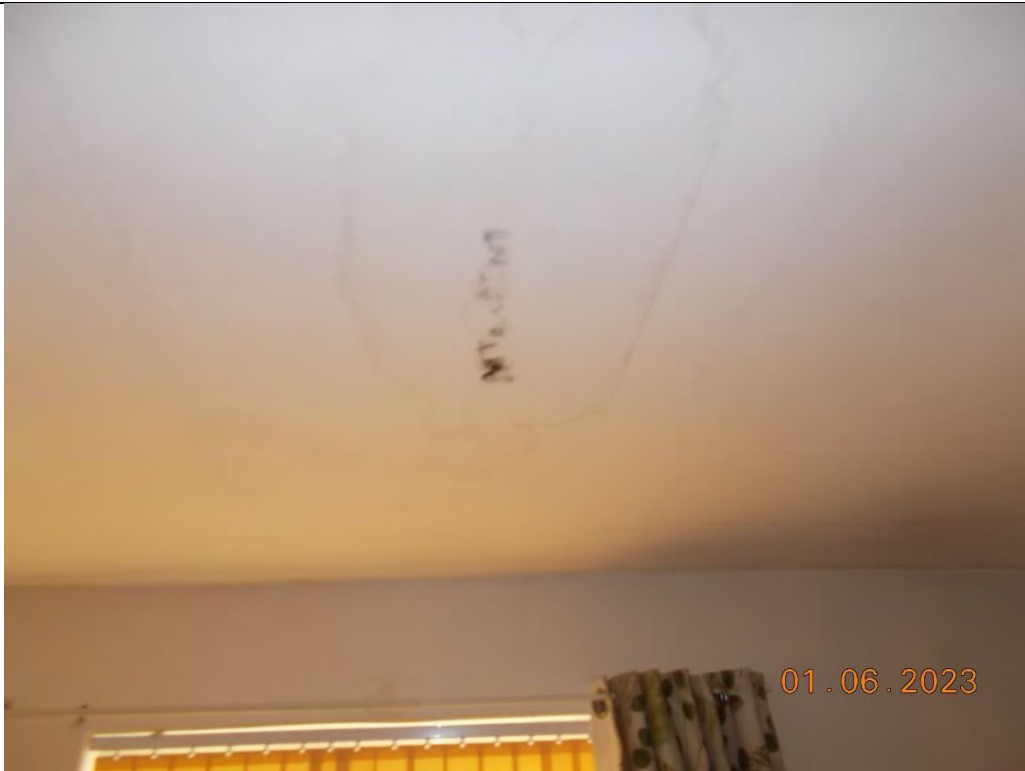
5. Damp stain and mould growth on ceiling of “middle” bedroom. Damp meter confirmed still damp.

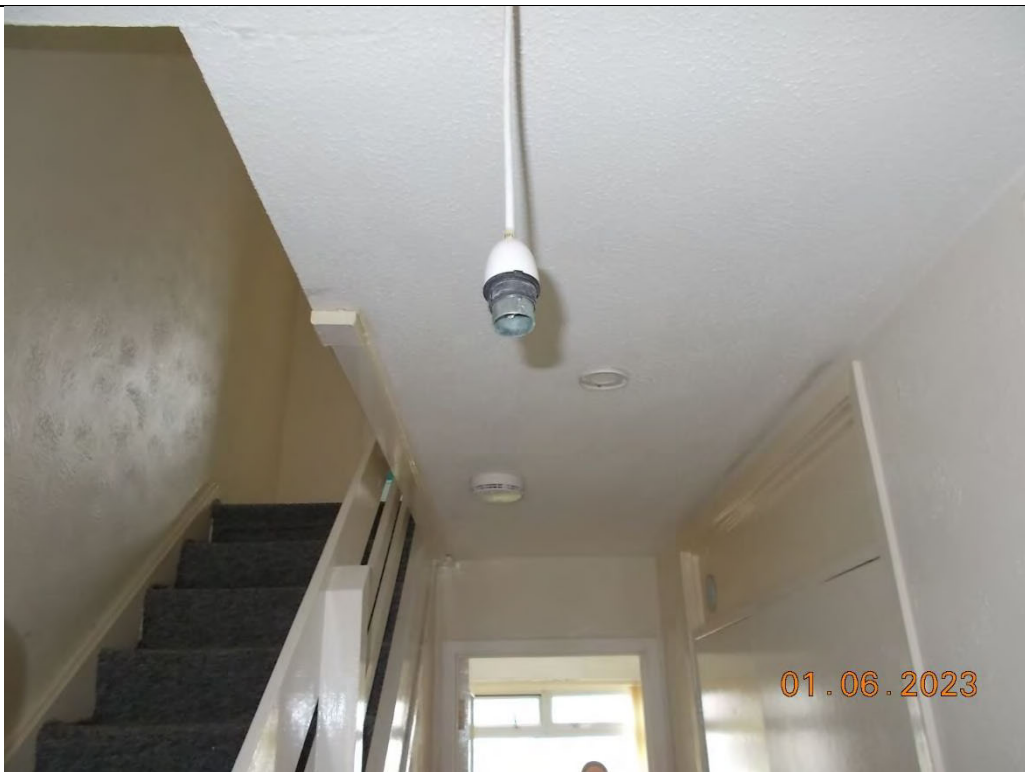
6. Bulb holder to light in lower hallway with missing ring to retain shade.

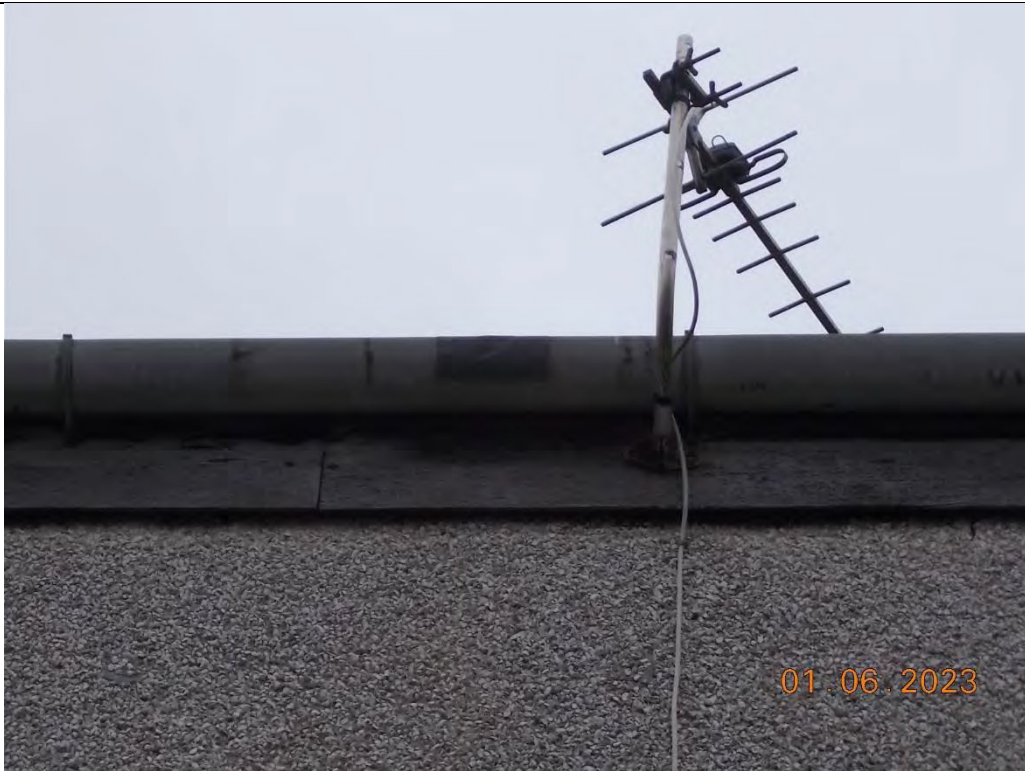
7. Patch on front gutter

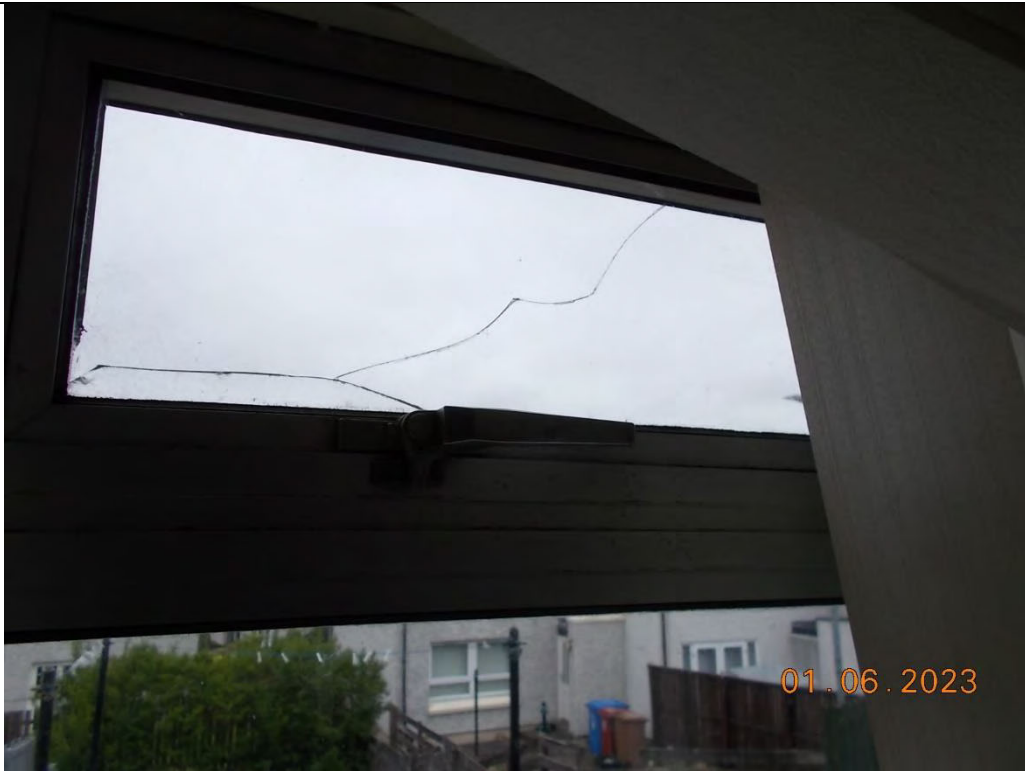
9. Cracked sealed double glazed unit in Kitchen window.

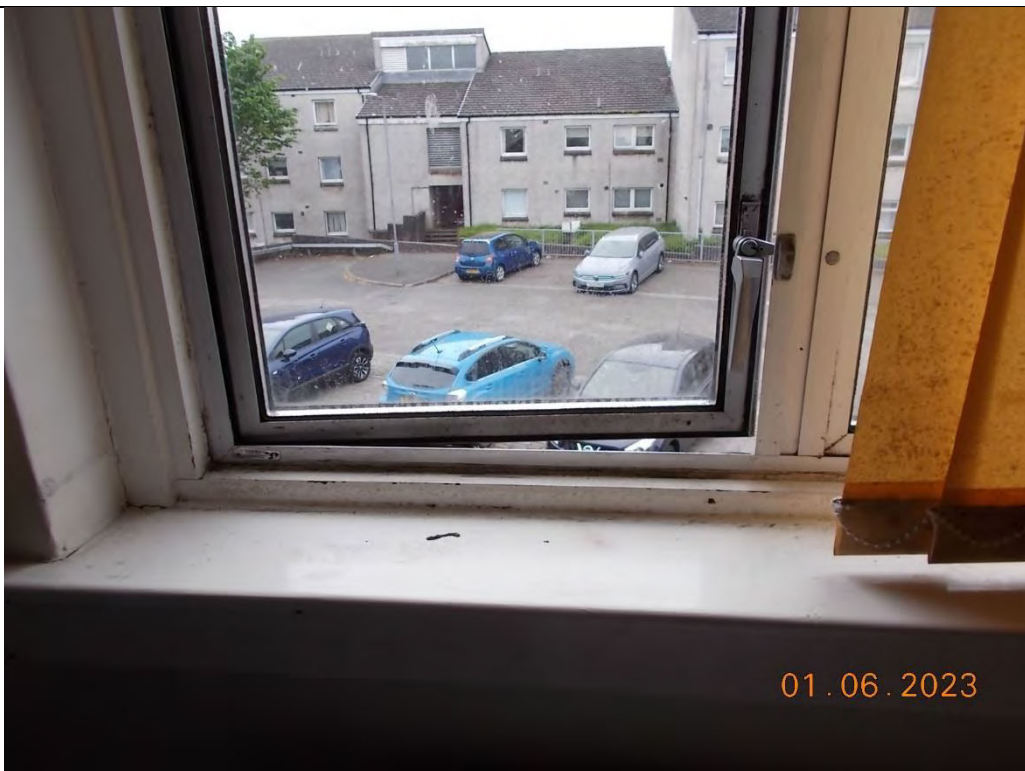
10. Window in "middle" bedroom.

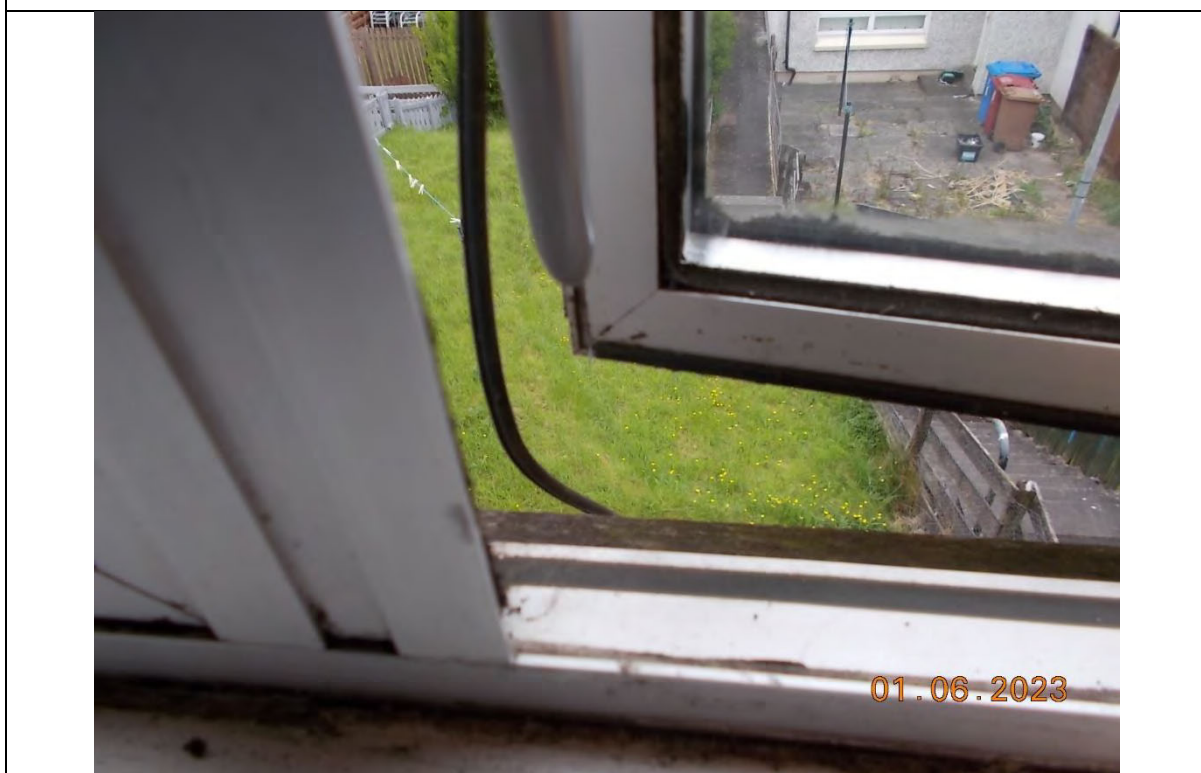
16. Window in "rear" bedroom. Loose sash seal.

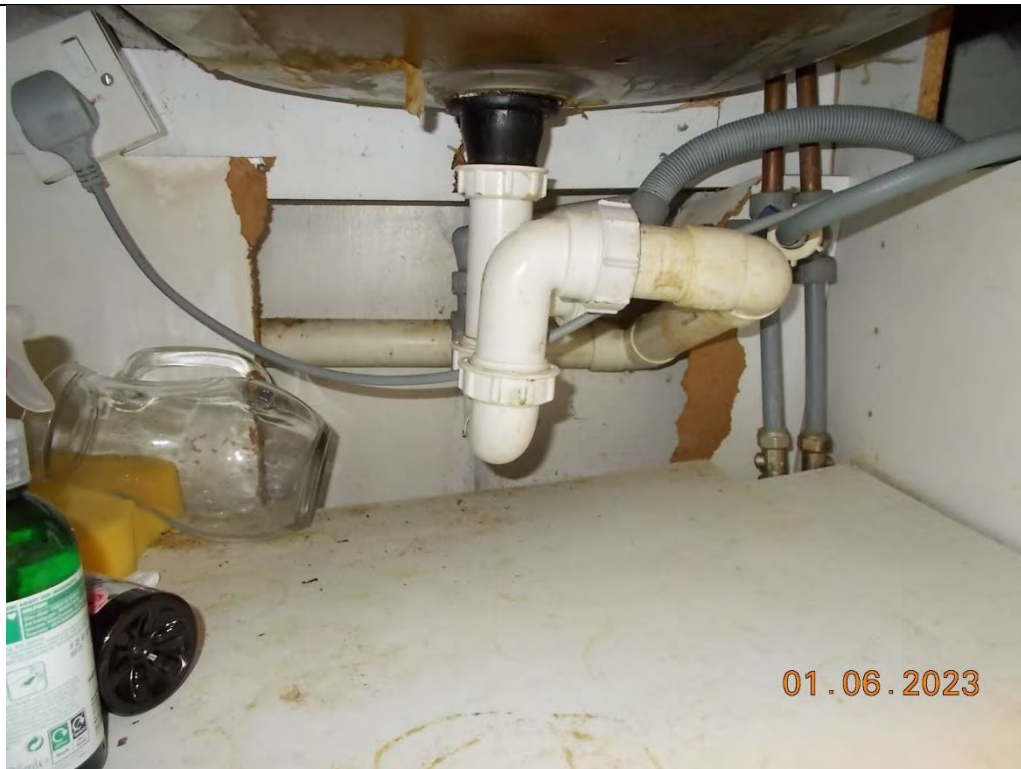
22. Pipework below sink in Kitchen. No current leak detected.

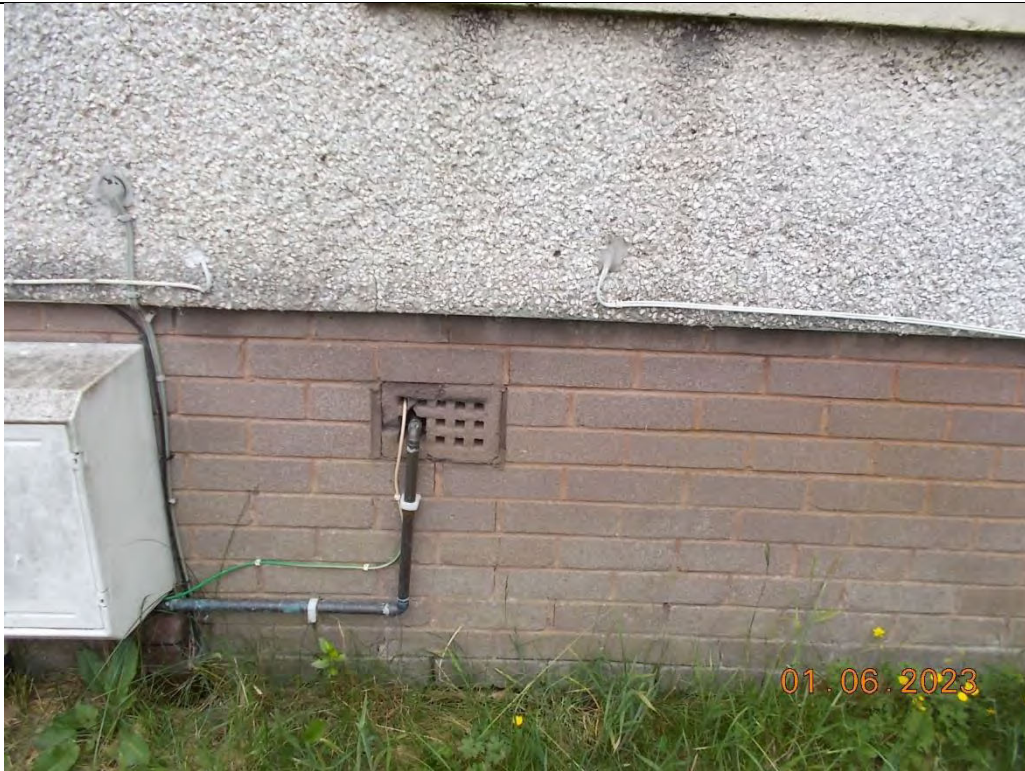
23. One airbrick on front elevation damaged by gas supply pipe passing through.

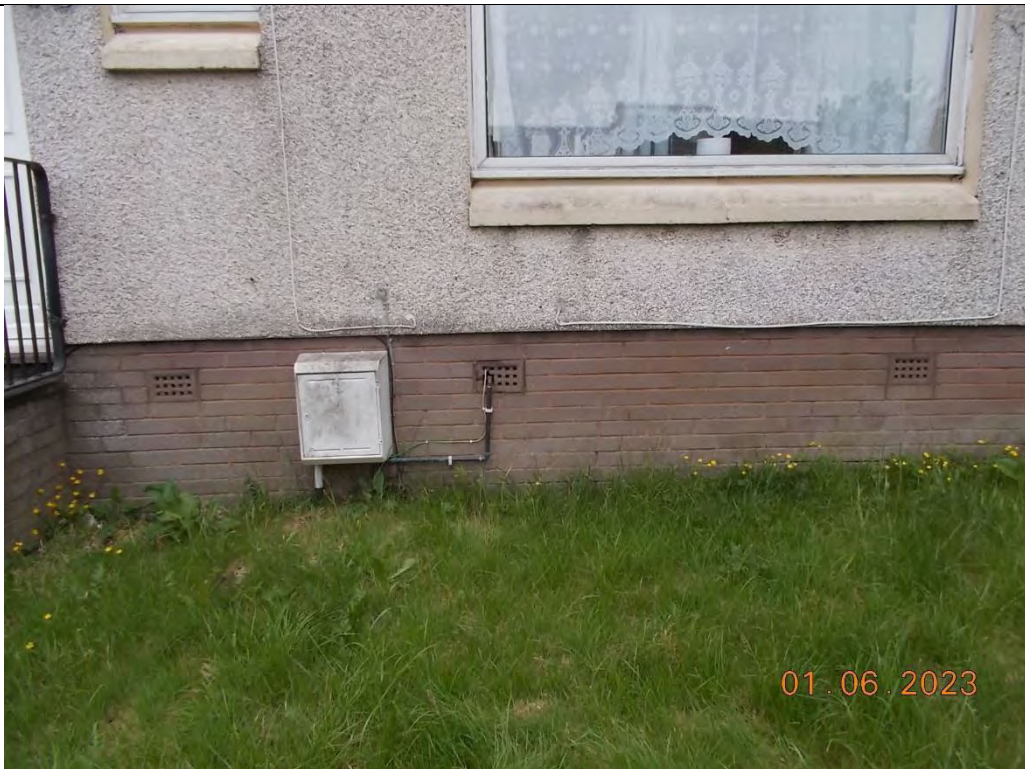
24. Other airbricks to front elevation intact.
