Housing and Property Chamber
First-tier Tribunal for Scotland

First-tier Tribunal for Scotland (Housing and Property Chamber) ("the Tribunal")

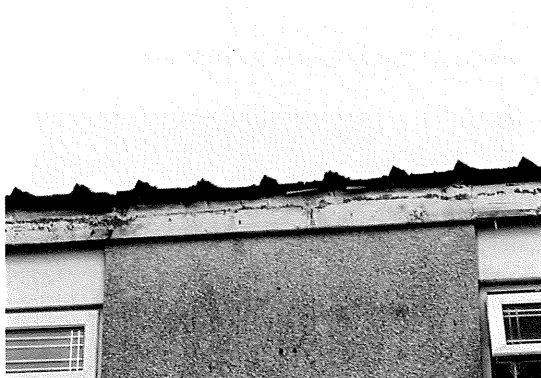
Photo 1 – Missing guttering on rear elevation

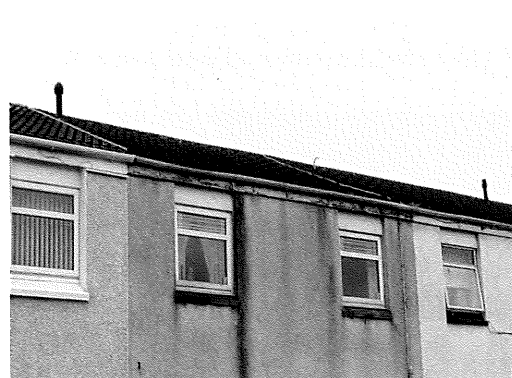
Photo 2 – Off level guttering and staining on F/E

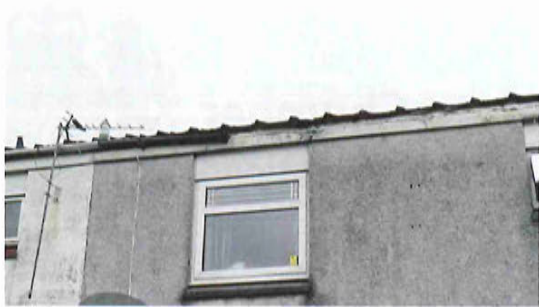
Photo 2 – Facia boards in poor condition

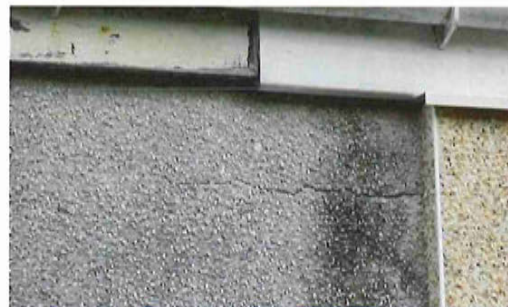
Photo 3 – Facia board detail and roughcast crack

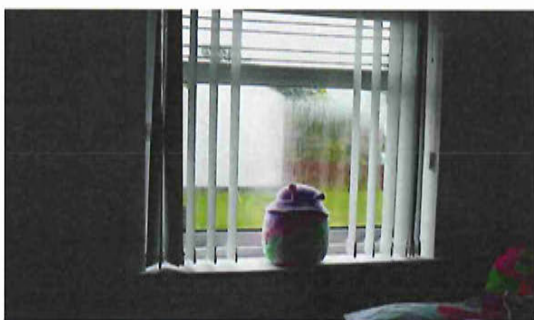
Photo 4 – Sealed glazing failure in rear Bedroom

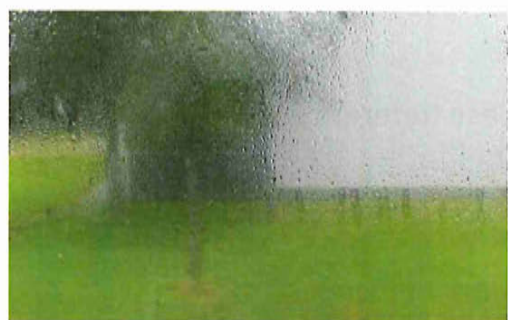
Photo 5 – Condensation within sealed unit

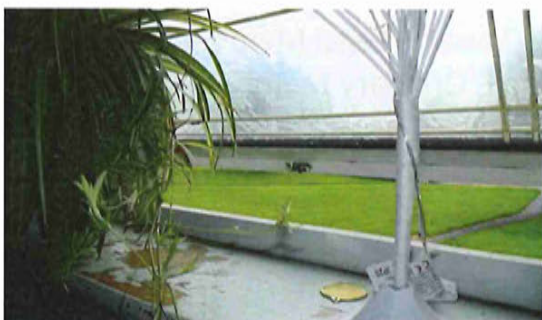
Photo 6 – Missing handle on Bathroom window unit

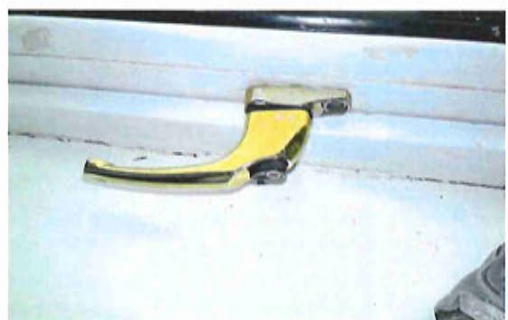
Photo 7 – Loose handle in small front Bedroom

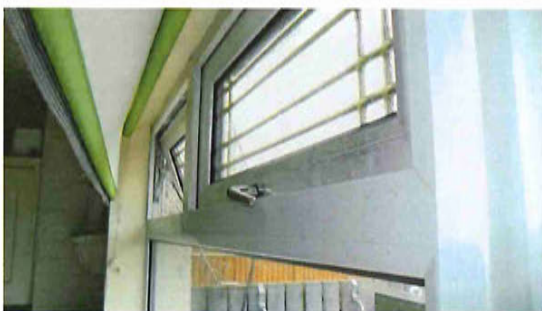
Photo 8 – Noticeable draft from closed Kitchen window

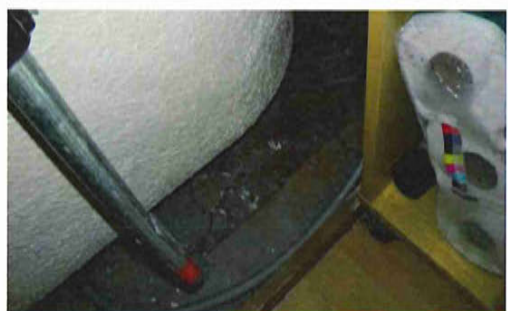
Photo 9 – Dry floor under bath + historic staining

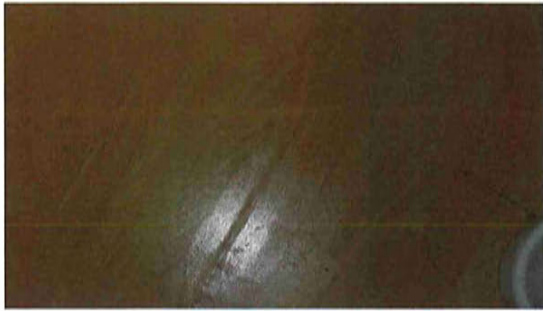
Photo 10 – Water affected floor surface in Bathroom

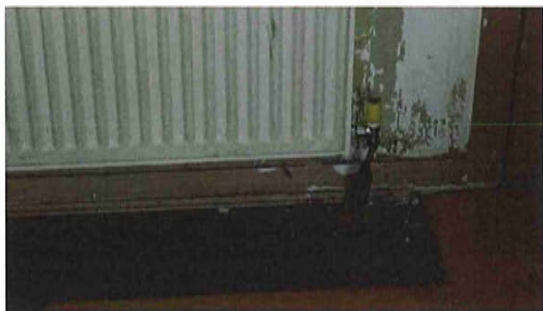
Photo 12 – Poor repair to radiator pipe in main Bedroom

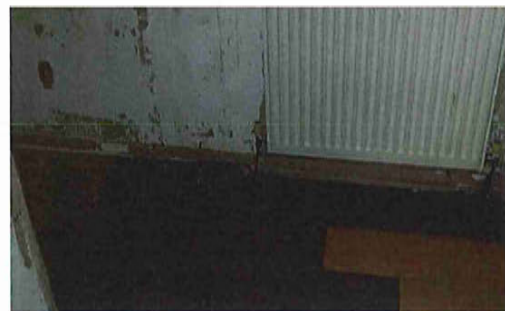
Photo 13 – Missing flooring in main Bedroom

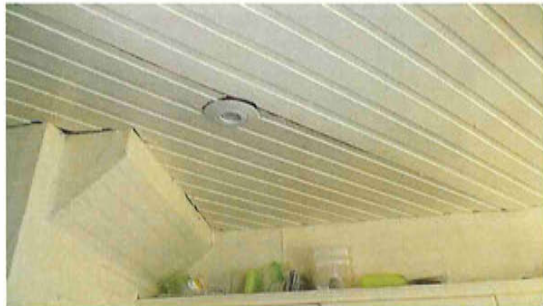
Photo 14 – Loose Kitchen ceiling

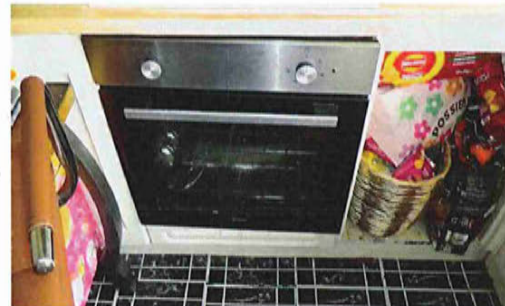
Photo 15 – Unsecured oven unit

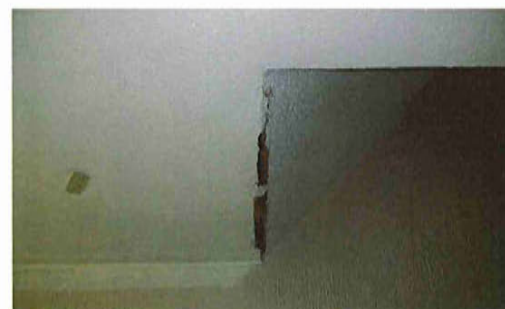
Photo 17 – Damaged ceiling at foot of stairs

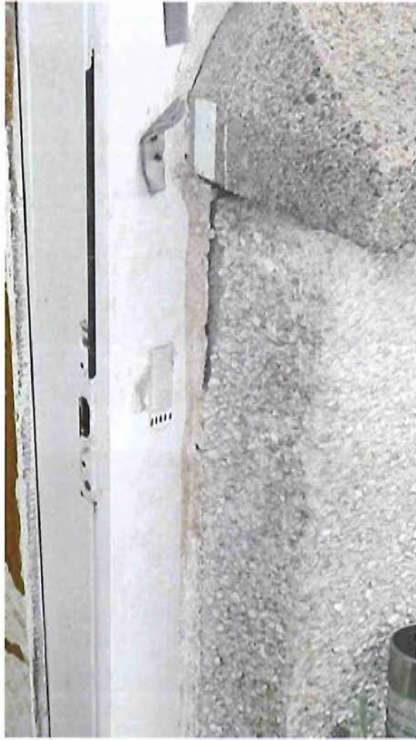
Photo 18 – Rear door detail

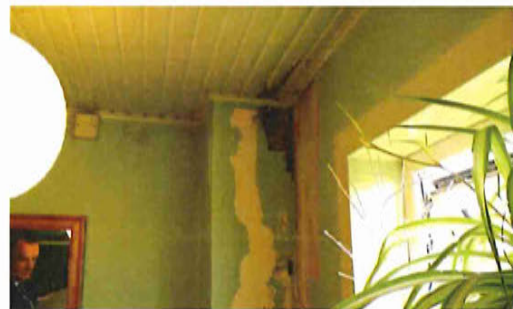
Photo 21 – Historic water damage in Bathroom
