# **Housing and Property Chamber**

## **First-tier Tribunal for Scotland**

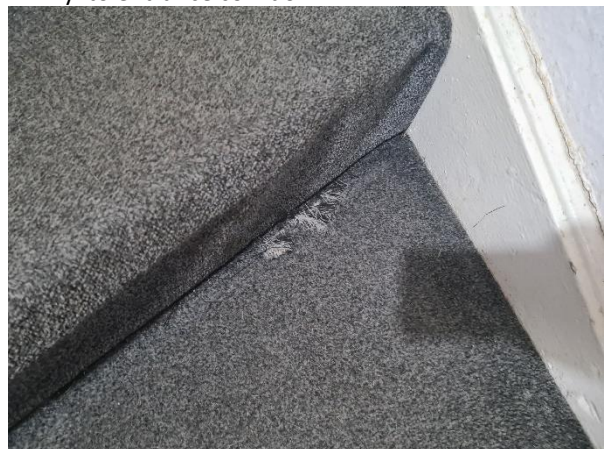
6 Example of frayed and loose carpet floor covering to staircase.

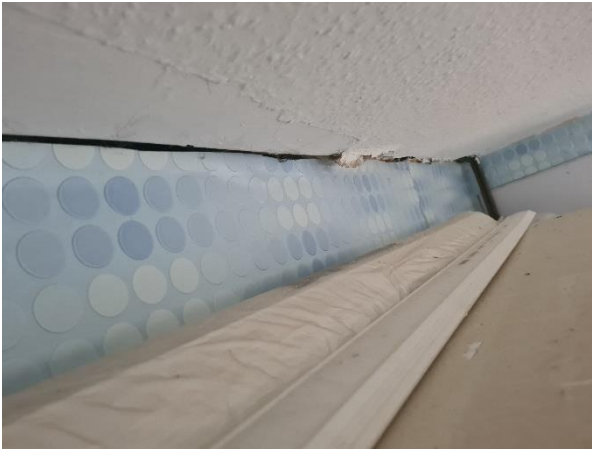
7 Gap where coving removed within Kitchen.

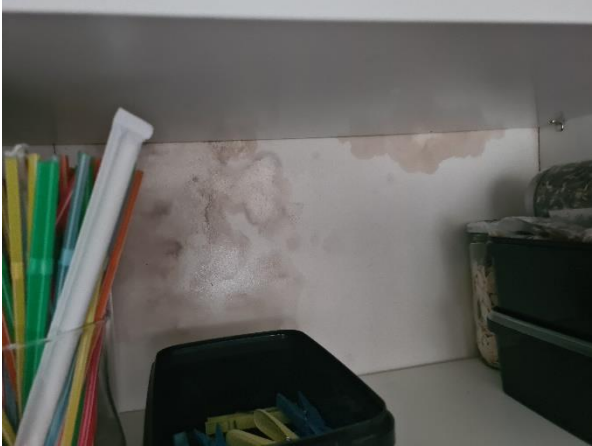
9 Staining to backpanels within kitchen units.

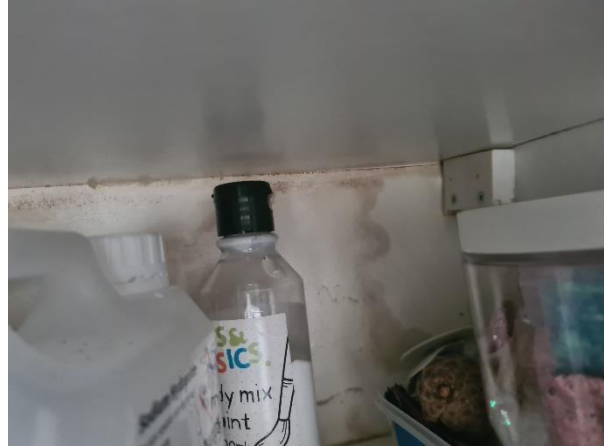
10 Staining to backpanels within kitchen units.

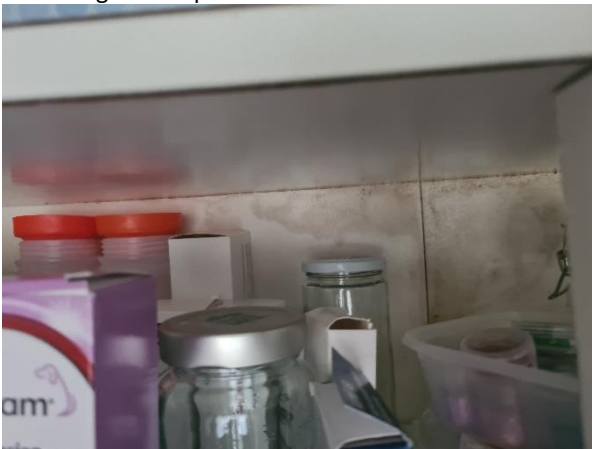
11 Staining to backpanels within kitchen units.

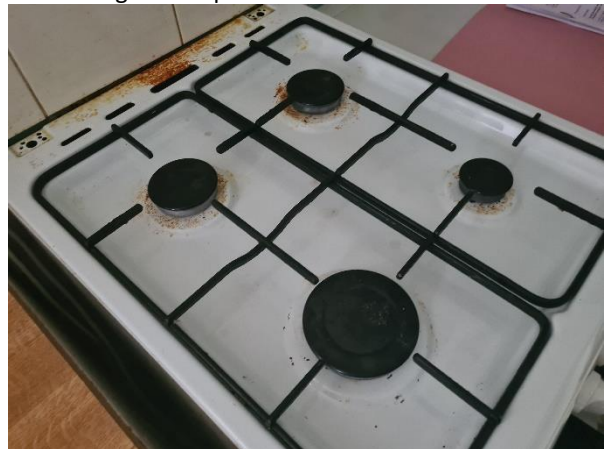
12 Gap between worktop and cooker.

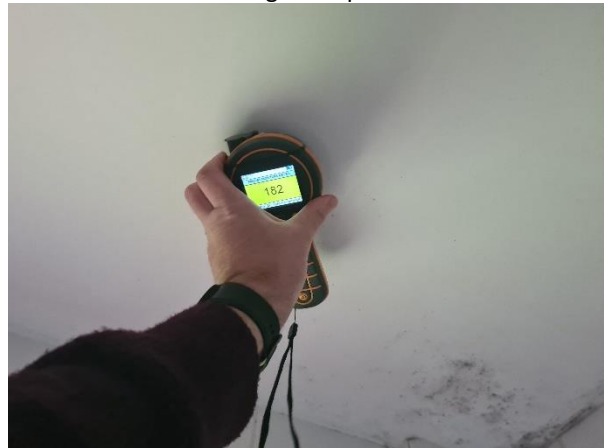
22 Moisture meter readings.

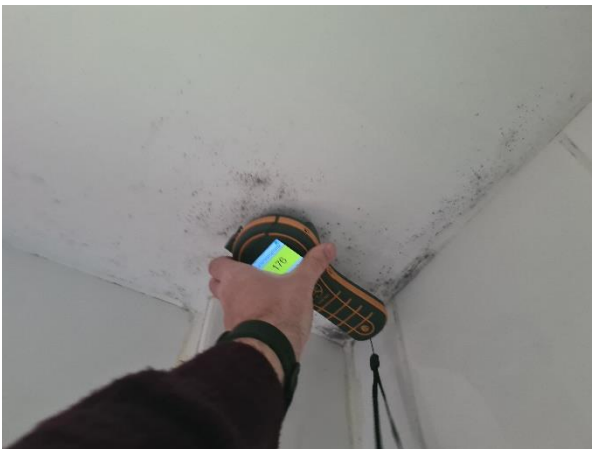
23 Moisture meter readings.

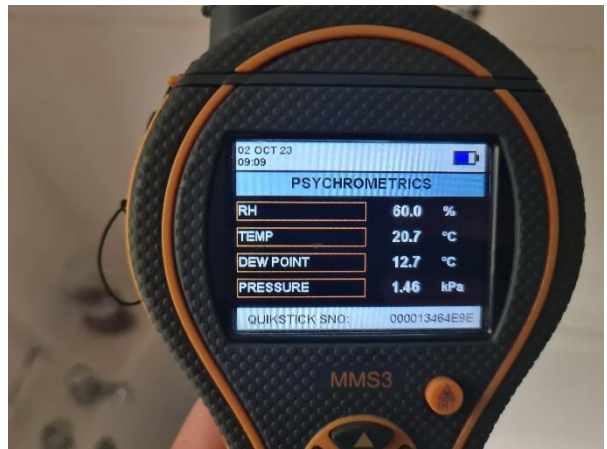
24 Psychometric data.

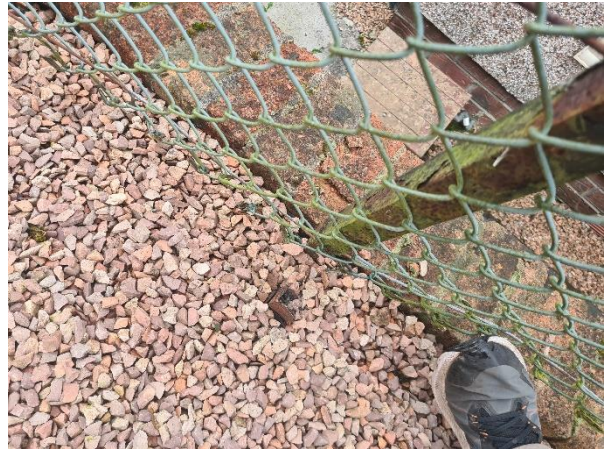
32 Corroded metal upright to boundary fence.

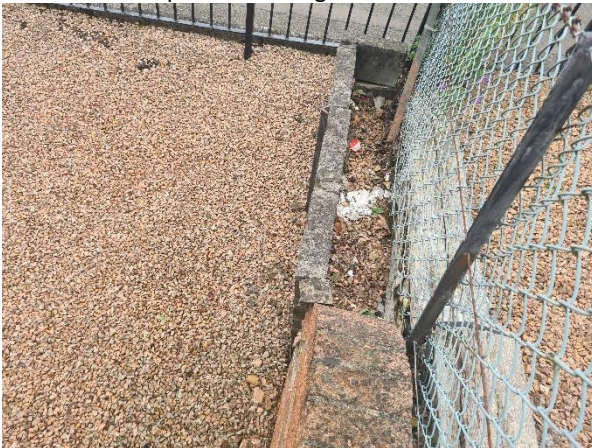
33 Movement evident and block wall out of plumb at boundary.

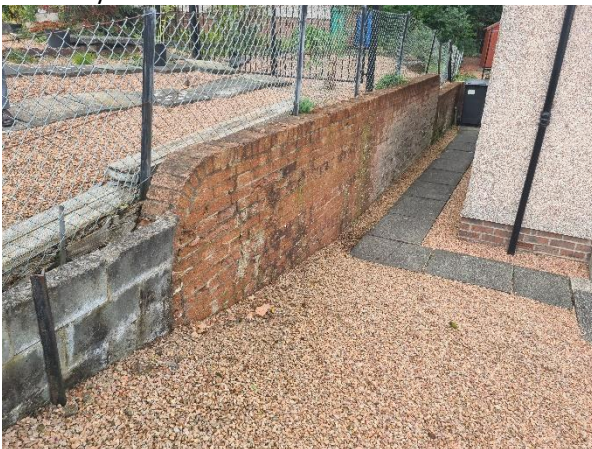
35 Spalling bricks to brick retaining wall.

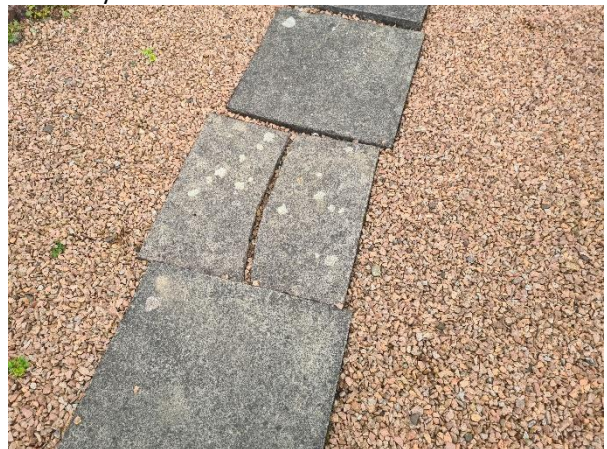
36 Cracked paving slab.
