Statement of Decision of the First-tier Tribunal for Scotland (Housing and Property Chamber) under Section 24 (1) of the Housing (Scotland) Act 2006.

Chamber Ref: FTS/HPC/RT/24/1655

16 Ashgrove Crescent, Ecclefechan, Lockerbie, DG11 3EA Land Register of Scotland under title number DMF17282 ('The Property')

Schedule of photographs

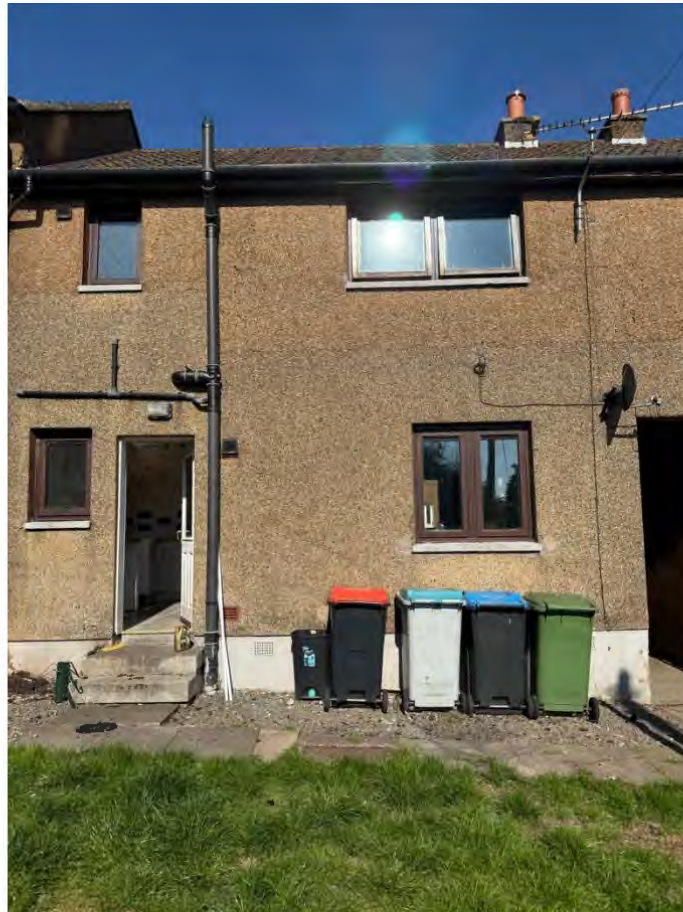
Photograph 1: rear elevation.

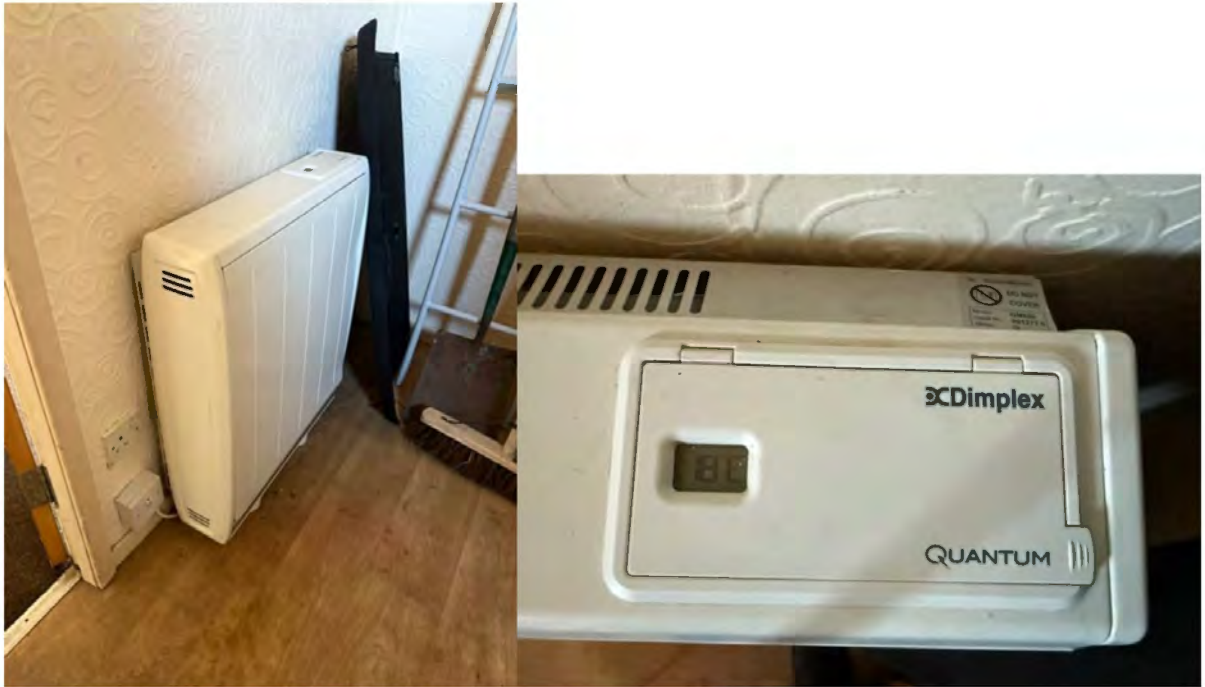
The electric storage heater turned on correctly at the inspection.

Photograph 2 and 3: Downstairs hallway: Electric storage heater

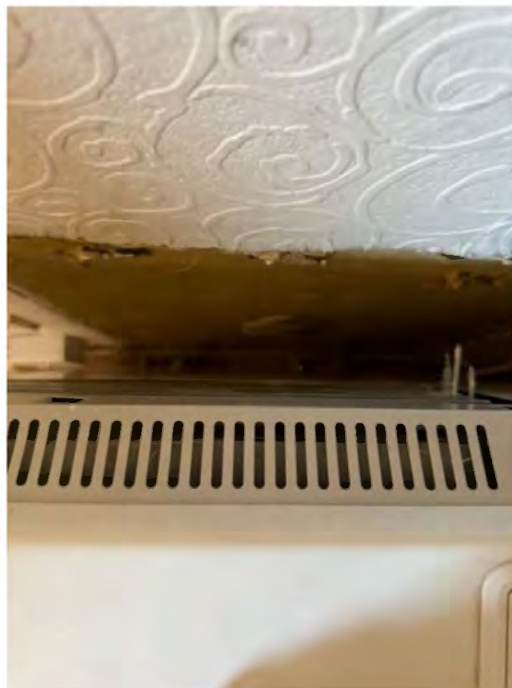
Photograph 4: Downstairs hallway: Electric storage heater not attached to wall

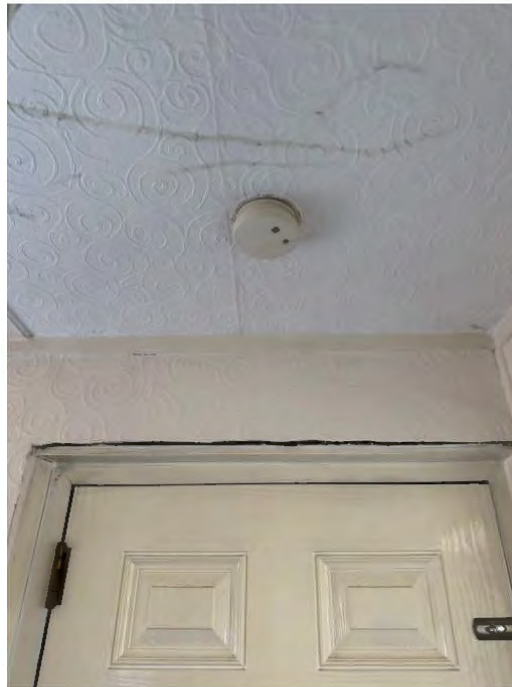
There was a smoke detector fixed to the ceiling of the downstairs hall that operated but was not interconnected.

13.1.8 The smoke detector in the downstairs hall is not interconnected.

Photograph 5: Downstairs hallway: Smoke detector (not interlinked)

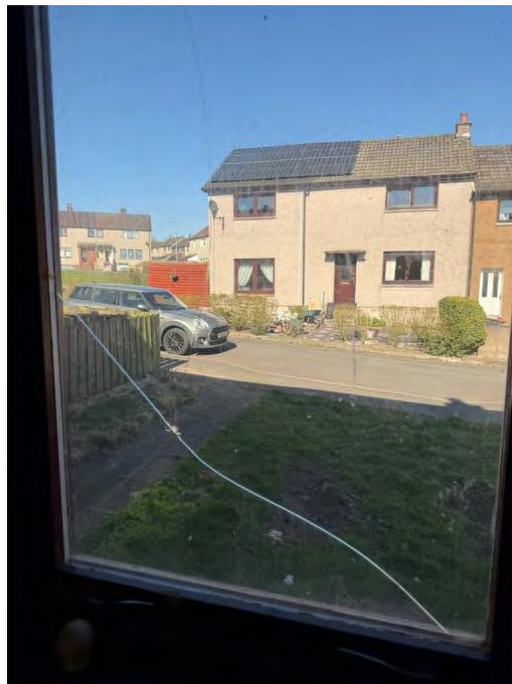
The front right hand window (facing the Property) is cracked.

13.1.1 The front window in the lounge is cracked.

The Tribunal determine that the condition of the cracked lounge window; the external soffit board above bedroom 2 at the rear of the Property; the vegetation growing in the gutters at the front and rear of the Property and the broken fence and gate in the rear garden, as already detailed, results in them not being in a reasonable state of repair and proper working order.

Photograph 6: Living room: Front window cracked

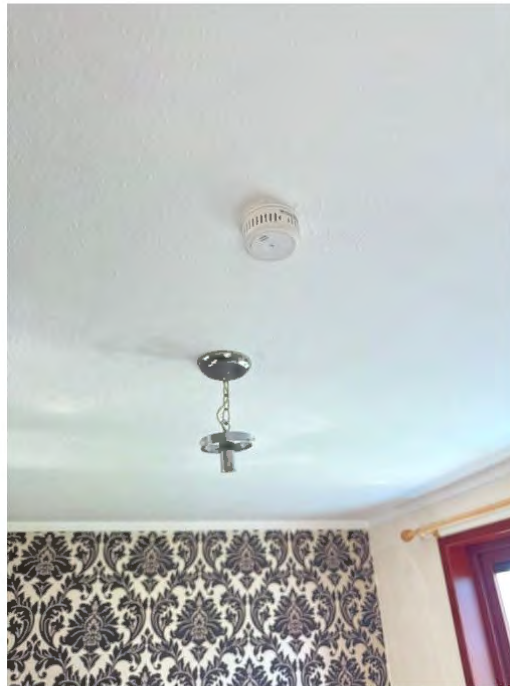
There was a smoke detector fixed to the lounge ceiling that operated but was not interconnected.

13.1.2 The smoke detector in the lounge is not interconnected.

Photograph 7: Living room: Smoke detector (not interlinked)

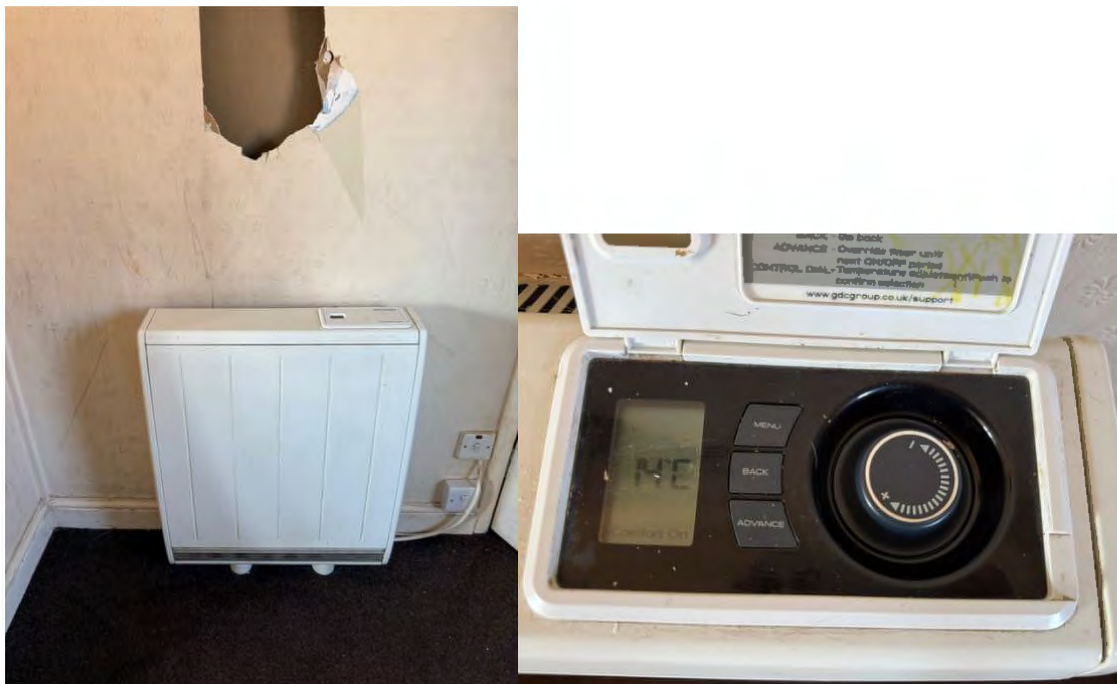
The electric storage heater turned on correctly at the inspection.

Photographs 8 and 9: Living room: Electric heater

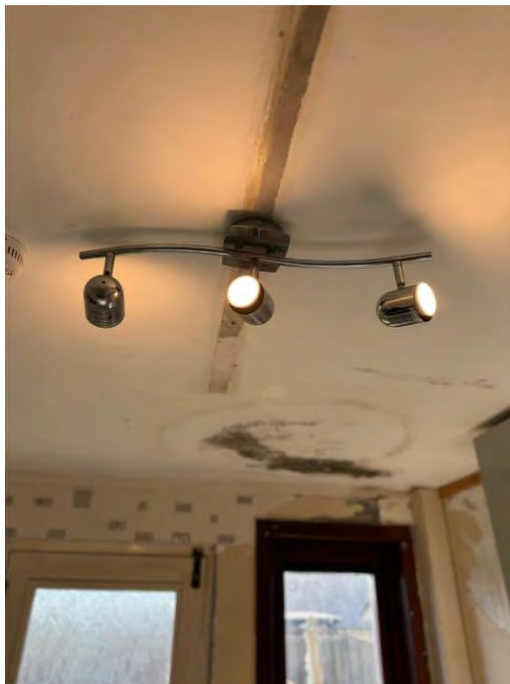
A kitchen ceiling light had been installed.

Photograph 11: Kitchen: Lighting

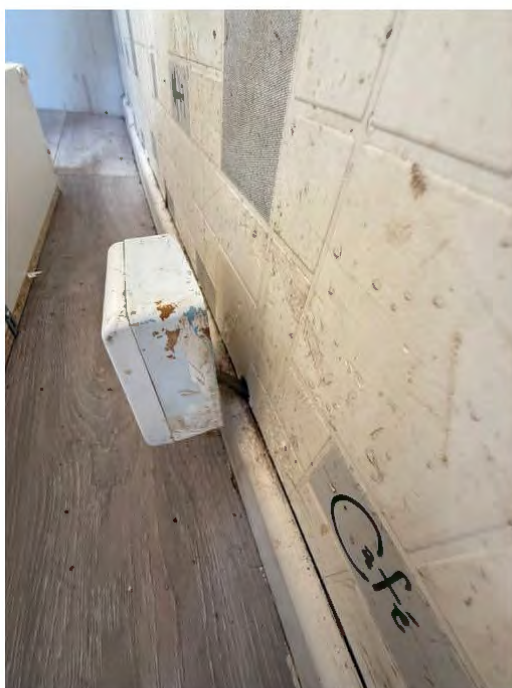
The Tribunal observed that the isolator switch at the bottom right hand wall was not fixed to the wall.

13.1.4 The isolator switch at the bottom right hand wall in the kitchen was not fixed to the wall.

Photograph 12: Kitchen: Isolator switch – bottom right hand wall (from back door)

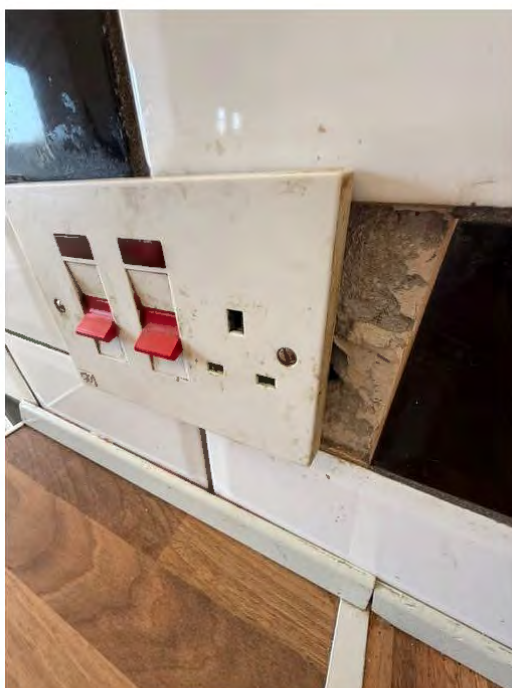
The Tribunal observed that the cooker isolator switch was not fixed to the wall.

13.1.5 The cooker isolator switch and plug were not fixed to the wall.

Photograph 13: Kitchen: Cooker isolator/plug – not fixed to wall

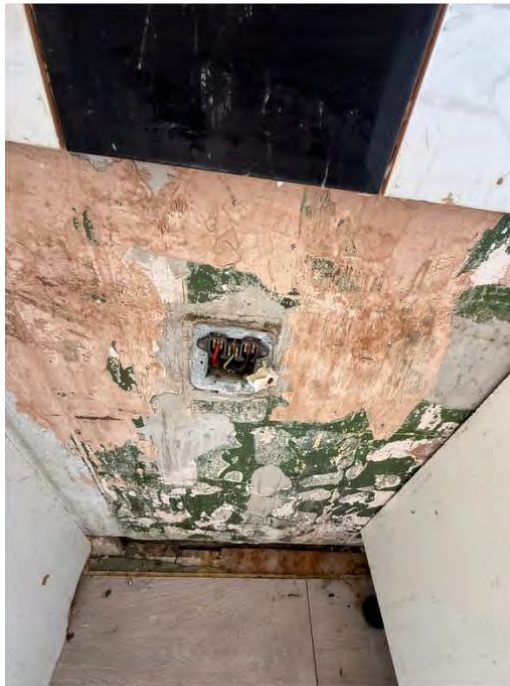
Photograph 14: Kitchen: Cooker space – bare wires

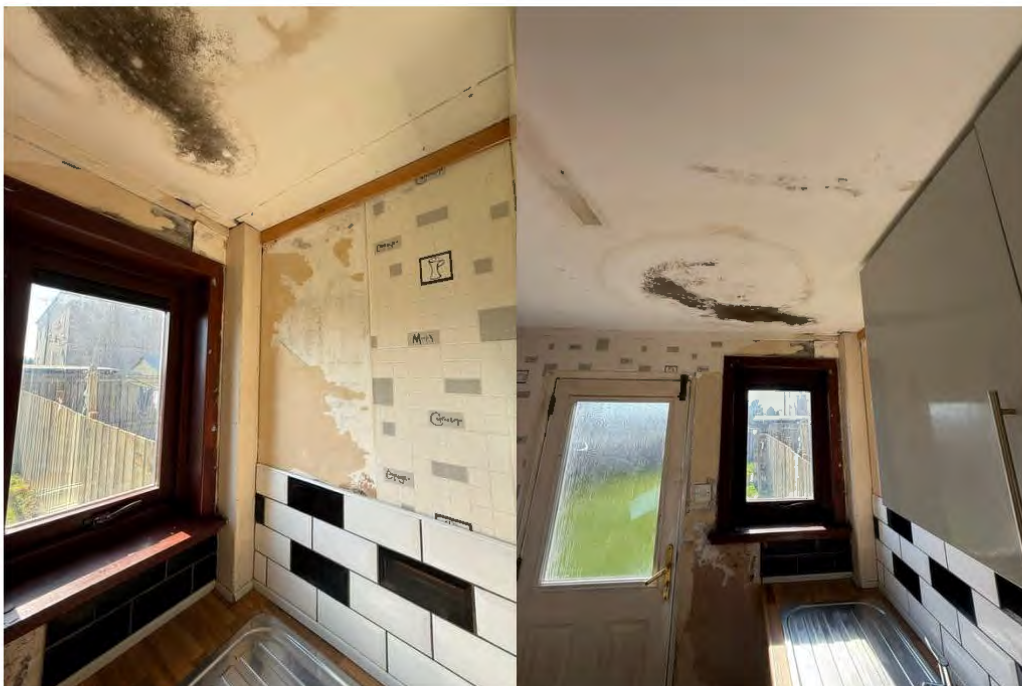
Some of the wallpaper in the kitchen was peeling from the wall.

There was no evidence of the leak in the bathroom. There was staining on the kitchen ceiling that was dry when tested with the damp meter.

13.1.6 Wallpaper in the kitchen is peeling from the wall.

The Tribunal determine that wallpaper in the kitchen is a fixture and the fact that it is peeling results in it not being in a reasonable state of repair.

Photographs 15 and 16: Kitchen: Leak from bathroom and peeling wallpaper

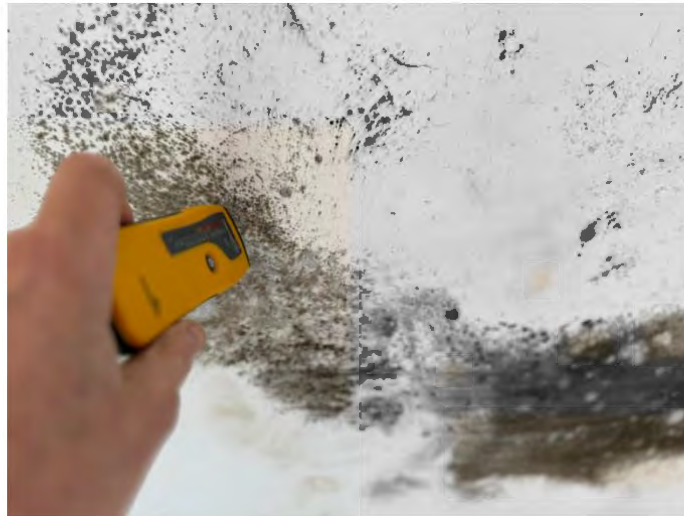
Photograph 17: Kitchen: mould to ceiling

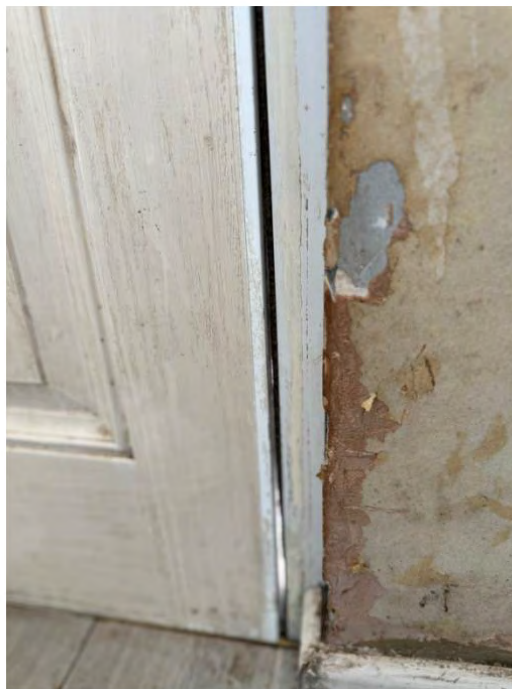
The Tribunal observed day light down the right hand opening side of the back door. It was not wind and water tight.

13.1.7 The back door does not seal properly and day light can be seen down the right hand side.

The Tribunal determine that condition of the back door already stated and the presence of mould/ dampness on the ceiling of the bathroom and bedrooms 2 and 3 results in them not being wind and water tight and in all other respects reasonably fit for human habitation.

Photograph 18: Kitchen: Ill-fitting back door

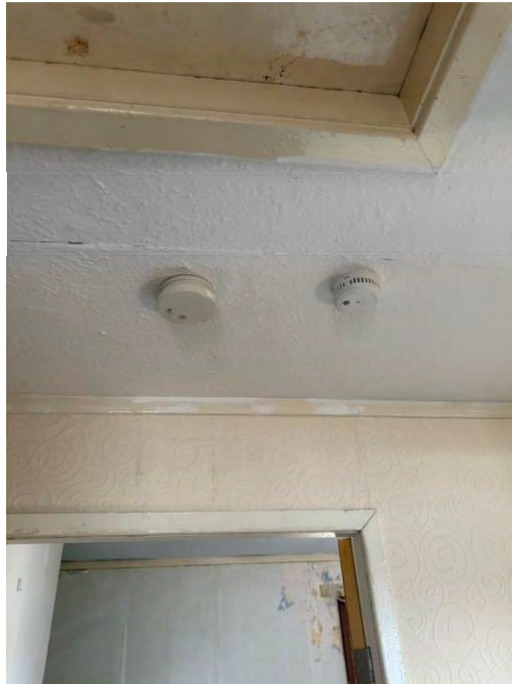
There was a smoke detector fixed to the ceiling of the upper hall that operated but was not interconnected.

13.1.9 The smoke detector in the upper hall is not interconnected.

Photograph 19: Upstairs landing: Smoke detectors (not interlinked)

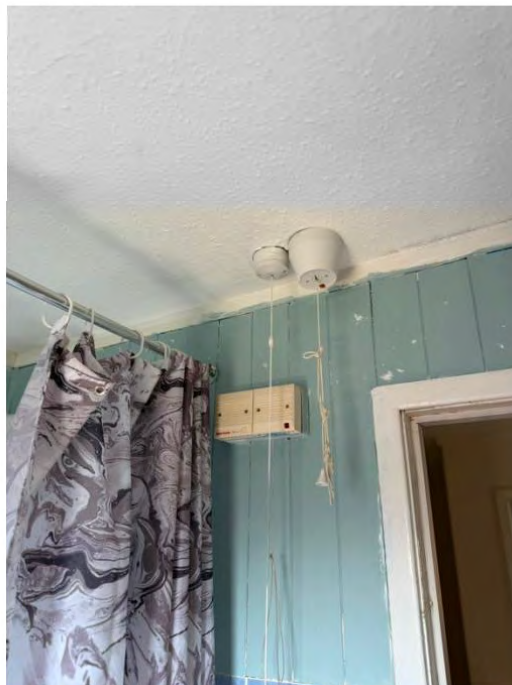
It was not possible to turn the bathroom light on at the inspection.

13.1.10 The main light in the bathroom does not work.

Photograph 20: Bathroom: Light switch and shower switch (light not working)

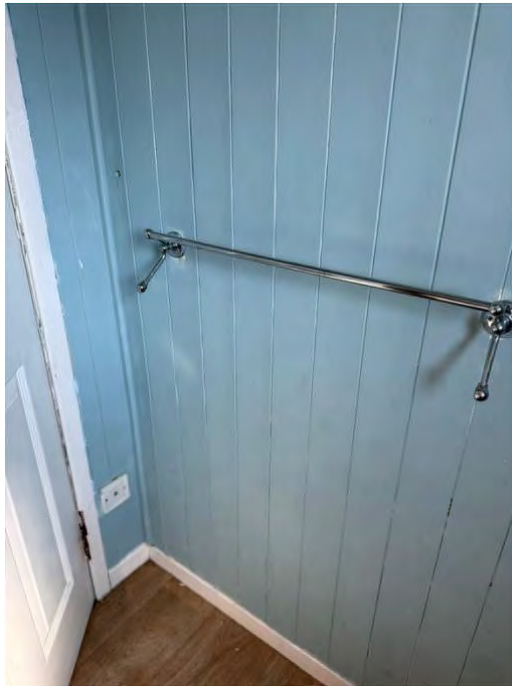
Photograph 21: Bathroom: Bare wire coming into the bathroom (heated towel rail removed)

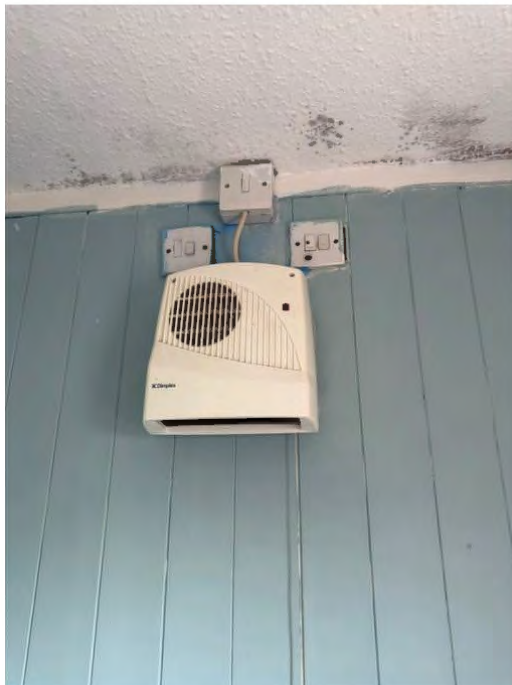
There was an area of black mould on the bathroom ceiling that was dry when tested with the damp meter.

13.1.11 There was an area of black mould/ damp on the bathroom ceiling.

Photograph 22: Bathroom: Mould to ceiling and heater

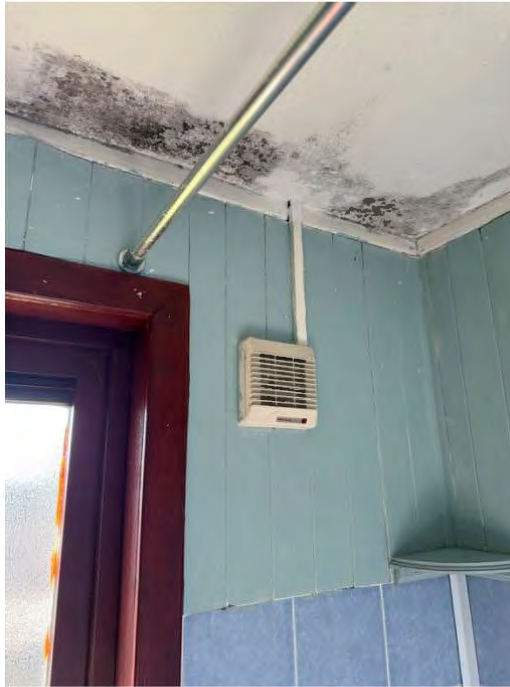
Photograph 23: Bathroom: Mould to ceiling and extractor unit

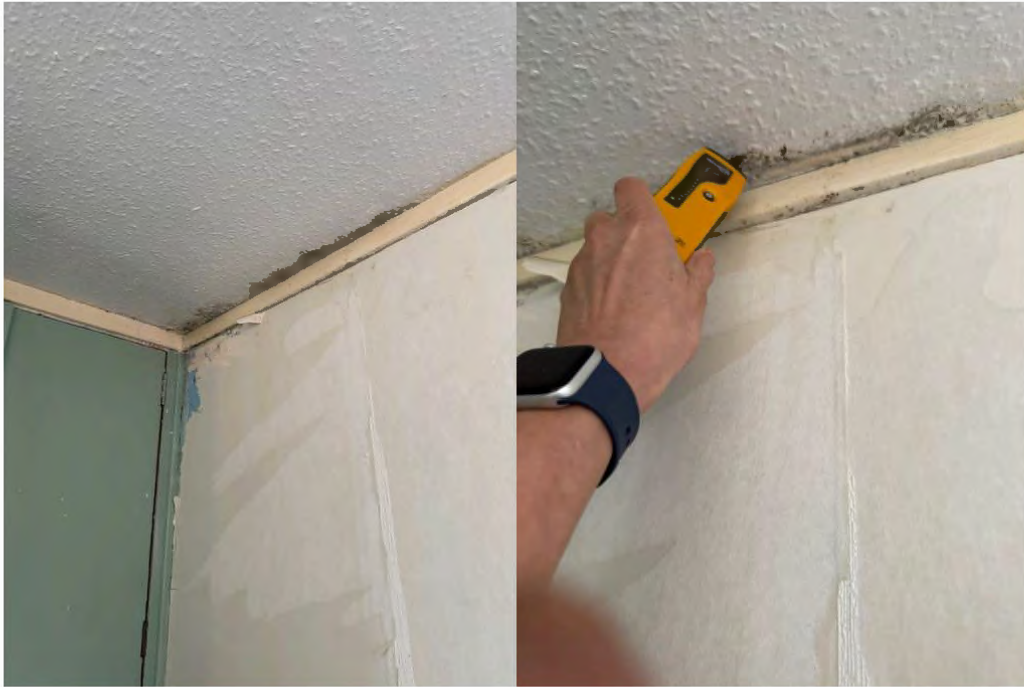
There was an area of black mould on the ceiling of bedroom 3 that was dry when tested with the damp meter.

13.1.12 There was an area of black mould on the ceiling of bedroom 3.

Photographs 25 and 26: Bedroom 3 (front): Mould to external wall

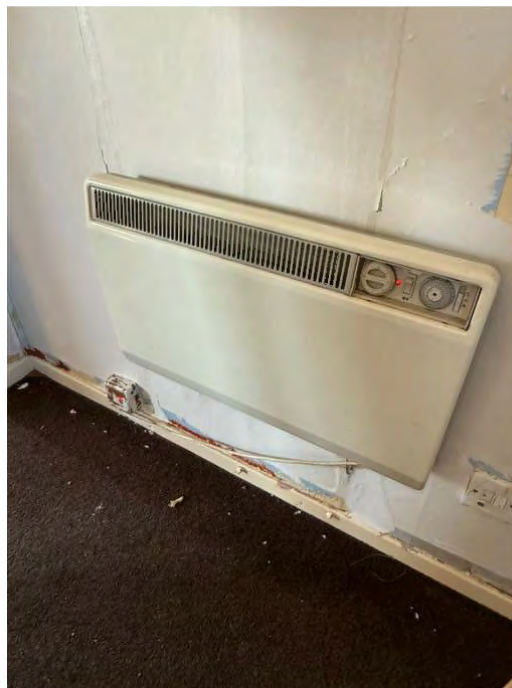
The electric storage heater turned on correctly at the inspection.

Photograph 27: Bedroom 3 (front): Electrical heater

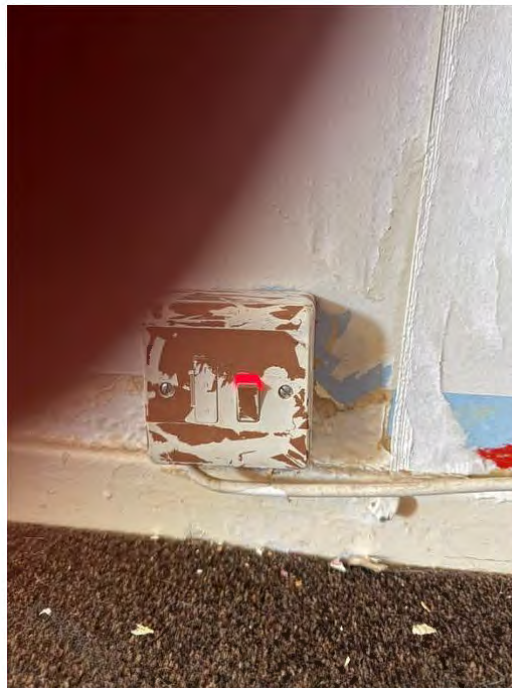
Photograph 28: Bedroom 3 (front): Isolator switch (tape removed)

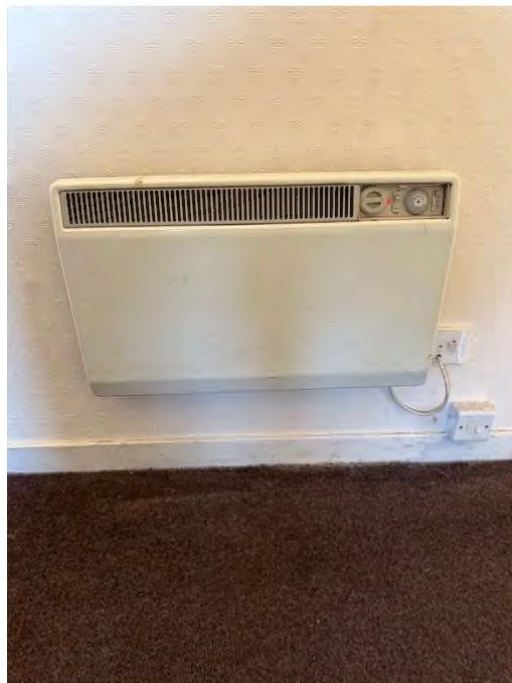
The electric storage heater turned on correctly at the inspection.

Photograph 29: Bedroom 2 (rear): Electric heater

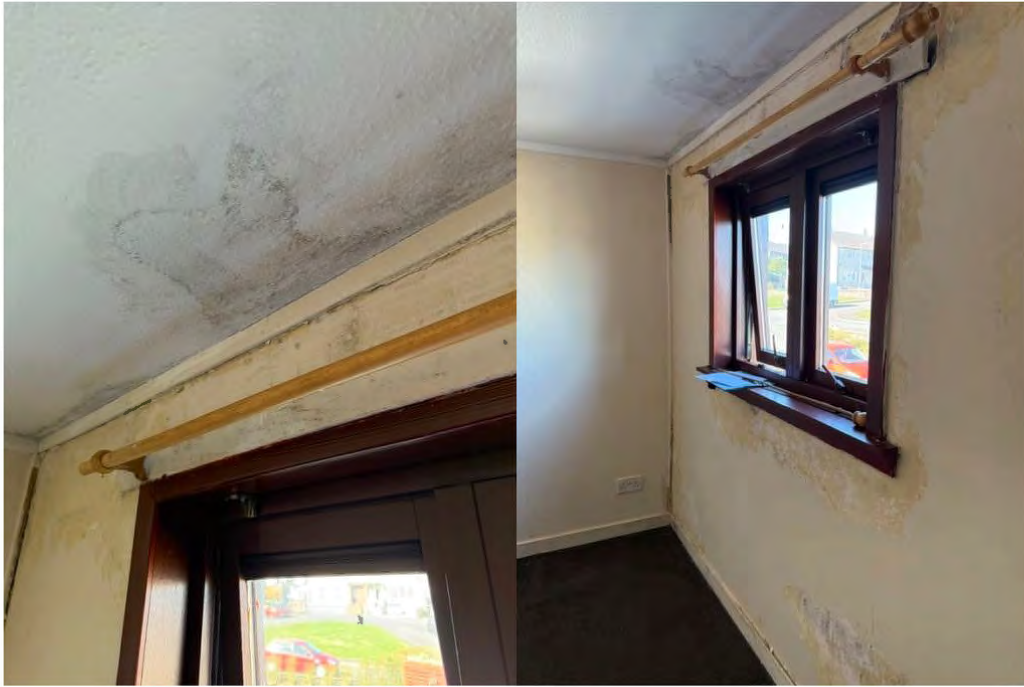
There was an area of black mould on the ceiling of bedroom 2 that was dry when tested with the damp meter.

The fascia board on which the curtain pole is attached was secure at the inspection.

13.1.13 There was an area of black mould on the ceiling of bedroom 2.

Photograph 30: Bedroom 2 (rear): Mould to ceiling; window and curtain pole fascia

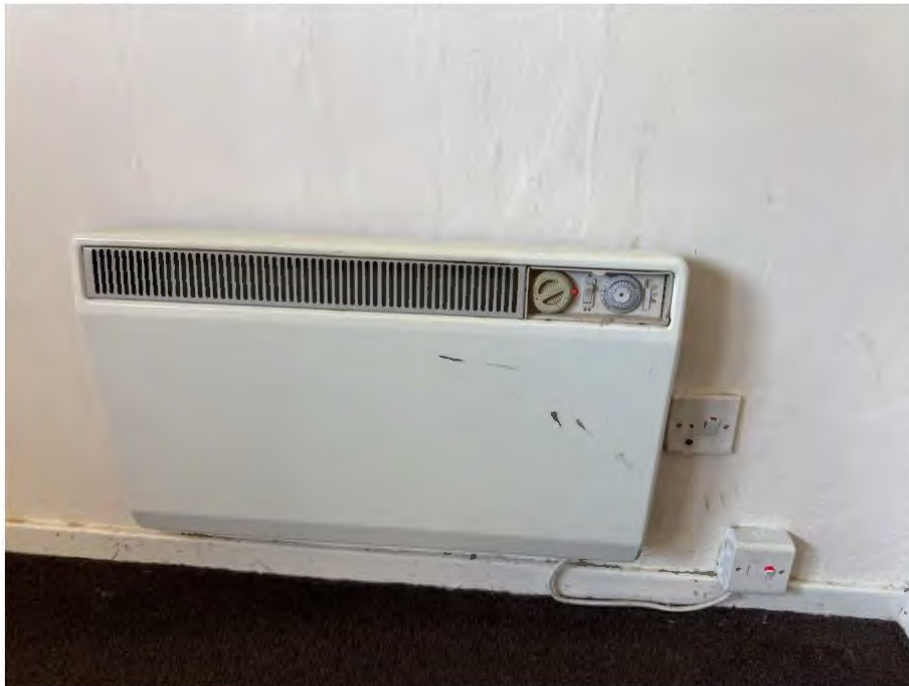
The electric storage heater turned on correctly at the inspection.

Photograph 33: Bedroom 1 (front): Electric heater

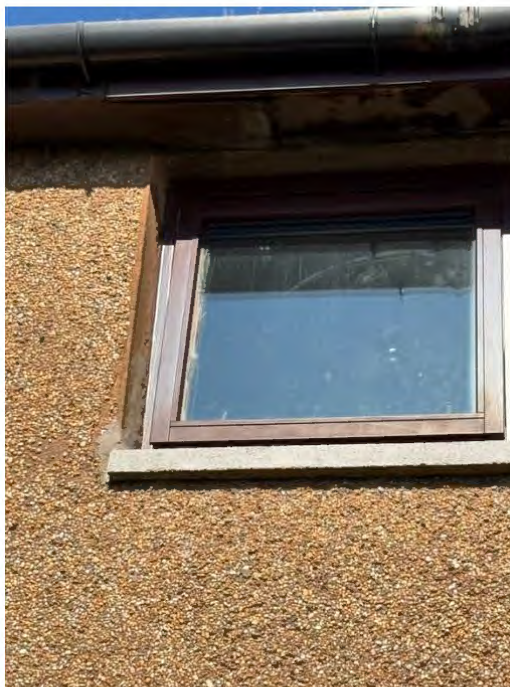
The soffit board above bedroom 2 was not secure.

13.1.15 The external soffit board above bedroom 2 at the rear of the Property was unsecured.

Photograph 34: Rear elevation: Soffit board not secured

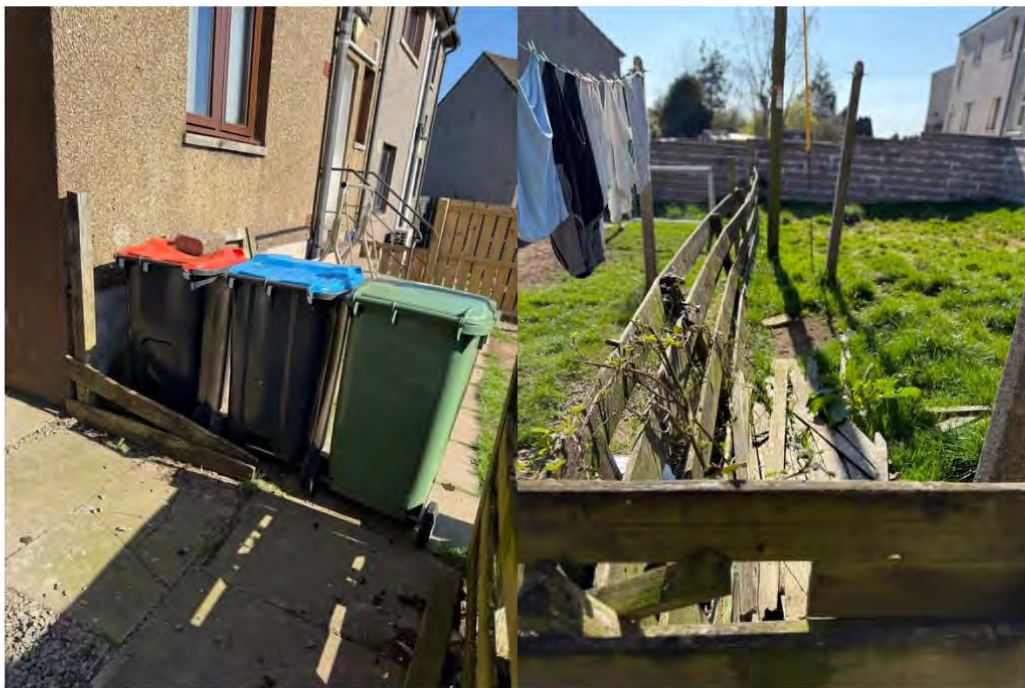
The rear boundary fence and gate at the rear of the property were broken.

13.1.17 The fence and gate accessing the back garden are broken.

Photographs 36 and 37: Rear elevation: Fence and gate broken

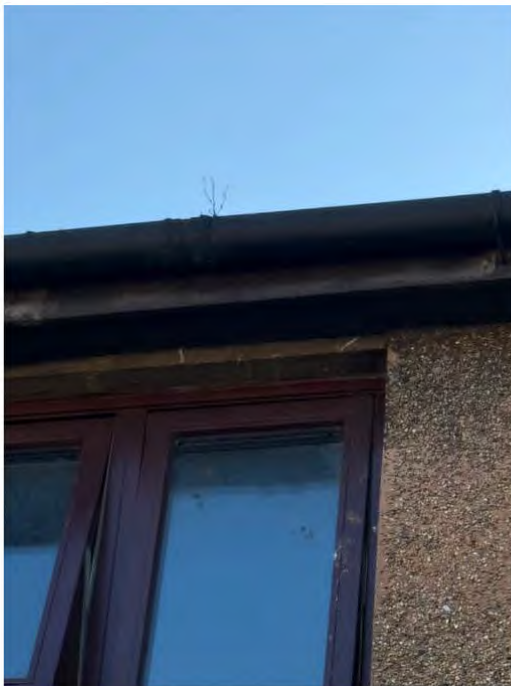
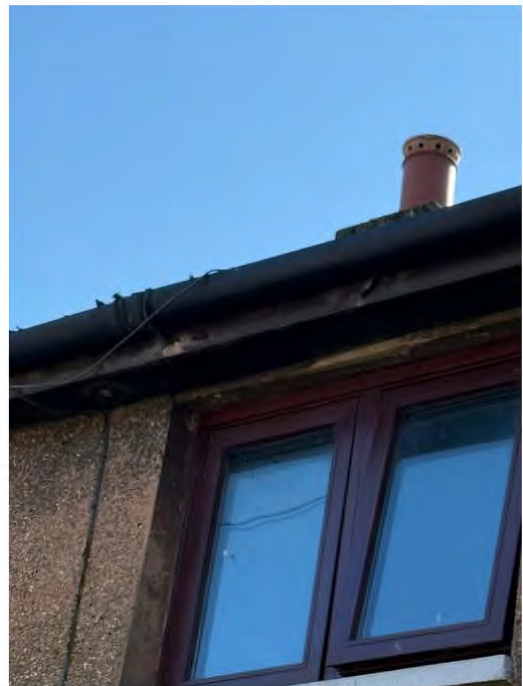
The Tribunal observed vegetation growing in the gutters at the inspection.

13.1.16 There is vegetation growing in the guttering at the front and rear of the Property.

Photographs 39 and 40: Front elevation: Vegetation to guttering
