### **Statement of Decision of the First-tier Tribunal for Scotland (Housing and Property Chamber)**

**Case Reference Number: FTS/HPC/RP/25/0284**

**Re: Flat 2, 46 Ardshiel Avenue, Edinburgh, EH4 7HS (“the house”)**

### Pre-hearing inspection summary and schedule of photographs

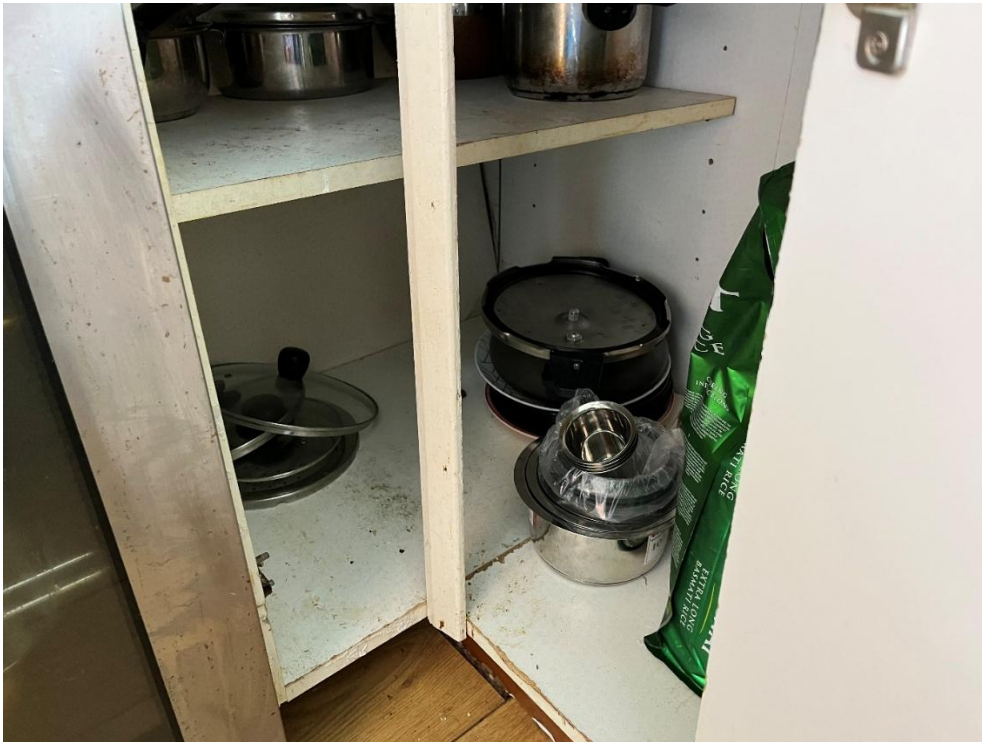
- The door of the kitchen cupboard next to the cooker was missing.
- The rear panel of the same kitchen cupboard was damaged.
- The base trim/plinth underneath the cupboard was also missing.
- The shelves in the adjacent kitchen cupboard were missing.

Kitchen cupboard showing missing door, missing base trim and damaged rear panel.

56. The tribunal determined that at the time of its inspection the cupboard door, shelving, base trim and rear panel mentioned above were not in a reasonable state of repair and in proper working order.

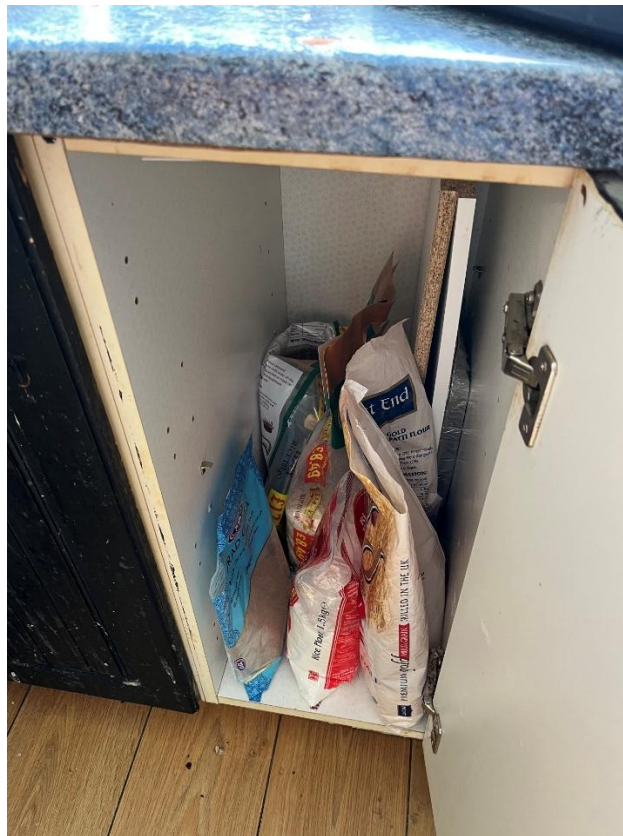
- b) The rear panel of the same kitchen cupboard was damaged
  - c) The base trim/plinth underneath the cupboard was also missing
  - d) The shelves in the adjacent kitchen cupboard were missing.

Kitchen cupboard showing missing shelves.

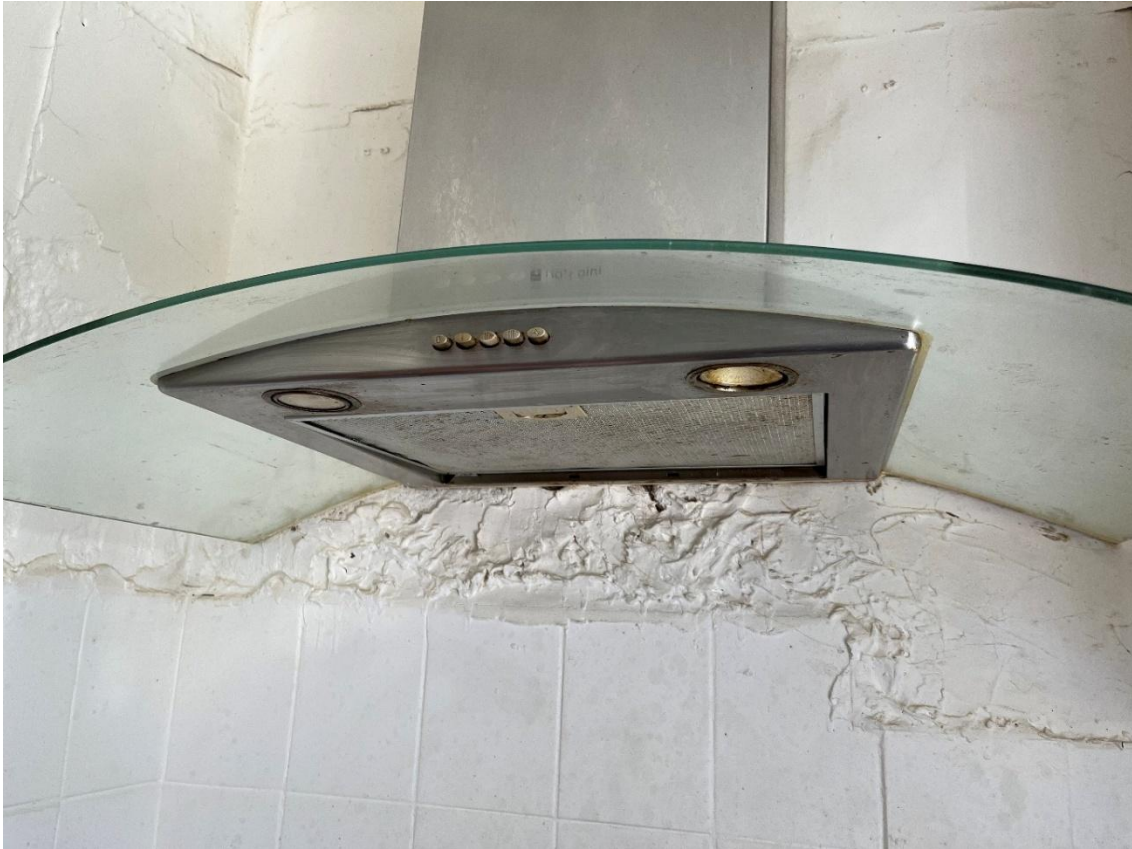
- 61. It became apparent at the inspection that the tenant's reference to "the extractor fan in the kitchen", related to the cooker hood. The tribunal observed during its inspection that the cooker hood was not operating correctly. The lights were defective, and the filter was loose and appeared to be damaged.
- 62. The landlord said that she had believed her joiner had fixed the hood. The tenant said that it was not working, and the filter fell out regularly, often behind the cooker.
- 63. The tribunal determined that as at the date of its inspection, the cooker hood was not in a reasonable state of repair and in proper working order.

Cooker hood showing defective lights and loose/damaged filter.

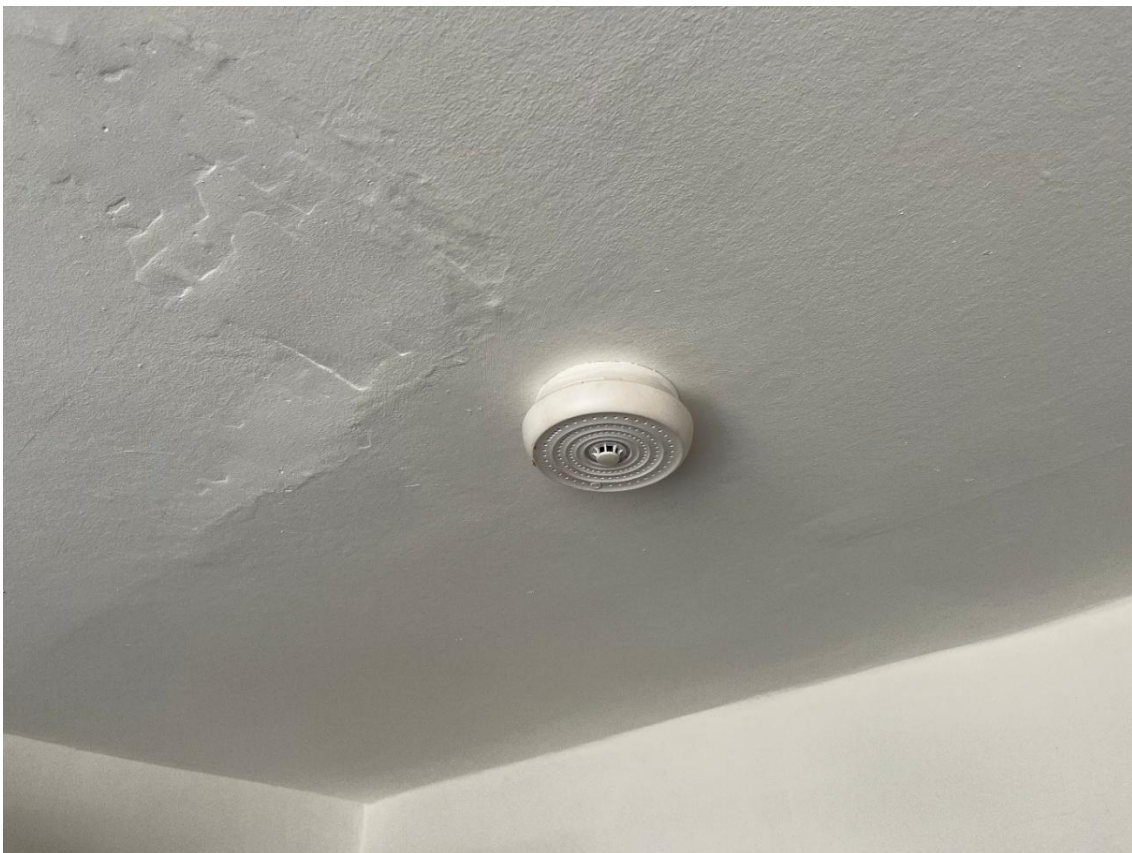
67. The landlord told the tribunal at the hearing that the heat detector was working, but that the battery required to be replaced.
68. At its inspection, the tribunal noted that the heat detector in the kitchen was not operational and was not interconnected to the smoke alarms in the living room and hallway.

Defective heat detector in Kitchen.

- one heat alarm in every kitchen,
  - all alarms should be ceiling mounted, and
  - all alarms should be interlinked.
71. The tribunal therefore determines that the house does not meet the repairing standard, as the heat alarm is not interlinked with the smoke alarms.

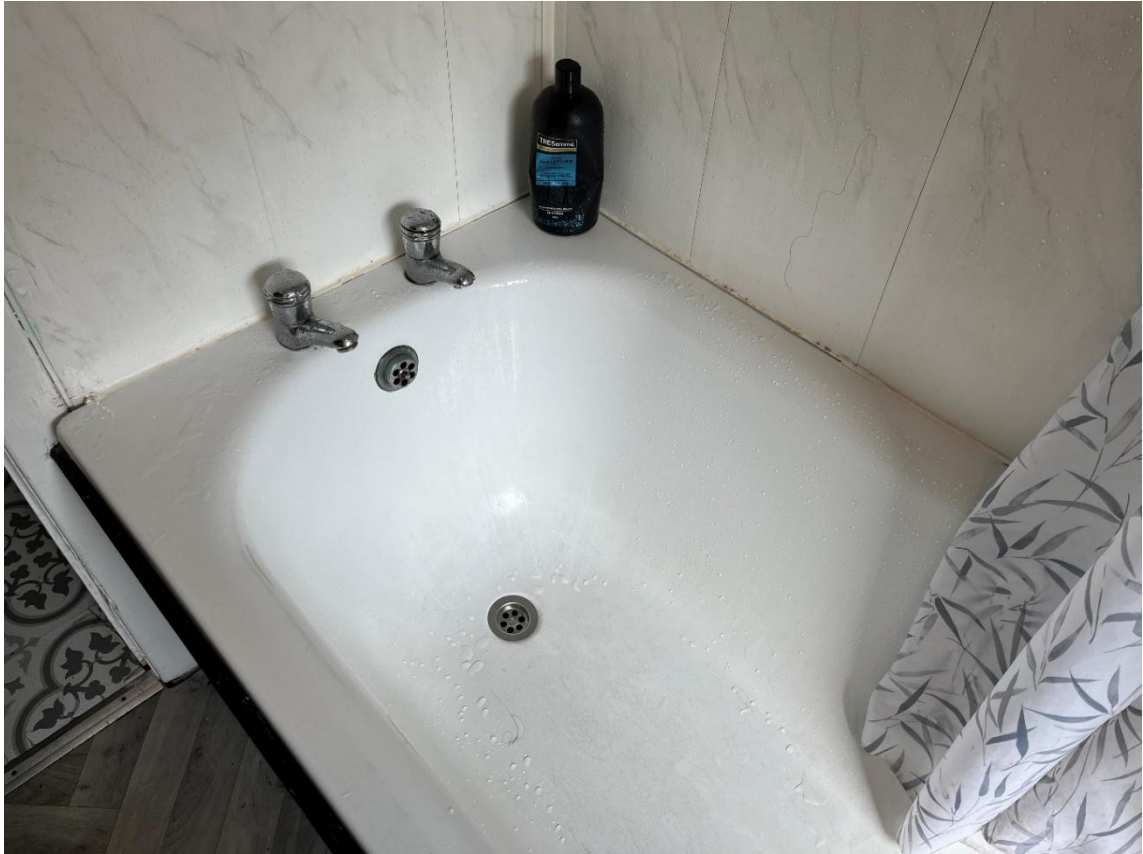
- 64. The tribunal observed during its inspection that when the bath taps were turned on, the water was slow to drain away.
- 65. The tenant told the tribunal that she had reported the issues with the plumbing in the bathroom when she had first moved in. Sometimes when water was being used in the bathroom sink, water came up through the drain in the bathtub. The water did not drain away, and she had to use drain cleaner regularly. She had engaged a plumber who had fixed it temporarily. Both she and the landlord had plunged the drain, but the problem kept returning.
- 66. The tribunal determined that as at the date of its inspection, the bathroom drainage system was not in a reasonable state of repair and in proper working order.

Choked drain from bath in Bathroom.

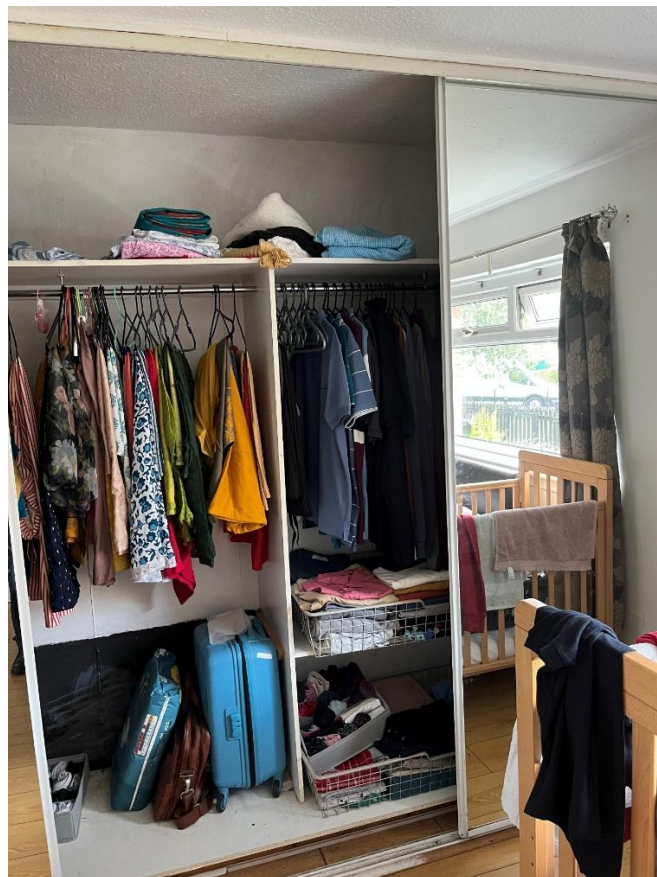
45. The tribunal observed during its inspection that one of the mirrored doors was missing from the fitted wardrobe in the main bedroom.
46. The tenant told the tribunal that the wardrobe had three mirrored doors when she moved in. She had reported to the landlord that one of the doors was not sliding properly on the day that she moved into the house. When the landlord had tried to fix the door, the wheels had come off. The landlord has sent a tradesman to fix it, but he had been unable to find a replacement wheel. The tradesman had come to the property while the tenant was out and when she came back, the glass had fallen out. The tradesman told her that the best solution was to remove the door, as the glass was too heavy to be supported by the wheel. The broken door was in the garden for safety reasons, as the glass was broken.

Missing wardrobe door in main Bedroom.

48. The tribunal determines that the wardrobe doors are not in a reasonable state of repair and in proper working order.
49. It became apparent at the inspection that the “missing coverings” referred to by the tenant in her application related to what she referred to as a “storage cupboard” within the main bedroom. This was the cupboard which had formerly housed the hot water storage tank. The tribunal observed at its inspection that this cupboard was unpainted and the plaster work was poor.

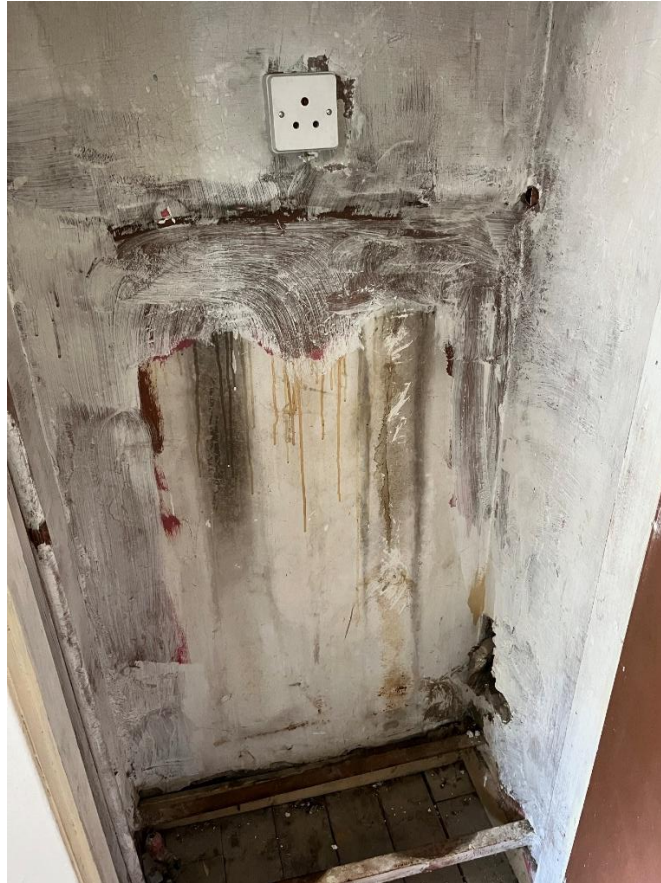
- i) Dampness readings were taken inside the wardrobe in the main bedroom. No signs of dampness was observed, and the area was found to be dry.
  - j) The cupboard in the main bedroom which had formerly housed the hot water storage tank was unpainted and the plaster work was poor.

Former hot water storage tank cupboard in main Bedroom.

51. The tribunal took the view that, whether the tenant had been told this or not, this was a cosmetic issue and was not therefore a breach of the repairing standard.

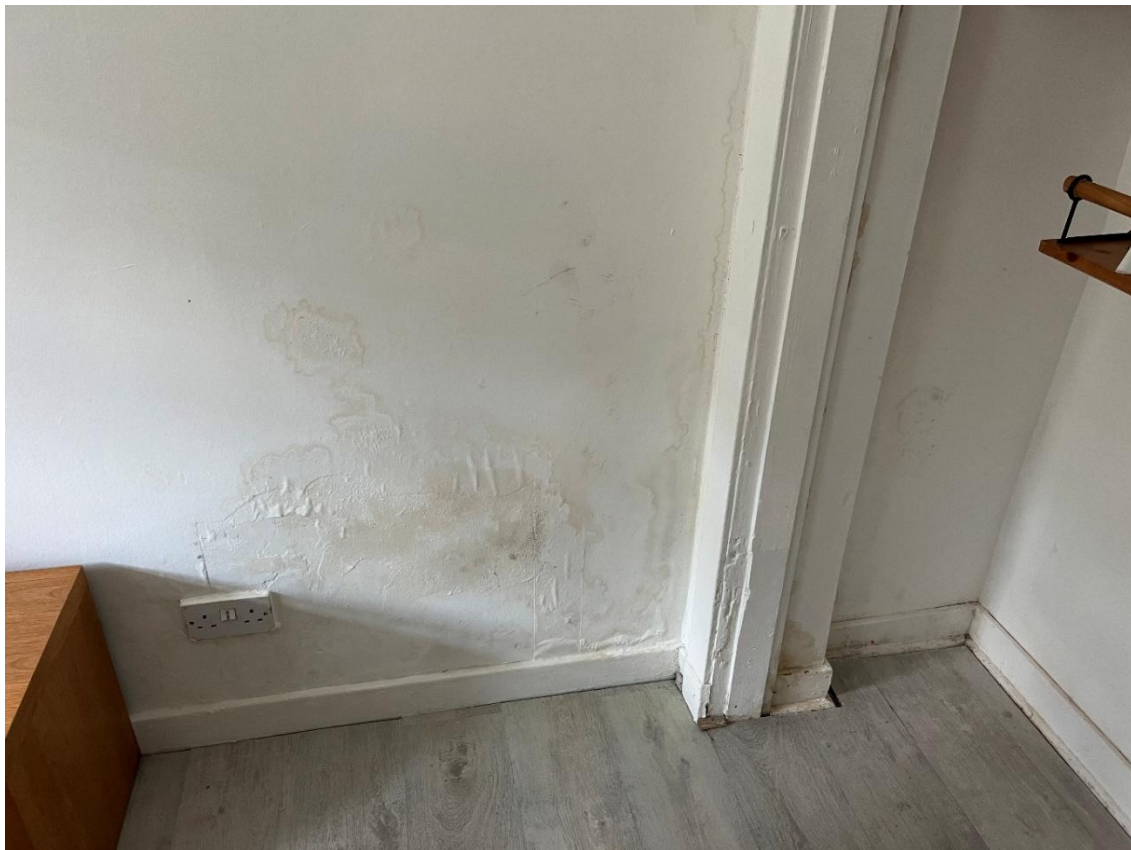
40. At its inspection, the tribunal observed that there was damp staining on the gable wall of the second bedroom. High dampness readings were obtained. The tribunal also observed that a constant flow of water was running from the overflow pipe of the second floor flat above the house, and down the outside gable wall where the second bedroom is located.

42. It was clear to the tribunal, using its special expertise, that this leak from the second floor flat, probably from the water tank, was the cause of the dampness on the gable wall of the second bedroom. The cause was not condensation, as the landlord had suggested. The tribunal noted that the leak was not referred to in the report from the specialist damp surveyor which the landlord had instructed.

Damp staining on gable wall of second Bedroom.

44. The tribunal determined that at the time of its inspection, the house was not wind and watertight and in a reasonable state of repair and in working order.

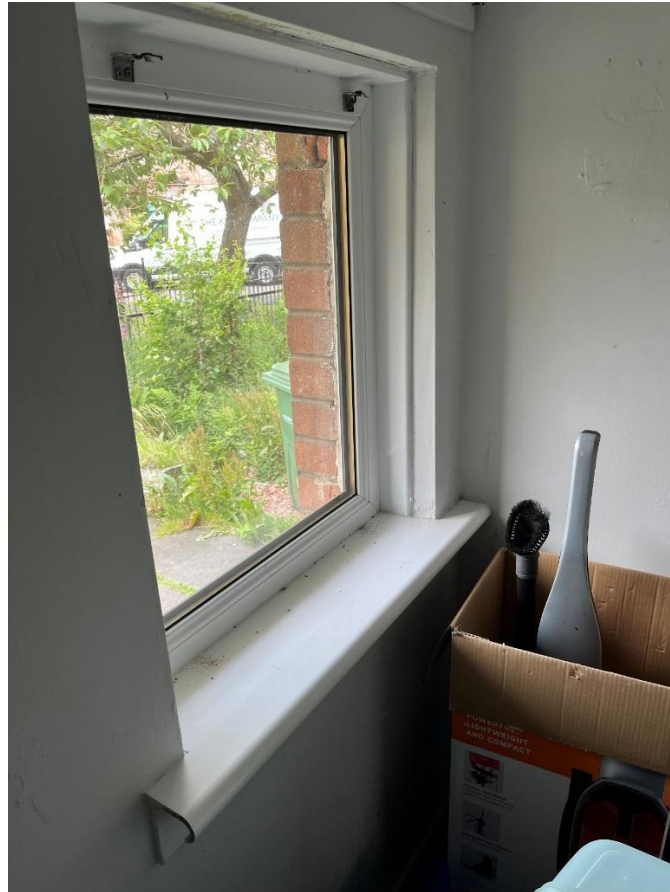
36. The tenant had also complained of dampness and pooling water in the storage area which is entered from the living room. During the tribunal's inspection, no signs of dampness were indicated, and the area was found to be dry.

Storage area entered from Living Room.

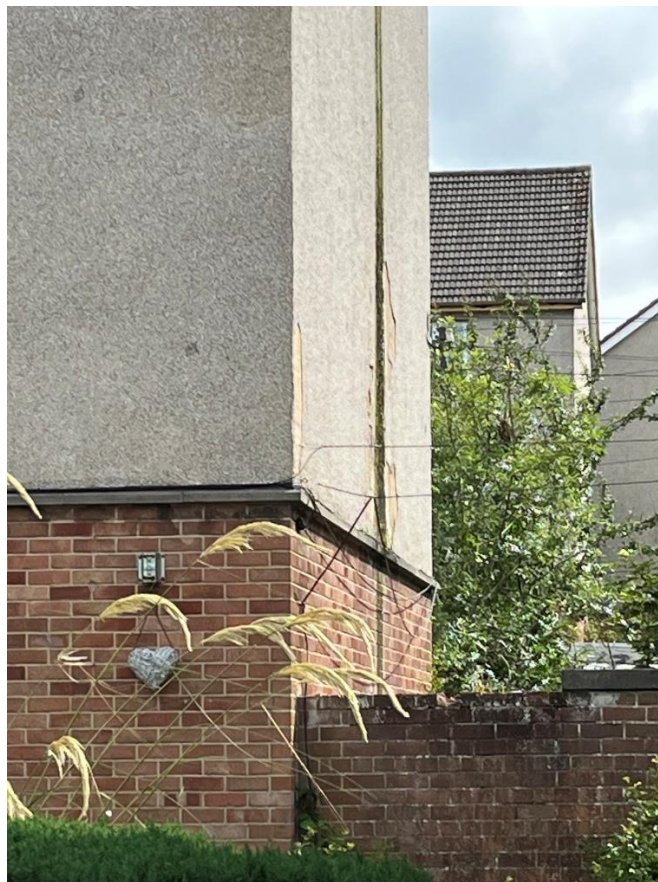
- l) There was damp staining on the gable wall of the second bedroom. High dampness readings were obtained.
  - m) Constant running water was observed externally, coming from the overflow pipe of the second floor flat above the house.

Water running from overflow pipe of second floor flat above subject property.
