Statement of Decision: Housing (Scotland) Act 2006 (“the Act”) Section 24(1)

Chamber Ref: FTS/HPC/RP/25/2990

Re: Ground floor Flat 1, 71 Clermiston Road, Edinburgh, EH12 6UY
 (“the House”)

Schedule of photographs taken on 28 January 2026

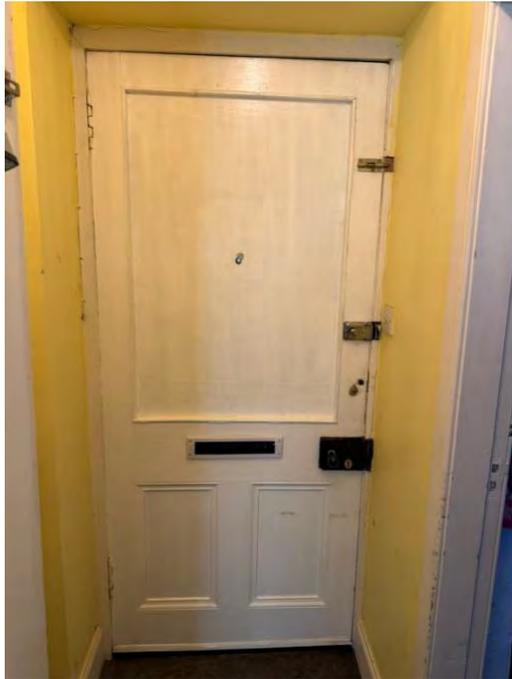
Photograph 3: Vestibule: higher than normal levels of moisture to wall near front door

- (2) Around the front door in the vestibule hall, damp staining was evident. Damp meter readings were taken, and they were in the amber zone indicating raised moisture. The tenant had directed the tribunal to an outside drain which she stated she had paid to be cleared, and she thought that this had improved the situation. The tribunal considered further investigations were required.

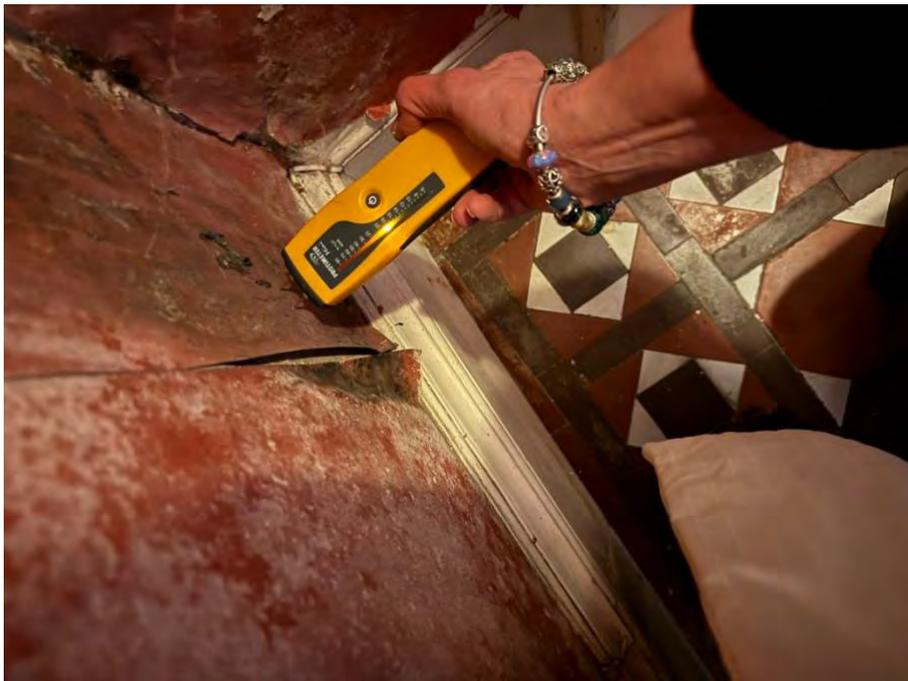
Photograph 4: External: Right hand side front door: drainpipe (cleared by tenant)

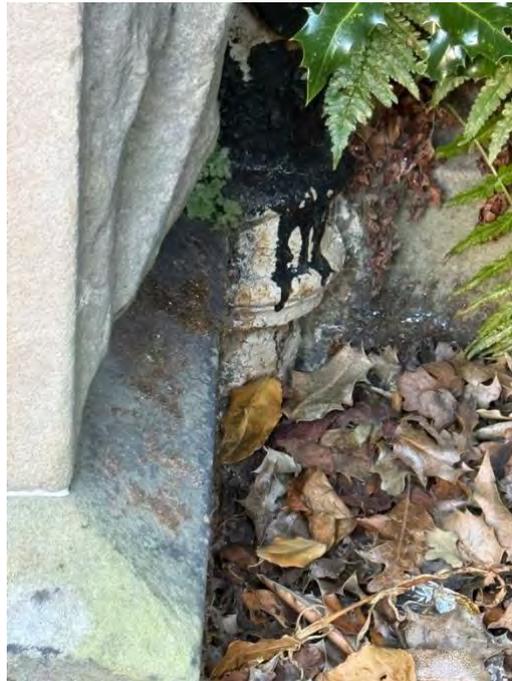
Photograph 5: Bedroom 1: dampstaining to internal wall (abutting front vestibule)

- (4) The main bedroom which is adjacent to the vestibule hall has signs of damp staining. Damp meter readings were taken, and they were within acceptable levels. This may be because there has been a degree of drying in the areas affected. The tribunal considered further investigations were required.

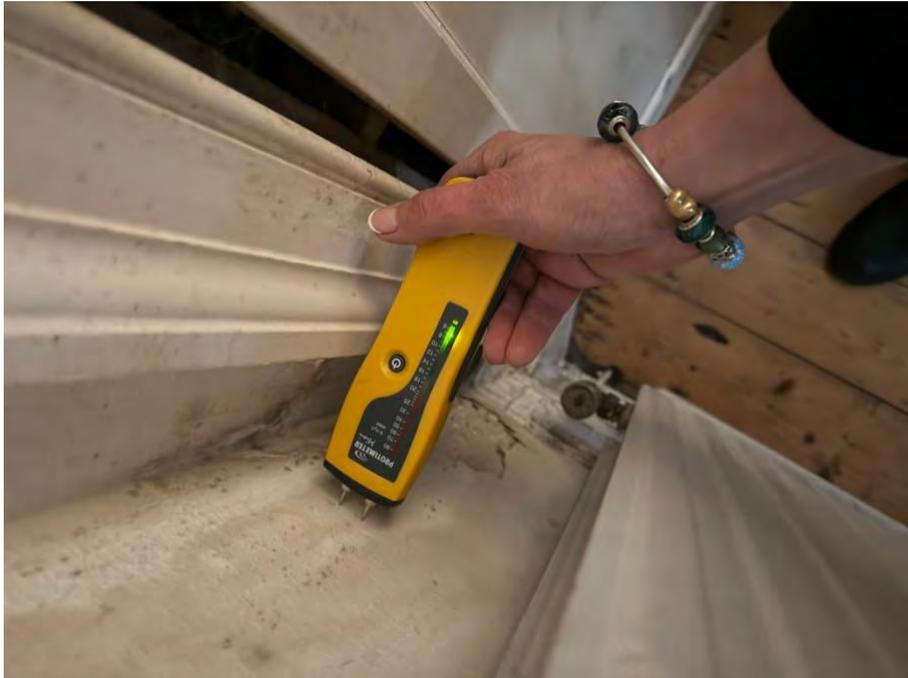
Photograph 7: Bedroom 1: Mould at ceiling level (external corners)

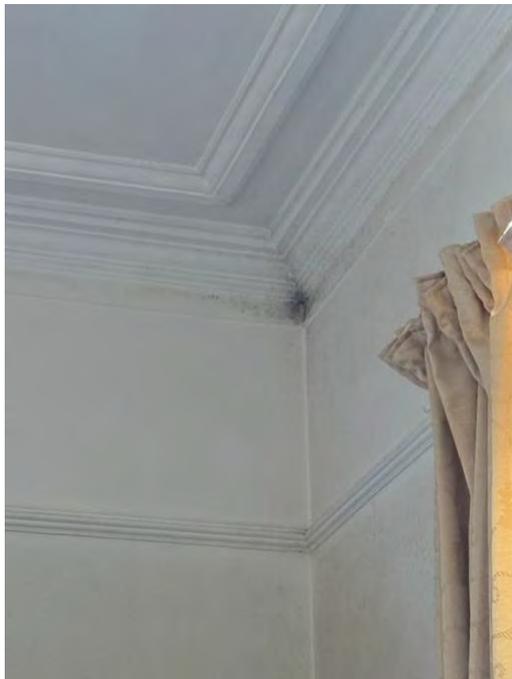
Photograph 8: Bedroom 1: Cupboard doors (no movement)

- (6) Within the main bedroom the built-in cupboard could not be used as the doors are either jammed or the wood has swollen preventing use. The tribunal considered further investigations were required and they needed repaired or replaced.

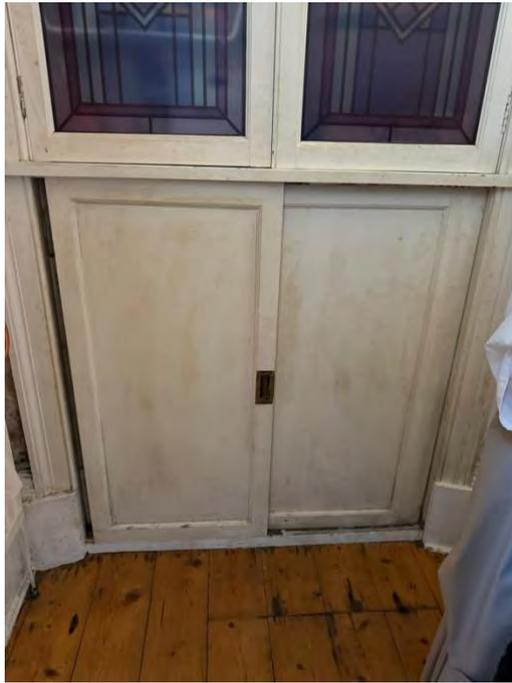
Photograph 9: WC (used as store): Mould and damp staining to walls and ceiling

- (7) Within the WC at the front door there was evidence of mould, and a pungent musty smell was apparent. Damp meter readings were taken, and they were in the red zone indicating high moisture

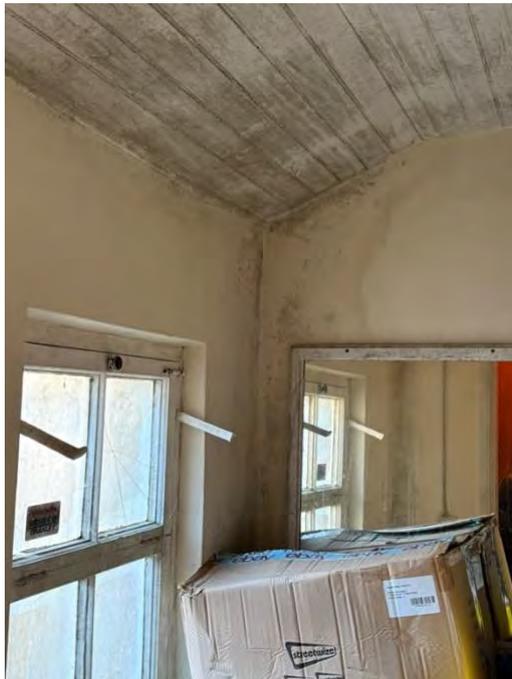
Photograph 10: WC (used as store): higher than normal levels of moisture to wall

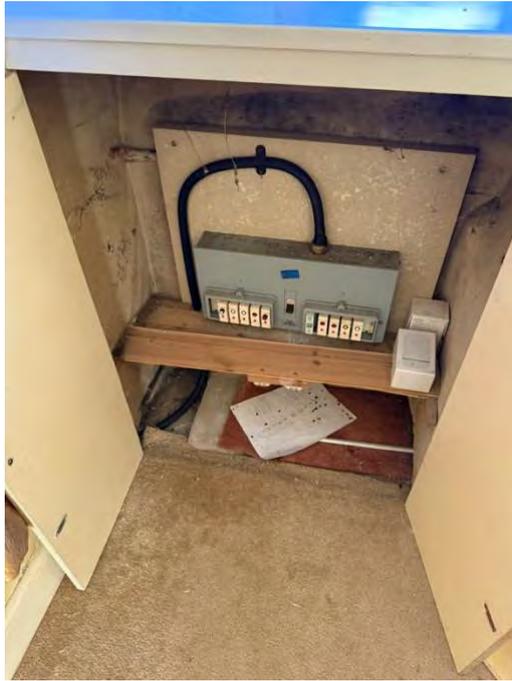
Photograph 15: Dining room: higher than normal levels of moisture and mould to cupboard

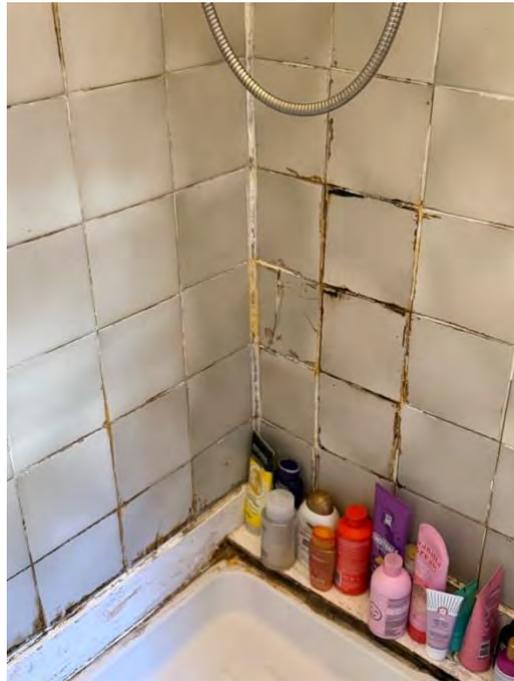
Photograph 17: Shower room: sealant to shower missing and not fit for purpose

- (12) Within the shower room the shower sealant was worn and sections of it were missing rendering it ineffective.
- (13) Within the shower room, black mould was visible at the ceiling board. The tribunal considered further investigations were required.

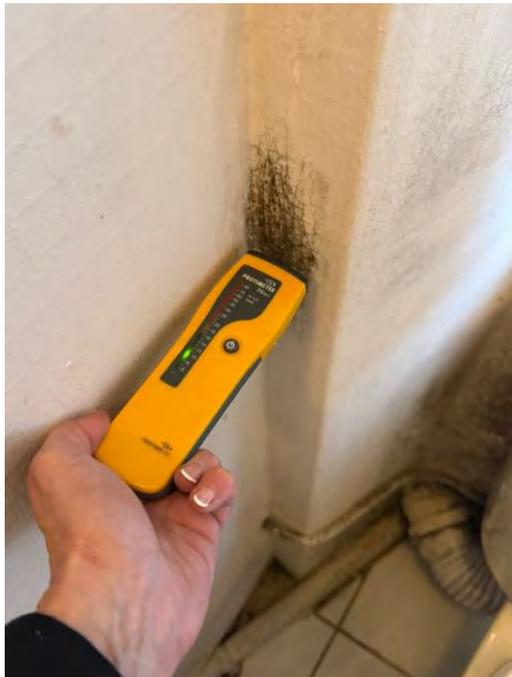
Photograph 20: Shower room: Cupboard: mould to walls and rusting to external face of pipes

- (14) Within the shower room cupboard that houses the cold-water tank and the hot water cylinder tank there were signs of moisture. There was light leaking in pipes and there was evidence of rusting spots on the pipes. The tribunal considered further investigations were required. (items 14,15,16 & 17 on the list of complaints)

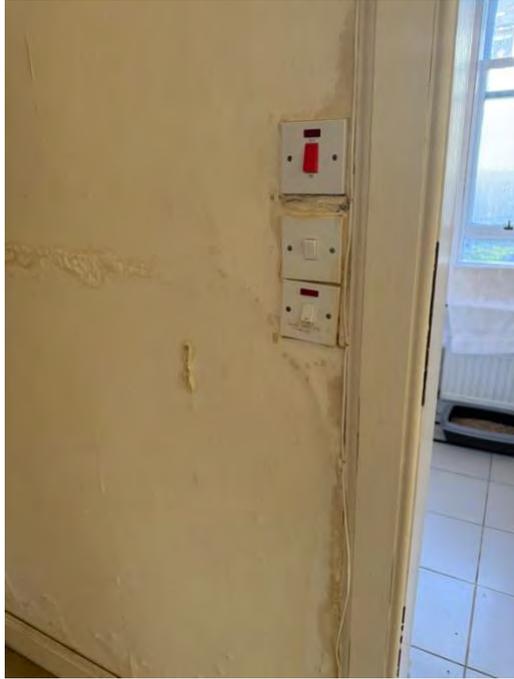
Photograph 25: Hallway: wall adjacent to shower room: higher than normal levels of moisture

- (16) As in 14 above.
- (17) As in 14 above.
- (18) Within the main hallway adjacent to the shower room there was evidence of damp markings. Damp meter readings were taken, and they showed high levels of moisture. The tribunal considered further investigations were required.

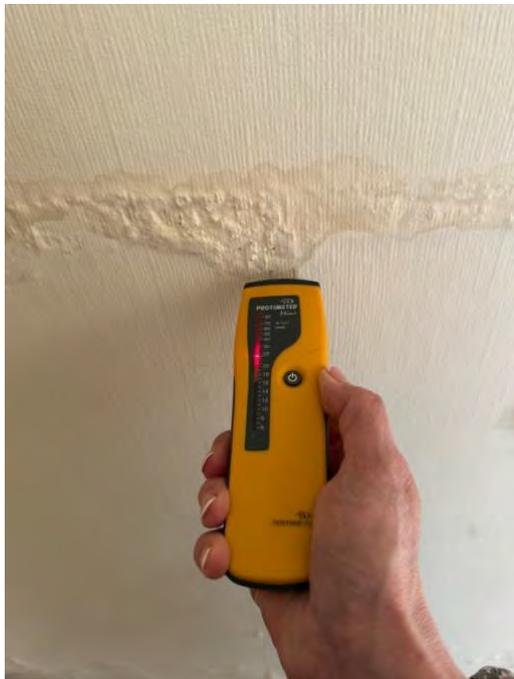
Photograph 26: Hallway: wall adjacent to shower room: higher than normal levels of moisture

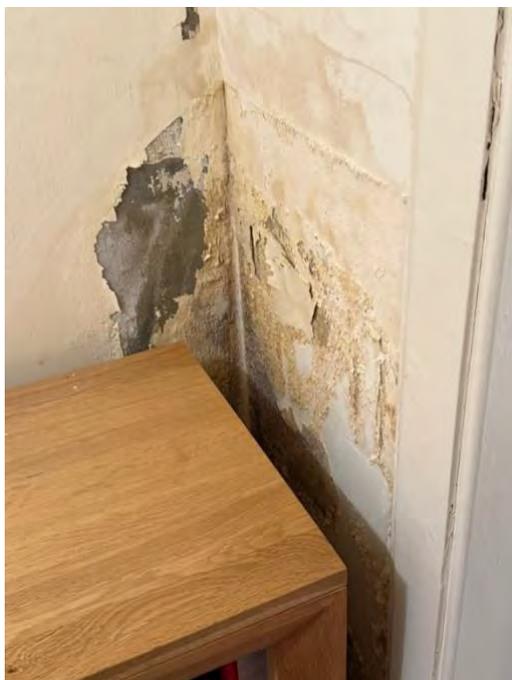
Photograph 28: Hallway: wall: higher than normal levels of moisture

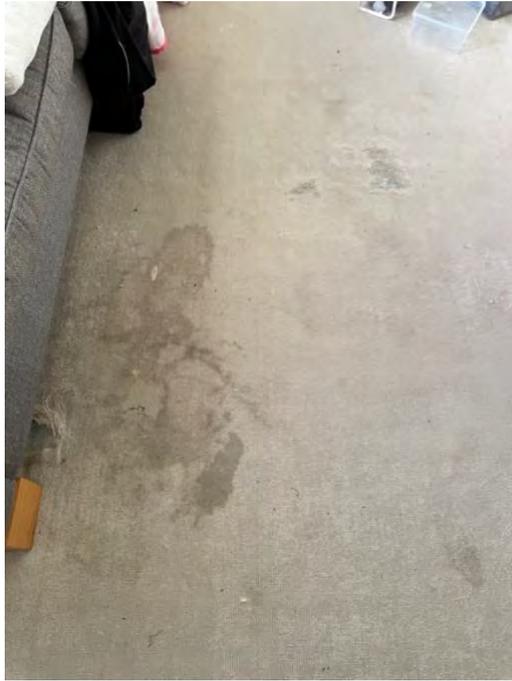
Photograph 43: Living room: worn carpet

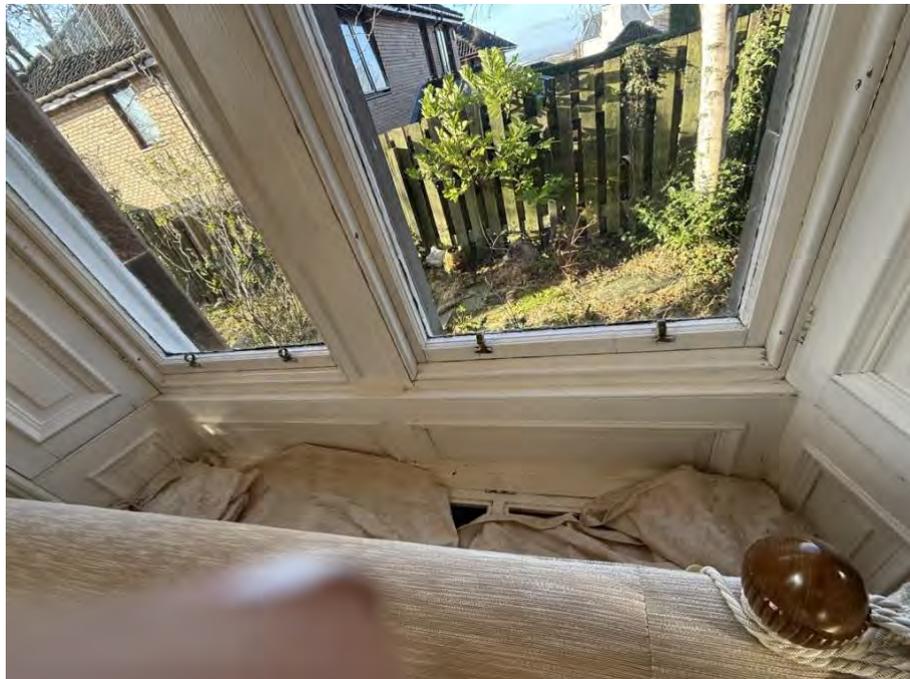
Photograph 56: Living room: sofa not fit for purpose and beyond useful life

- (42) The living room couch has a broken base and needs to be replaced.
 - (43) A selection of windows were tried and noted to be painted shut. Some have broken sashes and/or broken sash cords All windows in the House need to be overhauled so that they are in proper working order.

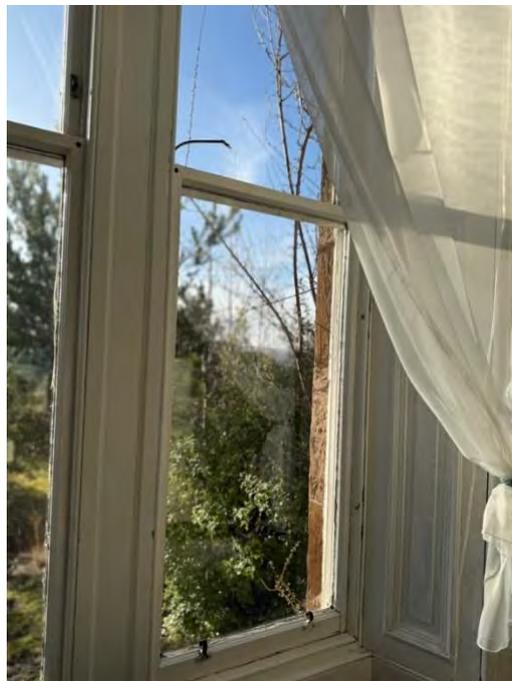
Photograph 60: Bedroom 1: Window shutter not opening

- (44) As above.
 - (45) Some window shutters in the larger bedroom did not open.
 - (46) Window glass was cracked in a few windows in the House. More notably in the bathroom and WC (front store).

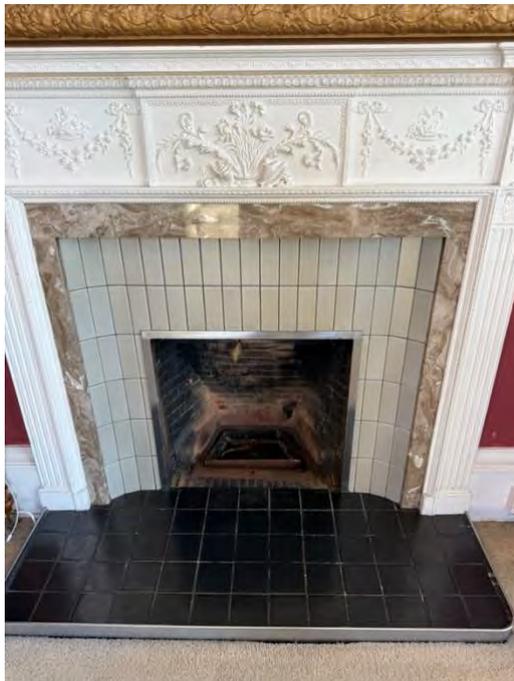
Photograph 64: Living room: Gas tap adjacent to open fireplace

- (47) Near the hearth of the living room fire there was the remains of a gas tap. This requires to be safety checked.
 - (48) There was noted to be missing sections of plumbing soil stack pipework above the back door which needs repaired or replaced.

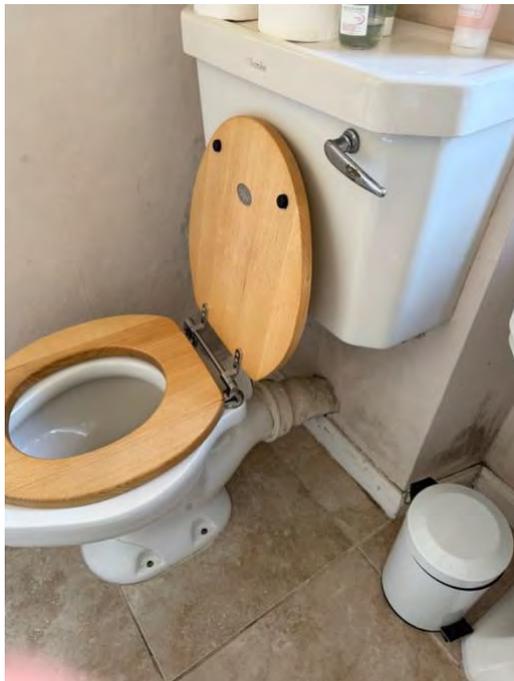
Photograph 70: Bathroom: mould to wall; higher than normal levels of moisture to wall
