STATEMENT OF DECISION: Housing (Scotland) Act 2006 Section 24 (1)

Chamber Ref: FTS/HPC/RP/19/3806

Flat1, 27 South Street, Dalkeith, Midlothian EH22 1AH

Photograph Schedule

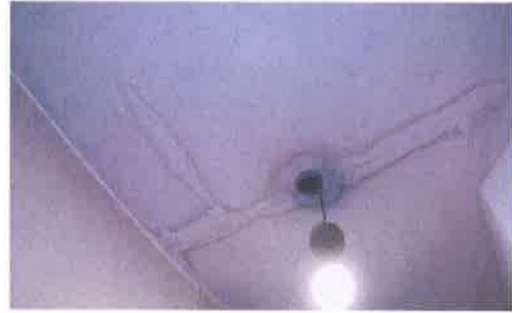
(c) The ceiling in the hallway is marked by water staining around the light fitting. The water staining is old, it was caused by a leak from the flat upstairs, which was fixed years ago and has clearly dried out.

(f) The light pendant in the hall is loose and the wiring exposed. The ceiling surrounding the light pendant is still water stained because there was a leak from the property upstairs some time ago. The water damage has dried completely, so that only staining is left.

Photo 3 – Exposed wires + water staining in hall

(a) Repair and replace light fittings in the bathroom, kitchen and hall

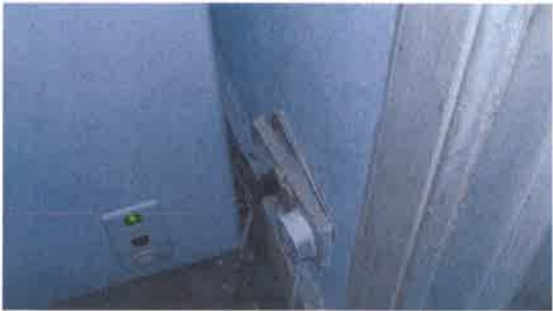
(d) Just above the skirting board in the hallway, adjacent to the bathroom door, there is a double electrical socket. The socket works, but the casing has come loose and hangs away from the wall.

(b) Tribunal members gathered in the hall of the property and could immediately see that a double electrical socket on the wall (just above skirting board level) adjacent to the bathroom was hanging off the wall. The socket was in use. An extension cable was plugged into the socket. That extension cable snaked into the bathroom to provide an electricity outlet lying behind the WC pedestal. The Tribunal observed that a garage/workshop style space heater was plugged into the extension cable to provide heating in the bathroom as an alternative to the radiator which no longer worked. The Tribunal further observed the close proximity of the extension cable and multi point socket to the bath and shower unit, and considered this to be unsuitable and dangerous.

Photo 4 – Damaged double socket in hallway

(b) Carry out all remedial works to the electrical system and then instruct an Electrical Installation Condition Report (EICR) and Portable Appliance Test (PAT) on the entire electrical installation of the property and all electrical appliances and equipment supplied by the landlord to be carried out by a suitably qualified and registered SELECT or NICEIC electrical contractor. Carry out works to rectify any identified issues in these reports and provide the First-tier Tribunal for Scotland (HPC) with an unqualified report from a suitably qualified and registered SELECT or NICEIC electrical contractor confirming the works are completed.

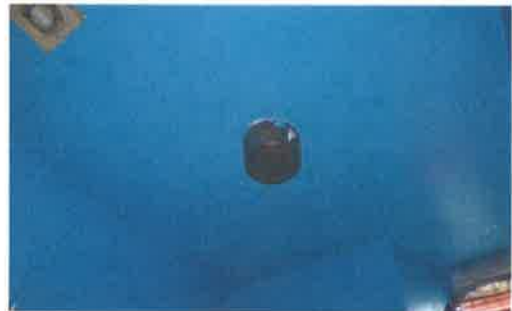
(e) The bathroom has a central ceiling light. That light fitting needs a replacement light bulb. The light in the bathroom would work if the light bulb was replaced. The Tribunal noted however that the ceiling light is of an inappropriate design for such an environment.

(c) Tribunal members noted the inappropriate light fitting located above the bath unit. The tenant told tribunal members that the light fitting worked, but the bulb needs to be replaced.

Photo 5 – Ceiling light fitting in bathroom

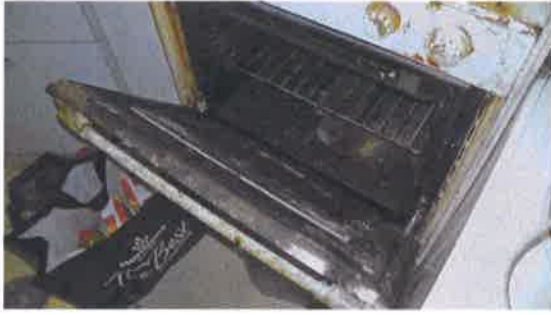
(e) The kitchen has fitted units which house an electric oven and gas hob. Both are filthy and past their useful life. The electric oven does not work. The

door of the oven is faulty. The oven and hob were so demonstrative of neglect that tribunal members are concerned about the state of the electrical and gas connections (which could not be viewed) behind the oven. There is still a supply of gas to the hob. In 2015 the applicant refused the respondent's offer to replace the oven and hob.

Photo 8 – Defunct oven in kitchen

(c) Remove and replace the hob and oven and then provide the First-tier Tribunal for Scotland (HPC) with a Gas Safety Record from a suitably qualified, and Gas Safe registered heating engineer on the safety of the gas central heating boiler and all other gas appliances in the property, &, if necessary, carry out any further repairs or replacement to ensure that all gas appliances are safe to use.

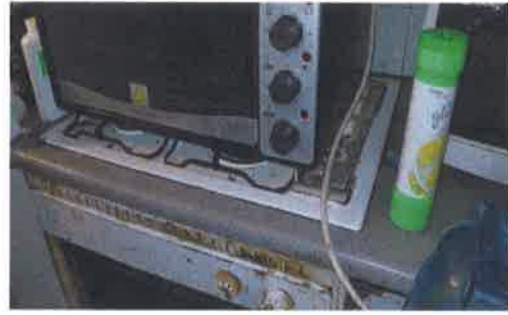
Photo 9 – Non serviceable gas hob above oven

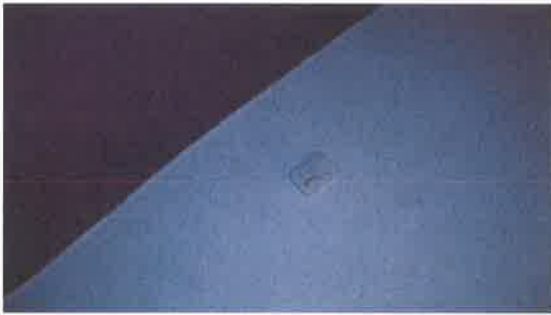
(g) There is no provision for heat detection anywhere in the property. There is a CO2 detector fixed to the ceiling of the living room in the property, and there is one defunct smoke detector on the ceiling in the hall way.

(i) There is no heat detector in the property There is a smoke alarm in the hallway, but it does not work. There is a CO2 detector in the Livingroom only, but it wasn't possible to test it. It wasn't possible to locate a CO2 detector in the kitchen.

Photo 10 – CO2 monitor on living room ceiling

(d) Ensure adequate provision of interconnected Smoke, heat and CO2 detectors within 7 days

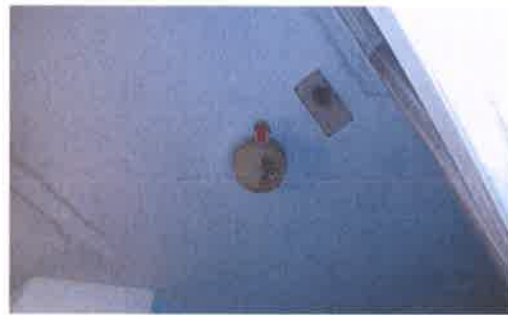
Photo 11 – Defunct smoke detector in hall way

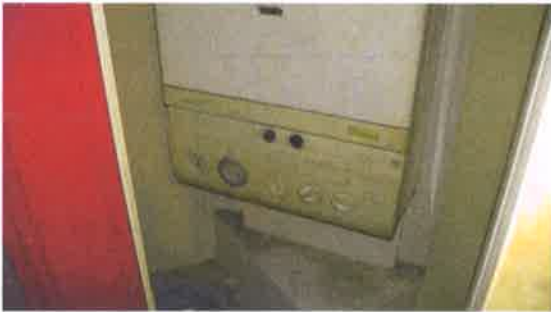
(h) The Living room has a cupboard which houses the central heating boiler. The handle to the boiler cupboard door is broken. It is very likely that the central heating boiler is inadequately ventilated. The property is littered with electrical adaptors and extension cables.

(j) The central heating boiler is located in a cupboard off the Livingroom. The door handle to that cupboard is broken,. The venting for the central heating boiler may be inadequate. The respondent believes that she has a current gas safety certificate.

Photo 12 – Gas boiler in living room cupboard

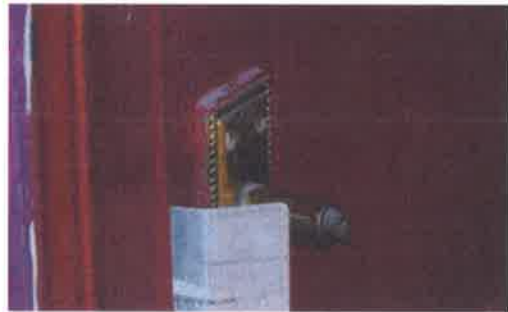
Photo 13 – Door handle into boiler cupboard

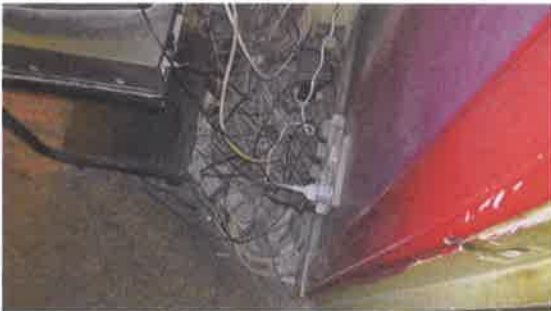
(g) The living room is cluttered with the tenants possessions. There are extension cables and seemingly over used power points throughout the living room leaving a tangle of wires throughout.

Photo 14 – Tangle of wiring, leads and extension cables

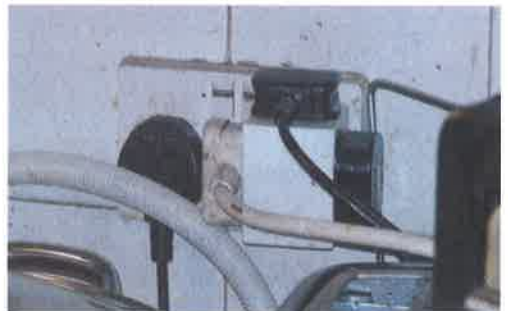
Photo 15 – Kitchen socket

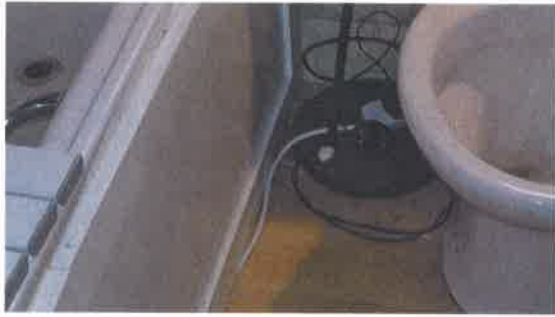
Photo 16 – Inappropriate power supply to bathroom
