**First-tier Tribunal for Scotland (Housing and Property Chamber)**

**STATEMENT OF DECISION: Housing (Scotland) Act 2006, Section 24(1)**

**Chamber Ref: FTS/HPC/RP/17/0043**

**Flat 16, 18 Simpson Loan, Edinburgh, EH3 9GB**  
**("The House")**

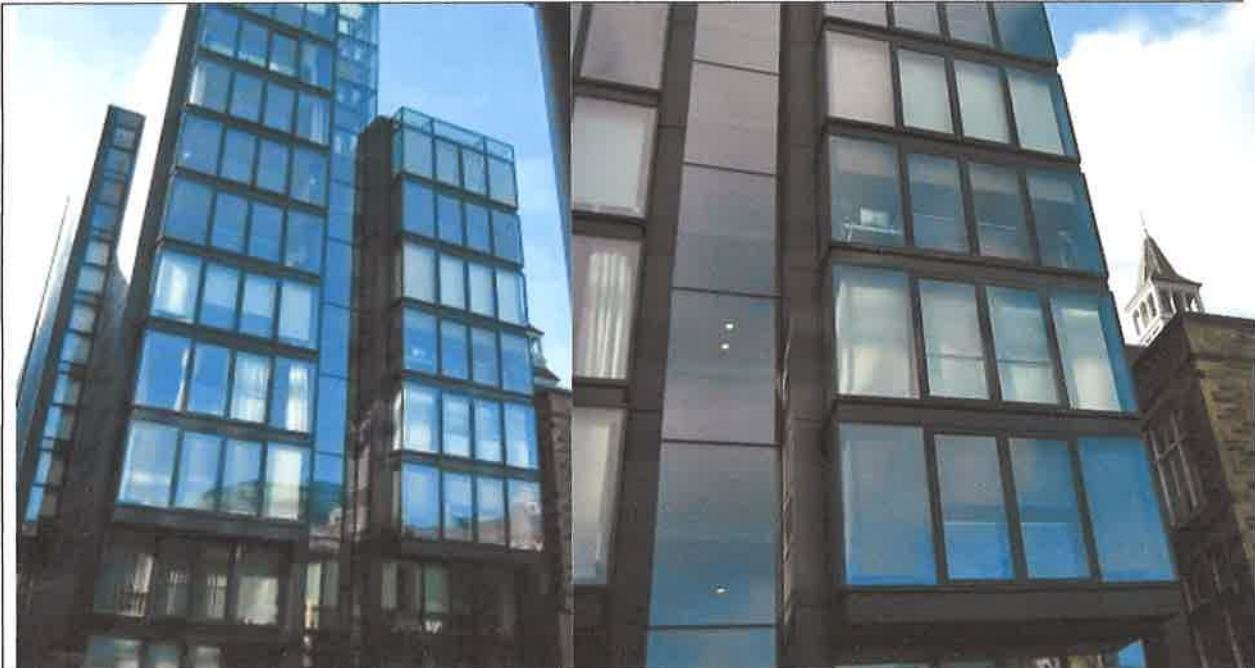
**Photo 1 – Exterior of property**

- 27.2. There are no other opening windows in the living area. (See *Schedule of photographs, no. 2 and 3*).
- 27.3. There is no means of allowing fresh air into the living area.

**Photo 2 – Exterior of flat ( with computer in window )**

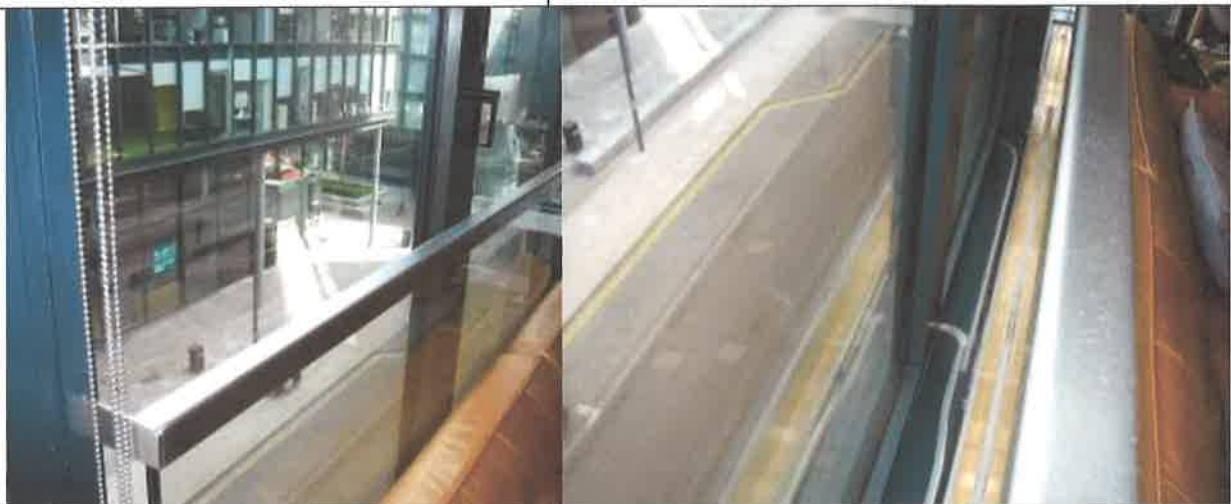
**Photo 3 – Internal glass safety balustrade**

- 27.4. The only window in the property is a window in the bedroom (See *Schedule of photographs, no. 8*).
- 27.5. The sliding door/window is designed to run on a track. (See *Schedule of photographs, no. 4*).

- 27.6. There is a permanent internal safety metal and glass balustrade which is attached to the metal window frame and prevents easy internal access to the lower part of the sliding door / window (See *Schedule of photographs, no. 3*).

**Photo 4 – Bottom track for door to open**

1. To repair or replace the sliding door/window and surrounding structures and mechanisms in the kitchen/dining/living area of the House to ensure that it is in proper working order and the house is reasonably fit for human habitation, in particular that the door/window can be safely and fully opened and closed.
2. To produce a report from a suitably qualified ventilation specialist to confirm that the installed ventilation system (including the boost function) in the House is in proper working order, has been maintained within the last six months in accordance with the manufacturer's guidelines and that the ducting is correctly and permanently connected to the fan unit in the ceiling area of the utility cupboard.

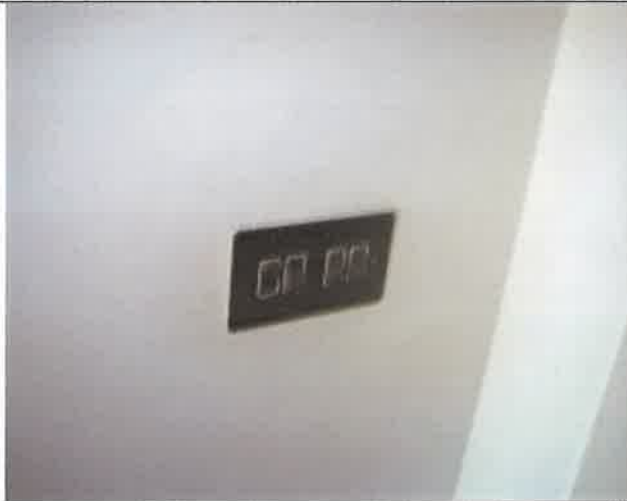
**Photo 5 – Booster switch (left) for fan**

- 27.12. There is a booster switch (the left hand switch on a panel of four) next to the kitchen area of the room. Pressing this is intended to increase the flow of the ventilation system. (See *Schedule of Photographs, no. 5*).

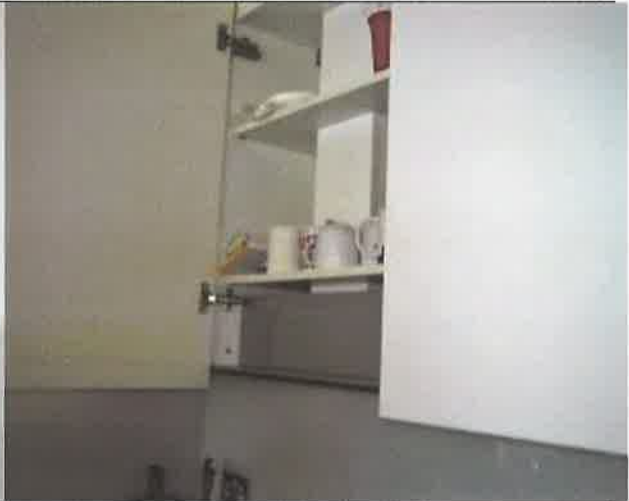
**Photo 6 – Kitchen extract**

- 27.10. There is access to piping through the bedroom. (See *Schedule of Photographs, no. 7*).
- 27.11. There is no standalone mechanical extractor fan in the kitchen area of the House. The unit above the hob appears to be part of the installed ventilation / extraction system in the property. (See *Schedule of photographs, no. 6*).

- 27.13. The ventilation /extraction openings in the House appear to be: (i) the cavity in the unit above the hob (See *Schedule of Photographs, no 6*.) and (ii) above the mirrored cabinet in the bathroom (See *Schedule of Photographs, No 9*).
