Housing and Property Chamber First-tier Tribunal for Scotland

Statement of Decision of the First -tier Tribunal for Scotland (Housing and Property Chamber) (“the Tribunal”) under section 24 (1) of the Housing (Scotland) Act 2006 (“the Act”) issued under the First-tier Tribunal for Scotland (Housing and Property Chamber) (Procedure) Regulations 2017 (“the regulations”)

Chamber Ref: FTS/HPC/RP/19/3193

Property: 5 Sunnyside Place, Barrhead, Glasgow, G78 2RT (“the property”)

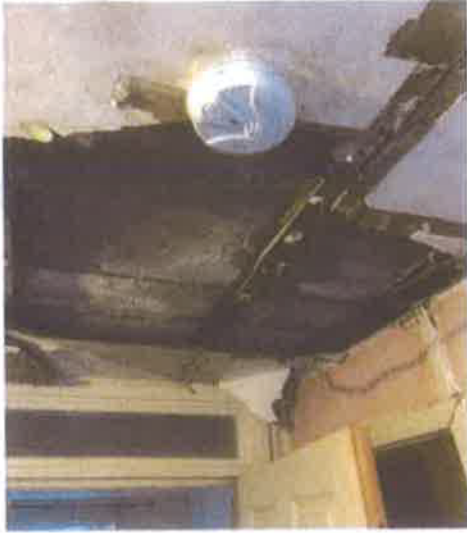
Photo 2 – Water damaged kitchen ceiling

- *To repair or replace the installations in the house for the supply and heating of water to ensure that there is an adequate supply of hot water in the property.*
- *To repair or replace as necessary all windows to ensure that they are wind and water tight.*
- *To repair or replace as necessary the internal doors at the living room, kitchen, bathroom and bedroom 1 to ensure that they are in a reasonable state of repair and in proper working order.*
- *To have a suitably qualified expert investigate the source of the dampness throughout the property and to produce a report showing findings.*
- *To produce an Electrical Installation Condition Report ("EICR") from a registered member of SELECT or NICEIC post dating this order.*
- *To repair or replace as necessary the ceiling in the kitchen and kitchen cupboard ensuring that the ceiling is dry.*

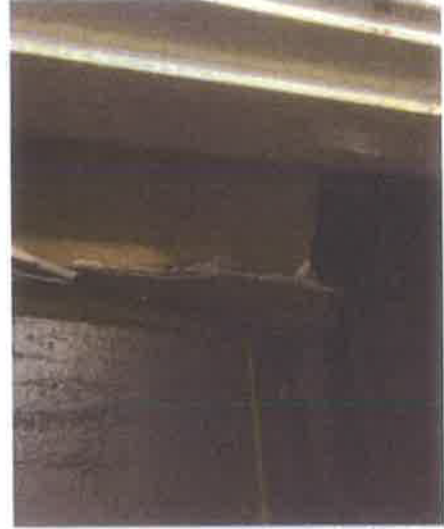
Photo 3 – Damaged cupboard ceiling

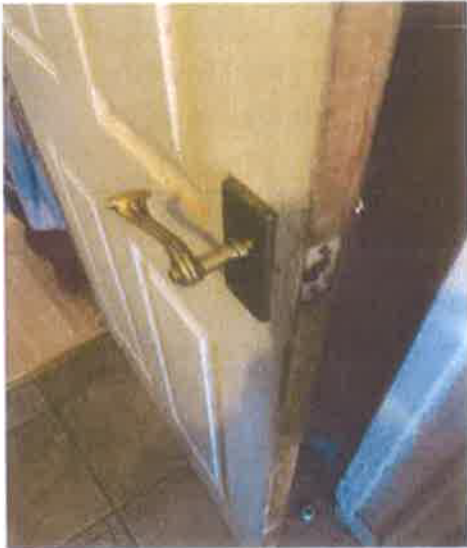
Photo 4 – Defective kitchen door

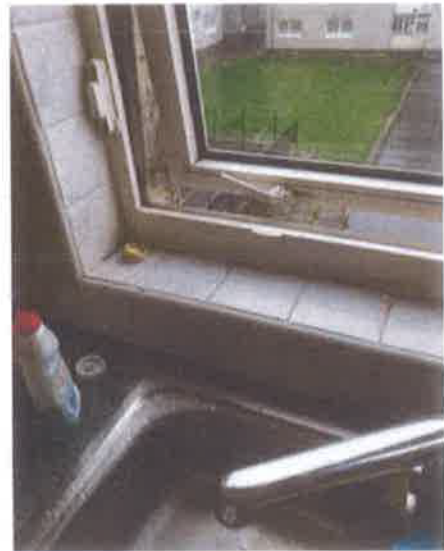
Photo 5 – Dampness below tiles

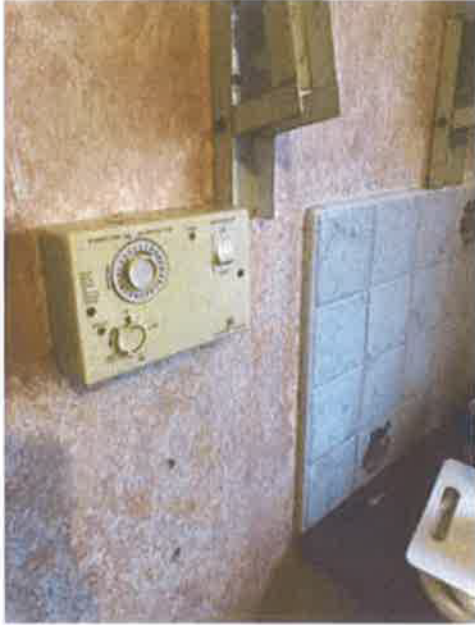
11. In the course of the inspection, the Tribunal identified the following:
12. **Kitchen.** There was no hot water in the kitchen. The control panel for the immersion heater was attached to the kitchen wall. It wasn't clear if the unit was functioning correctly. The door leading into the kitchen did not close properly as the snib was missing and the handle broken. The kitchen window is positioned behind the sink. The surveyor obtained below-surface dampness readings from beneath the tiles around the window opening. High levels of dampness were obtained. A large hole was evident both in the ceiling of the kitchen and within the hot water cylinder cupboard, the result of water damage from a flood from the property above. Photographs from the inspection (attached to this decision) illustrate the extent of the damage.

Photo 6 – Immersion heater for water cylinder

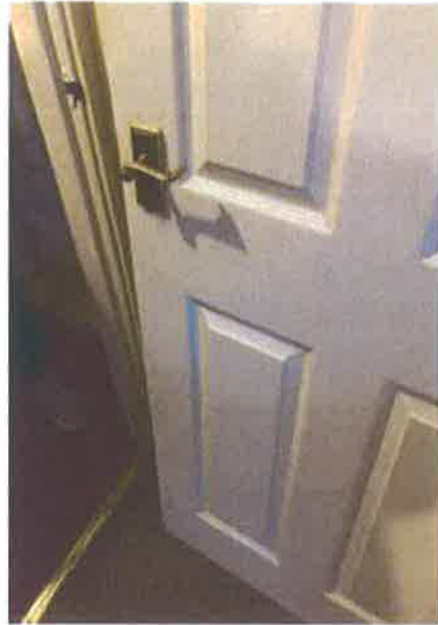
14. **Bedroom 1 facing to the front of the building.** The door which led from the hallway into the bedroom had broken from its hinges and was leaning against the bedroom wall. Black mould spores were evident on the wall to either side and below the window. Surface readings were taken from below the window showing notable levels of dampness. The surveyor identified condensation related mould on the bottom of the wall of the bedroom at the right hand side of the window. The window sill was damp with condensation.

Photo 7 – Broken bedroom door

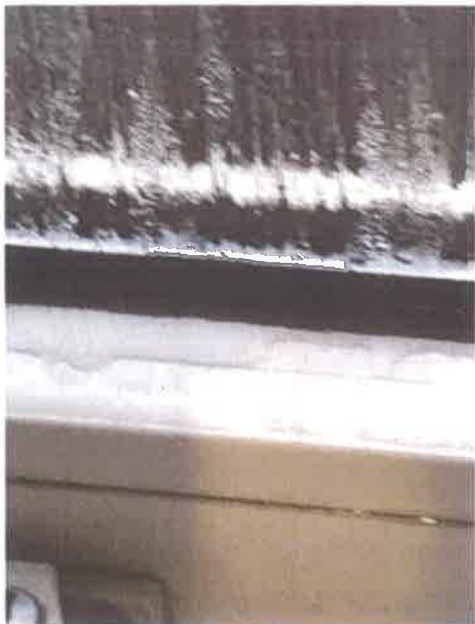
13. **Living room.** The window is positioned on the front elevation, and was closed. The trickle vents were closed. The surveyor was unable to open the trickle vents. Condensation related pools of water were formed on all window sills. The living room walls were checked for dampness and high dampness readings were obtained from a section of wall between the left hand side of the window and the gable wall. The handle on the door between the living room and the hallway was loose and not working properly. An electric heater was positioned in the living room which provided the main source of heat to the room. Electric panel radiators were attached to the wall below the window were not in use by the tenant. The tenant said that when switched on the heater would produce smoke. It was also stated by the tenant that activating the electric wall heater in conjunction with the shower unit, hot water

Photo 8 – Condensation on windows

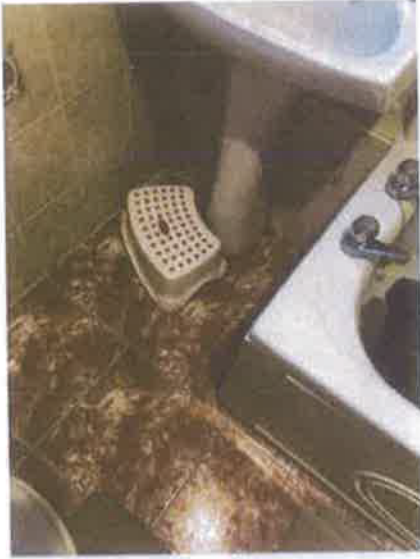
28. The surveyor commented that the surface of the bathroom floor was wet to touch on inspection. The surveyor also explained that his damp meter, on a different setting, had recorded readings of dampness beneath the floor's surface and noted that these dampness reading diminished closer to the side of the bath unit. The tenant advised that the bathroom floor was 'permanently' wet.

Photo 10 – Below surface dampness on floor

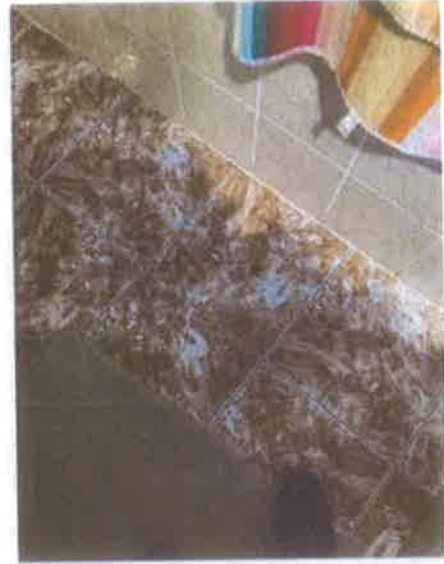
Photo 11 – Dampness beneath floor tiles

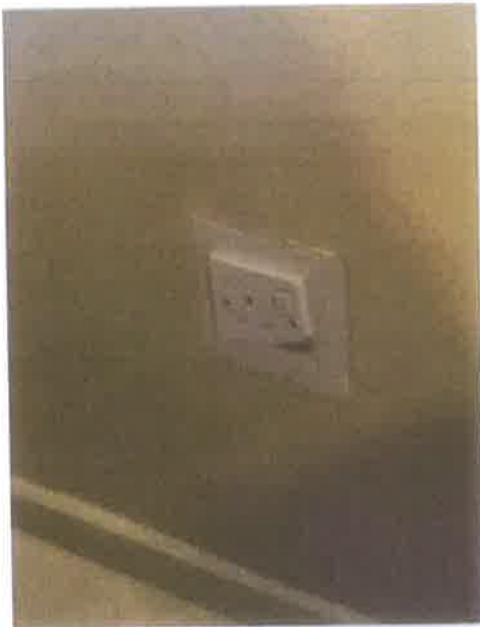
Photo 12 – Broken socket in Living Room

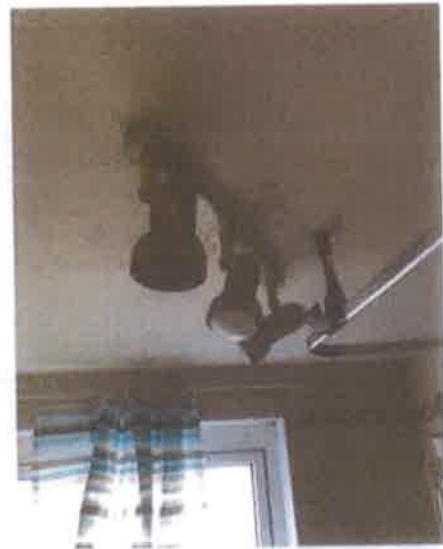
39. The surveyor highlighted to the letting agent that he had observed that the light fitting in the bathroom was inappropriate for its operating environment, and that the security entry system in the property, insofar as it can control access through the main door of the building is not functioning. The surveyor accepted that these did not form part of the application but shared these observations with Ms Wylie as she had been absent at the inspection. Again, Ms Wylie undertook to look into these matters although she highlighted that the security entry system may be a communal issue at the building. In the absence of a factor, her experience that issues with common property can prove difficult to address.

Photo 13 – Bathroom light fitting

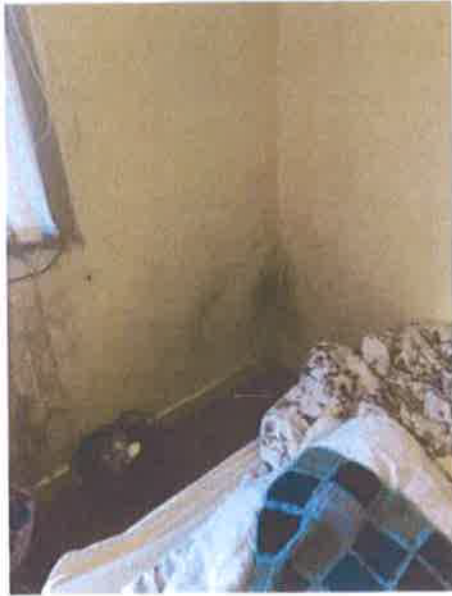
Photo 14 – Mould on wall in front bedroom

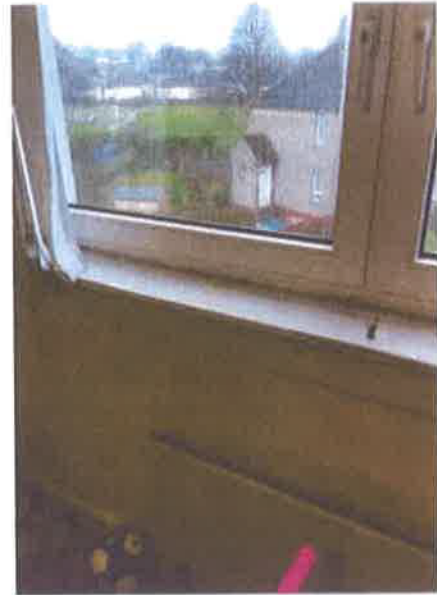
Photo 15 – More mould in same room
