First-tier Tribunal for Scotland (Housing and Property Chamber)

Determination: Housing (Scotland) Act 2006: Section 27

Chamber Ref: FTS/HPC/RP/23/0037

38 Ross Drive, Uddingston, G71 5NQ registered in the Land Register of Scotland under title number LAN84303 (“the Property”)

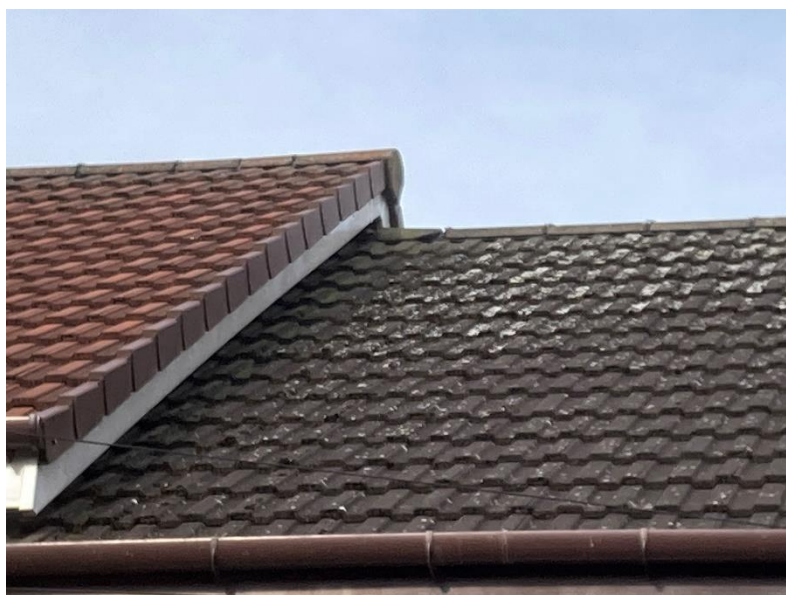
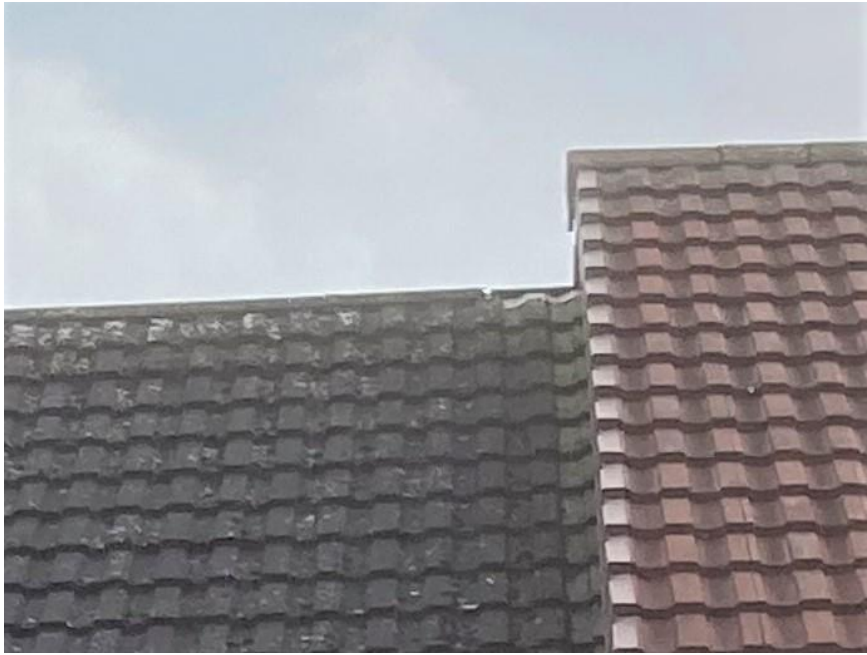
2&3

13. Externally there is a defective/slipped ridge roof tile which has contributed to significant water ingress within the attic, resulting in a collapse of the ceiling plaster exposing fibreglass insulation quilt and a PVC lining. Much of the remaining plasterboard within the attic is saturated.

- 22.8 There is a defective/slipped ridge tile.
- 22.9 There is evidence of significant water ingress in the attic as a result of a defect in the roof covering and some ceiling plaster has collapsed with other areas of ceiling plaster being saturated.

2. Rear roof pitch and ridge defective/slipped ridge tile

3. Front roof pitch and defective/slipped ridge tile.

Defective ridge tile as viewed from front and rear- likely source of penetrating damp in attic.

- 4. investigate and repair the defective roof covering ensuring that it is wind and watertight and in a reasonable state of repair.**
- 5. repair and renew where necessary the plasterboard ceiling panels in the attic space.**

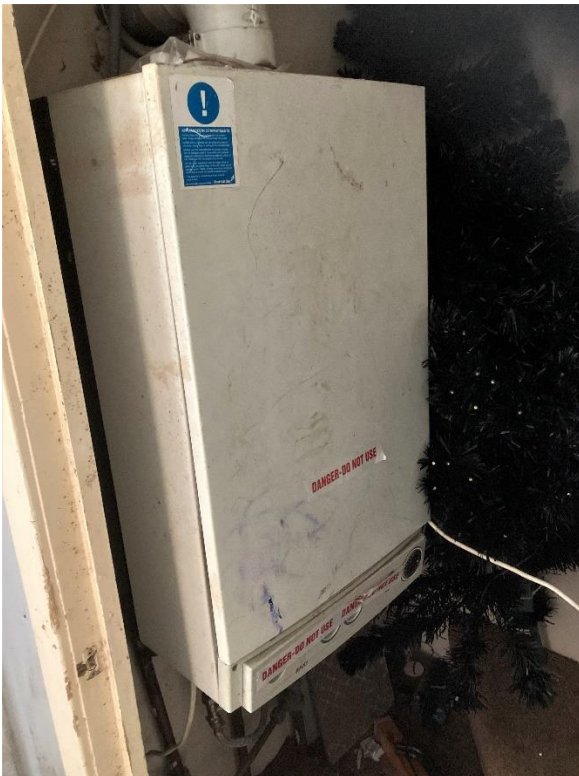
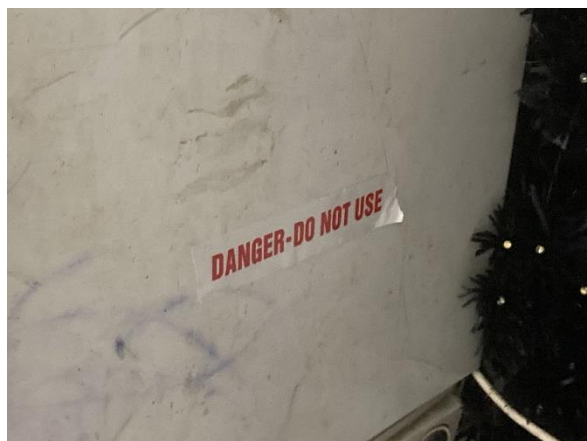
4&5

16. There is a wall mounted gas fired combination boiler in the front bedroom cupboard. Following a recent gas safety inspection, it was classed as dangerous and a "Danger do not use" certificate attached. The gas supply was very recently capped at the meter although it is understood that the boiler had not been in use for a period of time prior to the gas safety check.

- 22.3 There is no current gas safety certificate.
- 22.4 The central heating boiler is not functional and there is no heating or hot water in the Property.

4. Wall mounted gas boiler

5. Gas boiler front casing

Wall mounted gas boiler at base of stairs leading to floored attic with a fixed warning "Danger do not use notice" attached, following a gas safety inspection dated 8 March 2023.

- 3. renew or replace the central heating boiler ensuring that it is in a reasonable state of repair and in proper working order and capable of supplying a permanent supply of hot water and a satisfactory system of space heating throughout the Property.**

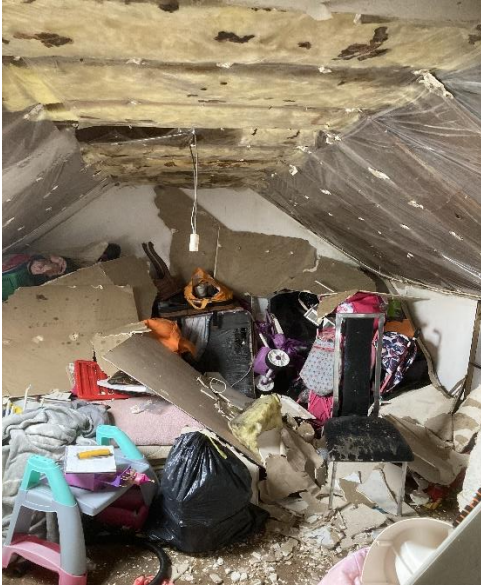
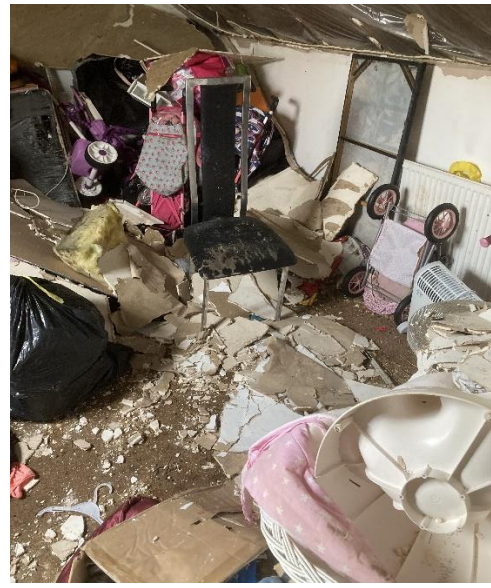
6&7

6. Floored & "lined" attic

7. Floored and lined attic

Collapsed plasterboard "ceiling lining" exposing fibreglass insulation quilt and supporting PVC lining

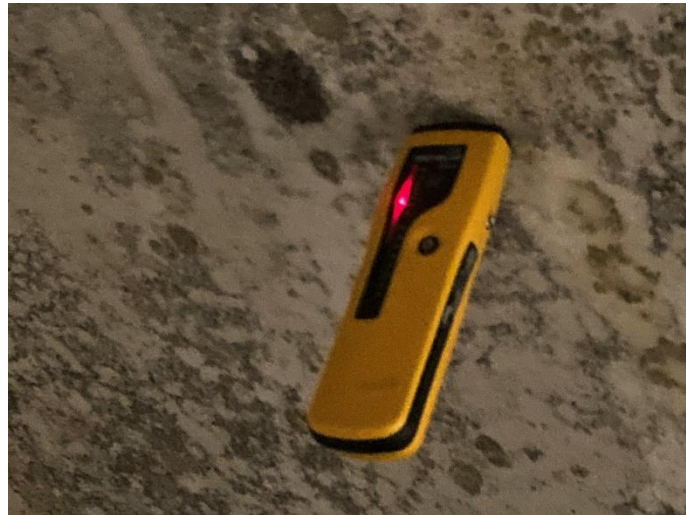
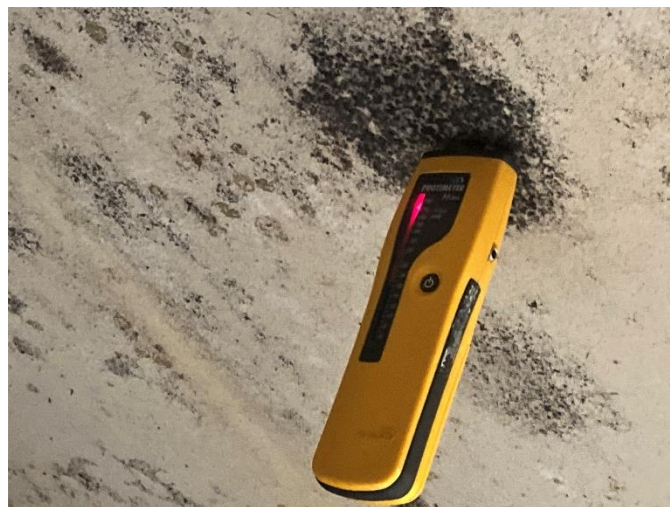
8&9

8. Damp "ceiling plaster" in attic

9. Damp "ceiling plaster" in attic

Positive damp readings in remaining ceiling plaster within the attic confirming a high damp content arising from water ingress through the roof

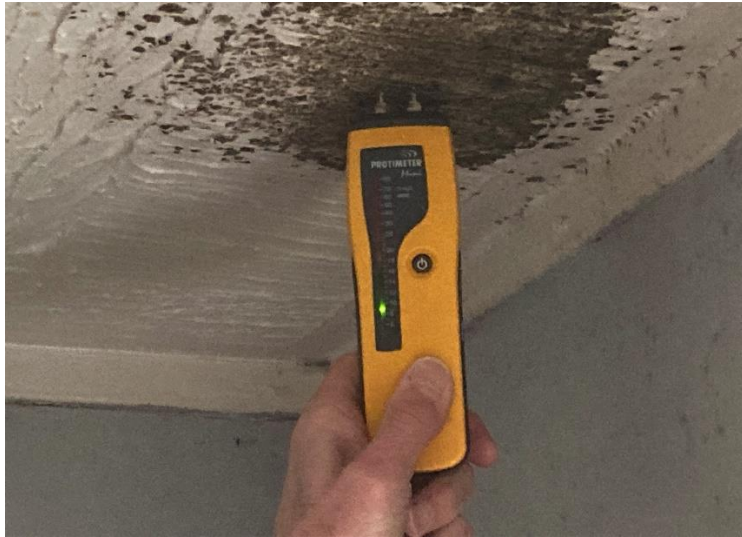
10

10. Staining (dry) front bedroom ceiling

Historic damp staining at front bedroom ceiling, dry at date of inspection. Original source not clear.

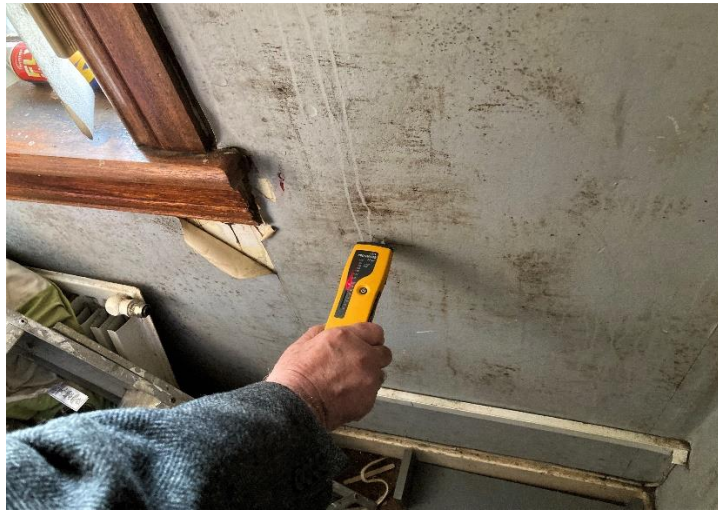
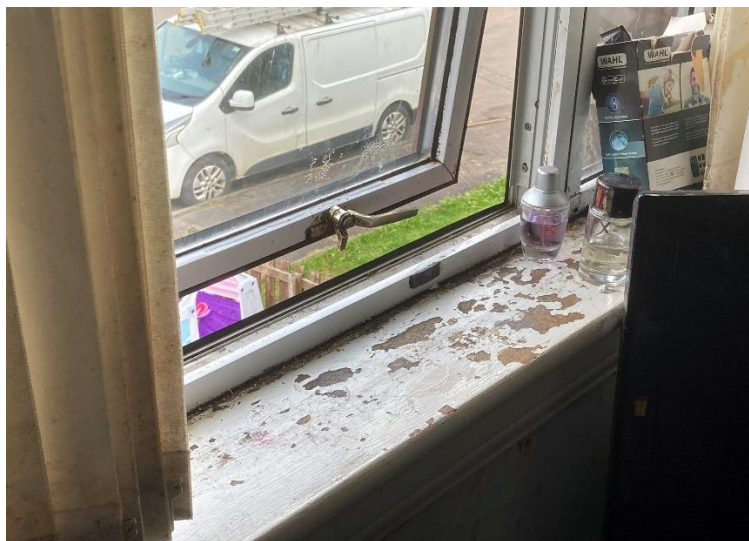
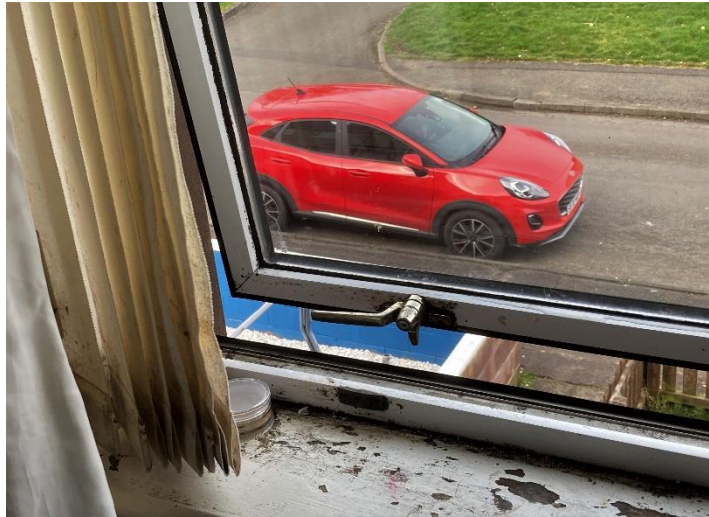
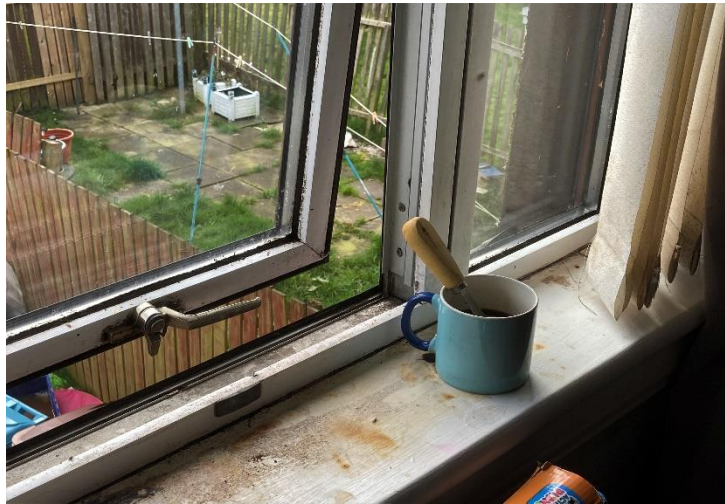
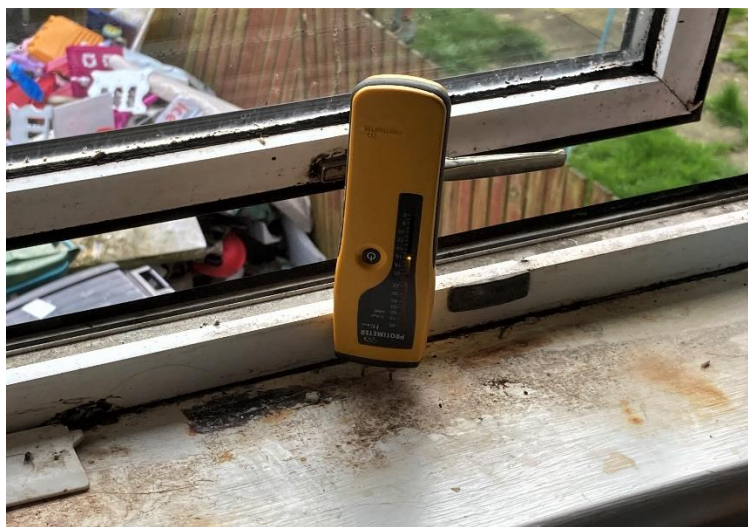
11-15

11. Damp wall plaster front bedroom

12. Condensation at front bedroom window

13. Condensation at front bedroom window

14. Condensation at rear bedroom window

15. "Amber" damp reading at condensation stain rear bedroom

Condensation staining in walls and window sills in first floor bedrooms.

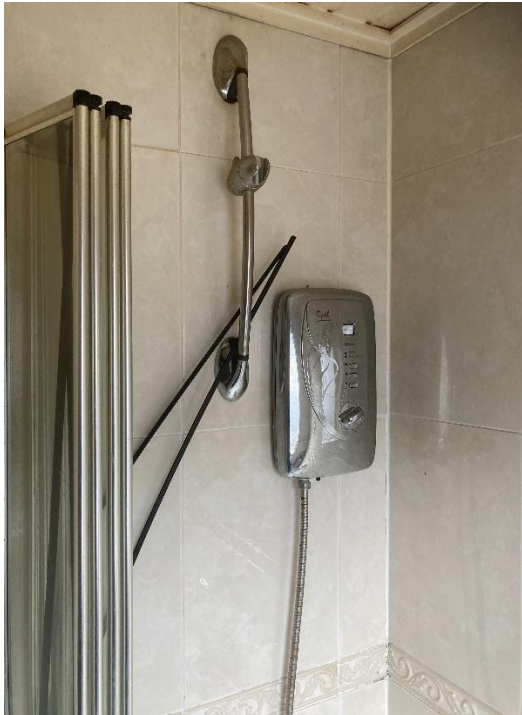
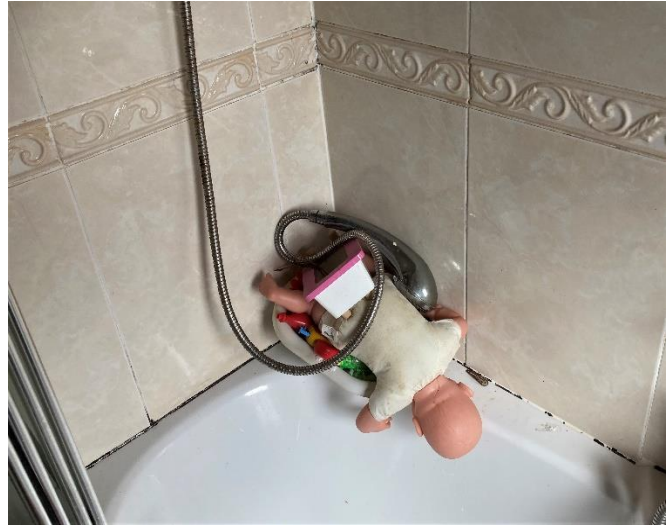
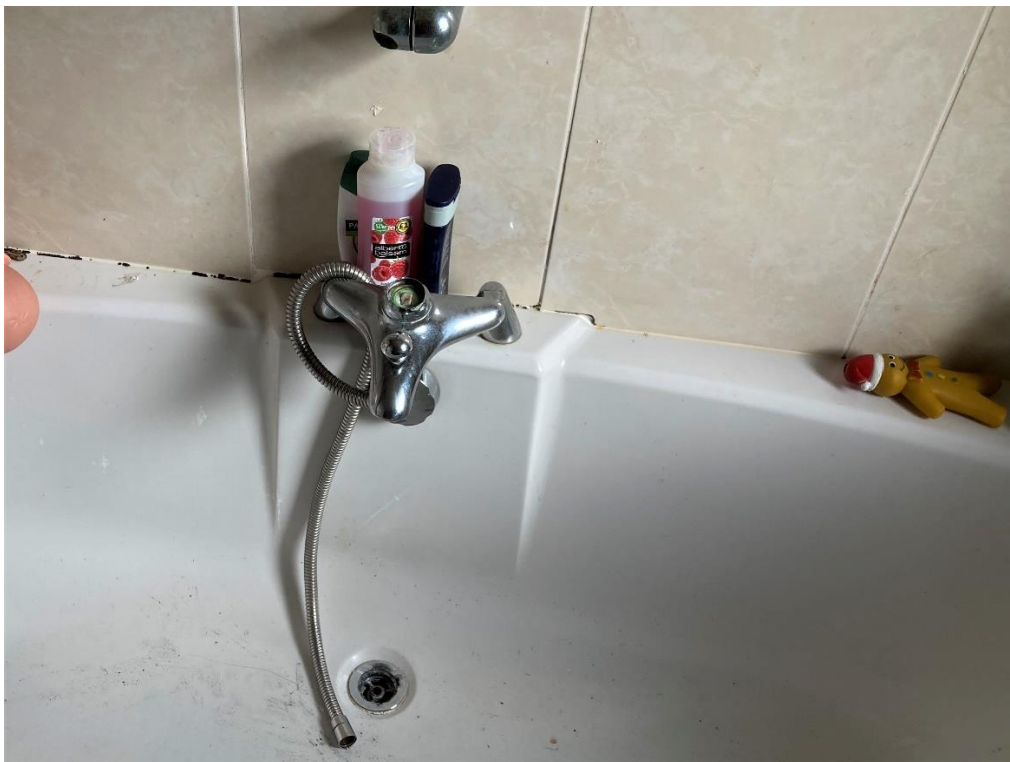
16-18

18. The electric shower fitting is broken as are the mixer taps and handheld shower at the bath.
19. On the external face of the front elevation, immediately below the expansion pipe leading from the boiler there is residual staining affecting the rendering, the mono pitched tile roof projection below and the associated lead flashing.

Broken electric shower and shower head attachment

18. Broken mixer tap and "hand held" shower attachment

Broken and defective electric wall mounted shower above bath and broken/missing hand held shower attachment connected to broken mixer tap.

- 7. repair or renew the electric shower, bath taps and hand held shower attachment to ensure that they are in effective working order.**

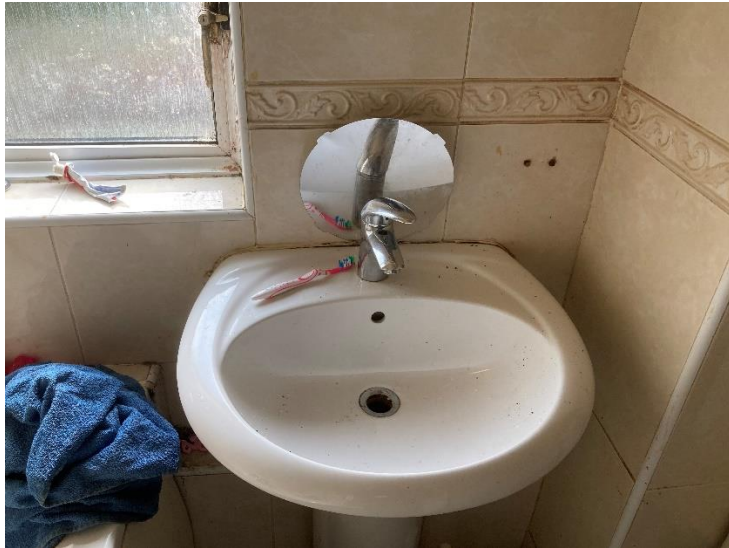
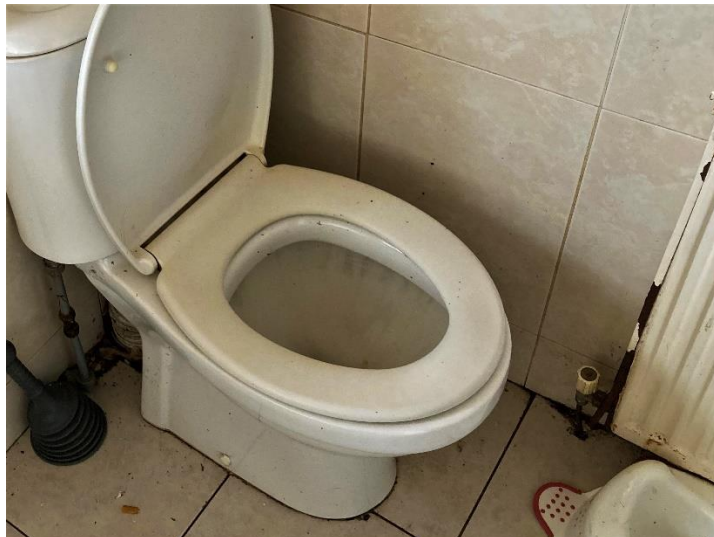
19&20

19. Condensation around wash hand basin and bathroom window

20. damp around base of wc and corroded radiator

Condensation around window frame and wc in bathroom contributing to significant corrosion at radiator.

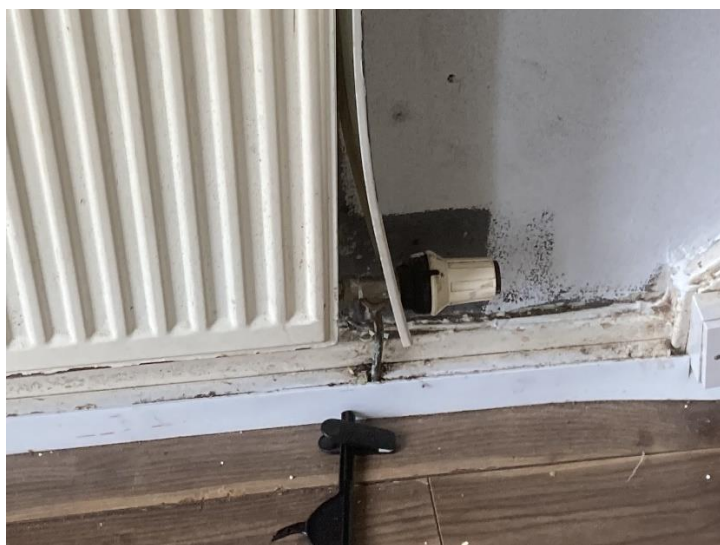
21

21. Broken radiator panel and condensation staining in hall

Condensation staining at skirting level at entrance hall and defective/broken panel at radiator.

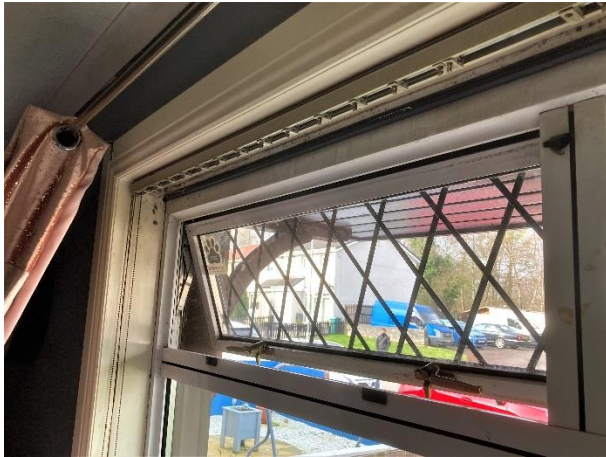
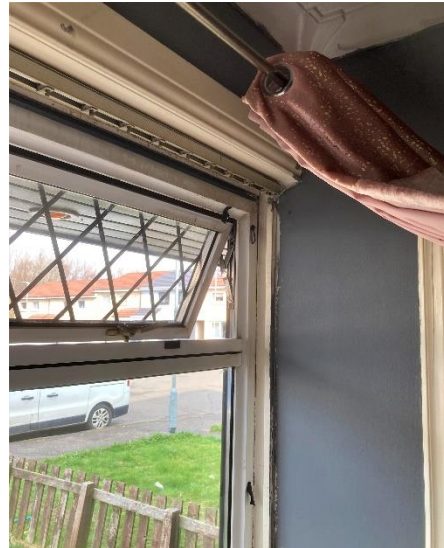
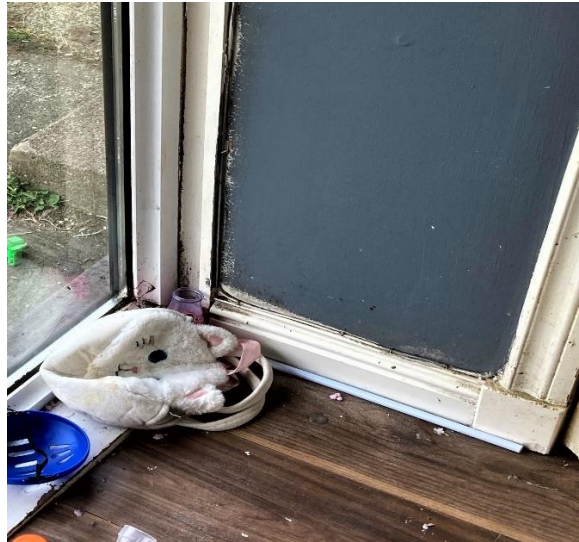
22-24.

Condensation - livingroom window

24 Condensation at skirting board and base of livingroom window

Condensation around and above front facing "picture window" in living room and at skirting level on internal wall.

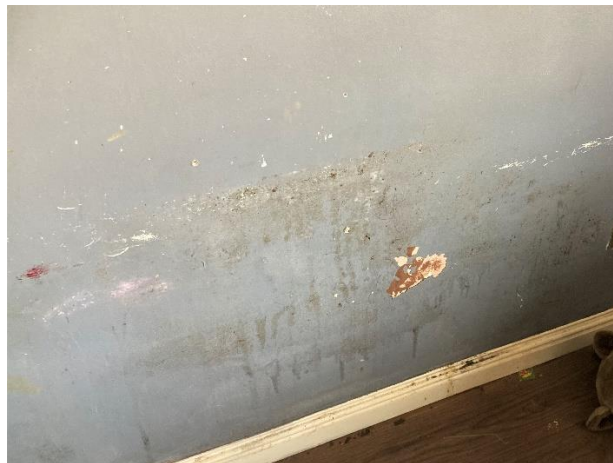
25. "Spillage staining" (DRY) in mutual living room/external pend wall

Staining on the inner face of the mutual wall with the external pend (see also photograph 28). No evidence of damp at this location and most likely cause appears to be a "spillage" accident.

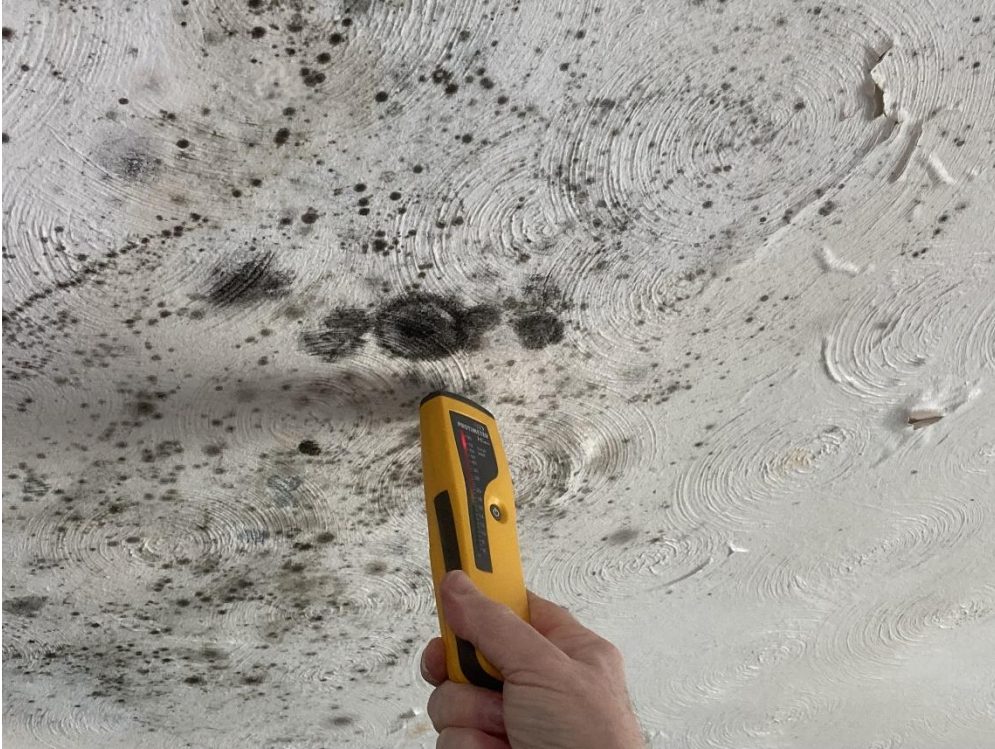
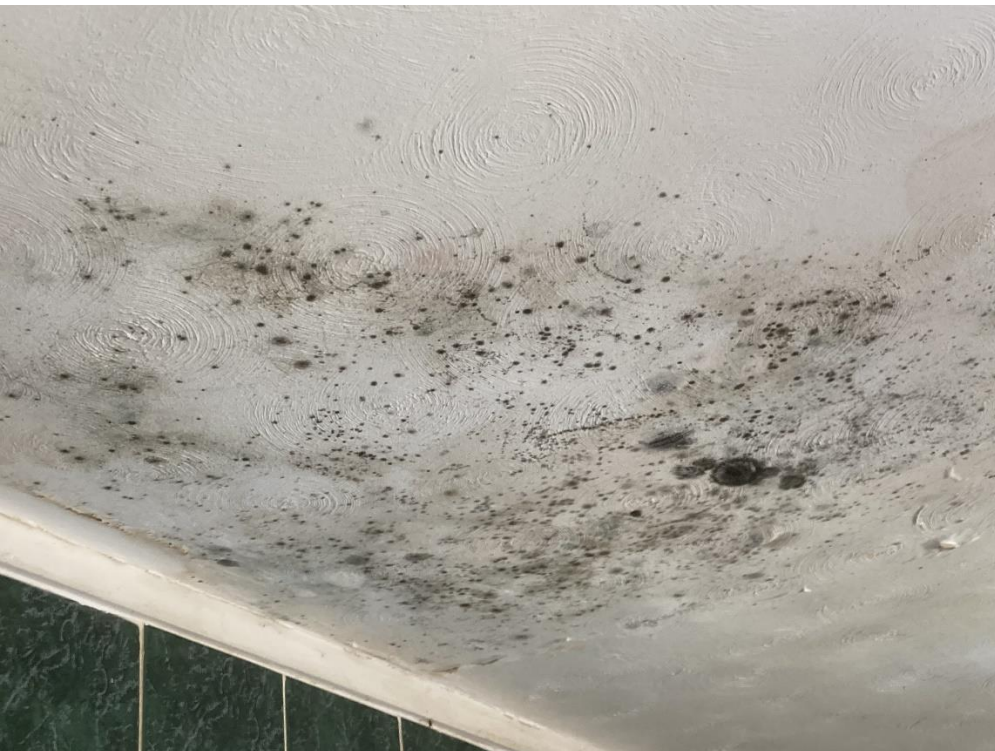
26&27

14. Throughout the property there is significant evidence of the effects of condensation with visible staining and mould growth.
15. At the kitchen ceiling there is significant mould and the corresponding high moisture readings confirmed localised saturation, which almost certainly stems from the first floor bathroom which is located immediately above.

26. High damp readings in kitchen ceiling below bathroom

27. Damp staining kitchen ceiling below bathroom

Positive damp readings confirming high levels of moisture in the kitchen ceiling, directly below the first floor bathroom and the likely source.

- 6. investigate and repair the cause of the water ingress to the kitchen ceiling and thereafter repair the ceiling and make good the décor as required.**

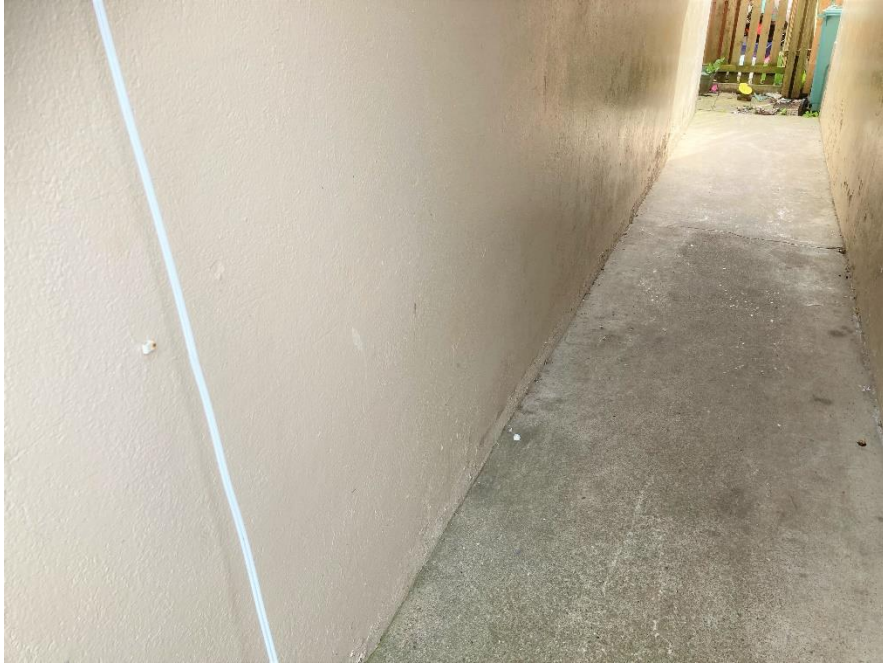
28.

28 Flaking paint and general staining pend wall – no significant defects evident

The inner walls of the pend access leading to the rear garden. No obvious defects noted other than minor wear, staining and some flaking paintwork.

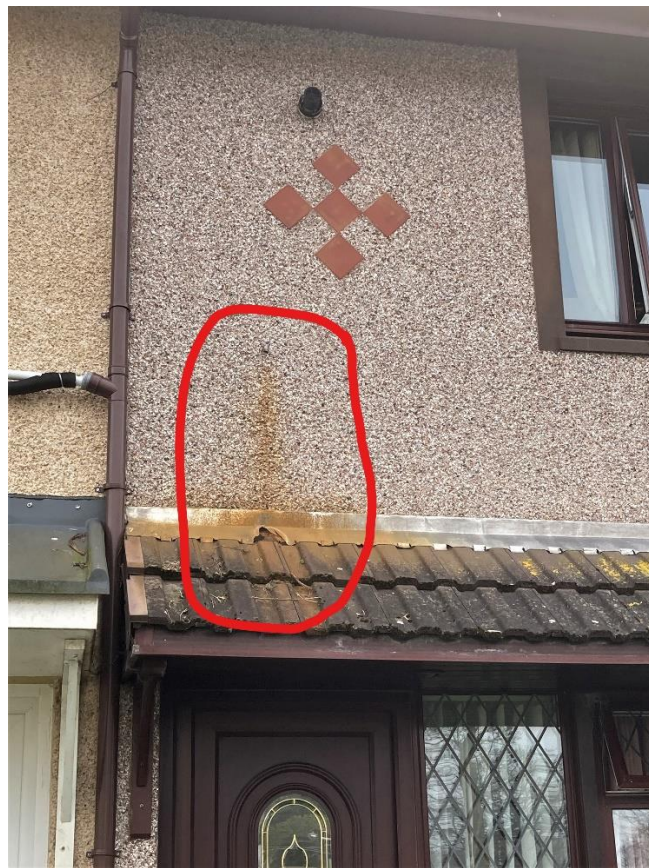
29.

29 Residual staining below overflow pipe from boiler

Staining on the rendering and ground floor overhang tiles, below the expansion pipe at the now disused and broken boiler.
