Repairing Standard Enforcement Order

Reference PRHP/RP/15/0147

RE: Property at 5 Burnfoot Avenue, Barrassie, Troon KA10 6RF being the subjects more particularly described in Land Certificate Title Number AYR84275 (hereinafter referred to as "the house")

Schedule of photographs taken at the inspection on 1st July 2015

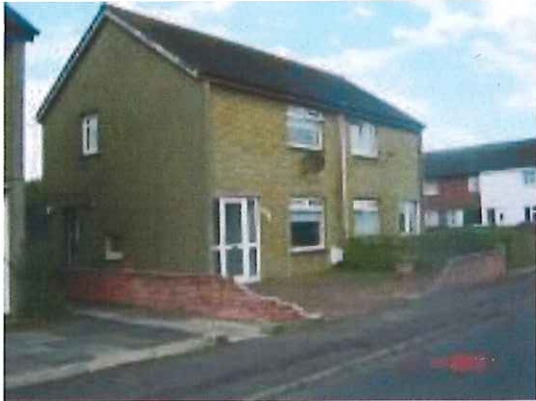
PHOTO 1.

- (a) The boundary wall to the front of the house bounding the pavement and the dividing wall at the front between the house and next door property are in disrepair. The walls are constructed of single brick with a coping at the top. Sections of both walls have collapsed. The brickwork from the section of collapsed walls has been removed but rubble and mortar remains (photo 1).

Front elevation and boundary walls

- (g) *To employ a plumber to sink the rodding eye into the ground so that it is flush with the garden ground level.*
- (h) *To reinstate the front and side boundary walls.*

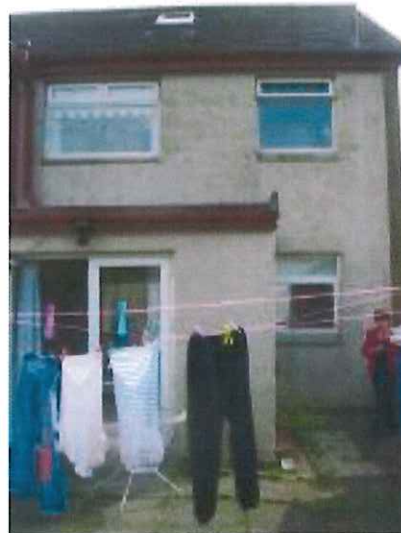
PHOTO 3

- (b) The external wall light next to the front door is damaged. It is sitting at an angle and is held in place by exposed wires (photo 2).
- (c) There is an extension to the rear of the house (photo 3).

Rear elevation

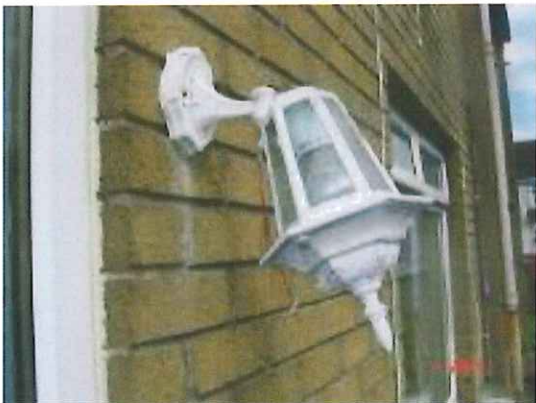
PHOTO 2

Wall light on front wall

- (a) *To arrange for an inspection of all aspects of the electrical wiring at the house including an inspection of the fittings and appliances provided by the Landlord, said inspection is to be carried out by a SELECT or NICEIC Registered Electrical Engineer; and following that inspection, an electrical inspection report requires to be prepared and submitted to the private Rented Housing Committee; If works are identified as required in terms of that report, then these works require to be undertaken and certified as satisfactorily completed by the Registered Engineer and the Landlord is required to provide certification to confirm this from a SELECT or NICEIC Registered Engineer acceptable to the Committee.*

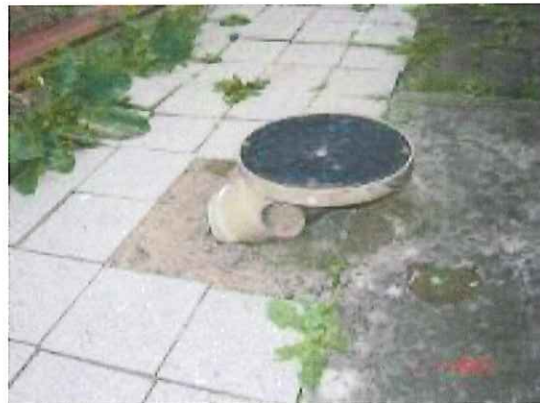
PHOTO 4

- (d) Adjacent to the rear extension, a rodding eye located in the garden area is sitting proud by about five inches from ground level and is a trip hazard (photo 4).

Rodding eye

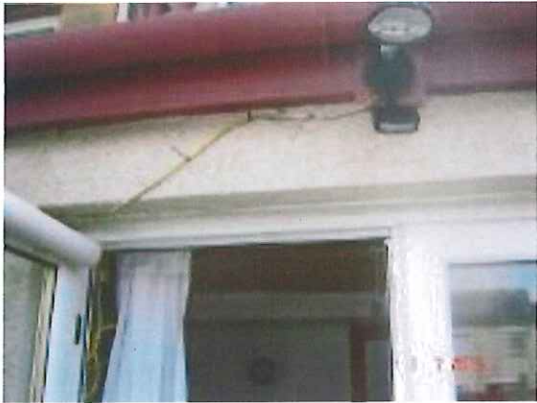
PHOTO 5

- (e) The external light on the rear extension above the patio doors has exposed wires (photo 5).
- (f) The guttering and downpipe at the rear extension is not connected (photo 6). From paperwork submitted to the Committee it appears that this item has not been notified to the Landlord.

Light and wiring at extension

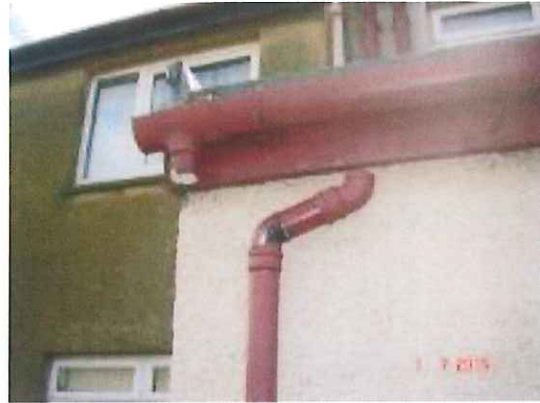
PHOTO 6

Gutter/downpipe at ext.

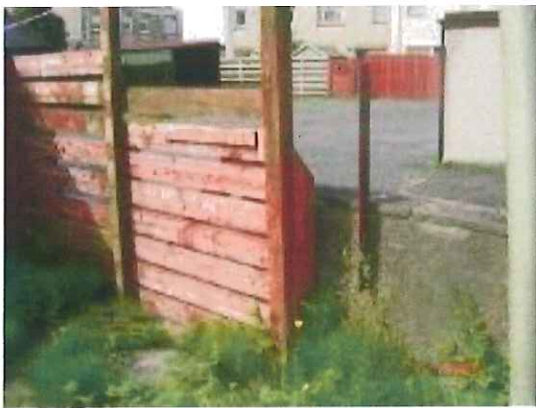
- (g) The rear garden fence has a slat missing, a metal strut is in place but there is no fence and there is no access through the gate (photo 7).
- (h) The timber garage wall is bulging and sections of the wood are rotten (photo 8). The garage door is constructed of grey asbestos and is crumbling (photo 9). The timber around the perspex window is rotten and the structure and roof of the garage is in poor condition (photo 10).

Rear garden fence - PHOTO 7

- (f) *To repair the fencing and the gate opening to ensure that it is constructed to a uniform style of uniform materials and finish and to ensure that it is in a reasonable state of repair and proper working order.*

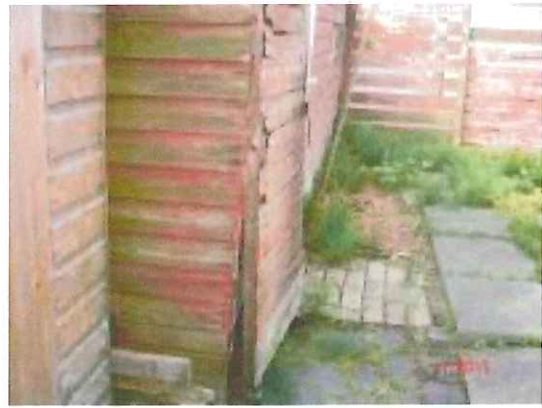
Garage wall - PHOTO - 8

- (e) *To remove and replace the garage which is at risk of collapse and is beyond economic repair. The replacement structure should be capable of housing a car. To remove the asbestos door of the garage using the services of a competent contractor who is licensed under the Waste Management Regulations who will dispose of the door and a receipt to confirm this is to be submitted to the Committee.*

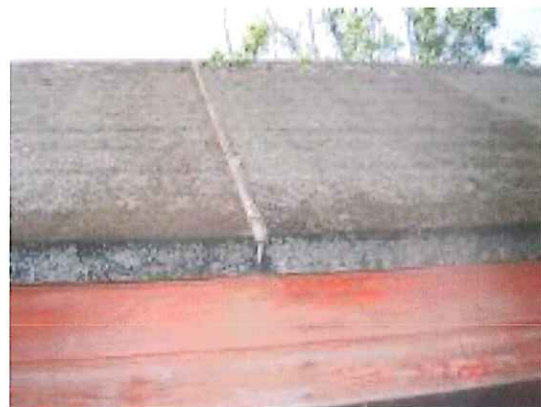
PHOTO 10

Garage roof

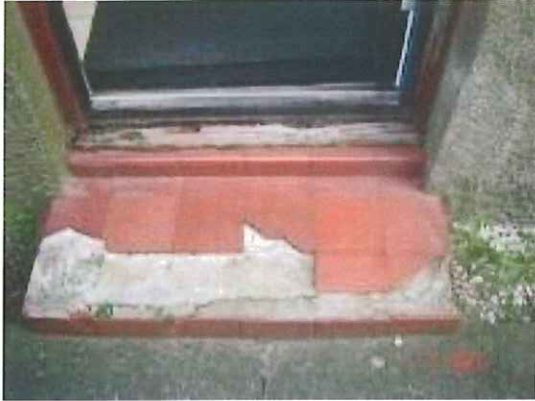
PHOTO 11

- (j) The external step at the kitchen door is in poor condition with broken quarry tiles. The wooden door sill is rotten (photo 11).
- (k) The rendering is cracked at the base of the rear gable wall (photos 12 and 13). This may be the cause of water penetration and dampness.

Ext step at kitchen door

- (c) *To replace the sill at the kitchen door with treated timber or a suitably weatherproofed material.*
- (d) *To repair and, as required replace, the quarry tiling at the kitchen exit step.*

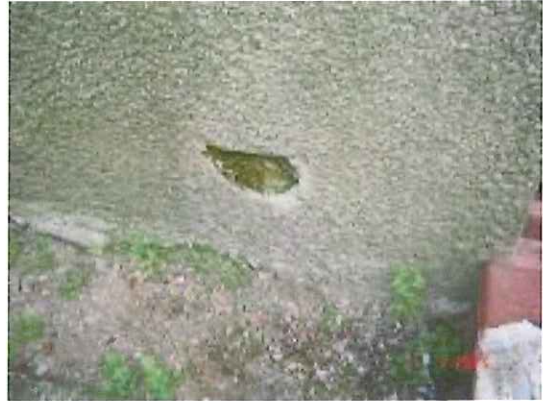
PHOTO 12.

Defective render at gable

- (b) *To identify the source of dampness and to rectify the cause to ensure that the house is wind and watertight; and to redecorate the affected area.*

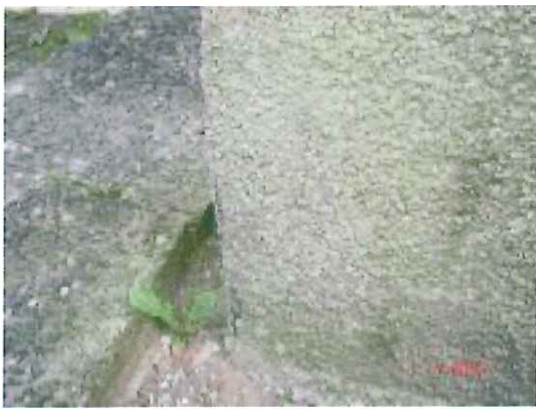
Render crack-gable/rear - PHOTO 13

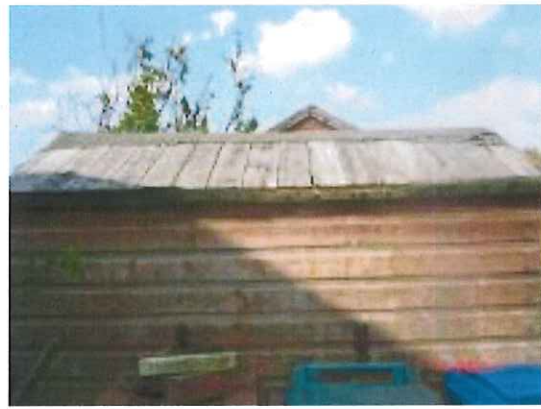
- (i) Felt is missing to the garden shed roof and parts of the timber are rotten (photo 14). From paperwork submitted to the Committee it appears that this item has not been notified to the Landlord.

Shed - PHOTO 14

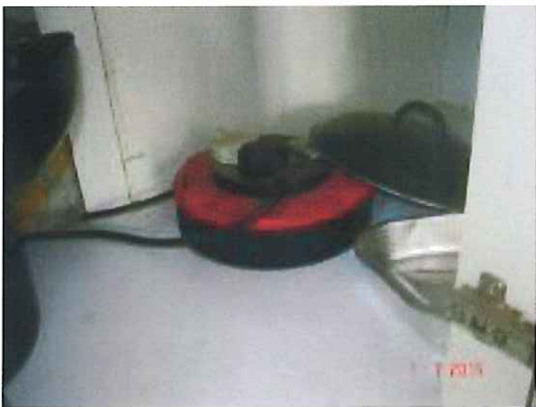
PHOTO 15

- (l) The dishwasher and washing machine are powered from an extension cable in the kitchen (photo 15). The fluorescent strip light in the kitchen does not work and the sole lighting in the kitchen is provided from a table light sitting on top of the fridge/freezer (photo 17). The fuse box in the hall cupboard requires to be checked

Cable extension in kitchen

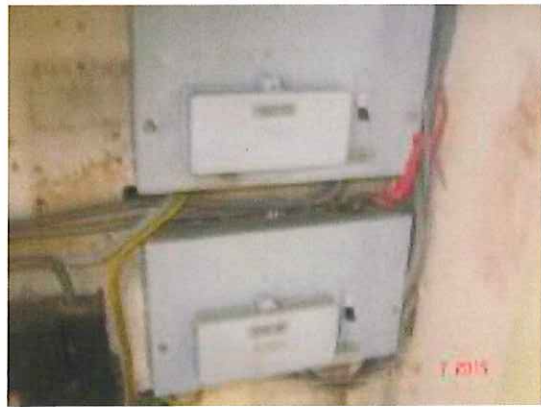
PHOTO 16.

by a qualified electrician given that it is located within a damp cupboard (photo 16).

Fuse boxes

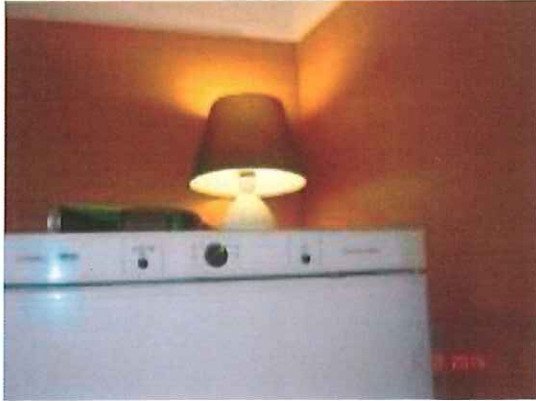
PHOTO 17

Light in kitchen

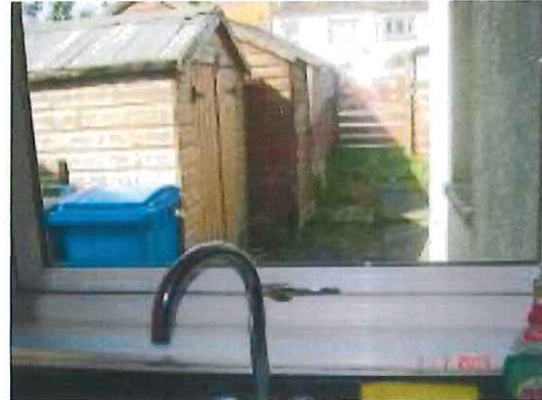
PHOTO 18

- (m) The kitchen window does not lock. The allegation is that the window is insecure and would fall out if opened. For safety reasons this was difficult to check given the associated risks to the Committee members and the possibility of damage to the window if an attempt had been made to open the window (photo 18). The Tenant confirmed there were no window keys. The upstairs hall window, which is the only window which has the means of exit in the event of fire, is locked (photo 32). This creates a risk that the upstairs occupants could not evacuate the house in the event of fire. Some other windows are unlocked and this causes the house to be insecure. Some windows are alleged to be draughty, which was difficult to ascertain at the inspection because of the calm weather conditions. It is possible that the rubber seals are not catching. The bathroom window does not shut and the window handle in the front bedroom is loose (photos 31 and 27).

Kitchen window

- (i) *To repair the windows as required to ensure that the windows are in a reasonable state of repair and in proper working order and draught free and that keys are provided to all windows with a locking mechanism. The hall window upstairs being used as a fire exit must be capable of being safely opened and closed.*

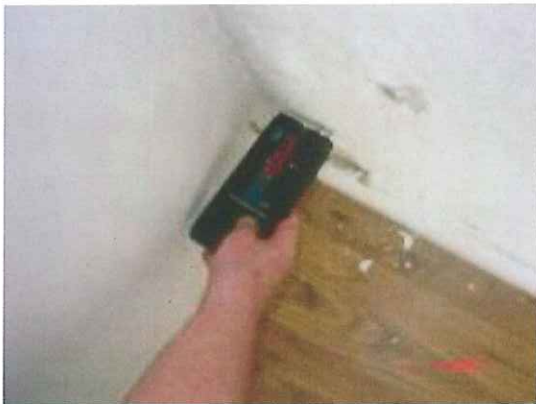
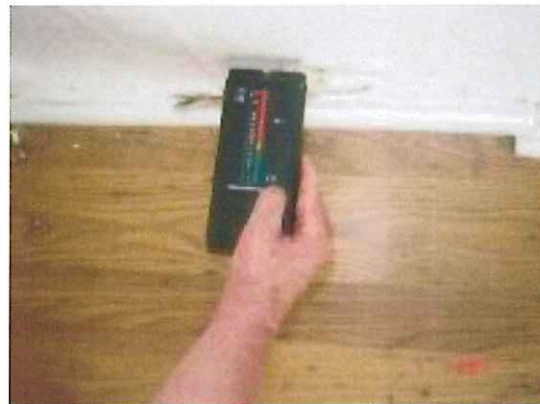
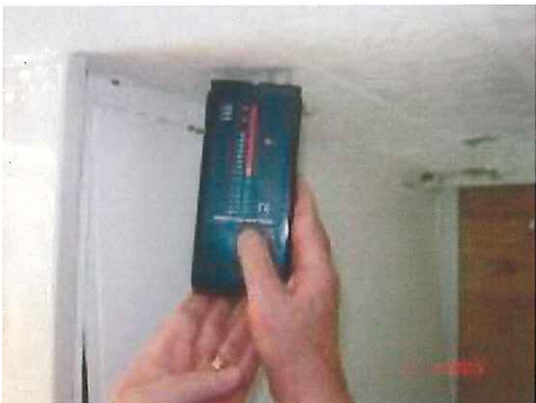
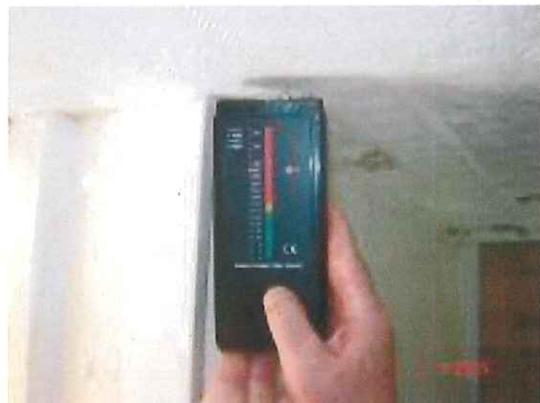
- (n) The damp meter displayed high moisture readings indicative of the presence of dampness in the vicinity of the downstairs hall window (photos 19-23) and in the electrical cupboard housing the fuse box (photos 24 and 25).

Damp reading-hall wall - PHOTO 19

Damp reading-hall wall - PHOTO 20

Damp reading-hall wall
PHOTO 21

Damp reading-hall wall
PHOTO 22

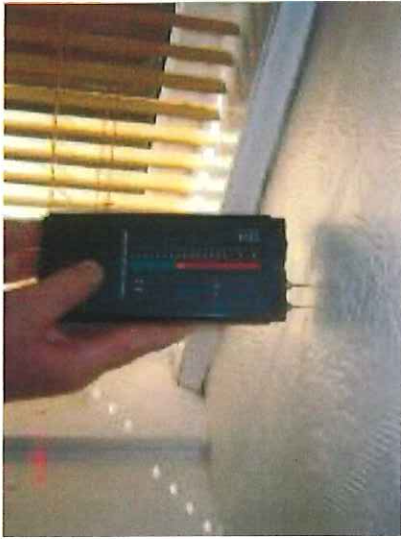
PHOTO 23.

Damp reading

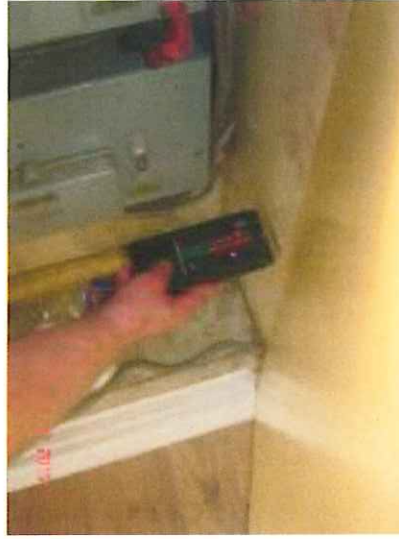
PHOTO 24

Damp reading in meter cpd

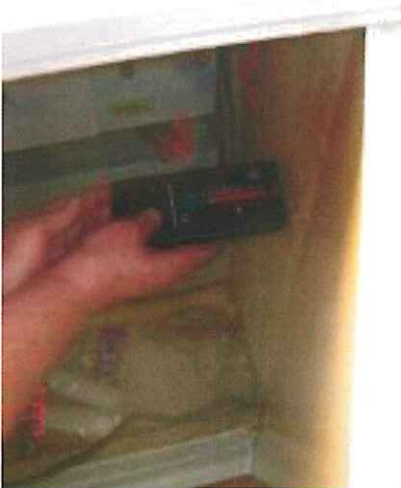
Damp reading - PHOTO 25

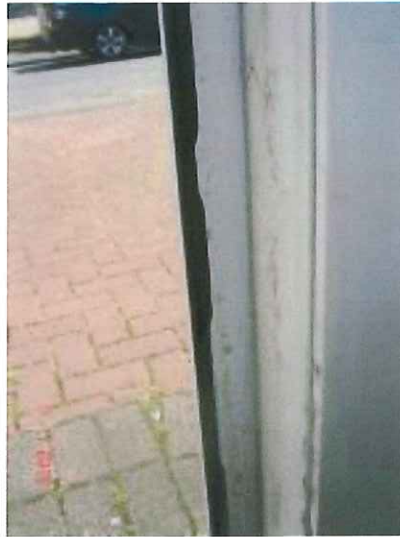
- (o) The rubber seal on the front door frame is twisted and is not performing its function as a draught excluder (photo 26).
- (p) The stairs to the first floor are open and there is no banister to prevent a fall onto the lower level (photo 29). This would be a particular danger to young children and anyone who has an unsteady gait. From paperwork submitted to the Committee it appears that this item has not been notified to the Landlord.

Front doorframe seal - PHOTO 26

- (j) *To repair the skylight velux window so that it is in a reasonable state of repair and in proper working order.*
- (k) *To repair the front door to ensure it is wind and watertight and draught free.*

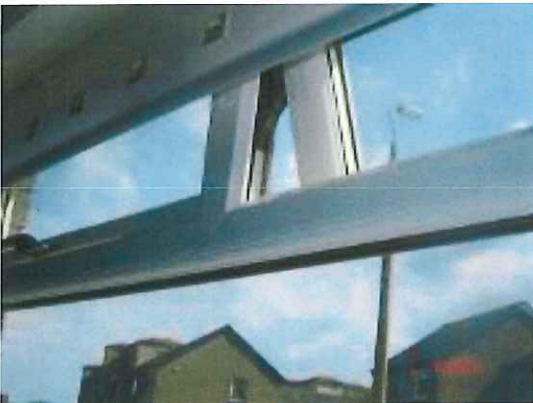
PHOTO 27

Living Room window

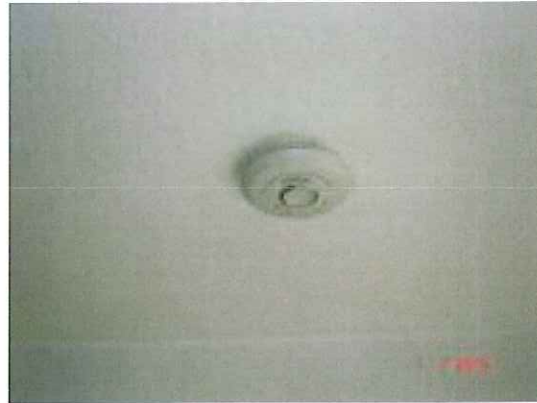
PHOTO 28

- (q) There are battery smoke detectors on the ceiling of the ground floor hall (photo 28), on the upper floor landing (photo 30) and on the attic ceiling (photo 35). The devices were checked by the Committee and the ground floor and attic devices do not work.

Ground floor hall - smoke alarm

(m) To install fire detection devices in the house which comply with the current guidance issued by Scottish Ministers for the provision for such devices. A copy of the Statutory Guidance referred to is attached to this Order.

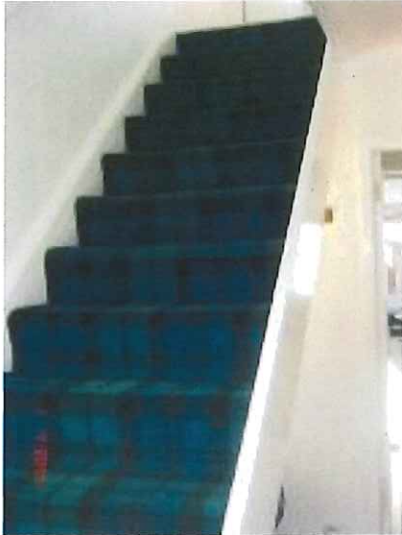
PHOTO 29

Main staircase

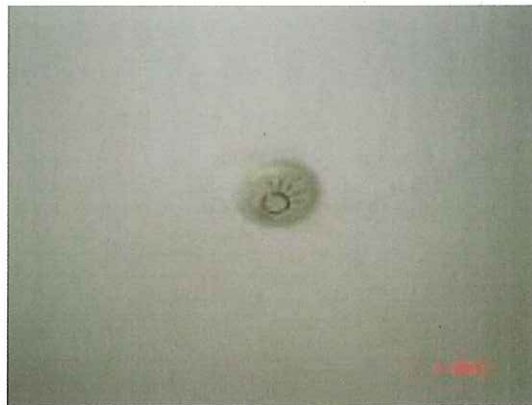
PHOTO 30

Upper floor landing – smoke alarm

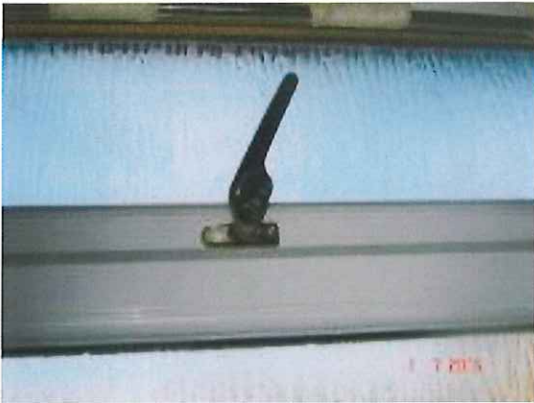
Bathroom window - PHOTO 31

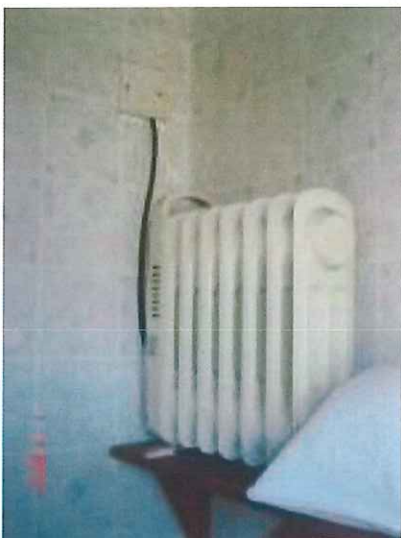
- (r) In the bathroom there is an electrical heater with an electric cable leading from a socket. It is doubtful if this configuration complies with electrical regulations (photo 33)

Bathroom-electric radiator
PHOTO 33.

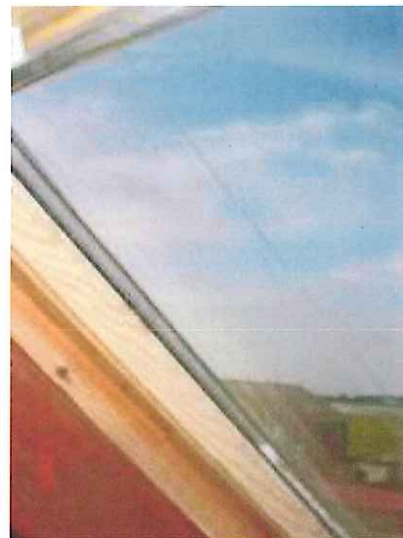
- (s) The glazing is cracked in the attic velux window (photo 34).
- (t) There are exposed bare wires in the attic (photo 36).
- (u) The access to the attic is by means of timber open stairs which are not fixed. The attic conversion does not appear to conform to building regulations.

Velux window
PHOTO 34

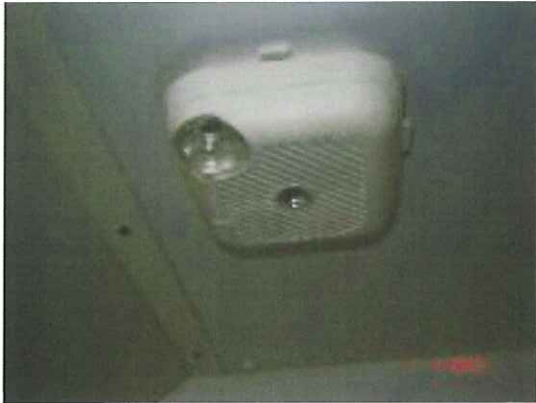
PHOTO 35

Attic smoke alarm

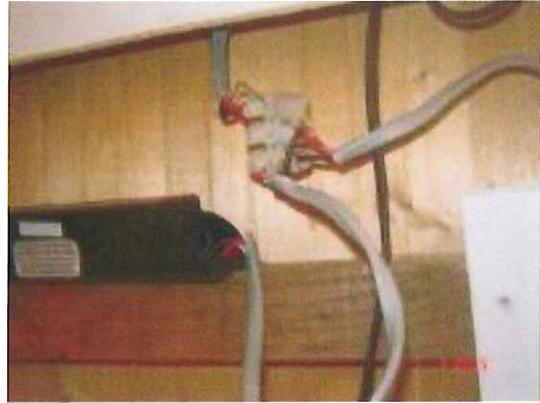
PHOTO 36

Attic-electric wiring

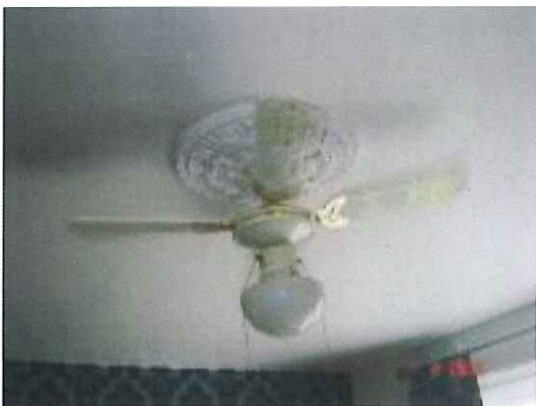
- (w) The ceiling light in the living room with fan attachment is unsafe and when it is switched on the fan rotates with such vigour that the glass bowl swings unsafely (photo 37).

Living room-fan light - PHOTO 37

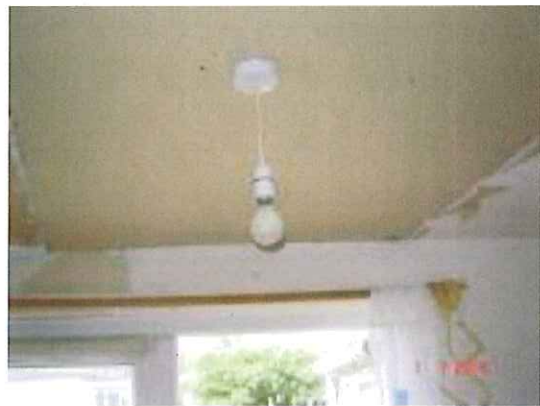
- (v) The bathroom ceiling light does not work, nor does the ceiling light in the dining room extension (photo 38). The ceiling in the dining room has a plasterboard repair which has not been finished. From paperwork submitted to the Committee it appears that this item has not been notified to the Landlord.

Ground floor bed ceiling - PHOTO 38

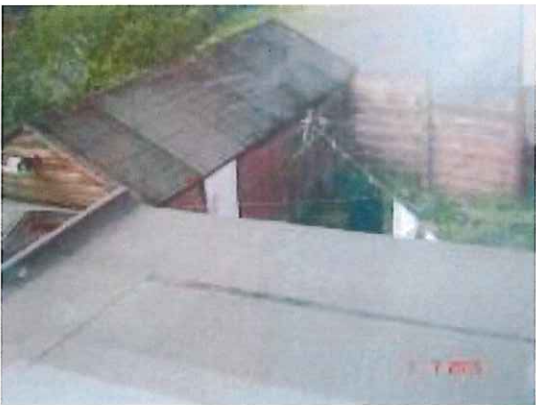
PHOTO 39

- (x) The felt on the flat roof extension does not overlap at one section (photo 39). This is likely to be a future weakness and may result in water penetration but is not the subject of complaint in the application. From paperwork submitted to the Committee it appears that this item has not been notified to the Landlord.

Rear ext roof/garage

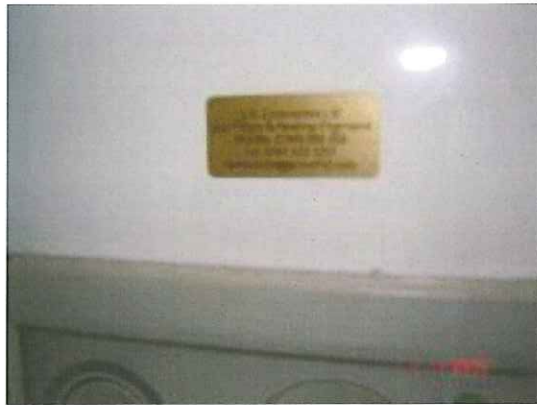
PHOTO 40

- (y) The sticker on the boiler provides the name of the installer (photo 40). It is SR Contractors Ltd. Enquiries by the Committee reveal this company is registered in the Gas Safe register (registration number 132449).

Gas boiler installer

- (l) *To produce an up to date and satisfactory Gas Safe certificate for the gas*

installation, the boiler and central heating system and any gas appliances provided by the Landlord.
